Final Reclamation Inspection

Operator: KERR MCGEE OIL & GAS ONSHORE LP #47120

Location ID: 305800

Inspection Photos
Location Name: DEWALT #19-11
Location ID: 305800

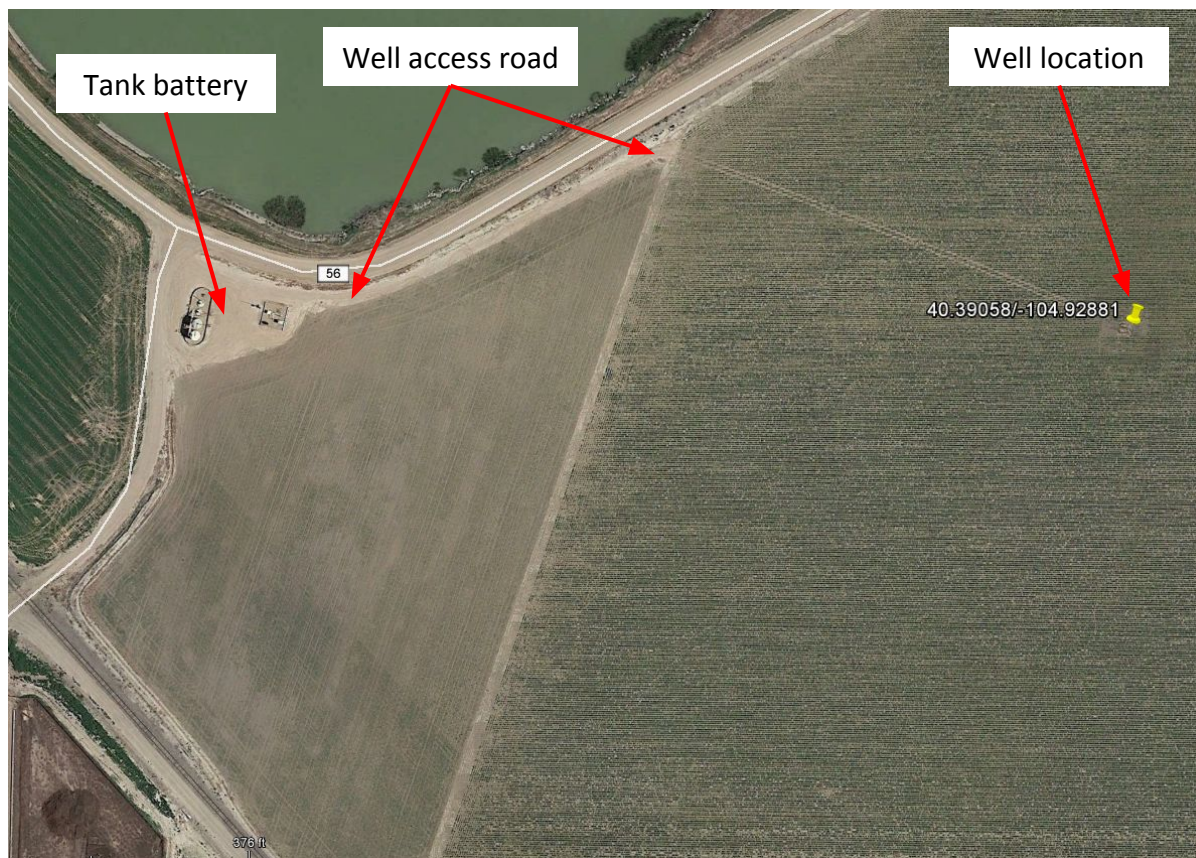
Google Earth aerial imagery taken June 19, 2014 during active operations. Photo illustrates the tank battery, well access road, and well location.

During the March 19, 2019 inspection, the tank battery and well access road remain and have not been reclaimed.

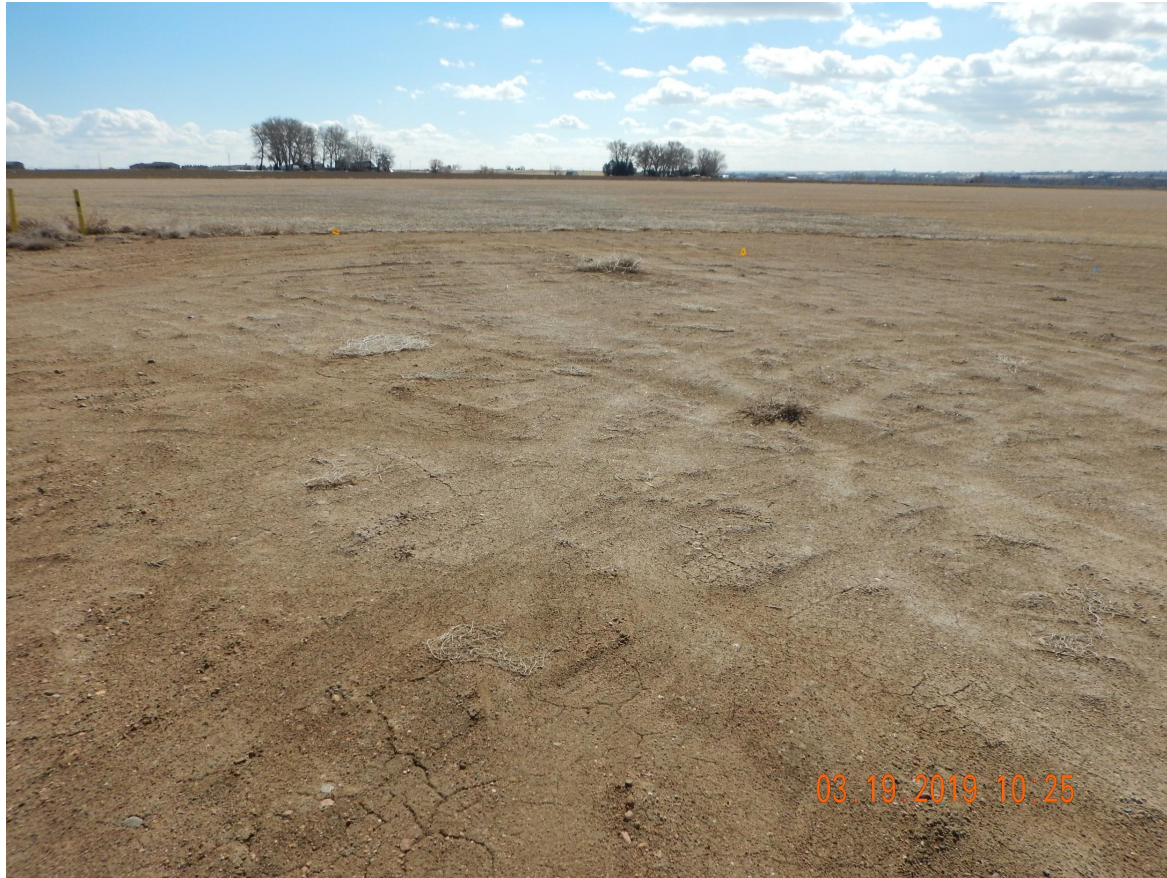
Photo 1. Photo taken from the tank battery location, facing South. Operator has failed to perform final reclamation activities at the tank battery and well access road.

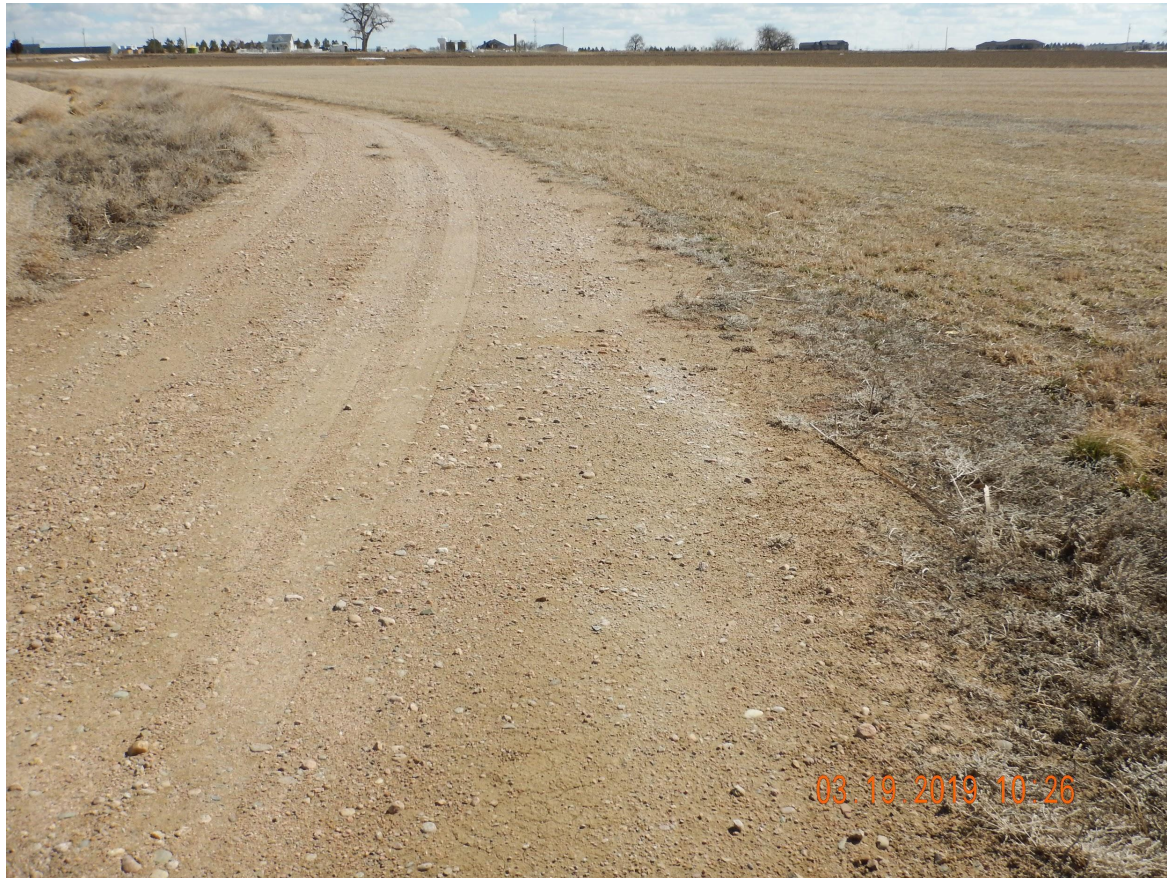
Photo 2. Photo taken from the western well access road, facing East. See comments under Photo 1.

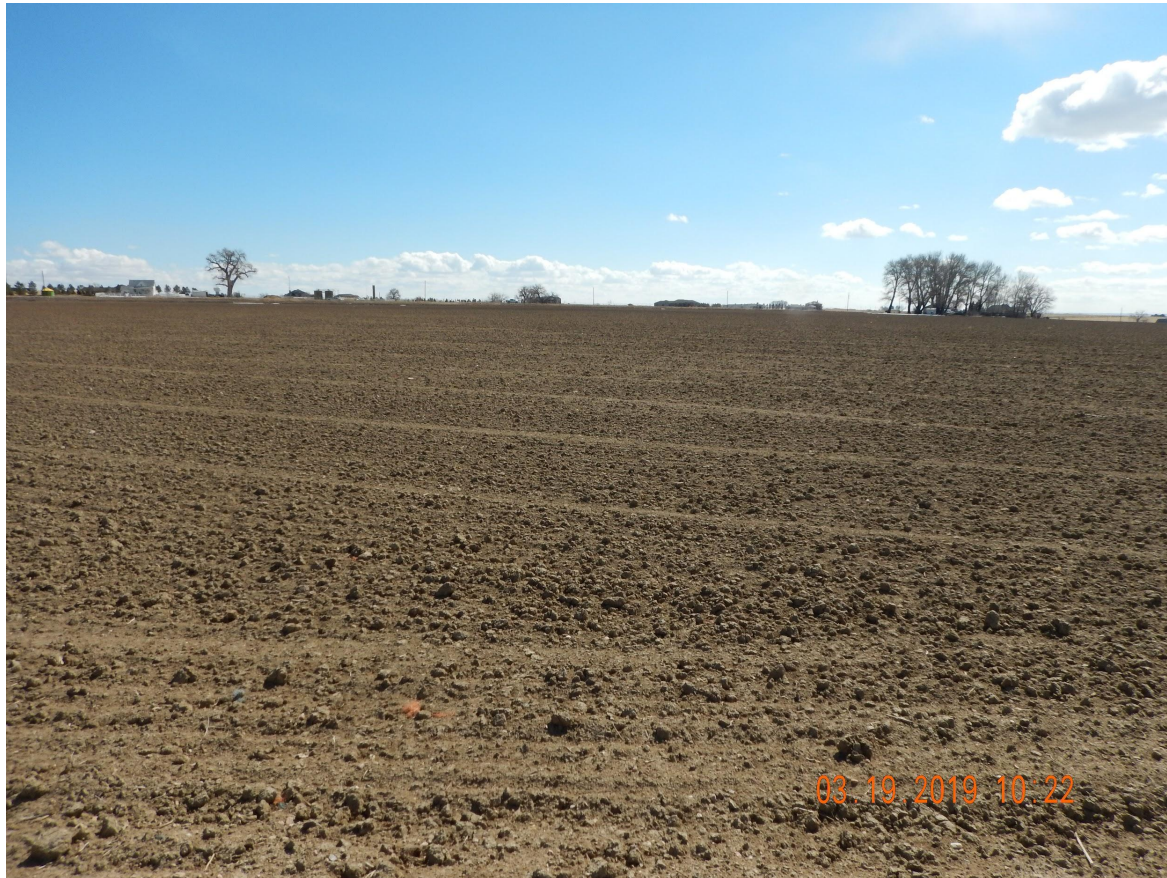
Photo 3. Photo taken west of the PA well location, facing East. A follow up inspection will have to occur during the growing season to assess the vegetative growth to ensure compliance with Rule 1004 standards.
