Inspection Photos

Operator: NOBLE ENERGY INC - 100322

Location ID: 422406

Inspection Doc. Number: 682504688

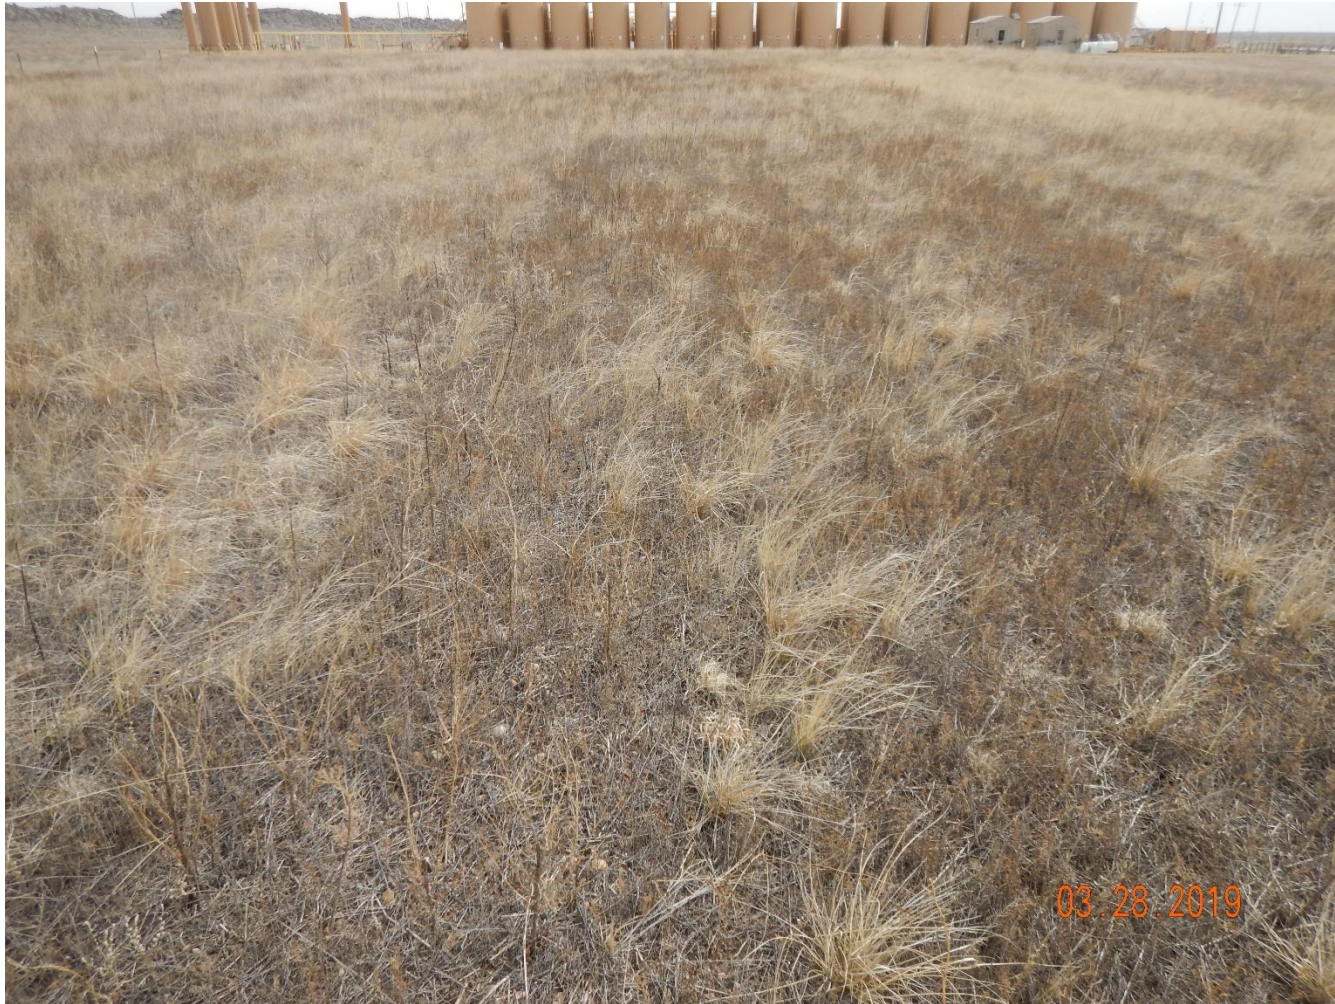
Photo 1: Photos taken from the northern interim area of the west end of the location, facing east. Photo shows vegetation over the reclamation area. Reclamation appear to be progressing towards COGCC 1000 standards, however large areas of the interim remain predominantly undesirable weedy plant species that may be hindering desirable perennial vegetative establishment. Weed management and additional seeding activities may be required for reclamation to meet COGCC reclamation standards.

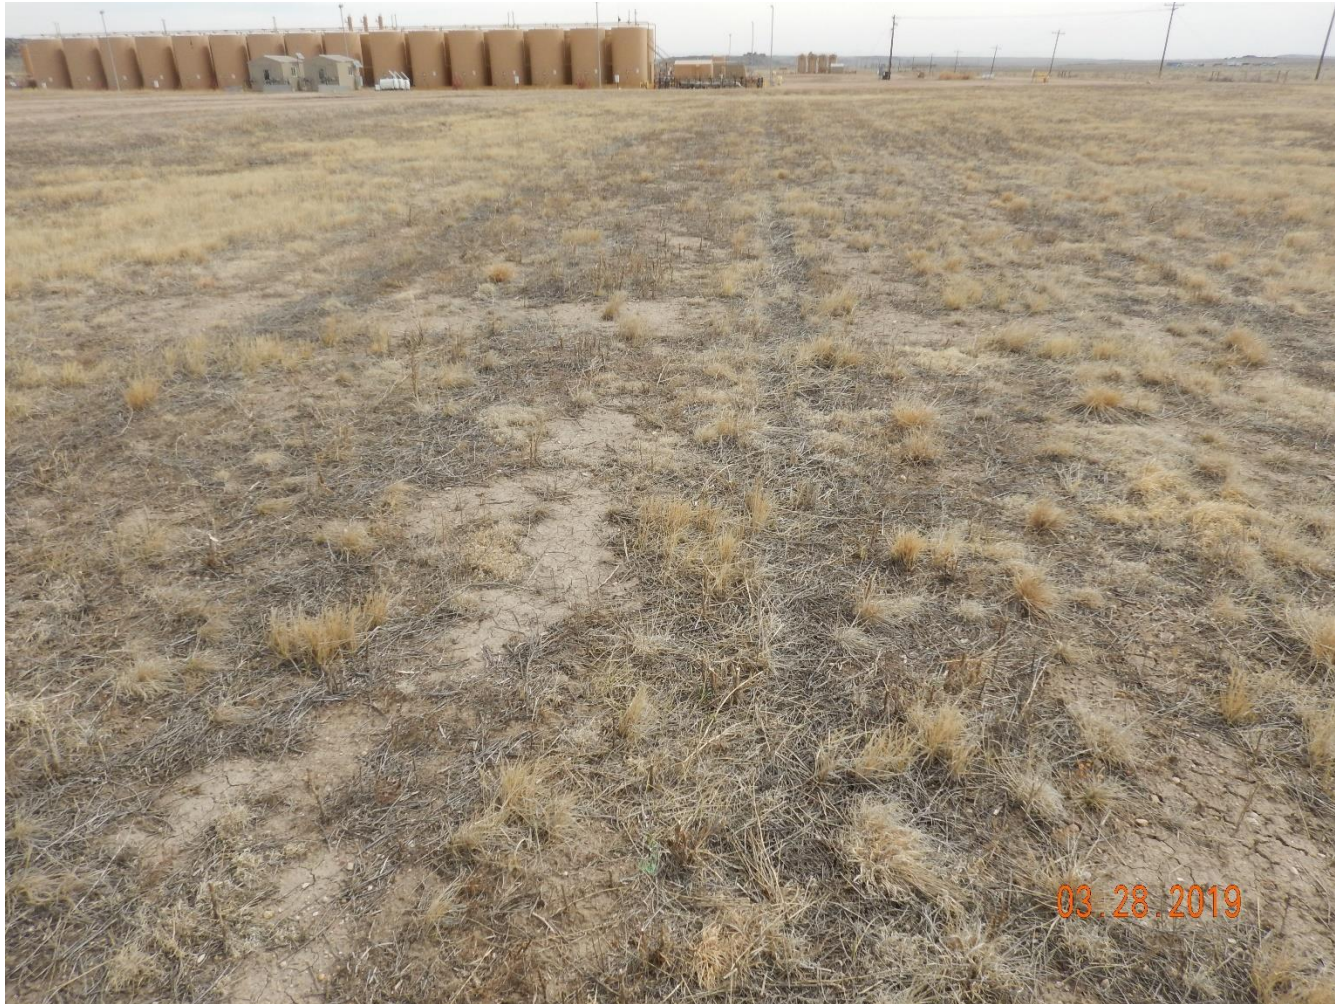
Photo 2: Photos taken from the southern interim area of the west end of the location, facing east. See comments under photo 1

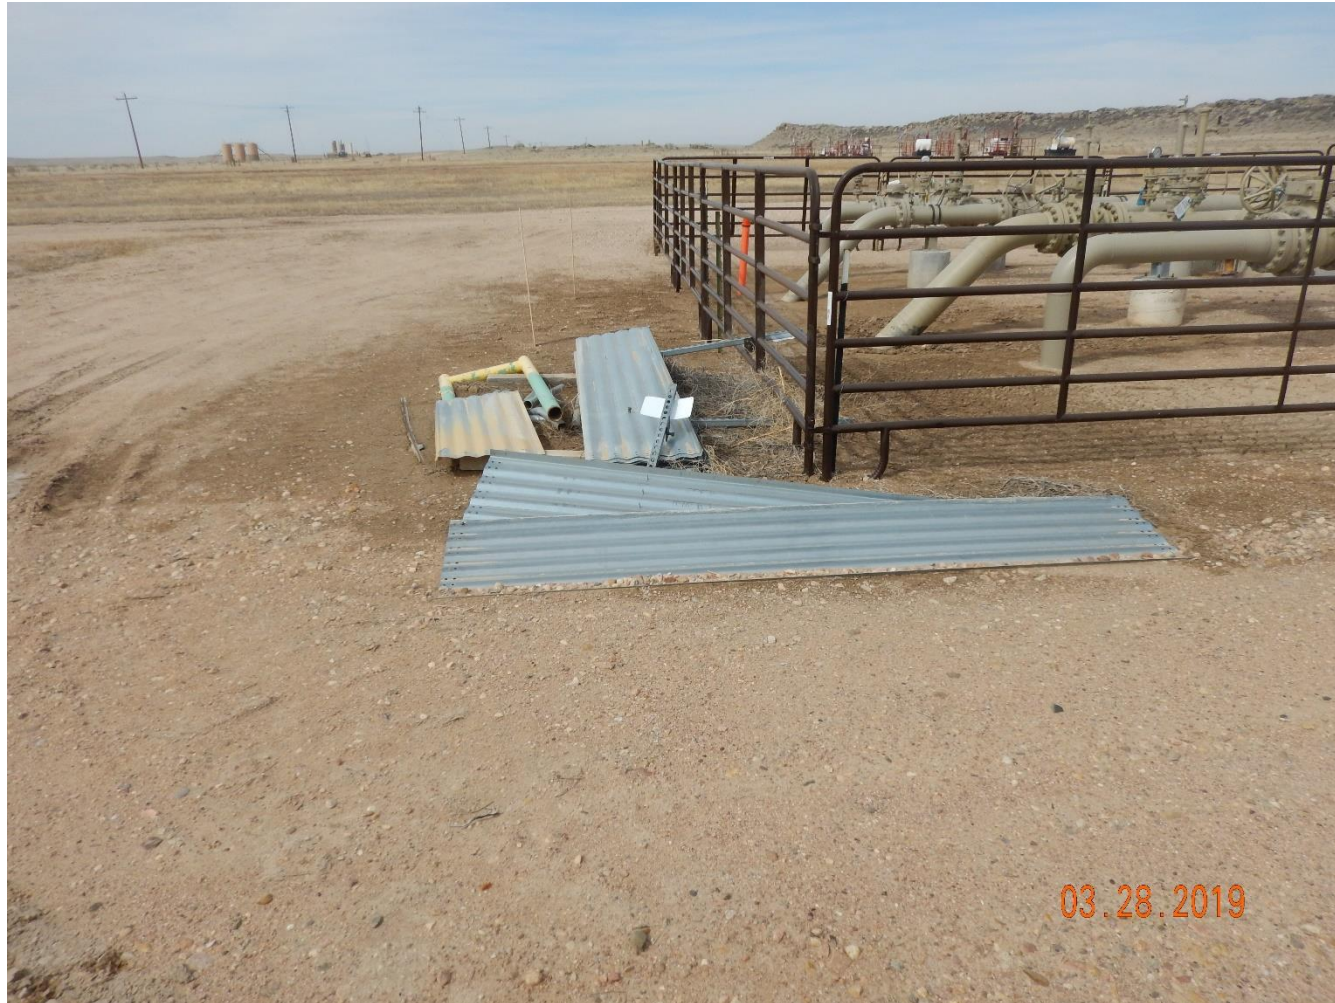
Photo 3: Photo taken from the west end of the battery, facing west. Photo shows various trash debris, or equipment being stored on the location.

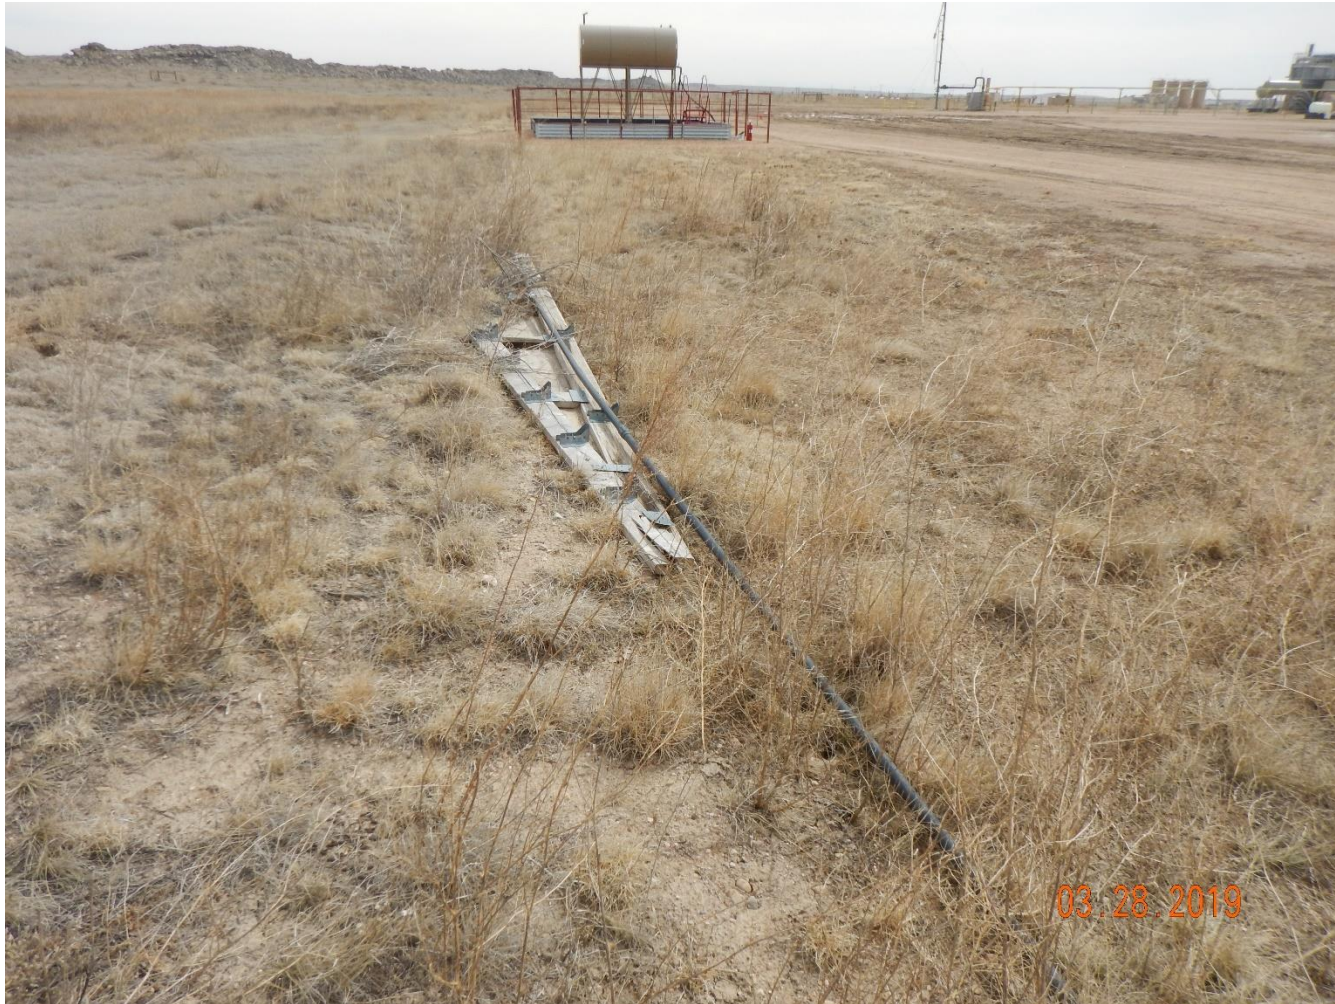
Photo 4: Photo taken from the north end of the battery, facing east. Photo shows various trash debris, or equipment being stored on the location.

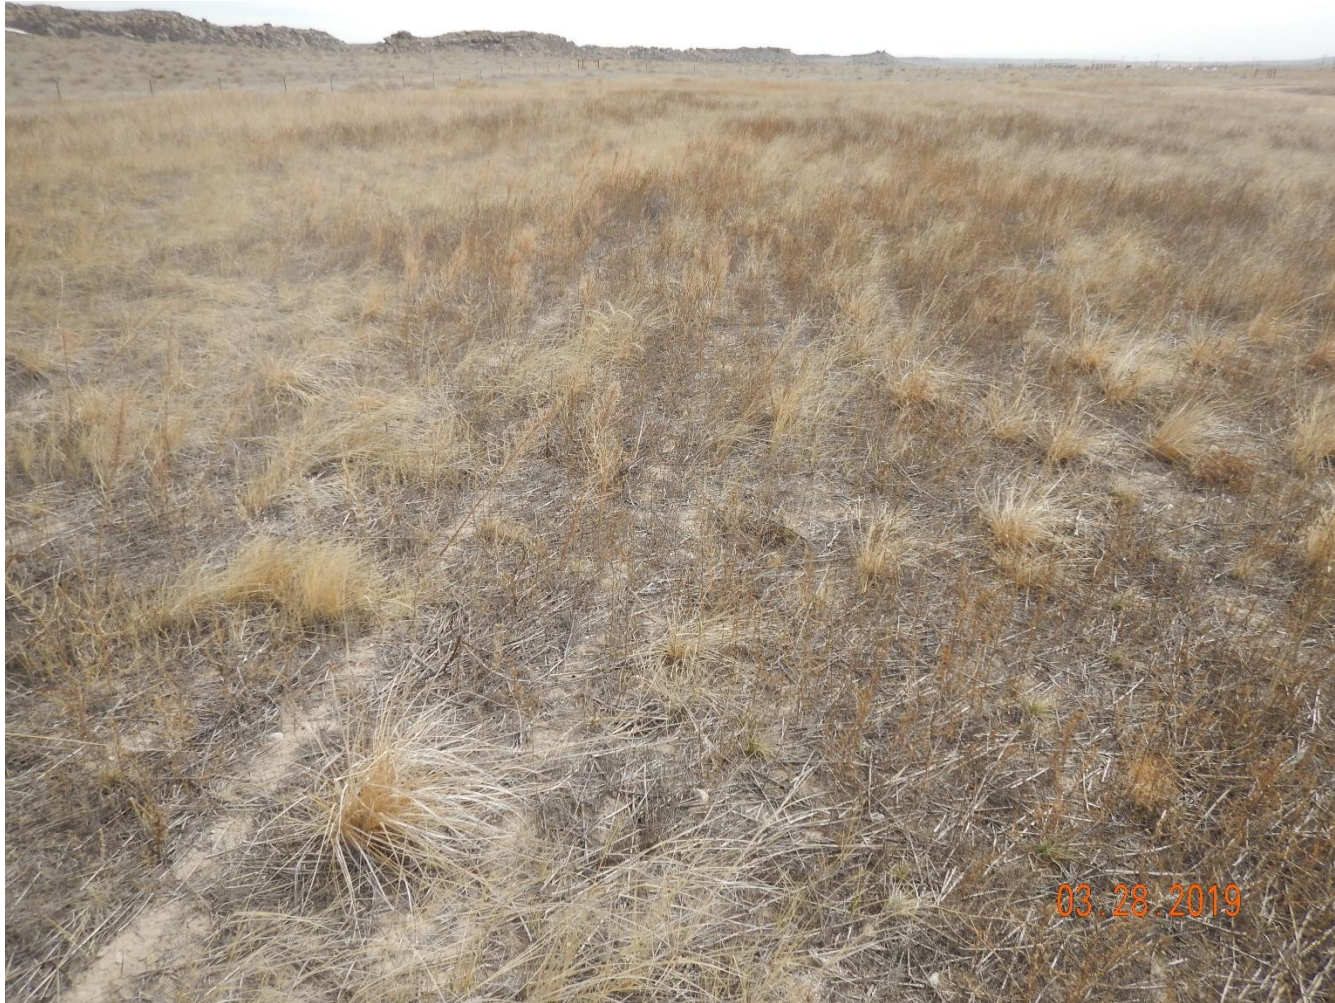
Photo 5: Photo taken from the northern interim area of the location, facing east. Photo shows vegetation over the reclamation area. Reclamation appear to be progressing towards COGCC 1000 standards, however large areas of the interim remain predominantly undesirable weedy plant species that may be hindering desirable perennial vegetative establishment. Weed management and additional seeding activities may be required for reclamation to meet COGCC reclamation standards.

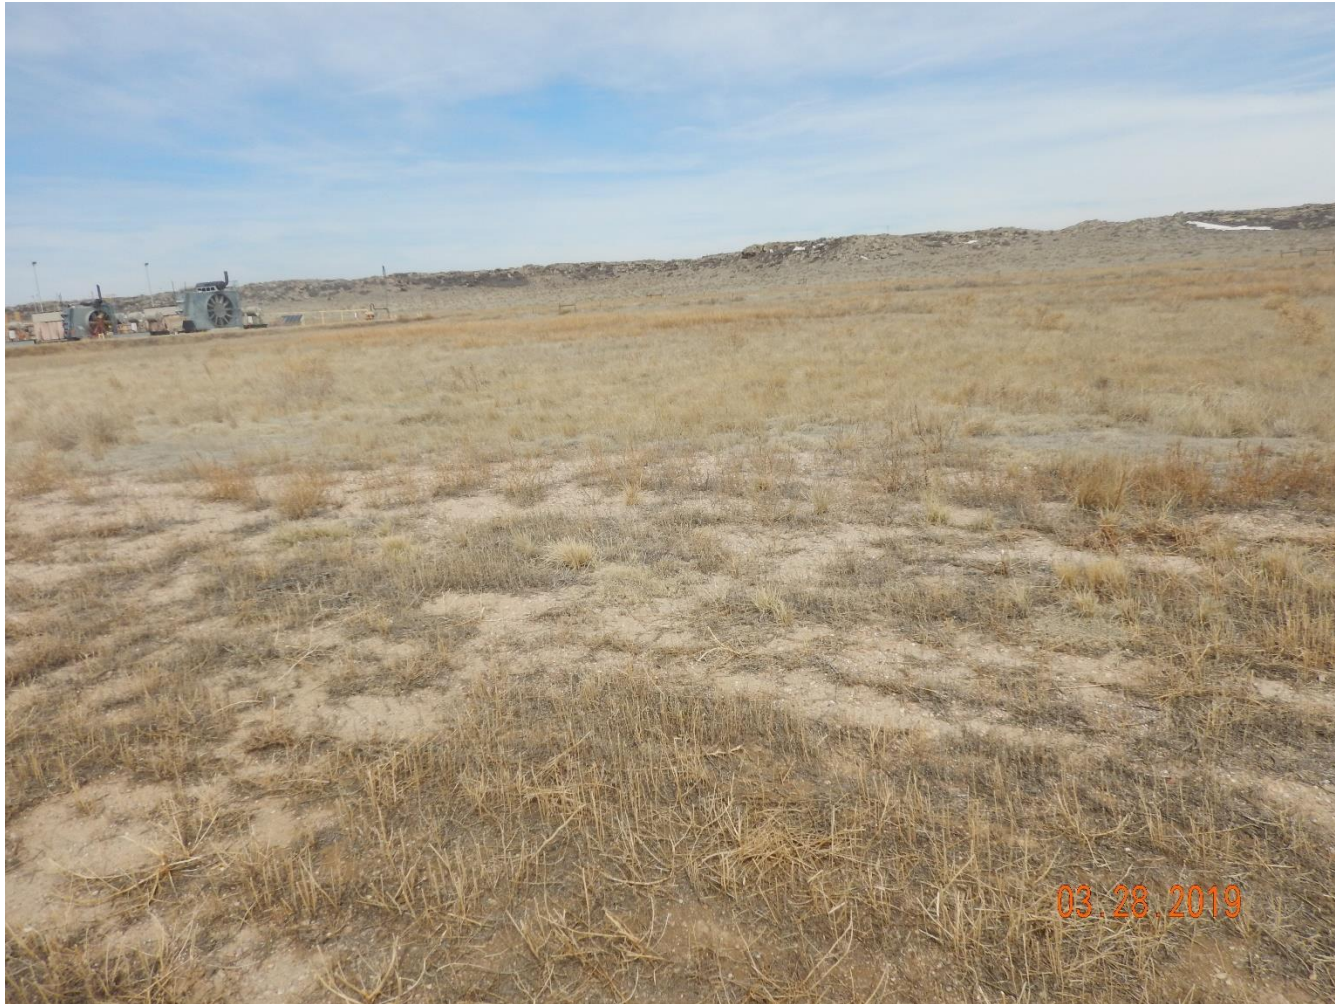
Photo 6: Photo taken from the northern interim area of the location, facing northwest. See comments under photo 5.

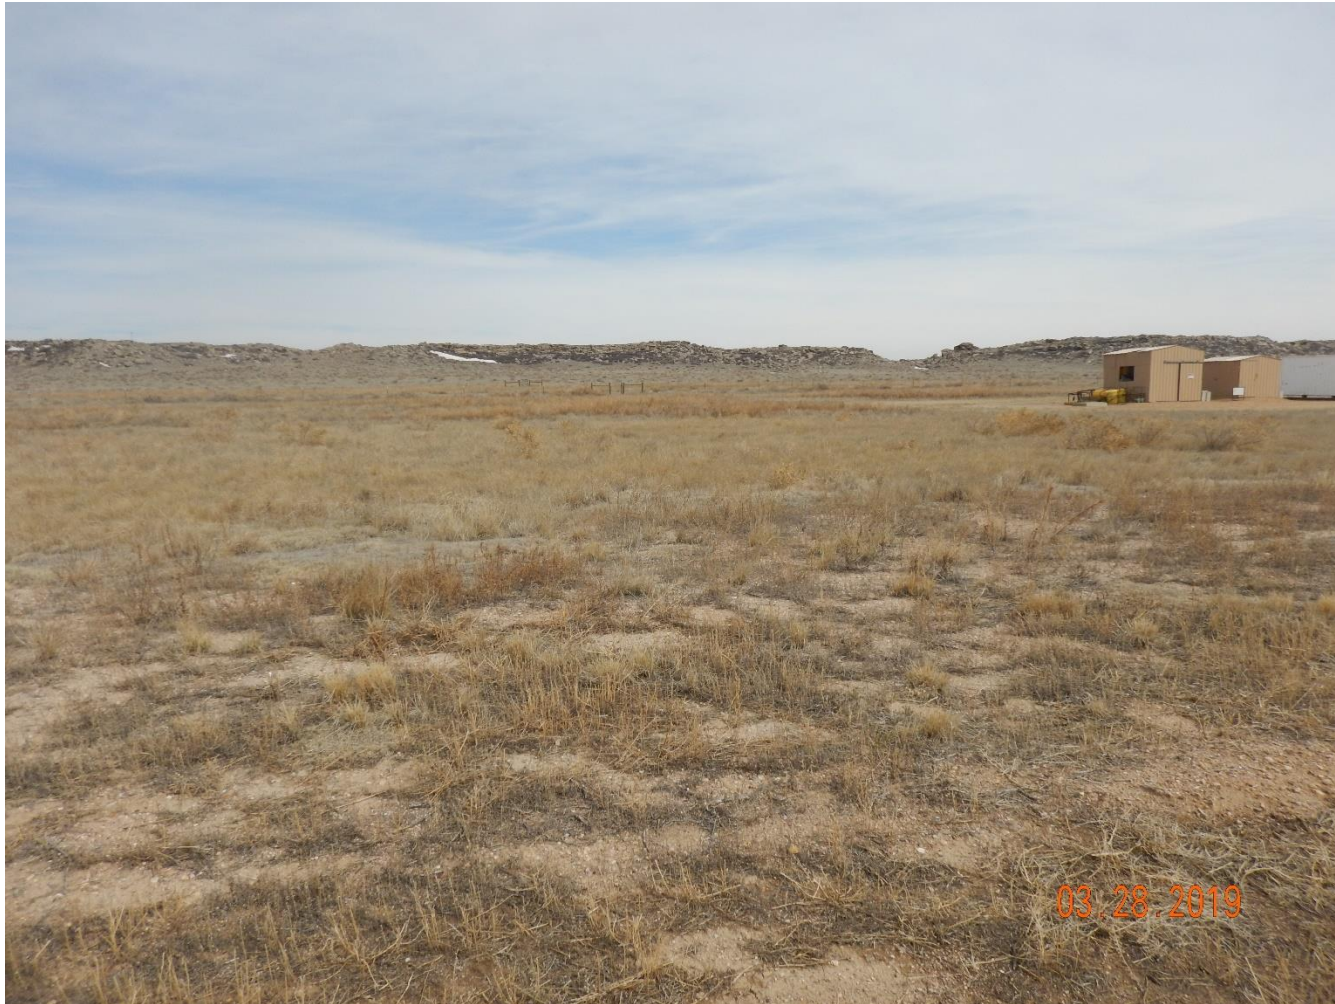
Photo 7: Photo taken from the northern interim area of the location, facing northeast. See comments under photo 5.

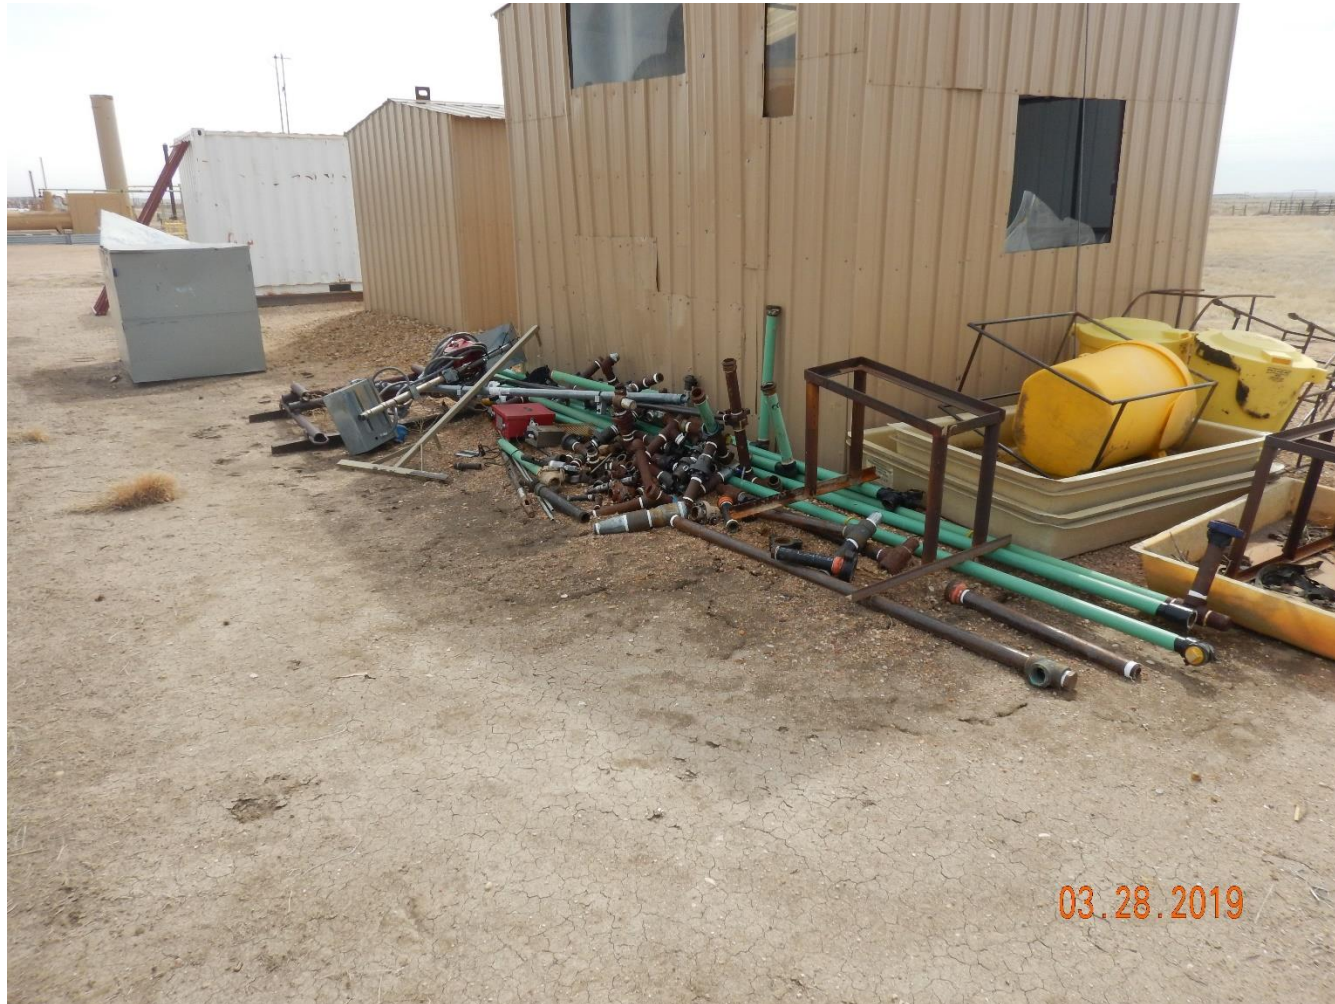
Photo 8: Photo taken from the north end of the battery. Photo shows various trash debris, or equipment being stored on the location.

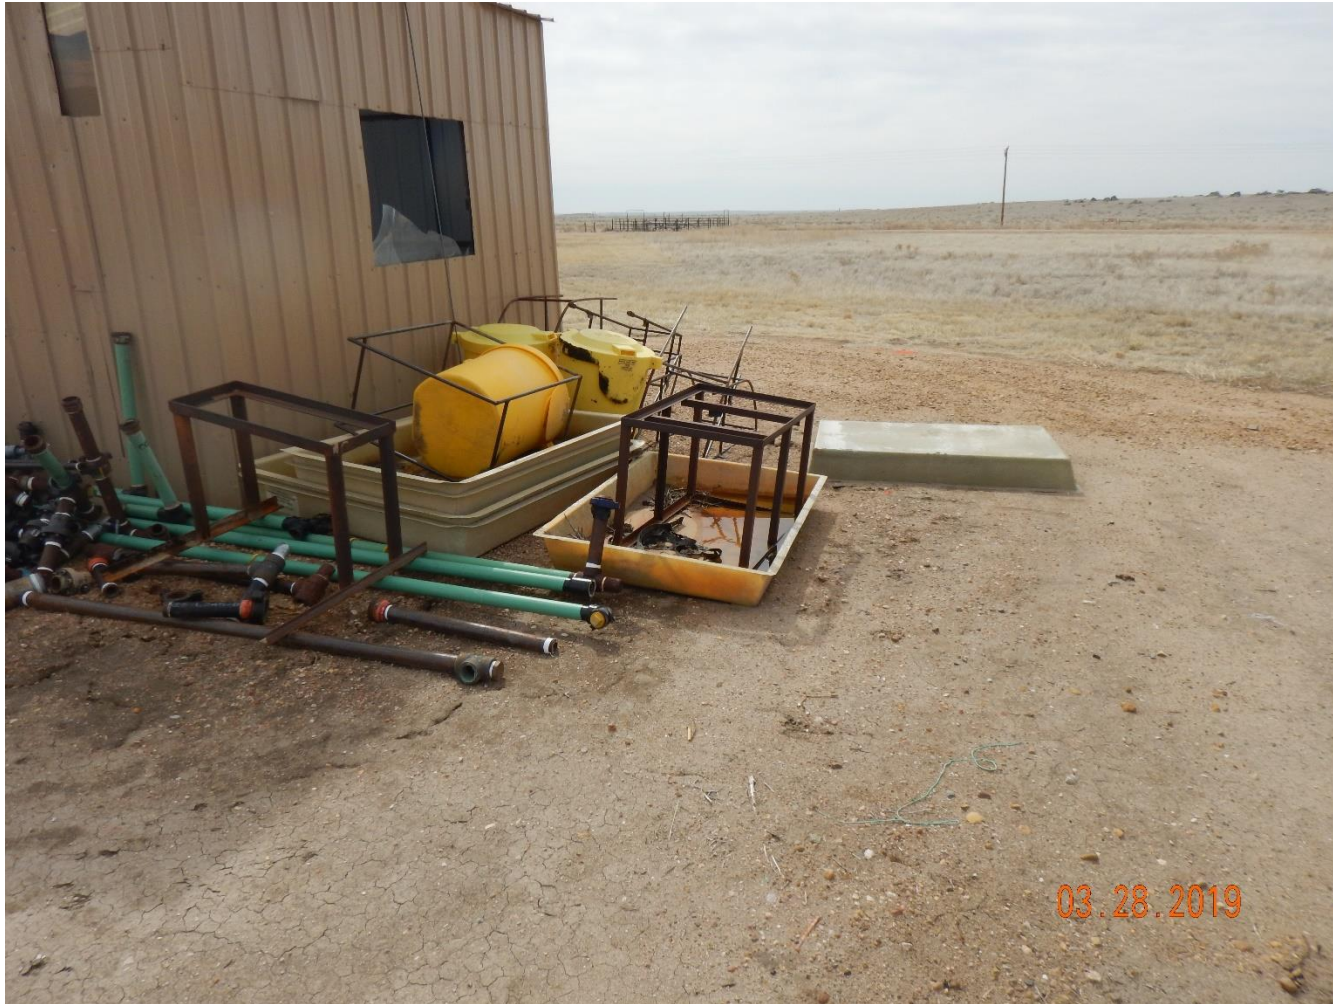
Photo 9: Photo taken from the north end of the battery, facing east. Photo shows various trash debris, or equipment being stored on the location.

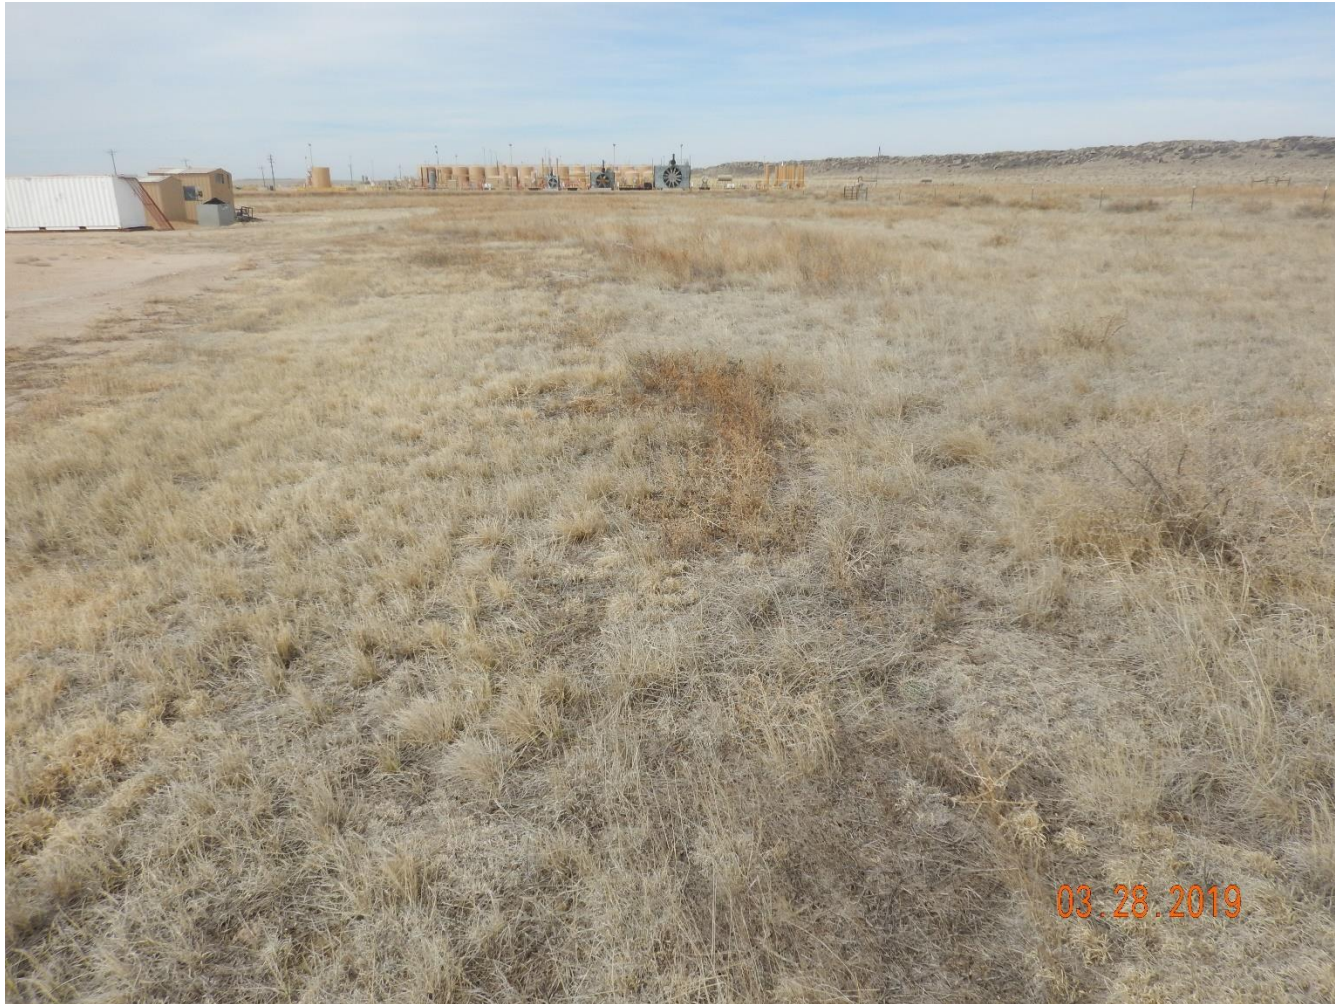
Photo 10: Photo taken from the northern interim area of the location, facing west.
See comments under photo 5.

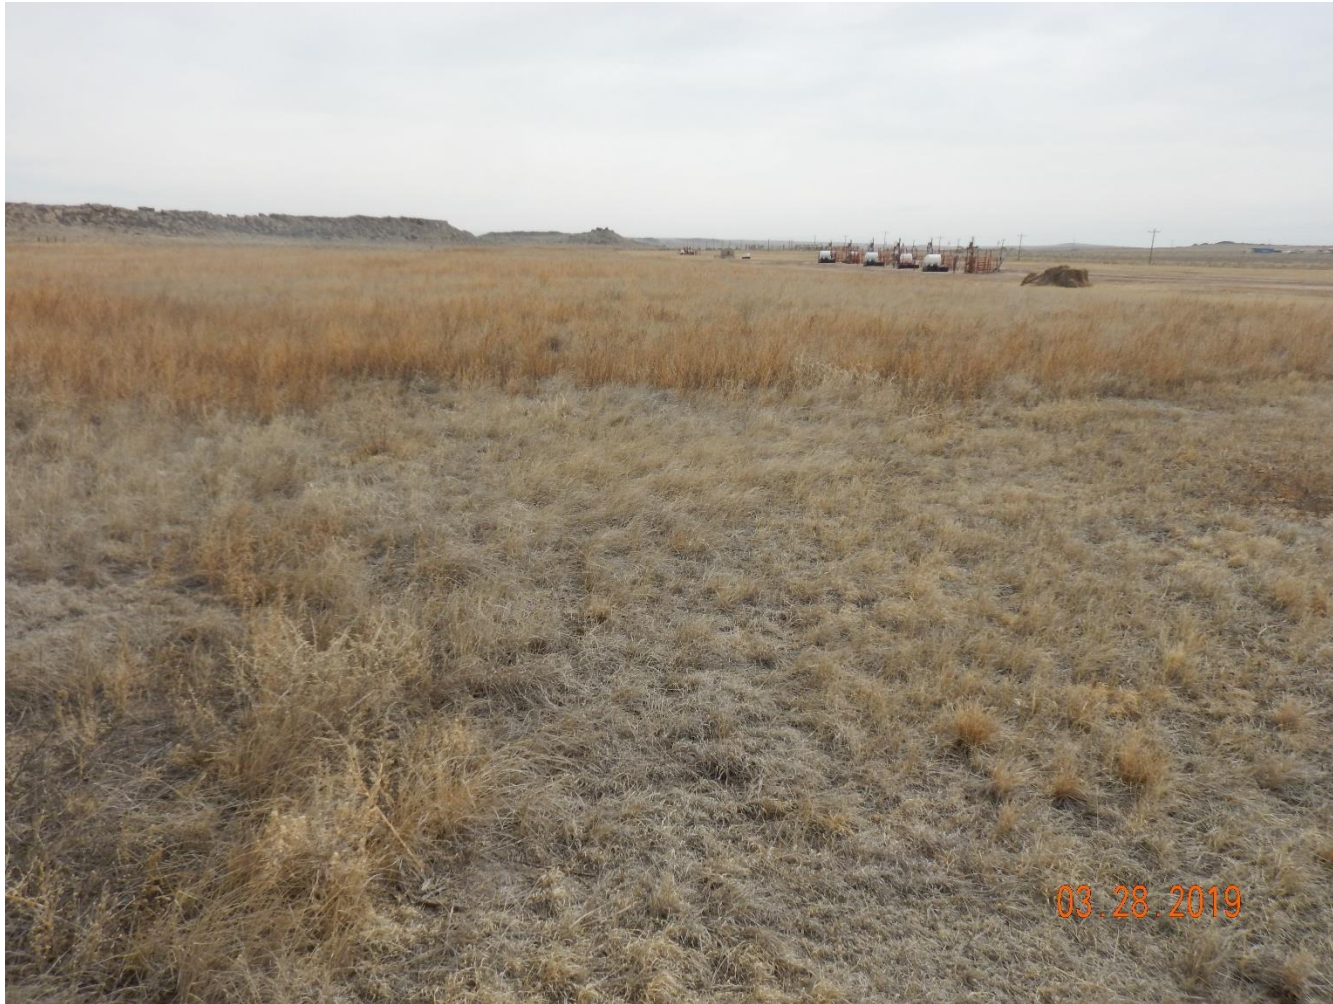
Photo 11: Photo taken from the northern interim area of the location, facing east. See comments under photo 5.

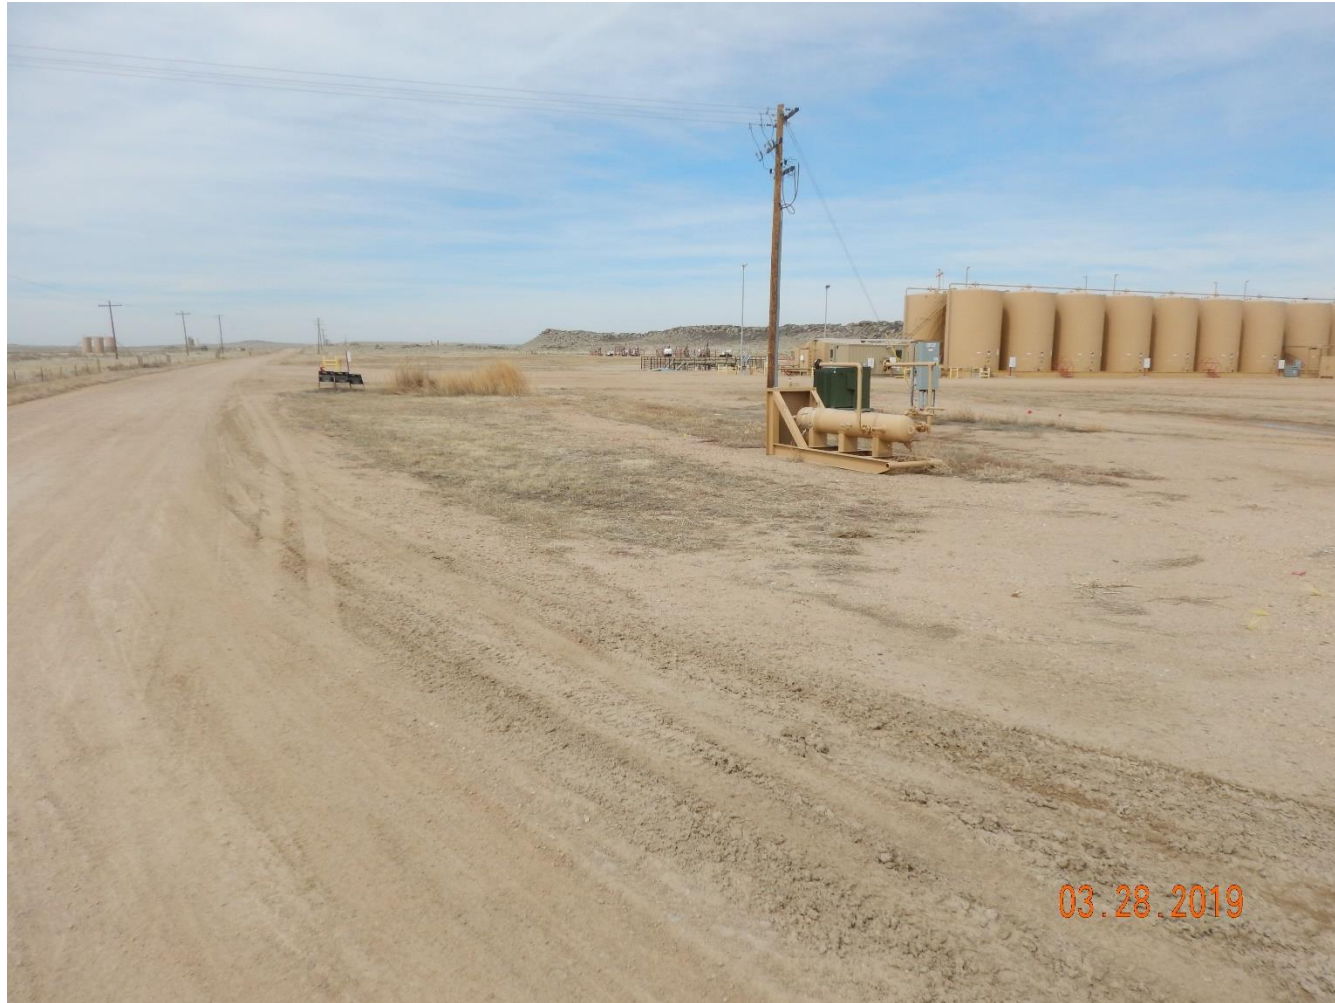
Photo 12: Photo taken from the south end of the battery, facing west. Photo shows unused equipment being stored on the location.

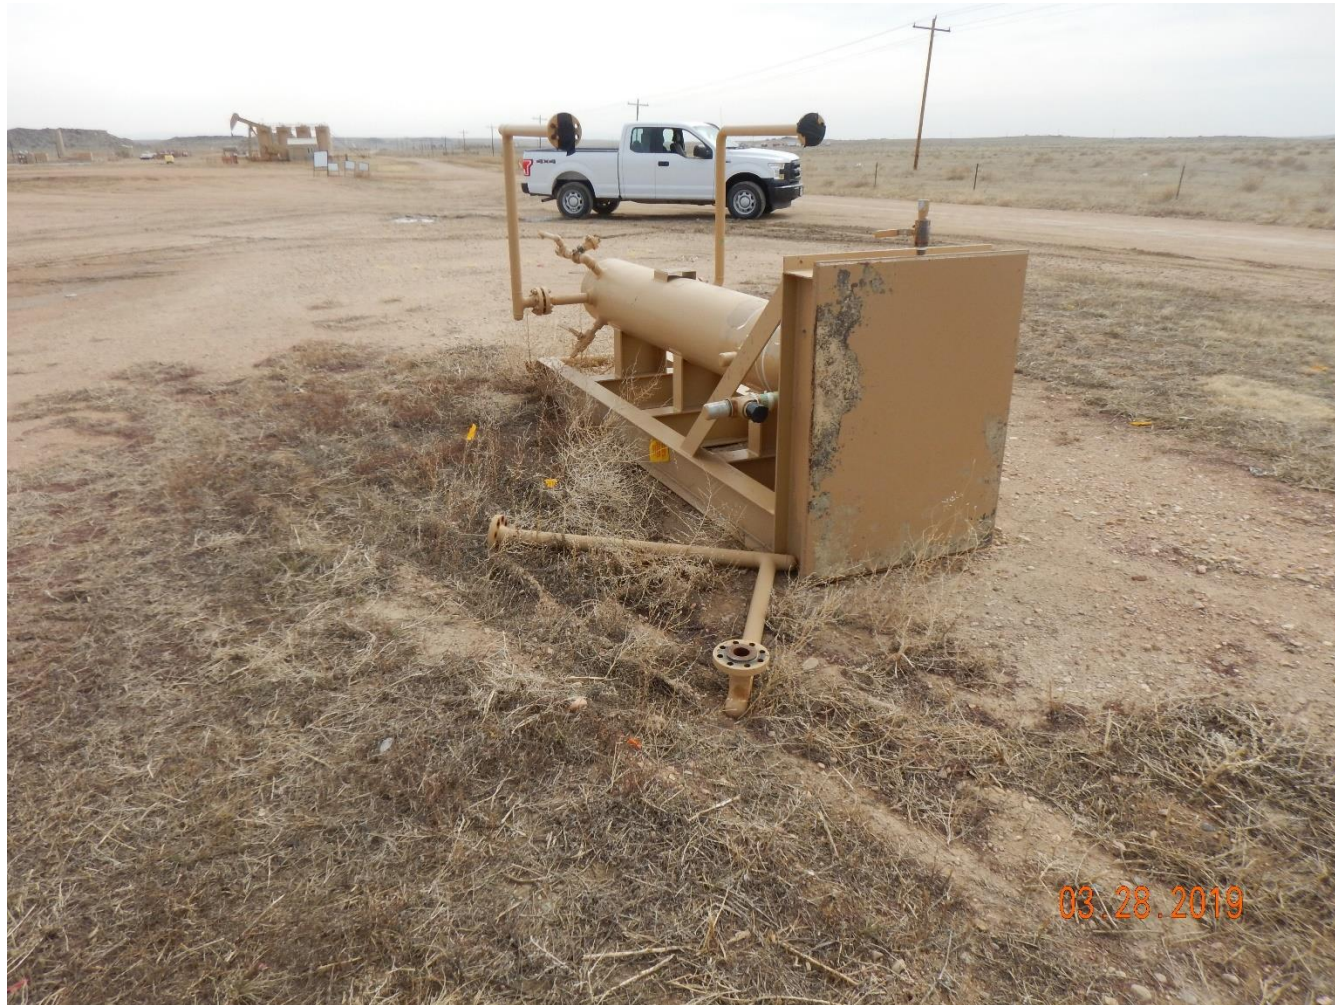
Photo 13: Photo taken from the south end of the battery, facing east. Photo shows unused equipment being stored on the location.

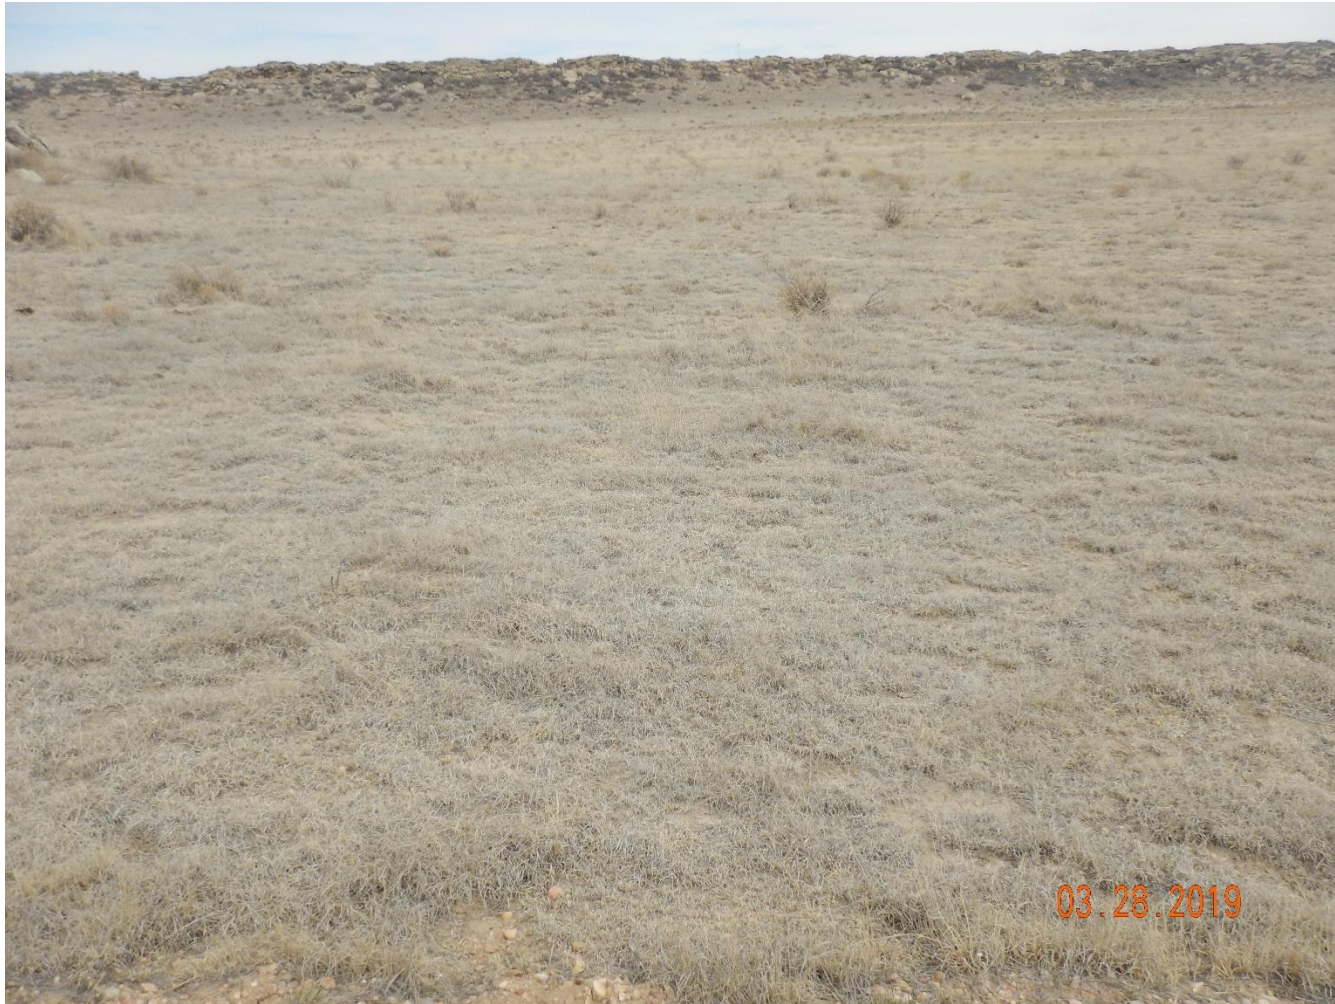
Photo 14: Photo shows vegetation on the reference area.
