Inspection Photos
Location Name: Bruton 30-03 Pad
Location ID #451421
Inspection Date: March 27, 2019

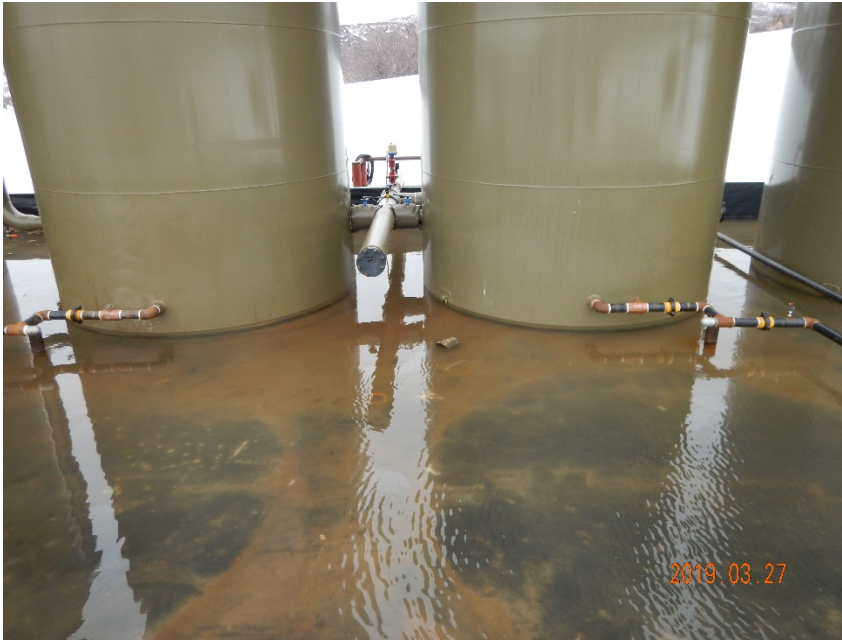
Photo #1 – View of fluids inside of tank battery containment berm, looking east.

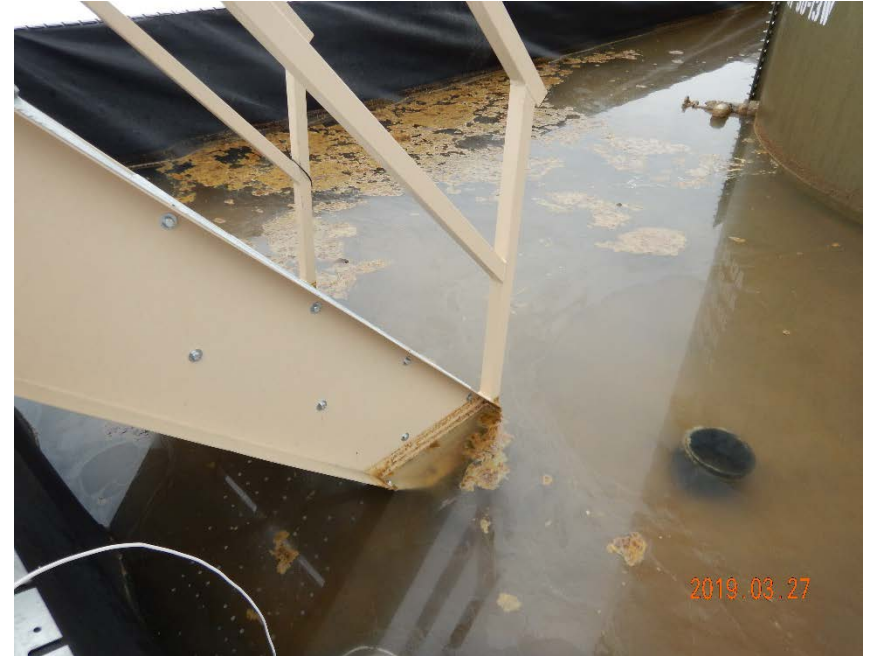
Photo #2 – View of fluids inside of northeast corner of tank battery containment. Note visible sheen and presence of waxy material on top of fluids.

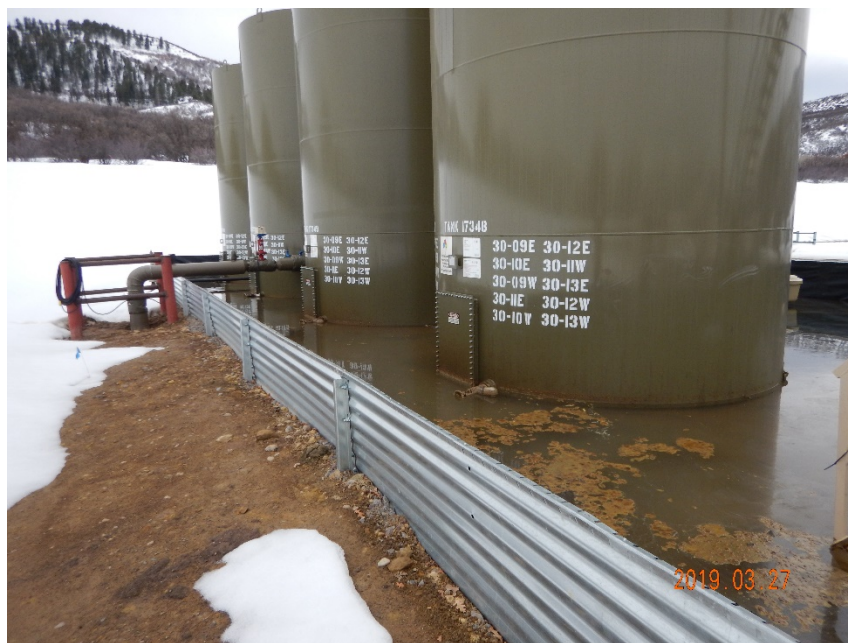
Photo #3 – View of east side of pad, outside of tank battery containment ring. No visible impacts were detected outside of tank battery containment ring during field inspection.

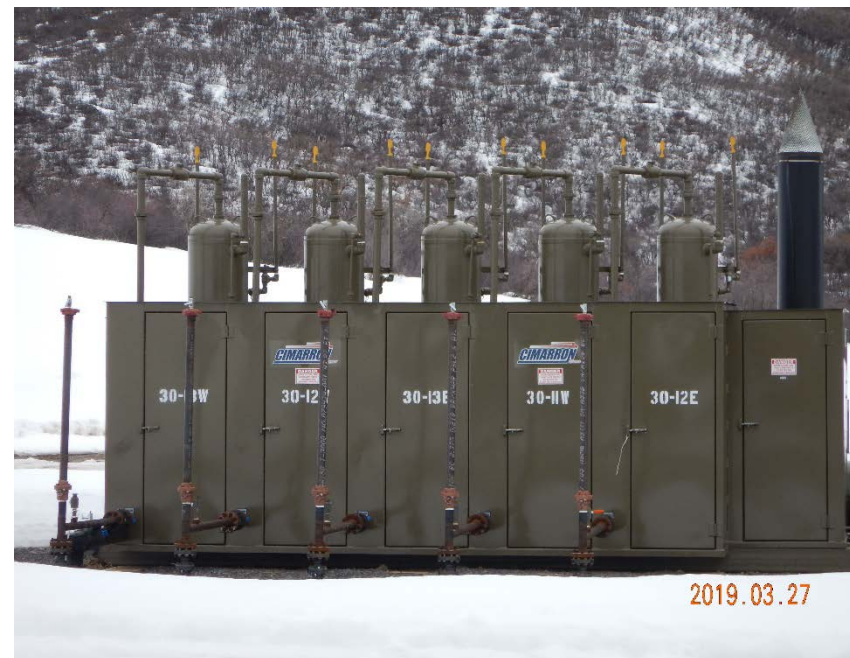
Photo #4 -Vertical separators located on west side of pad.
