Final Reclamation Inspection

Operator: PDC ENERGY INC - 69175

API: 05-123-12560

Inspection Photos
Location Name: FHA #10-1
API: 05-123-12560

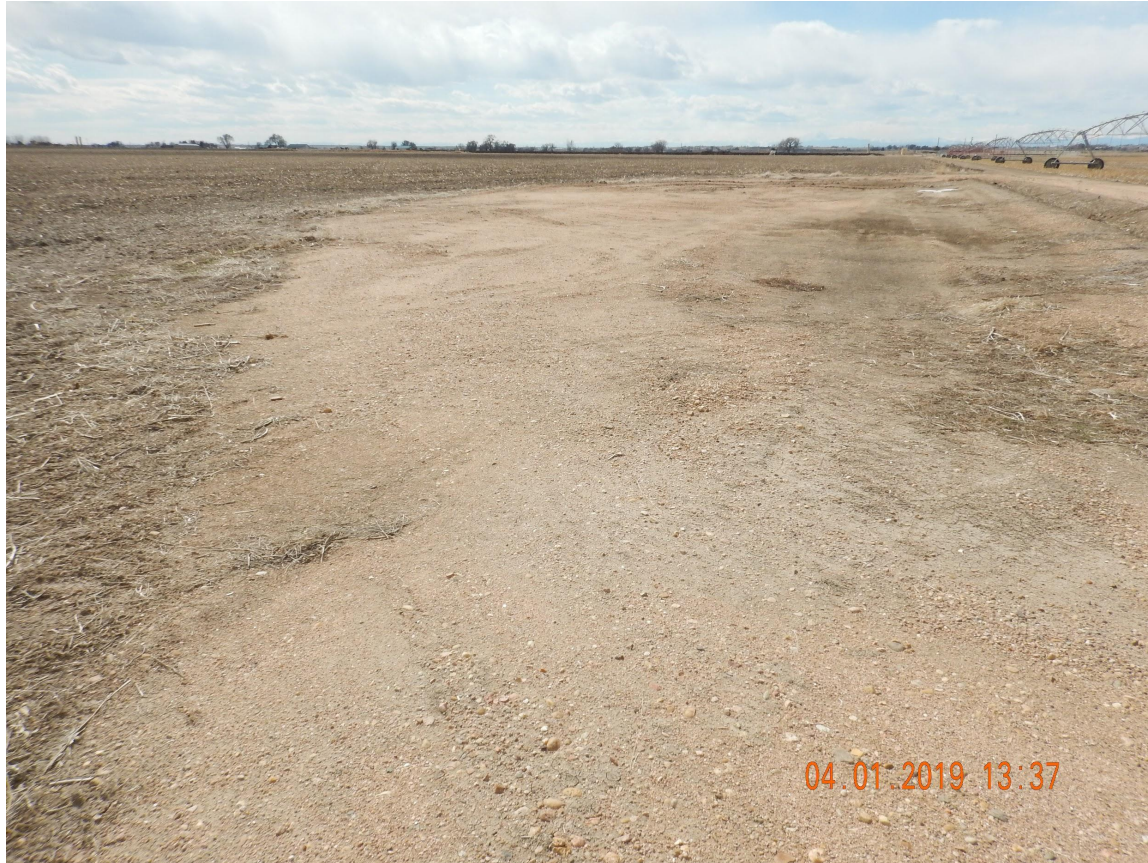
Photo 1. Photo taken from the eastern tank battery location, facing West. Operator has failed to perform final reclamation activities.

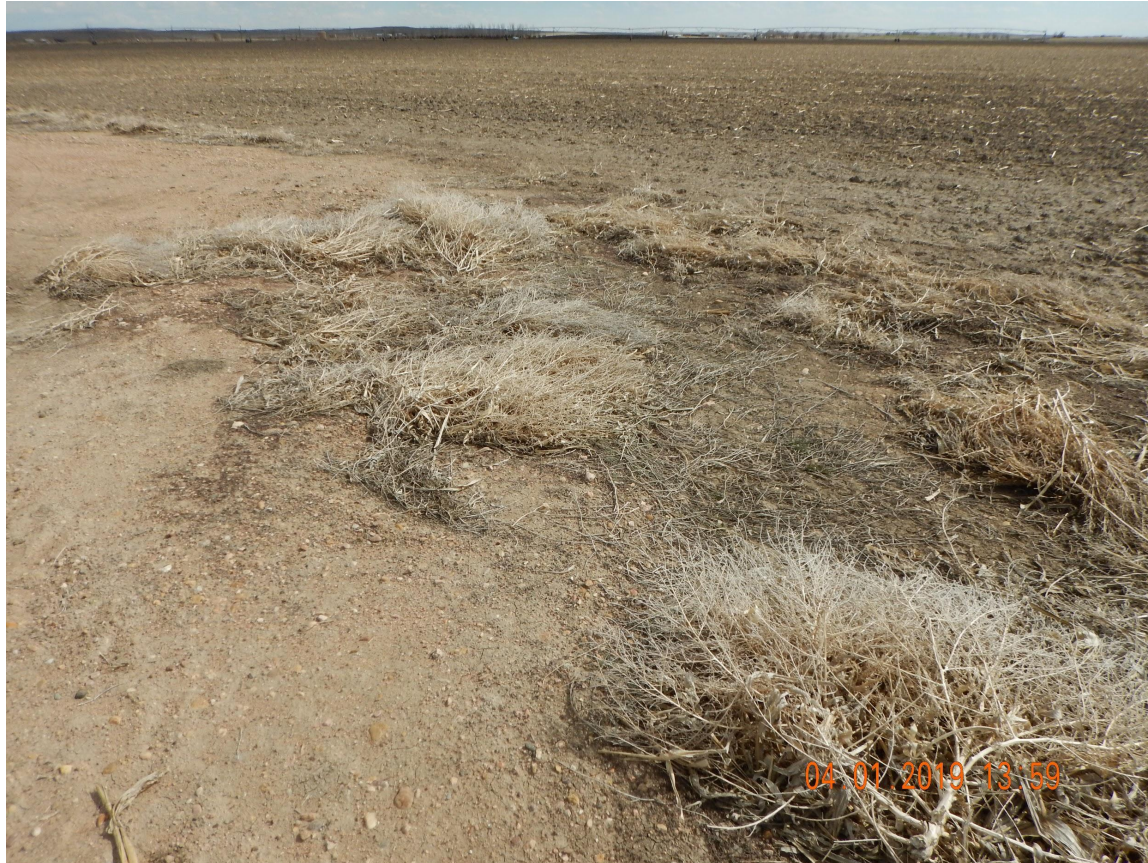
Photo 2. Photo taken from the western tank battery location, facing South. Photo illustrates unmanaged weeds and weed debris at the location.

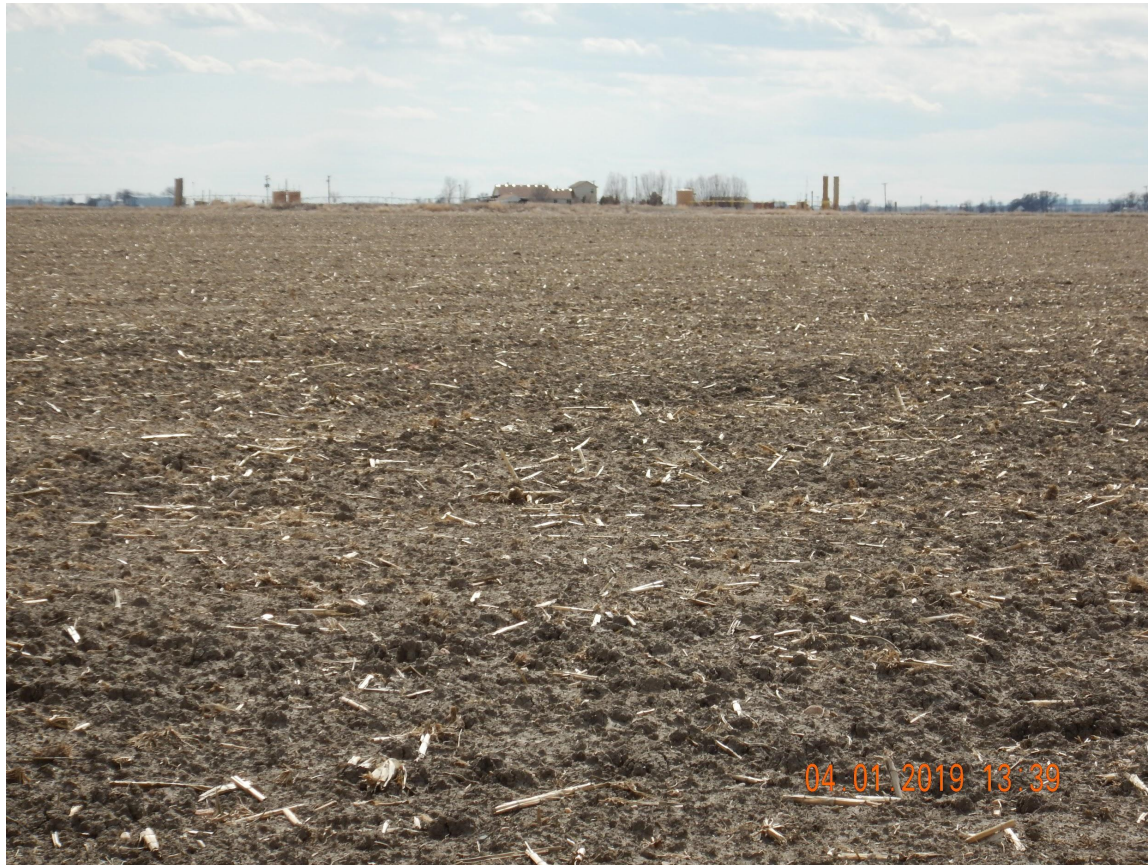
Photo 3. Photo taken from the tank battery location, facing South towards the well location. Well location is in a fallow crop field. A follow up inspection will occur in the future to ensure compliance with Rule 1004 standards.
