Final Reclamation Inspection

April 2, 2019

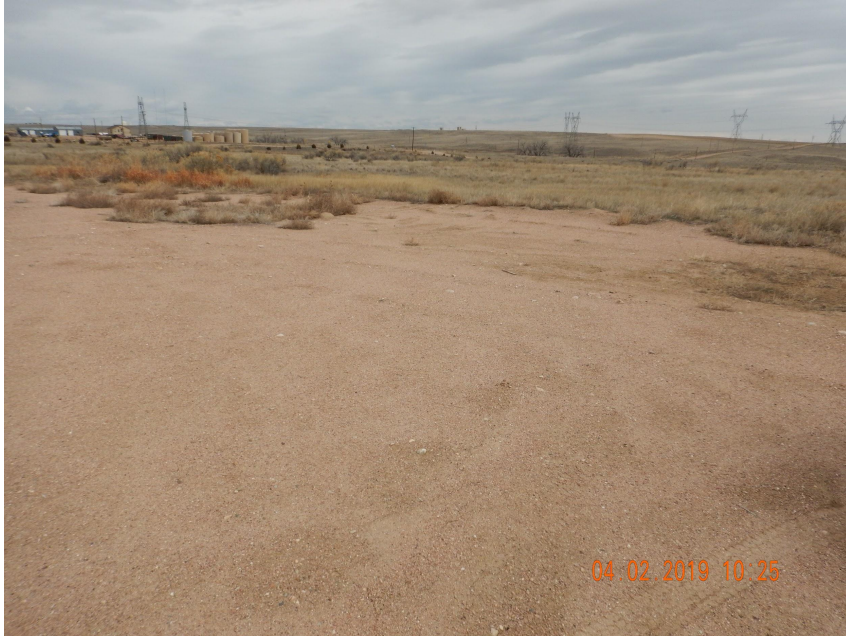
Photo 1. Photo taken from the well location, facing Northeast. Operator has failed to perform final reclamation activities at the well location and access road (i.e., remove gravel, decompact, seedbed prep and seed).

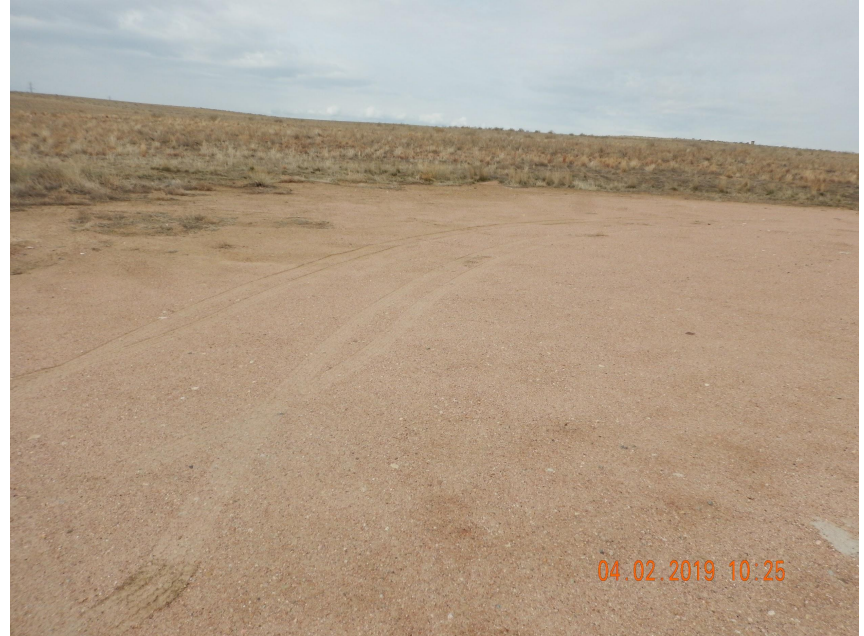
Photo 2. Photo taken from the well location, facing West. See comments under Photo 1.
