# Inspection Photos

Operator: H & M PETROLEUM CORPORATION #  
10032

Location ID: 458288

Inspection Doc. Number: 682504721

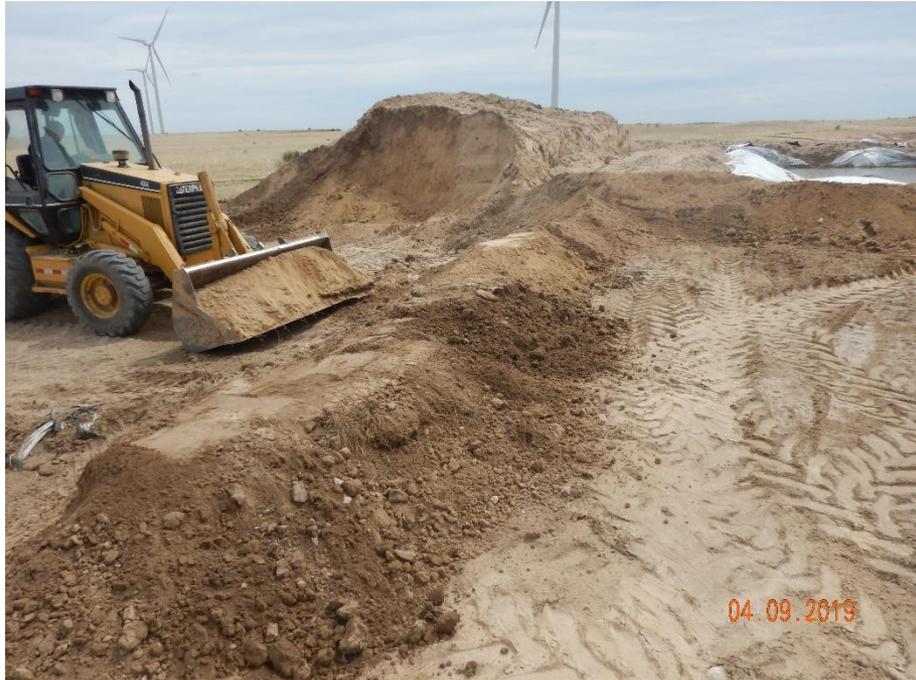
**Photo 1:** Photo taken from the east end of the location, facing south. Photo shows contractor on site was utilizing the soil stockpile salvaged from the pit, as material for the berms around the tank. Inspector discussed concerns regarding 1002.c with Mr. Dick Shanor who was also on location at time.

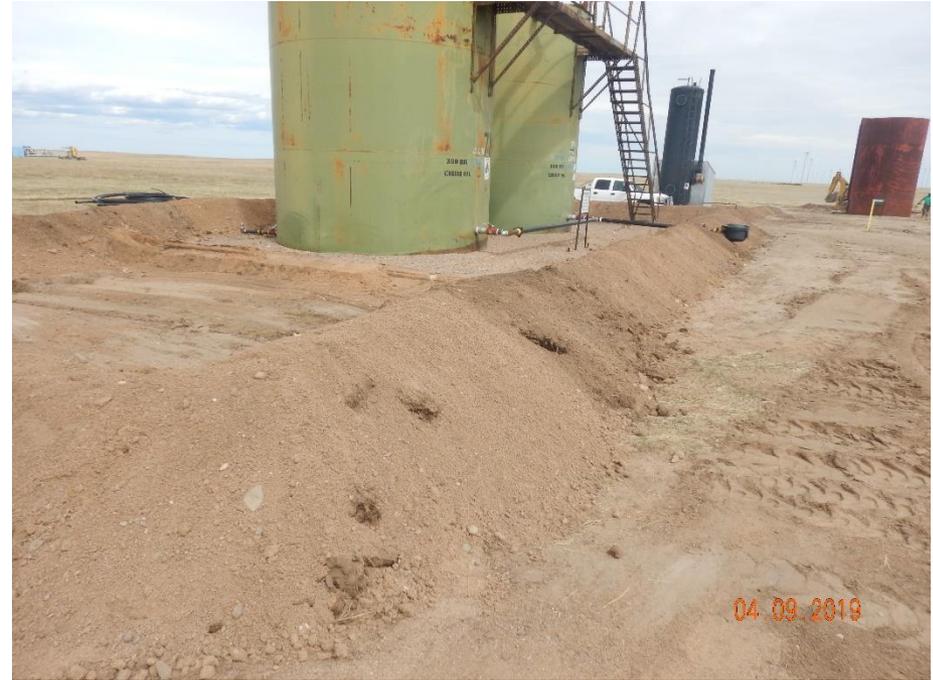
**Photo 2:** Photo taken from the southwest corner of the tank battery. Photo shows operator has updated the secondary containment.

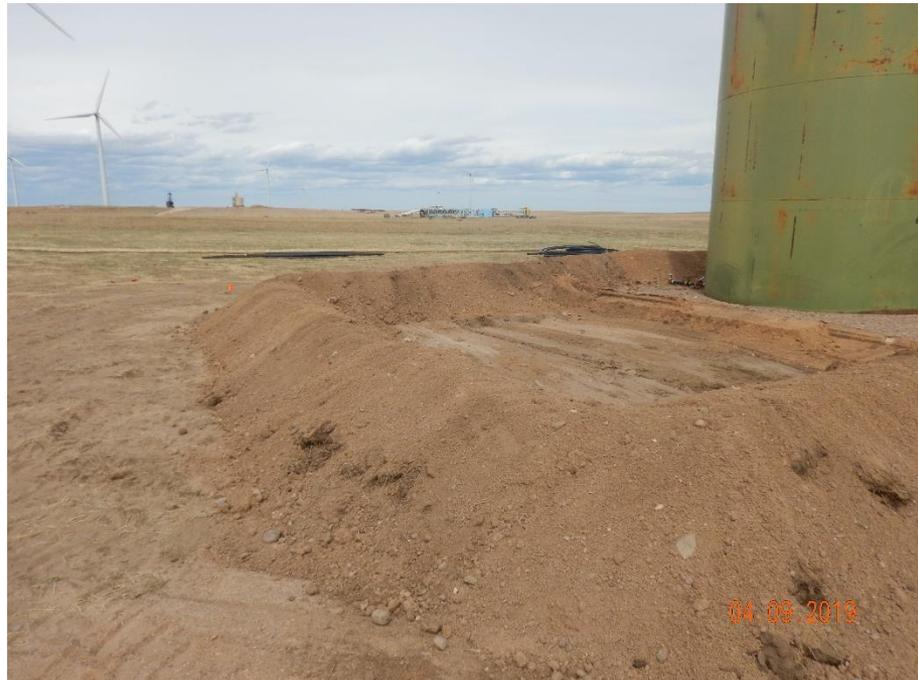
**Photo 3:** Photo taken from the southwest corner of the tank battery. Photo shows operator has updated the secondary containment.

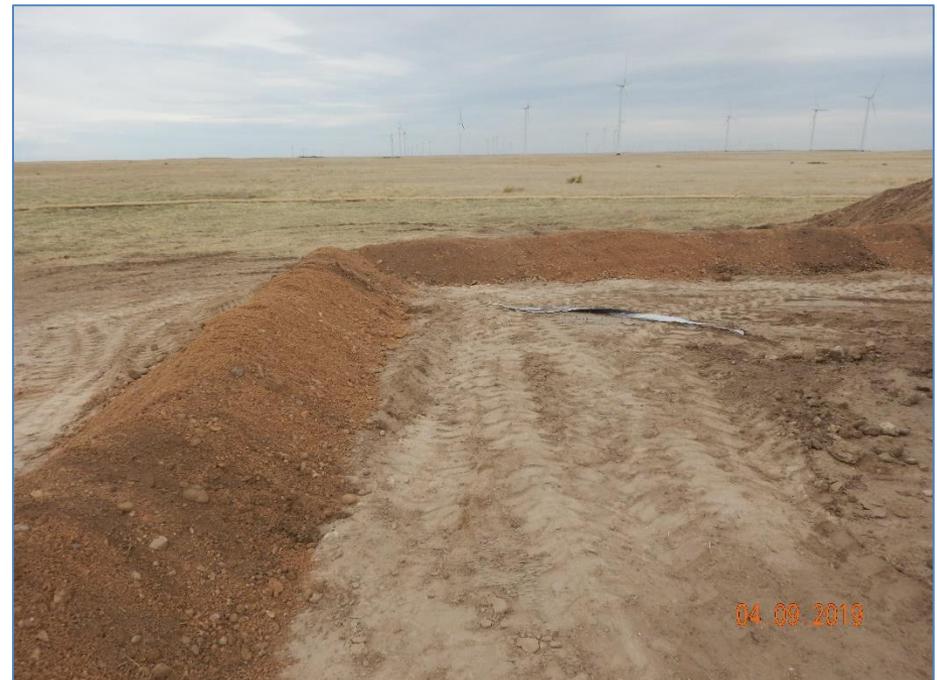
**Photo 4:** Photo taken from the red tank, facing east. Photo taken during a follow-up visit later in the day. Photo shows soils were returned to the stockpile and that the berms constructed and in proper functioning condition.

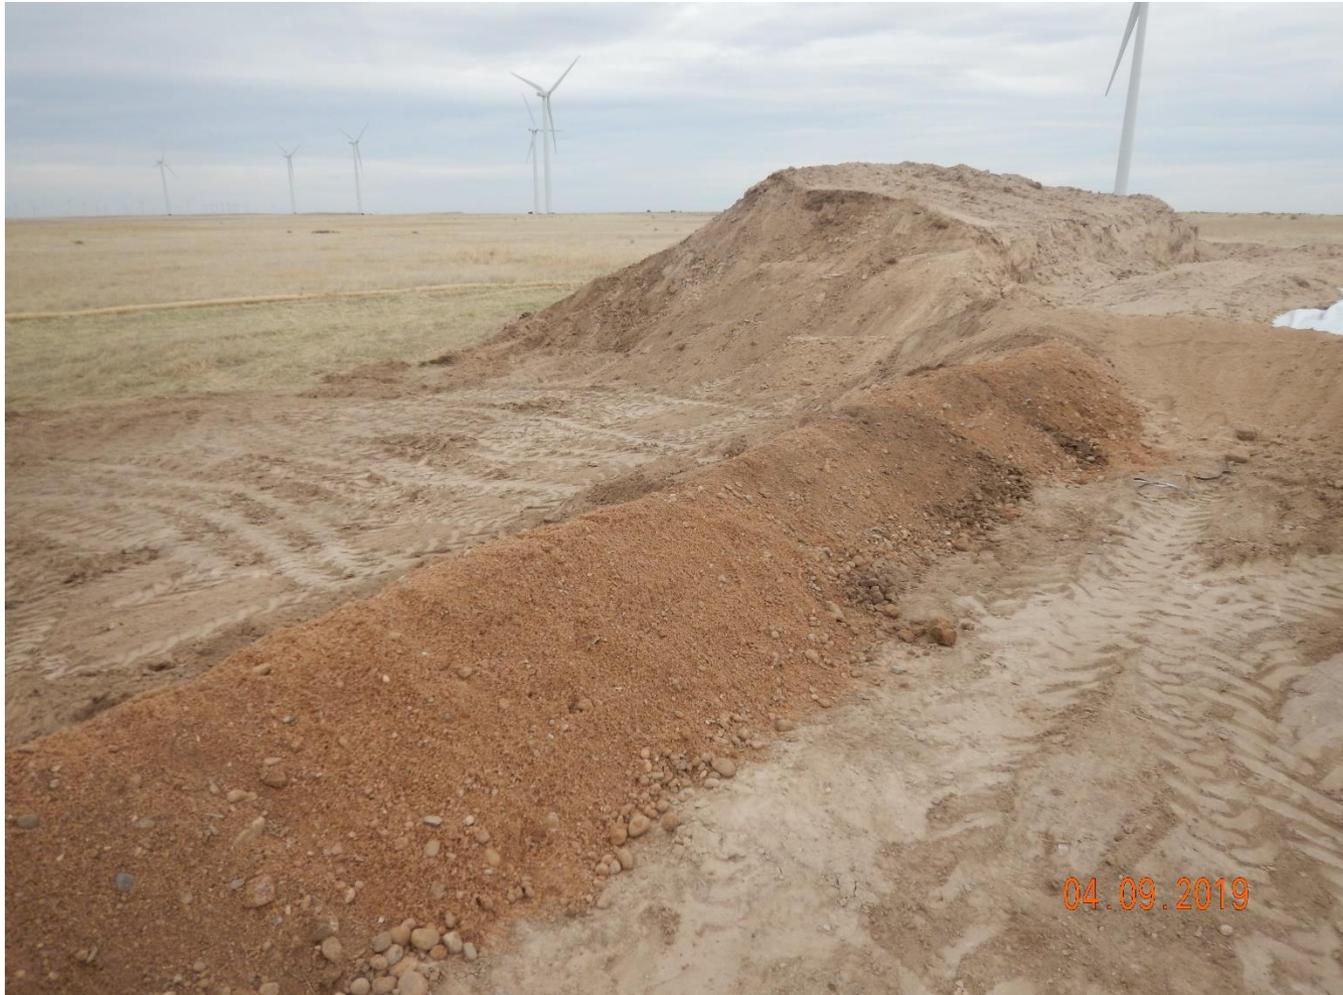
**Photo 5:** See comments under photo 4.
