Inspection Photos

Operator: NOBLE ENERGY INC # 100322

Location ID: 432189

Inspection Doc. Number: 682504745

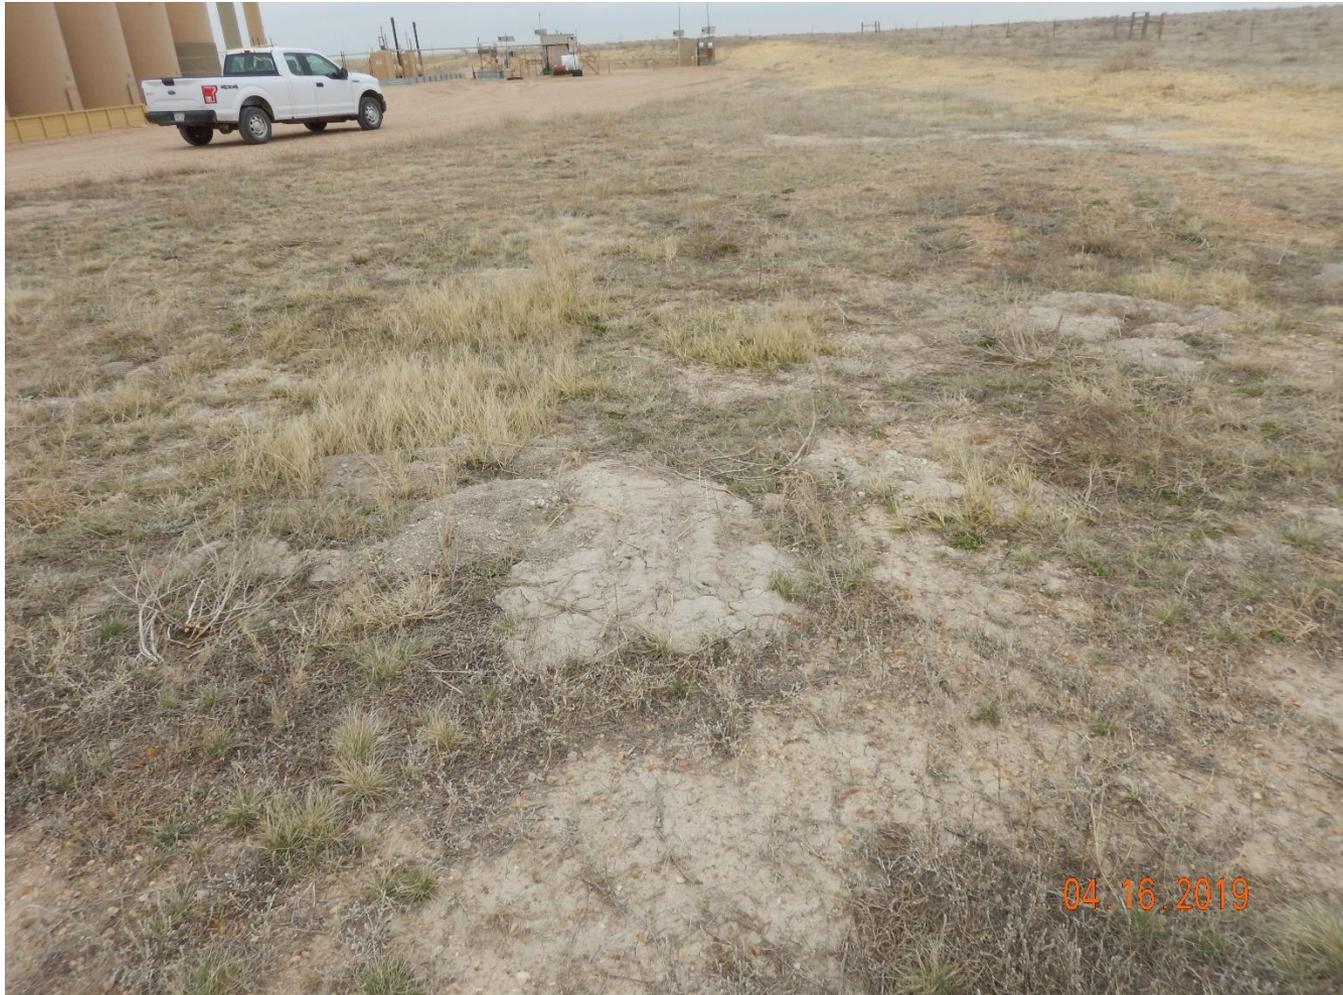
Photo 1: Photo taken from the northwest interim area of the location, facing south. Photo shows striations in the soil indicating additional seeding activities have been conducted via not-till seed drill.

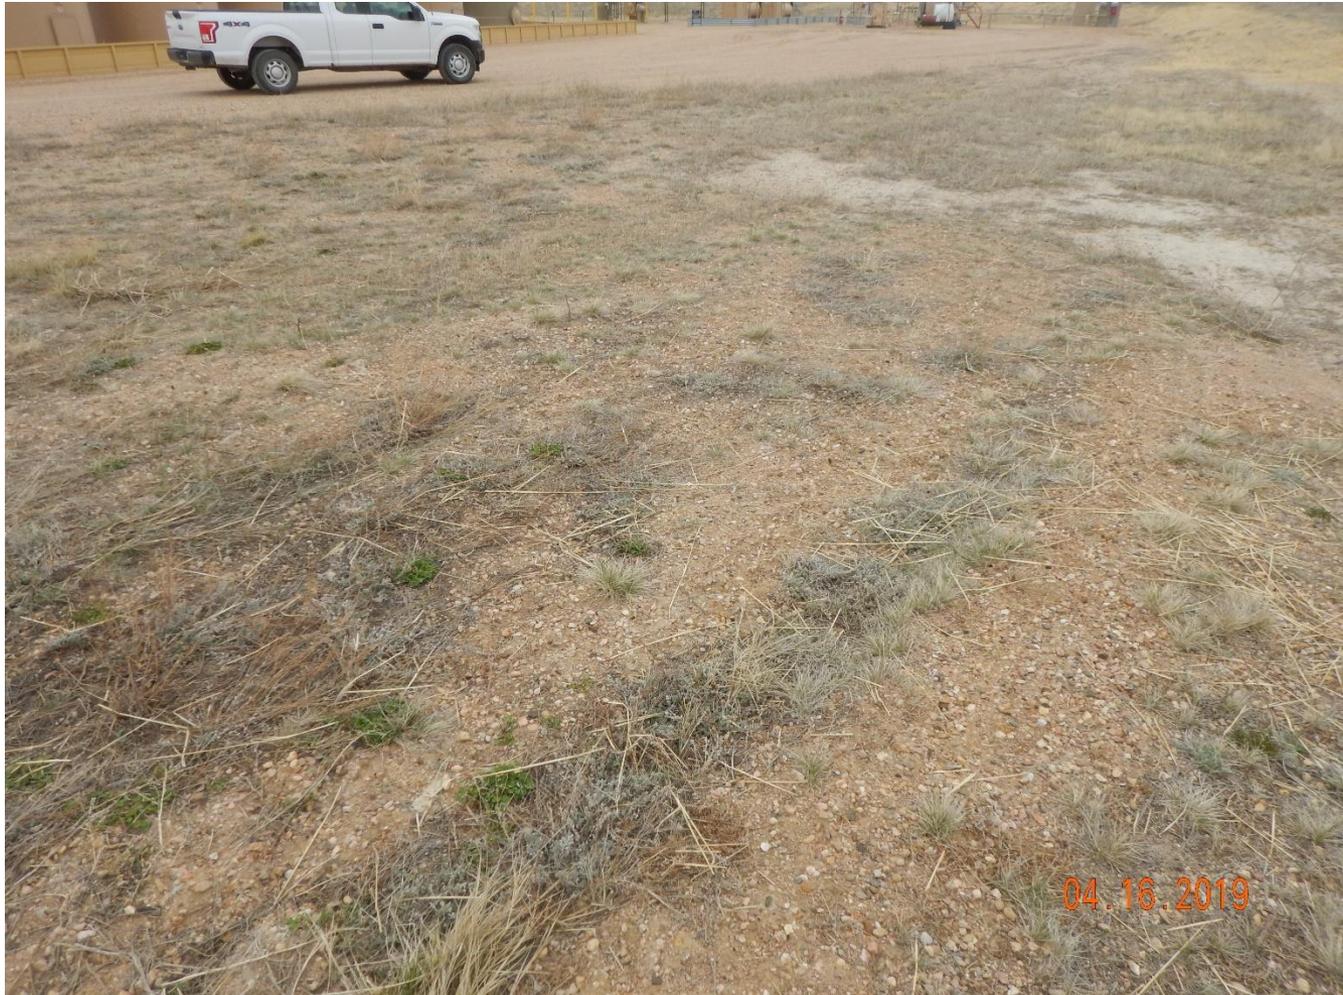
Photo 2: Photo taken from the northwest interim area of the location, facing south. Previous inspection documented gravel/base has not been removed from the interim areas and hindering reclamation. Inspection required operator to remove gravel/base. Photo shows gravel has not been removed from the interim area. Operator appears to have attempted to seed into the gravel rather than remove and reclaim.

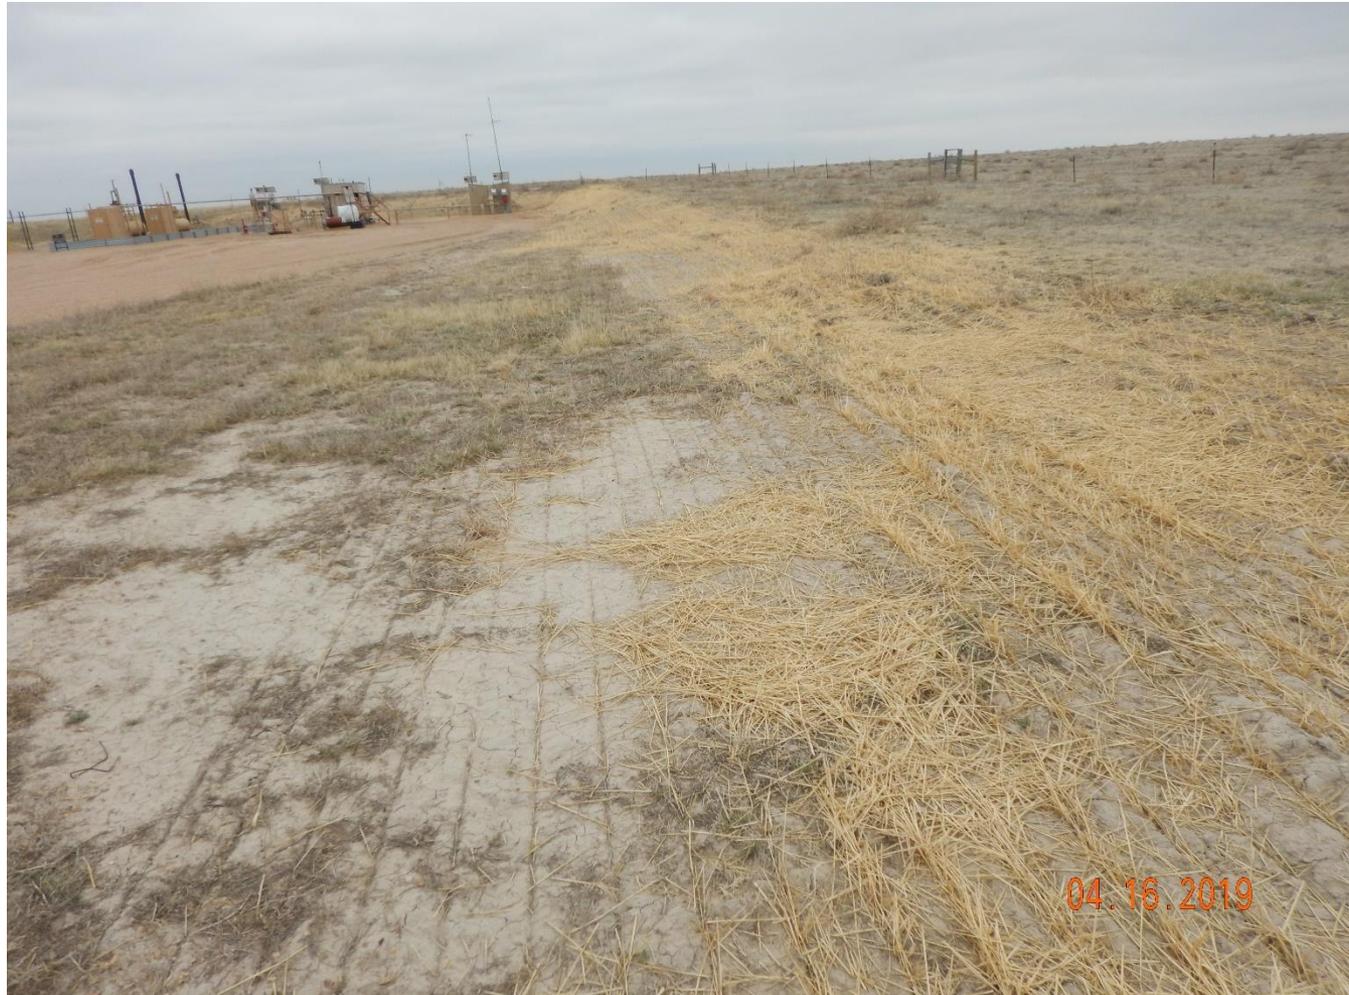
Photo 3: Photo taken from the west interim area of the location, facing south. Photo slopes appear to have been seeded and mulched.

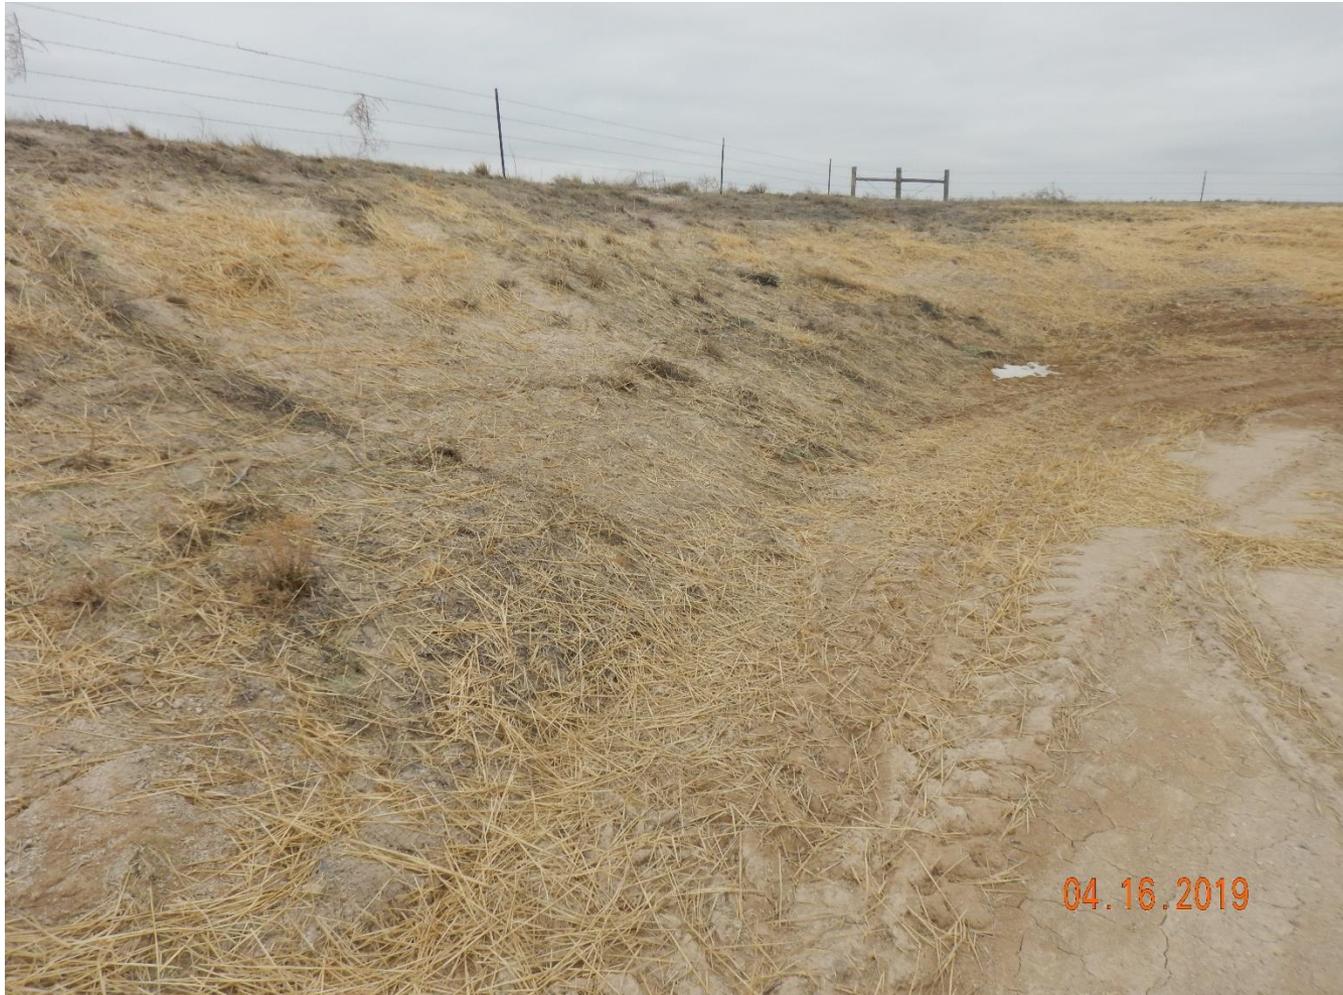
Photo 4: Photo taken from the south end of the location, facing west. Photo slopes appear to have been seeded and mulched.
