Inspection Photos

Operator: NOBLE ENERGY INC # 100322

Location ID: 440380

Inspection Doc. Number: 682504755

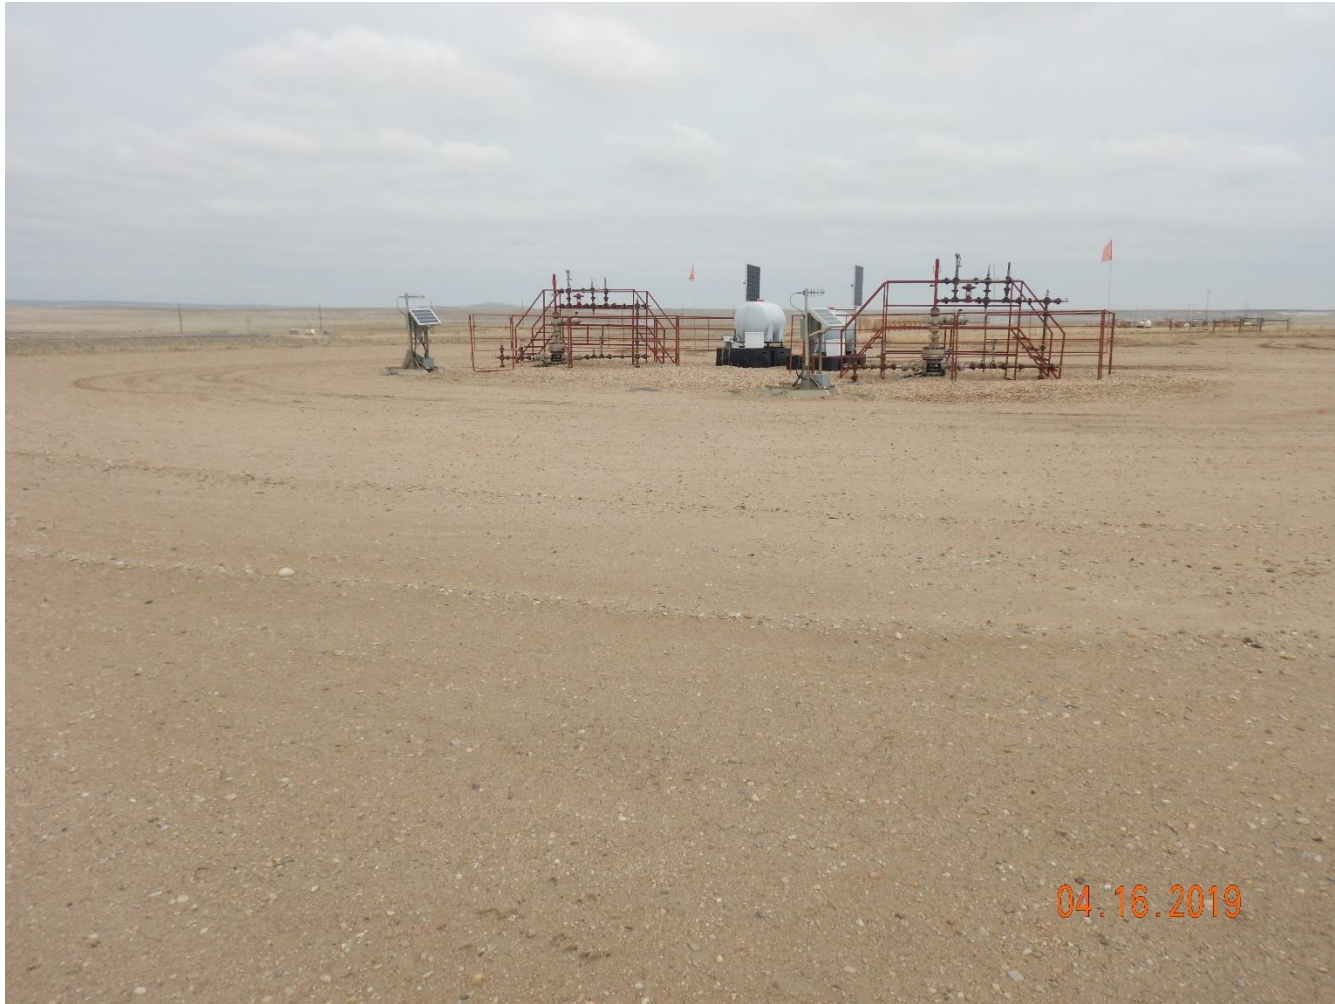
Photo 1: Photo taken from the location. Photo shows the two PR wells.

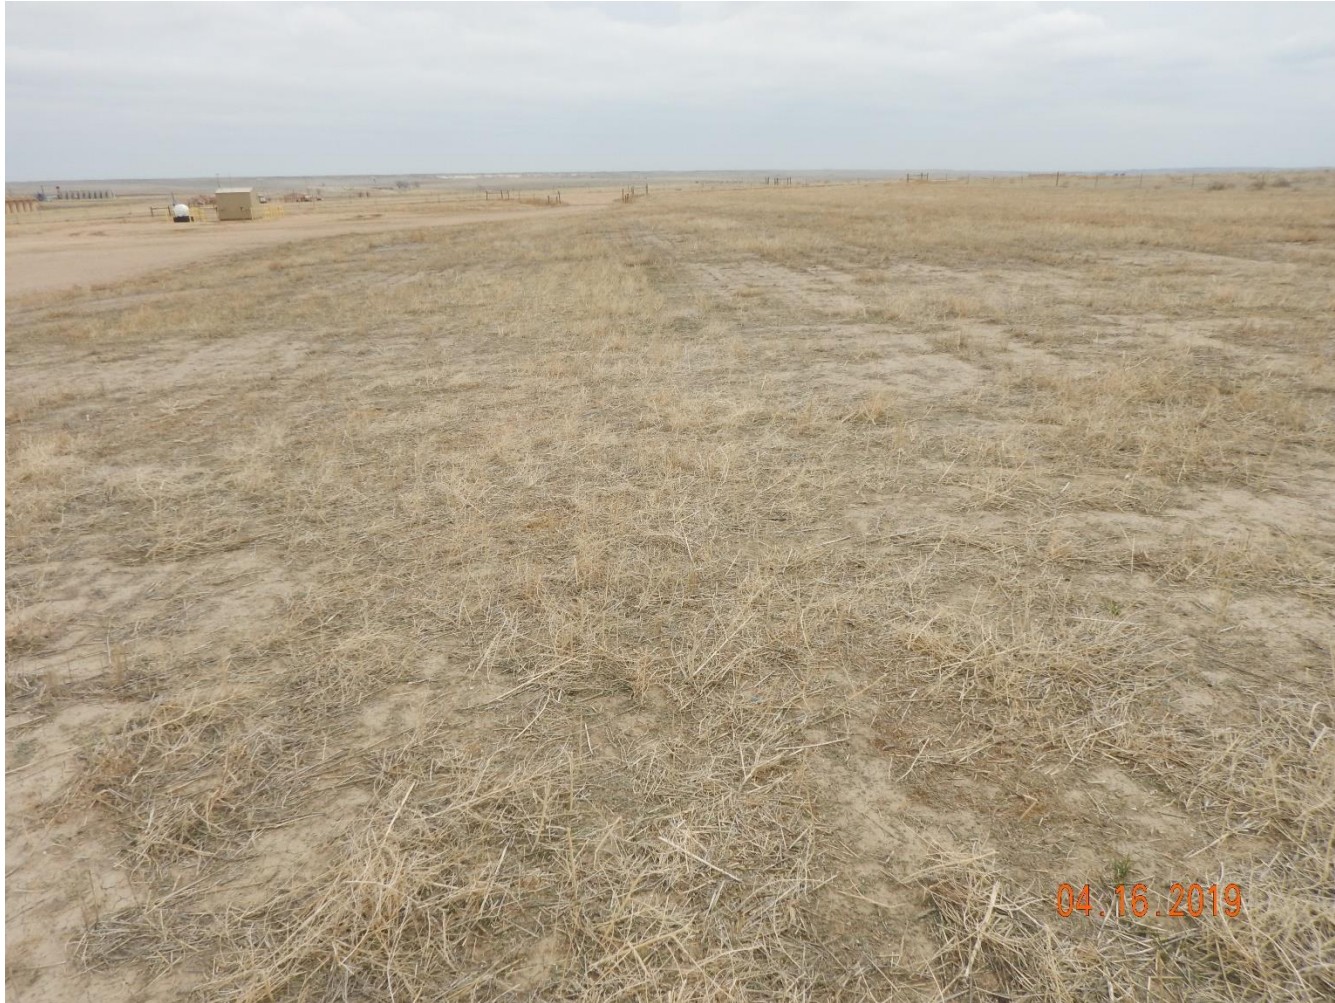
Photo 2: Photo taken from the south end of the location, facing east. Photo shows vegetation over the reclamation area. Interim areas are either predominantly undersirable weedy plant species such as Kochia, Salsola sp, or bare and exposed soil.

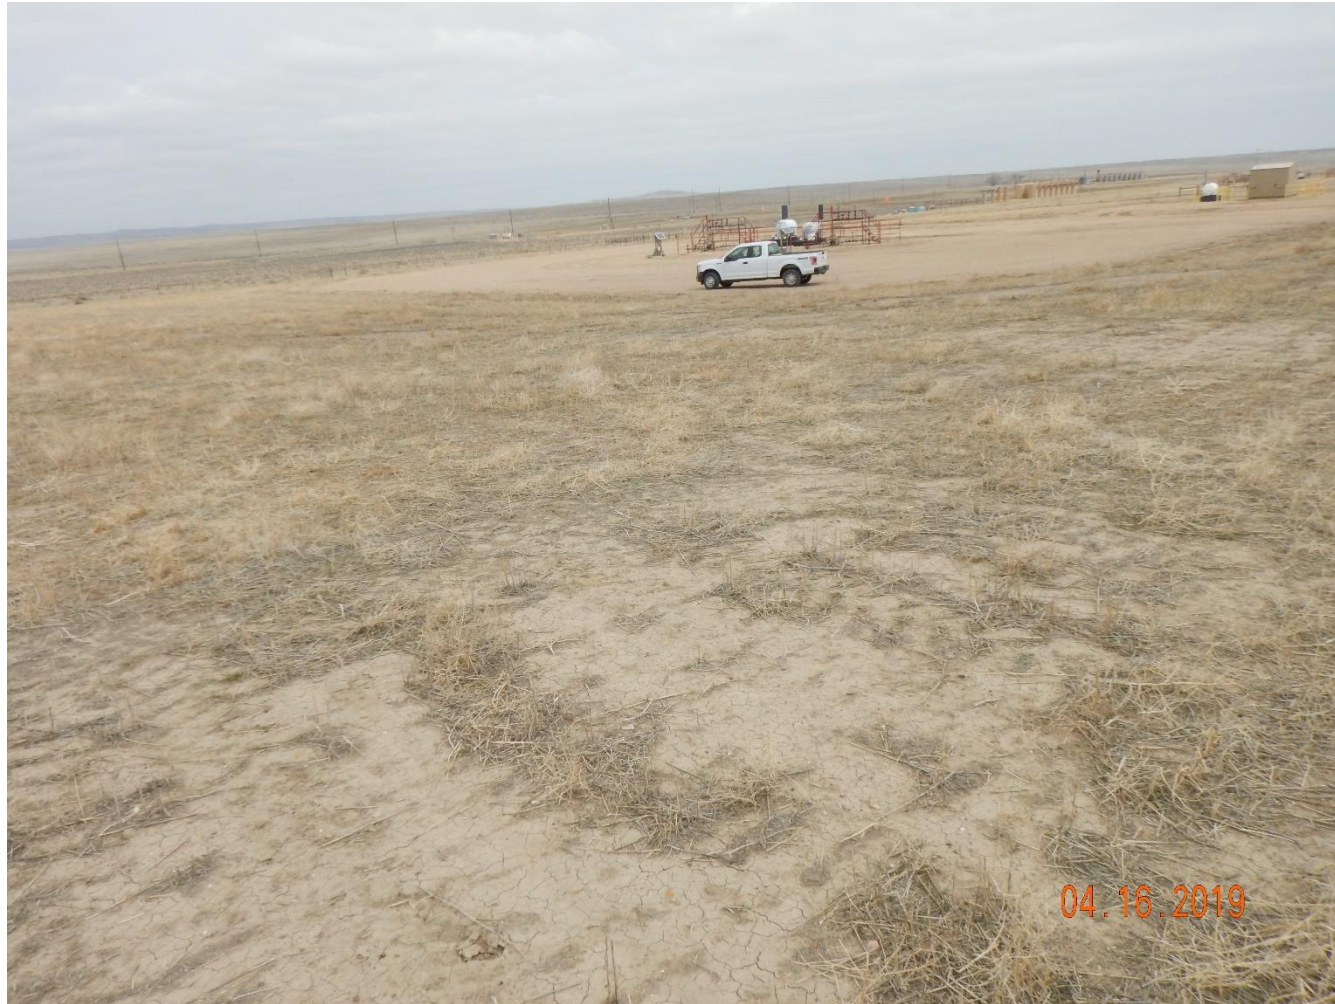
Photo 3: Photo taken from the south end of the location, facing northeast. Photo shows vegetation over the reclamation area. Interim areas are either predominantly undersirable weedy plant species such as Kochia, Salsola sp, or bare and exposed soil.

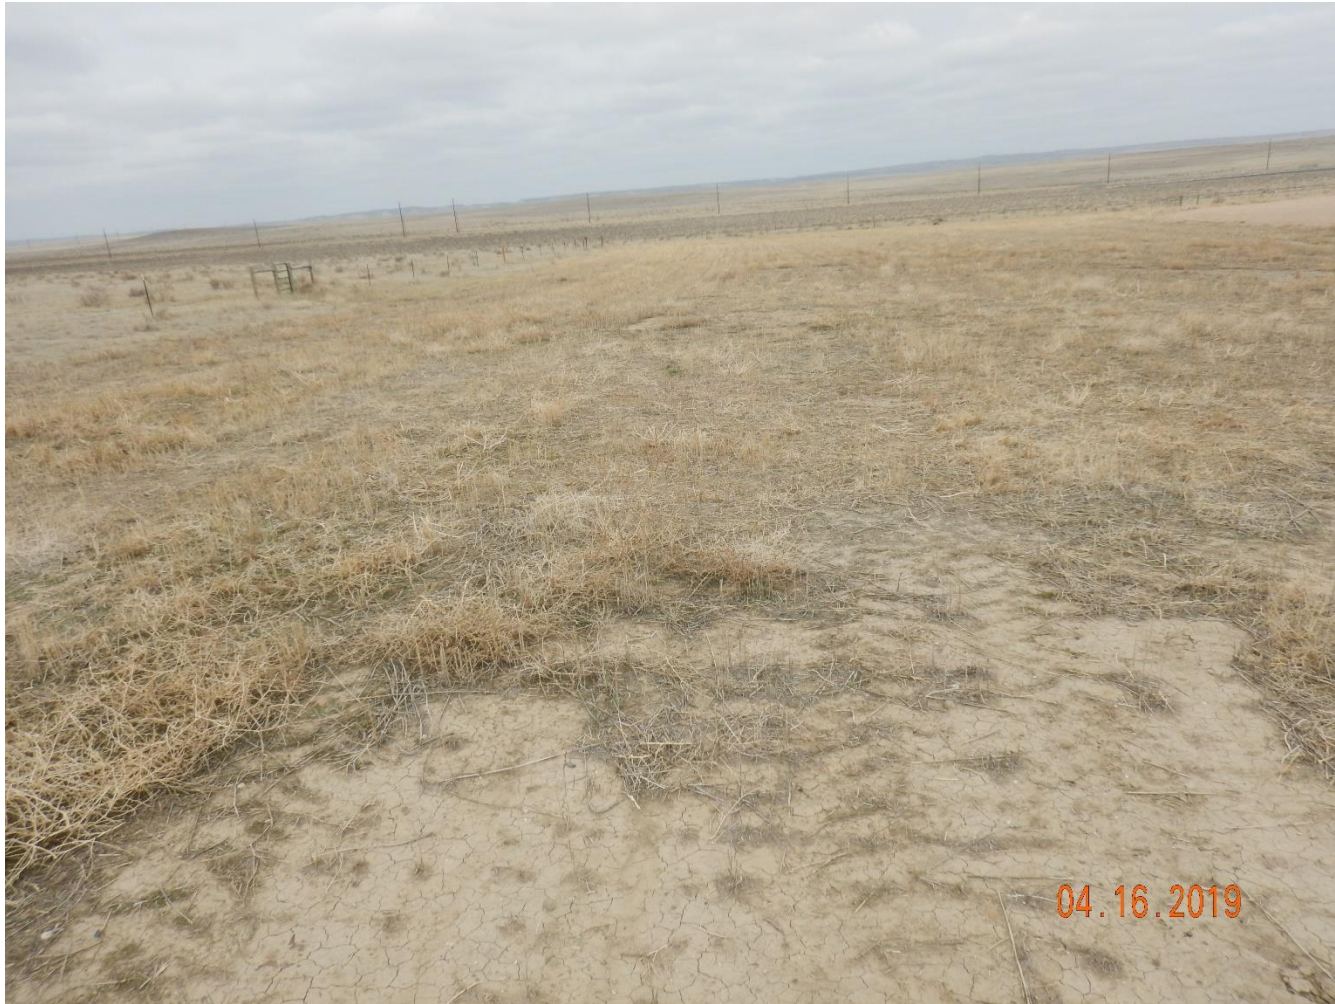
Photo 4: Photo taken from the south end of the location, facing north. Photo shows vegetation over the reclamation area. Interim areas are either predominantly undersirable weedy plant species such as Kochia, Salsola sp, or bare and exposed soil.

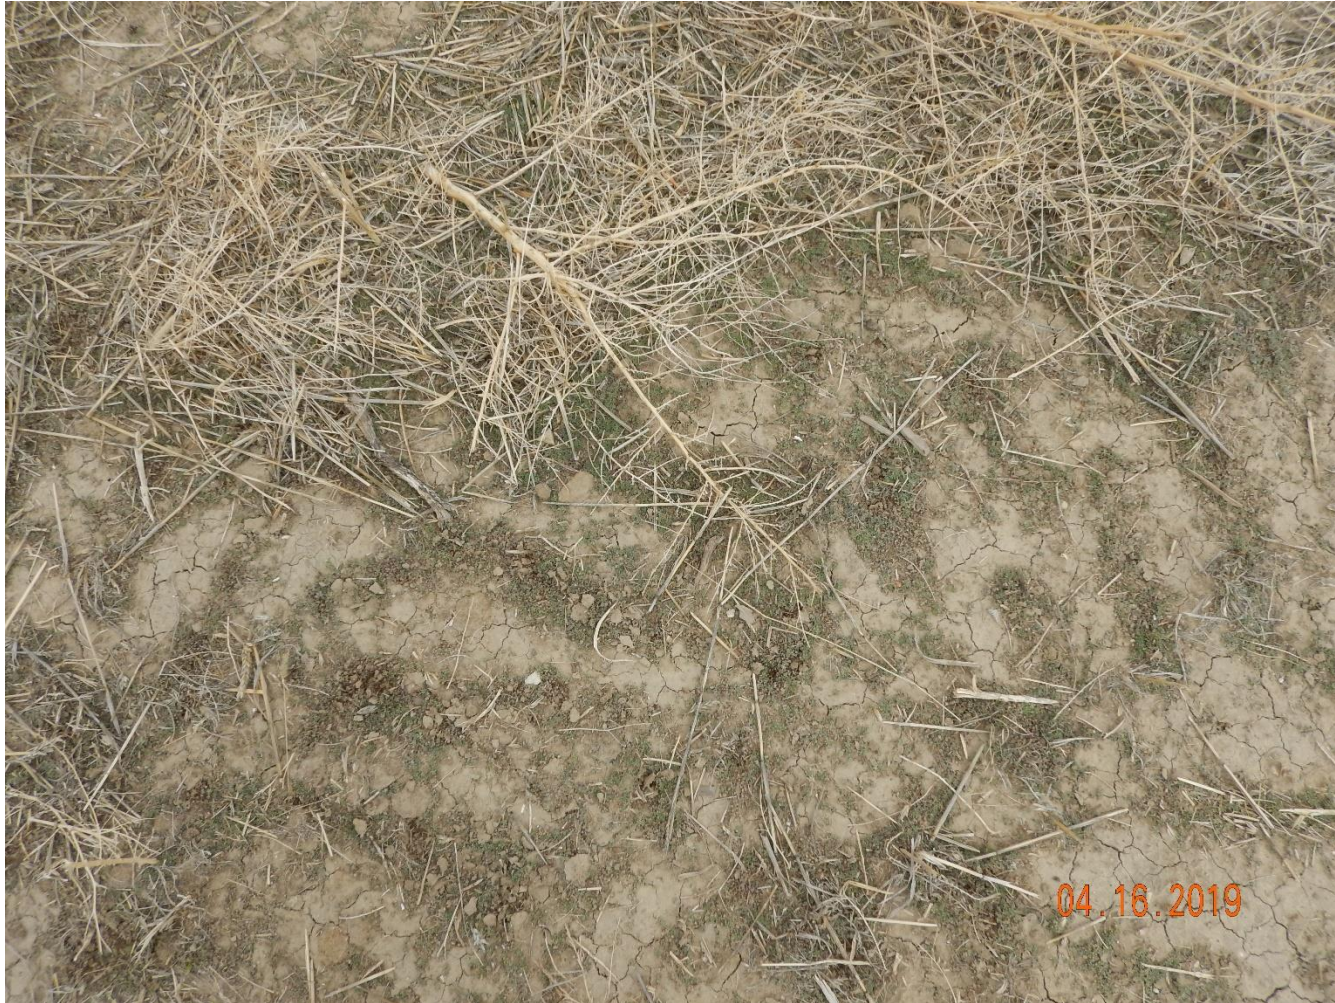
Photo 5 Photo taken from the interim areas. Photo shows plant germination observed on interim areas is undesirable weedy plant species such as Kochia and Salsola sp. Inspector was unable to observe desirable perennial vegetative germination.
