Inspection Photos

Operator: NOBLE ENERGY INC # 100322

Location ID: 440366

Inspection Doc. Number: 682504759

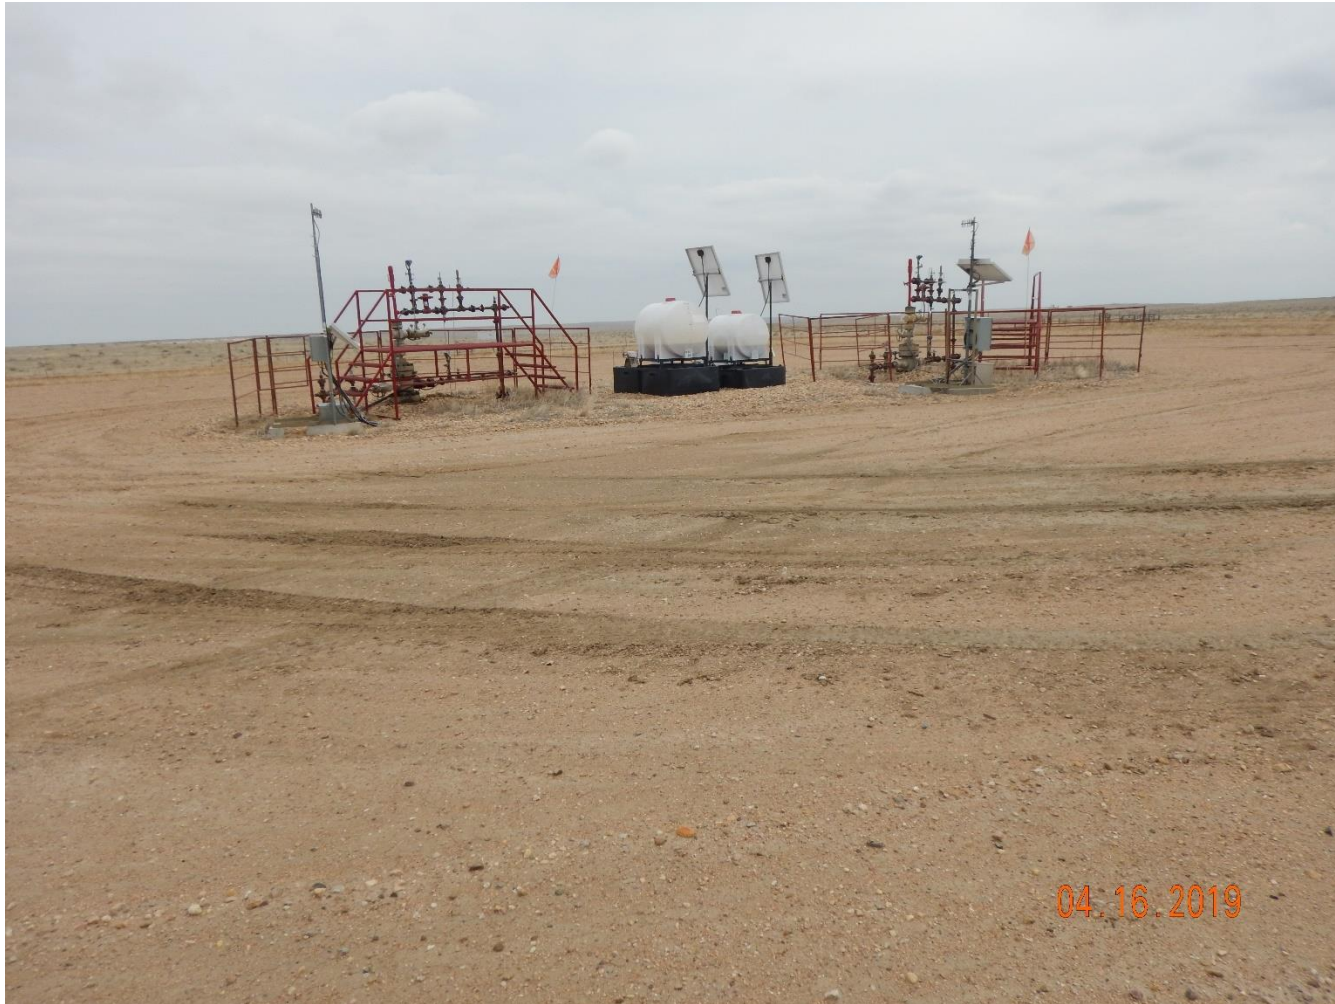
Photo 1: Photo taken from the location. Photo shows the two PR wells.

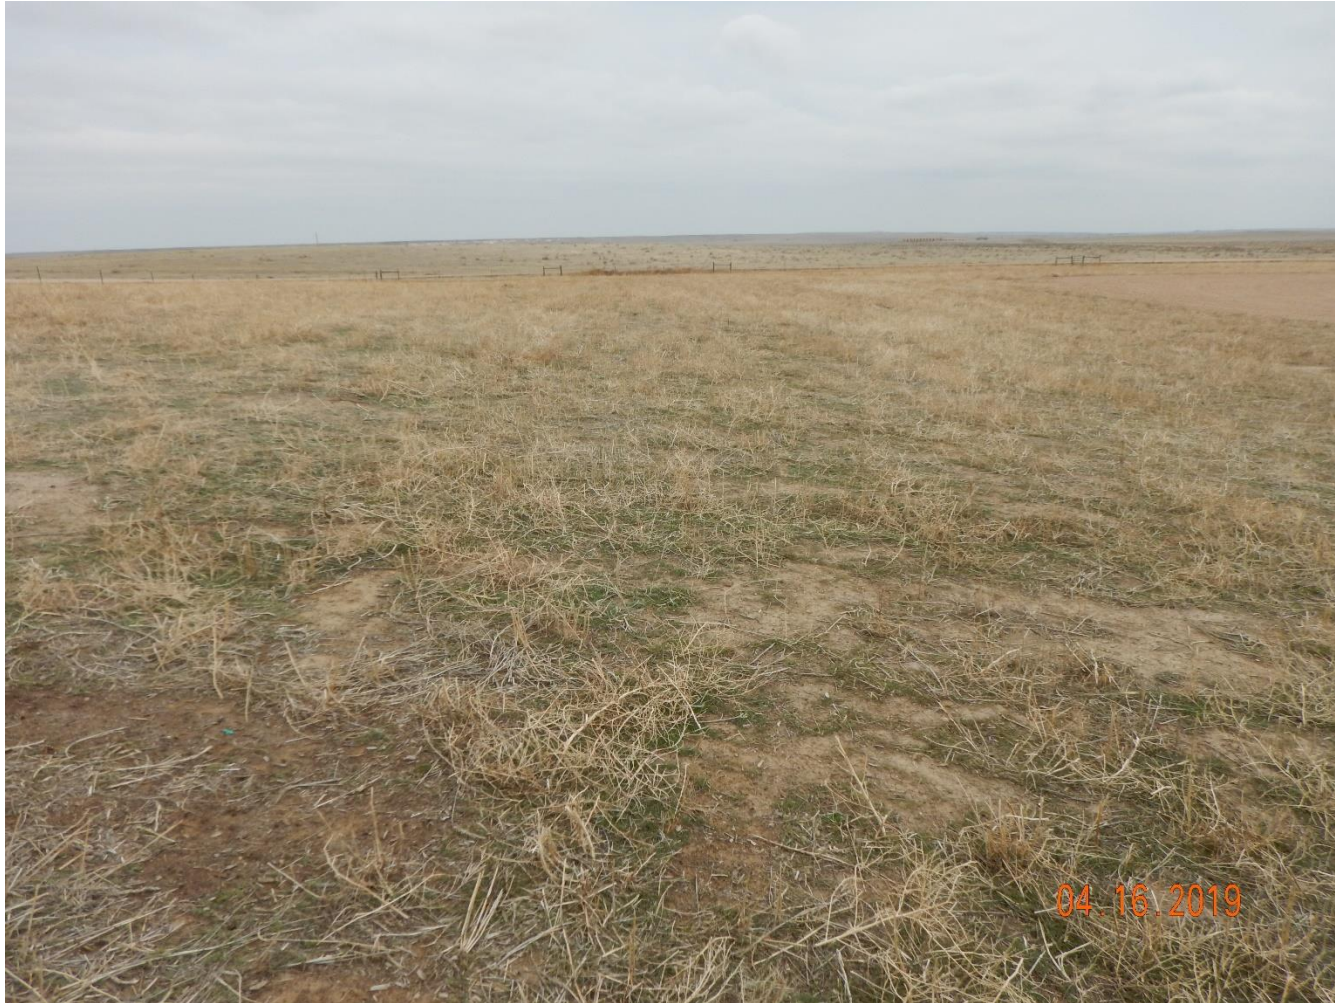
Photo 2: Photo taken from the northwest end of the location, facing east. Photo shows vegetation over the reclamation area. Interim areas are either predominantly undersirable weedy plant species such as Kochia, Salsola sp, or bare and exposed soil.

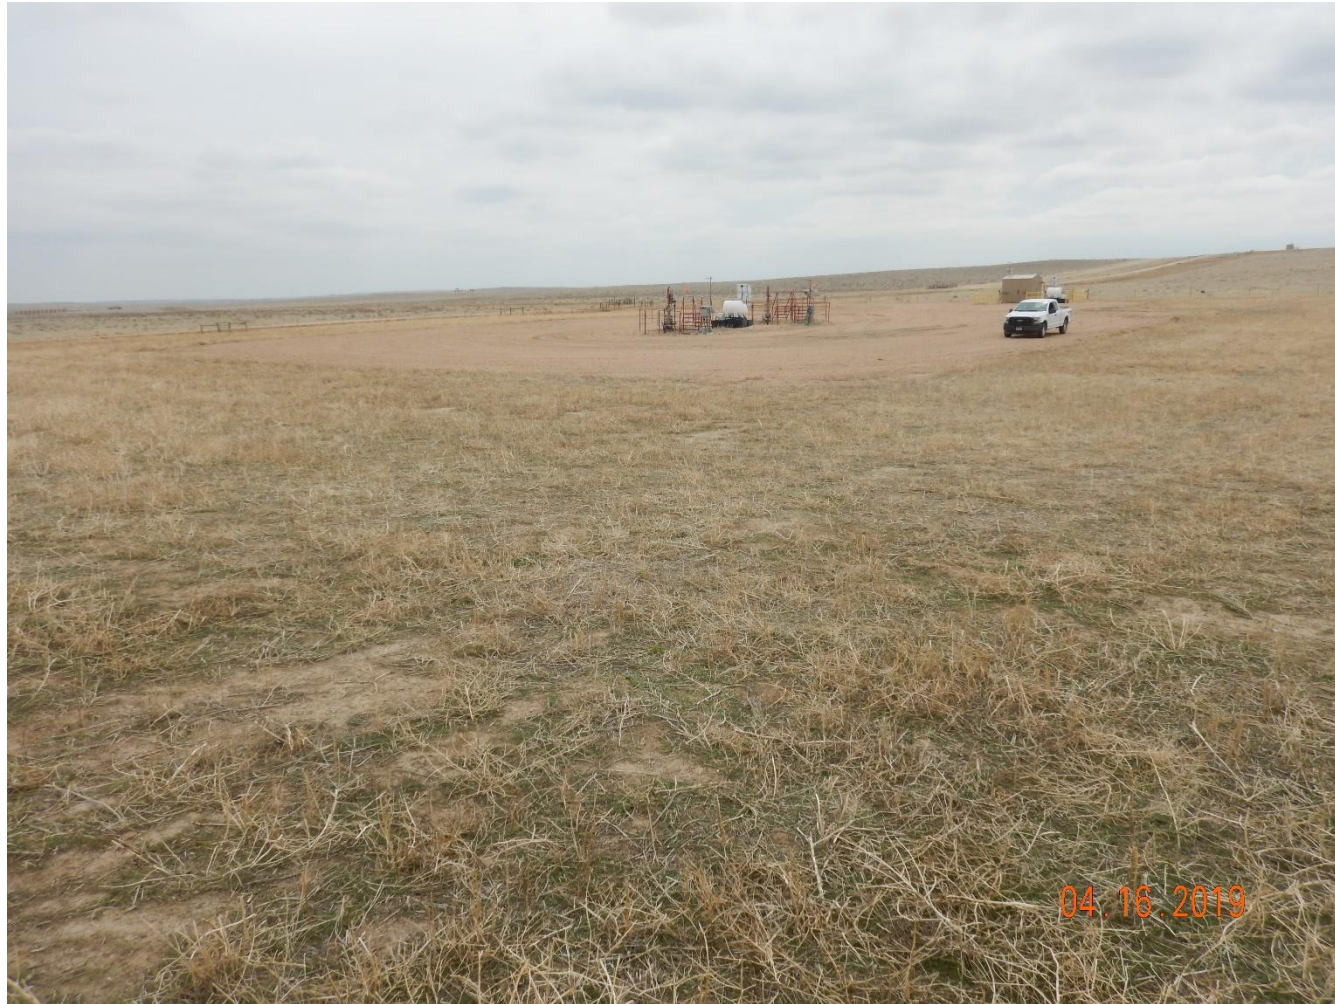
Photo 3: Photo taken from the northwest end of the location, facing southeast. Photo shows vegetation over the reclamation area. Interim areas are either predominantly undersirable weedy plant species such as Kochia, Salsola sp, or bare and exposed soil.

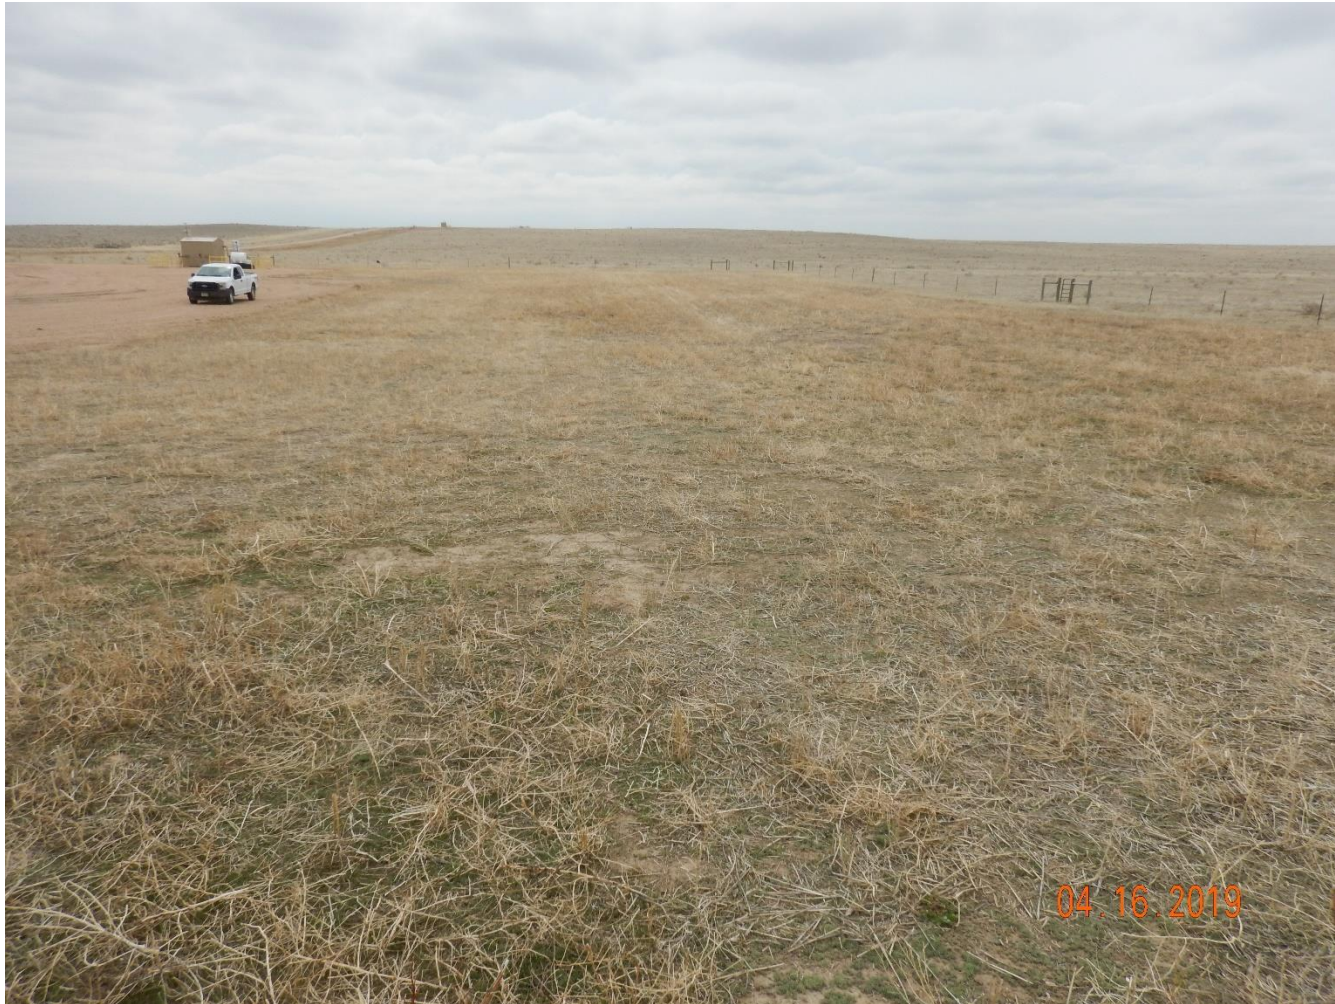
Photo 4: Photo taken from the northwest end of the location, facing south. Photo shows vegetation over the reclamation area. Interim areas are either predominantly undersirable weedy plant species such as *Kochia*, *Salsola* sp, or bare and exposed soil.

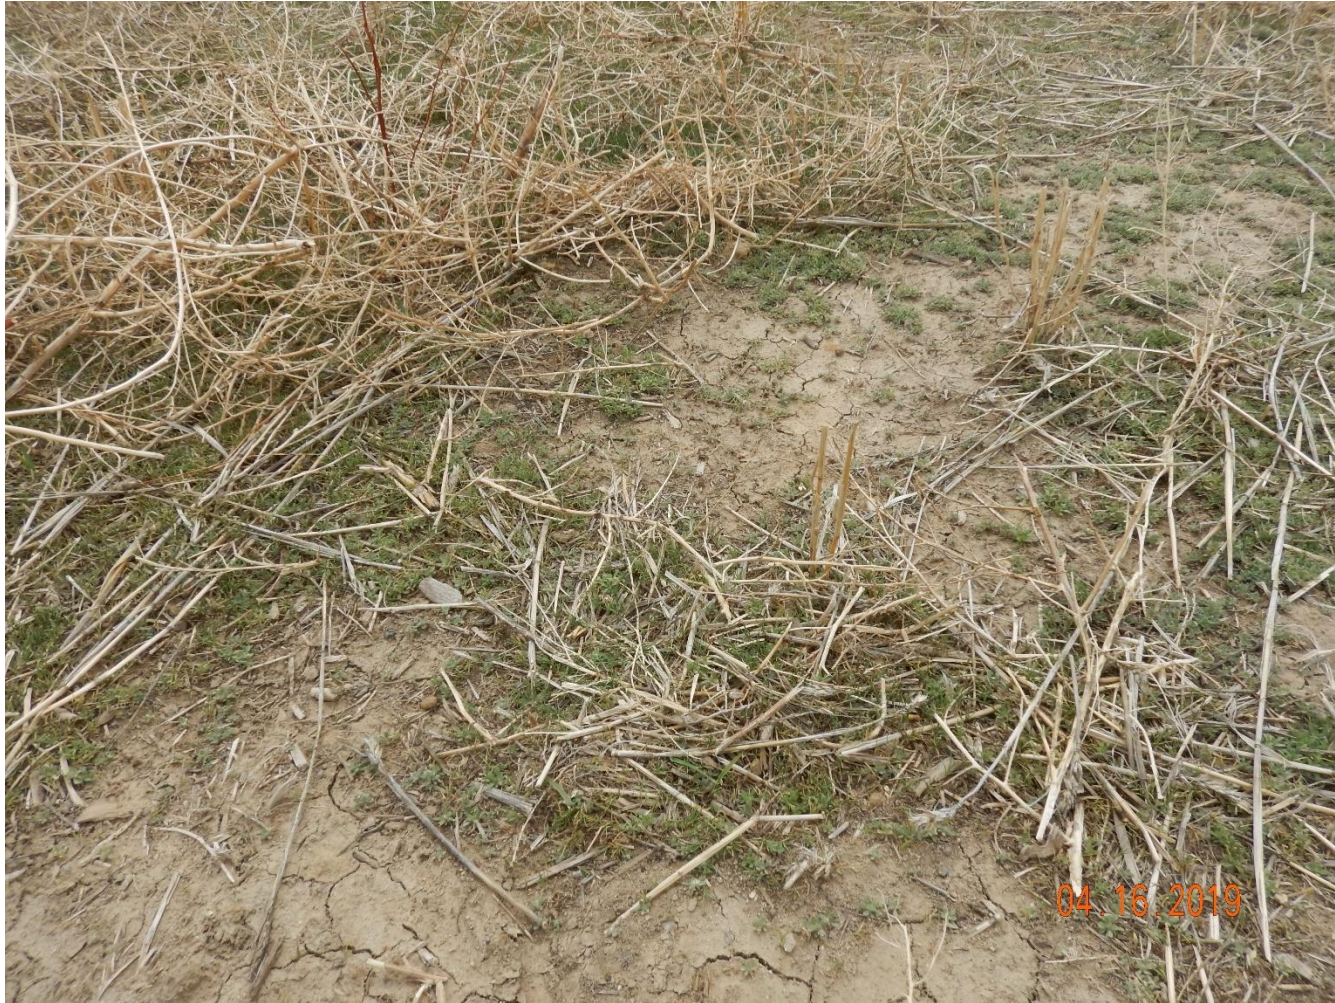
Photo 5 Photo taken from the interim areas. Photo shows plant germination observed on interim areas is undesirable weedy plant species such as Kochia and Salsola sp. Some desirable perennial germination was evident.
