Inspection Photos

Operator: NOBLE ENERGY INC # 100322

Location ID: 440372

Inspection Doc. Number: 682504763

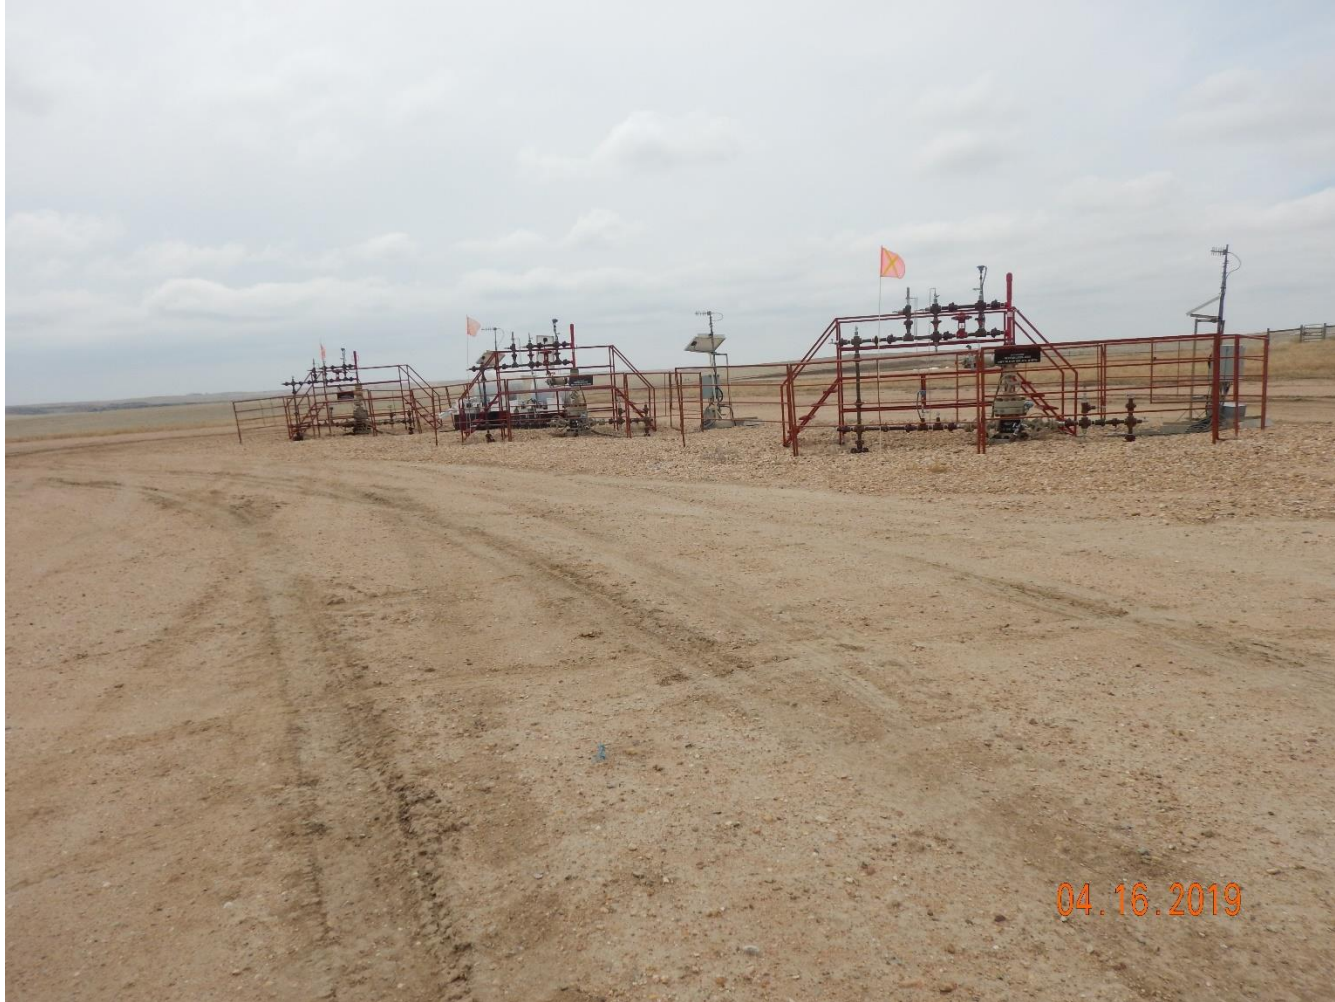
Photo 1: Photo taken from the location. Photo shows the three PR wells.

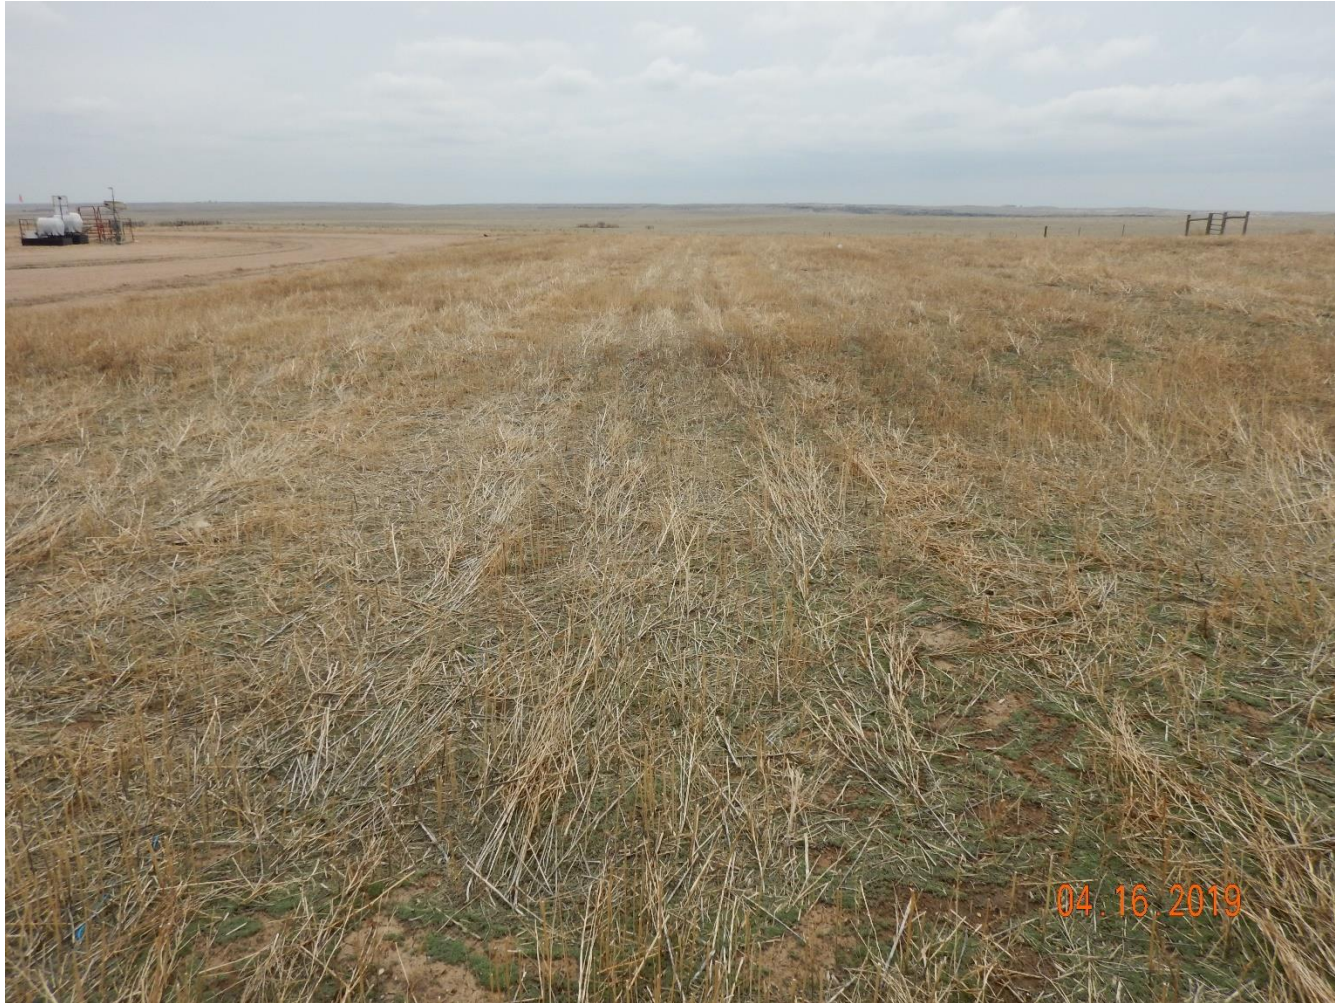
Photo 2: Photo taken from the northwest end of the location, facing south. Photo shows vegetation over the reclamation area. Interim areas are either predominantly undersirable weedy plant species such as Kochia, Salsola sp, or bare and exposed soil.

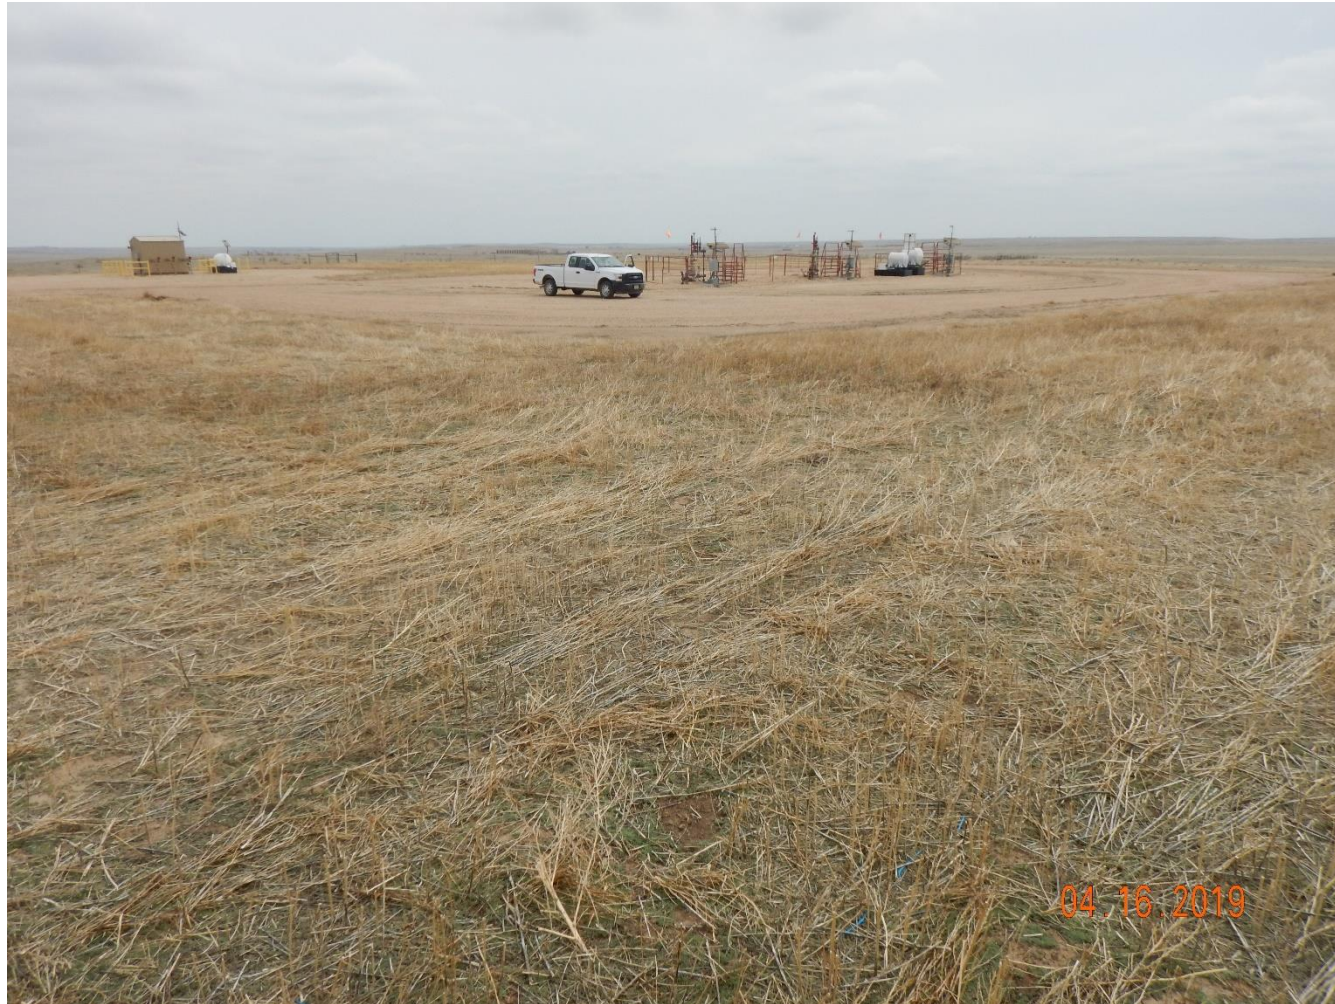
Photo 3: Photo taken from the northwest end of the location, facing southeast. Photo shows vegetation over the reclamation area. Interim areas are either predominantly undersirable weedy plant species such as Kochia, Salsola sp, or bare and exposed soil.

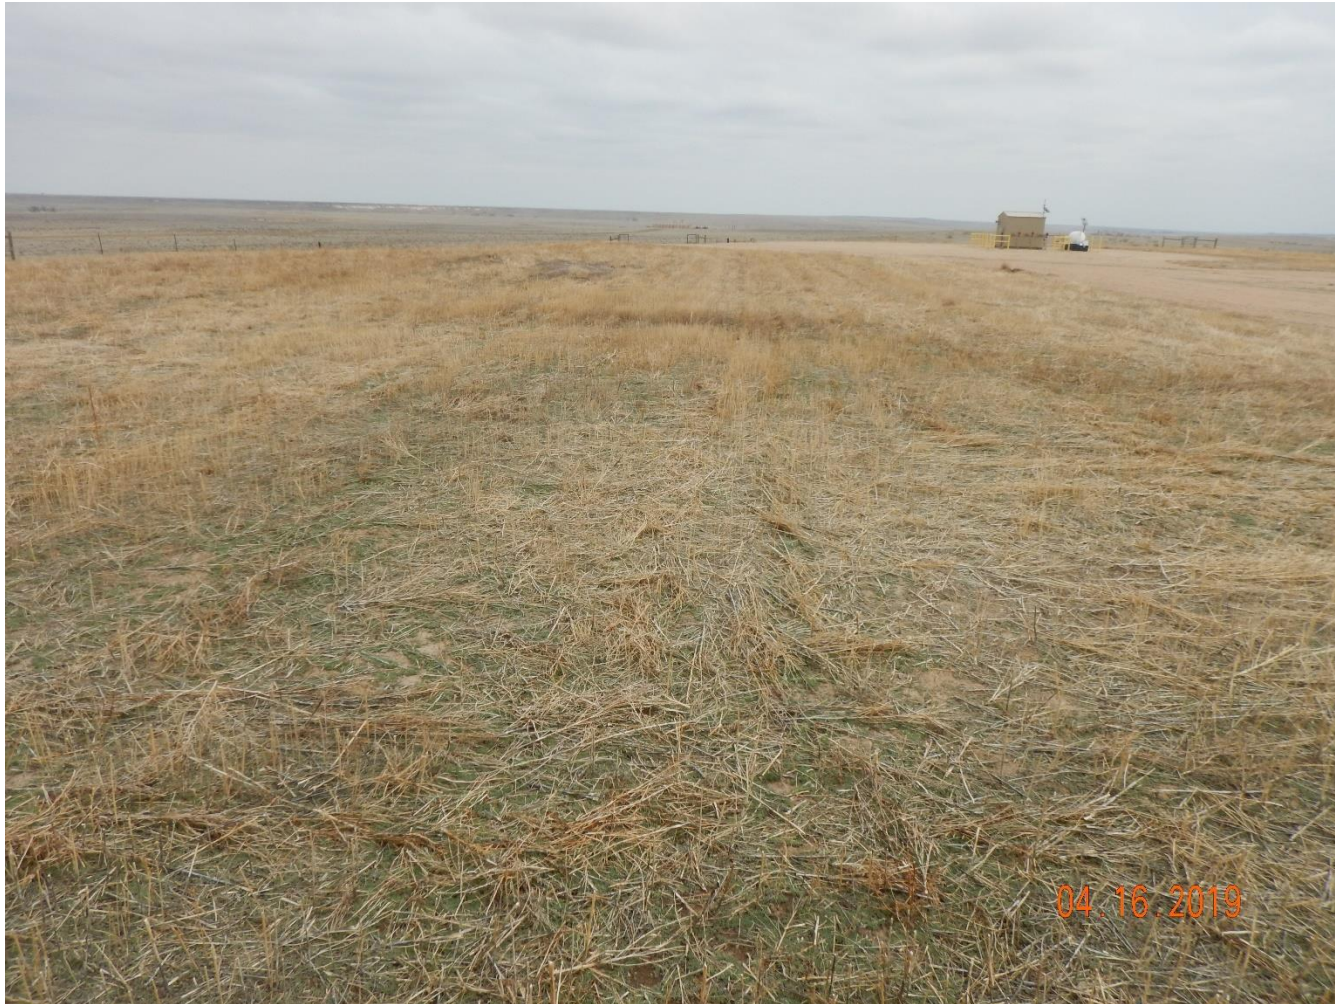
Photo 4: Photo taken from the northwest end of the location, facing east. Photo shows vegetation over the reclamation area. Interim areas are either predominantly undersirable weedy plant species such as Kochia, Salsola sp, or bare and exposed soil.

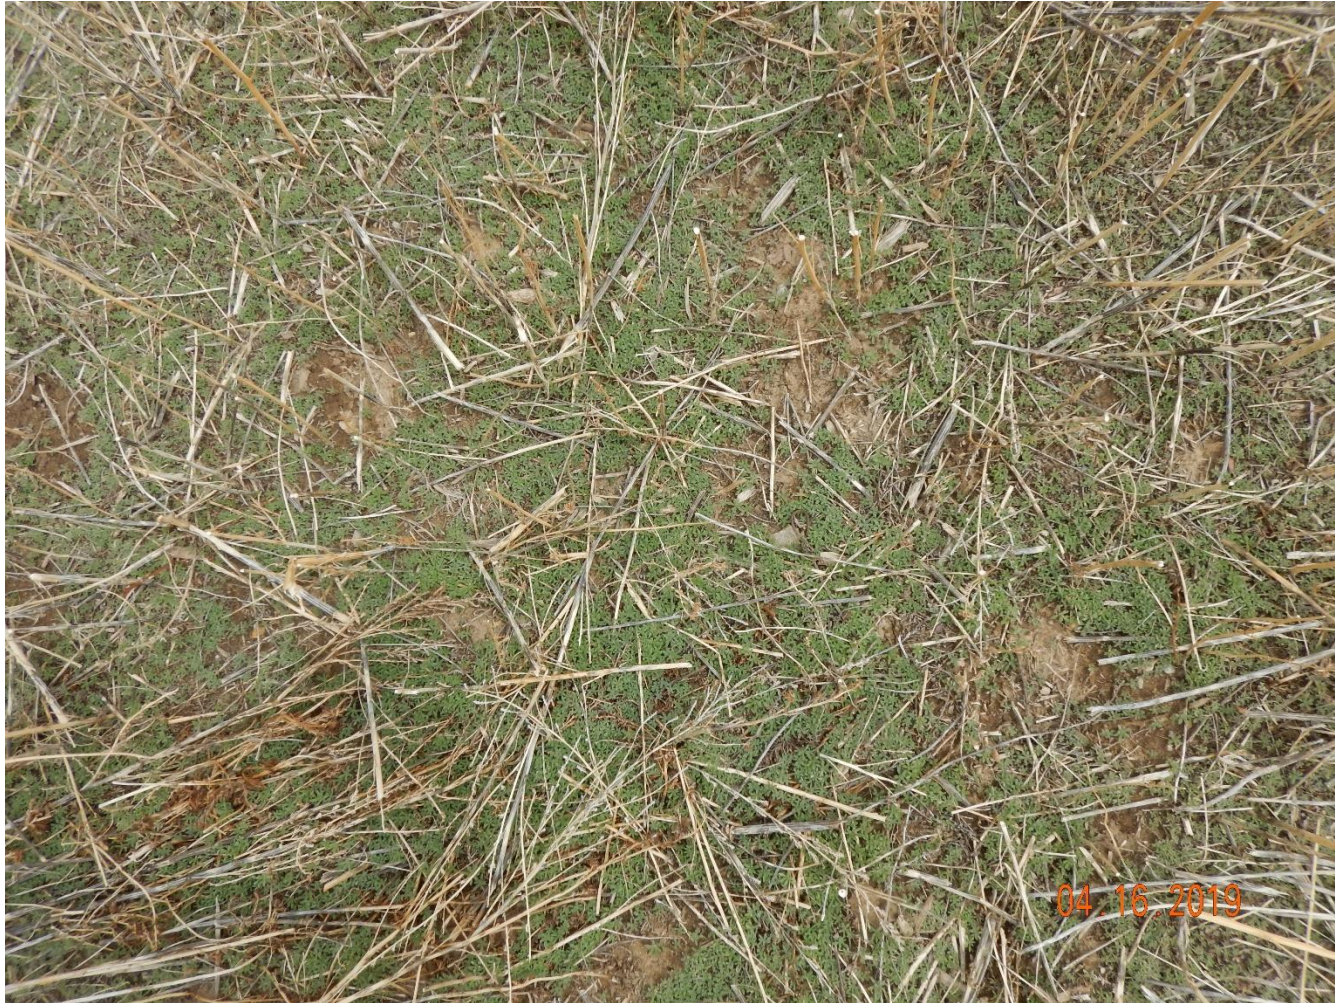
Photo 5 Photo taken from the interim areas. Photo shows plant germination observed on interim areas is undesirable weedy plant species such as Kochia and Salsola sp. Some desirable perennial germination was evident.
