Construction and Storm Water Inspection

Operator: NGL WATER SOLUTIONS DJ LLC - 10373

Location ID: 456888

Inspection Document #: 674902792

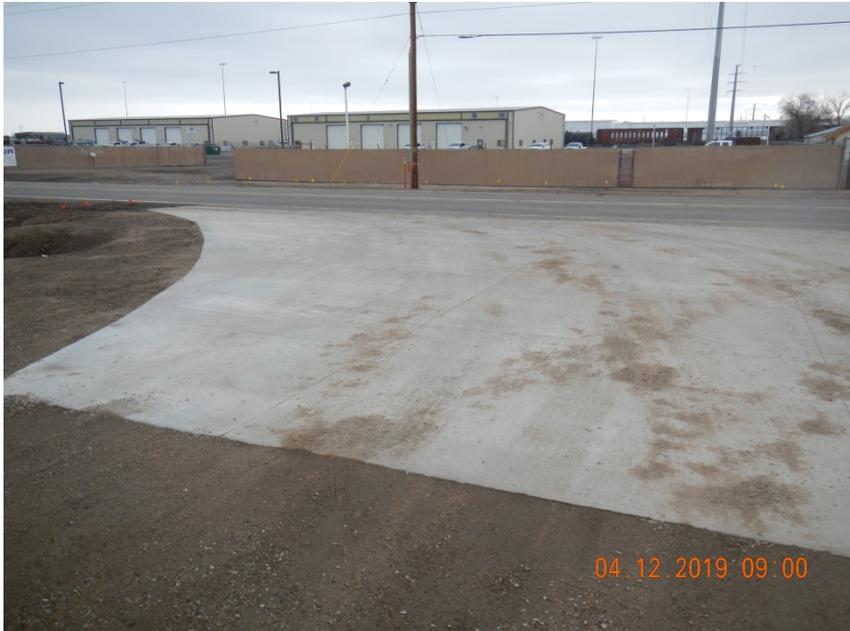
Photo 1. Photo taken from the entrance to the access road Off CR 27, facing Northeast. Photo illustrates a concrete pad installed by the Operator to potentially limit tracking on to the county road.

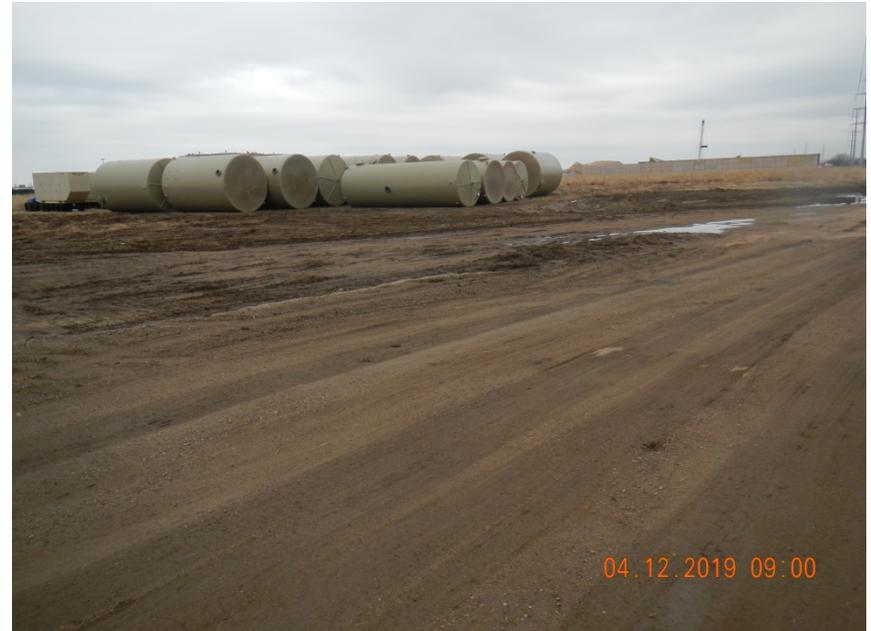
Photo 2. Photo taken from the access road facing Southwest. Photo depicts the storage area being utilized south of the access road.

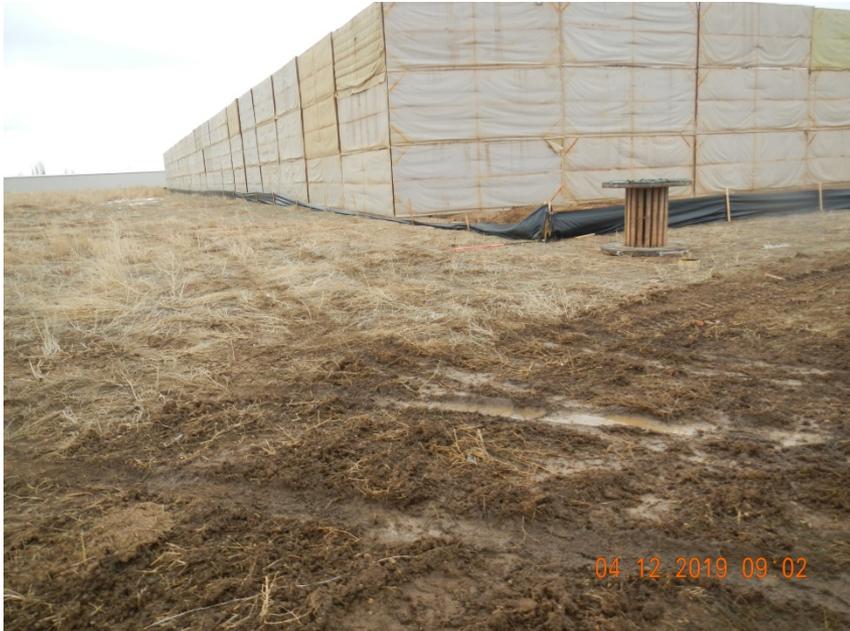
Photo 3. Photo taken from the northeastern perimeter of the location, facing South. Photo illustrates the installed silt fence BMP is not in proper functioning condition.

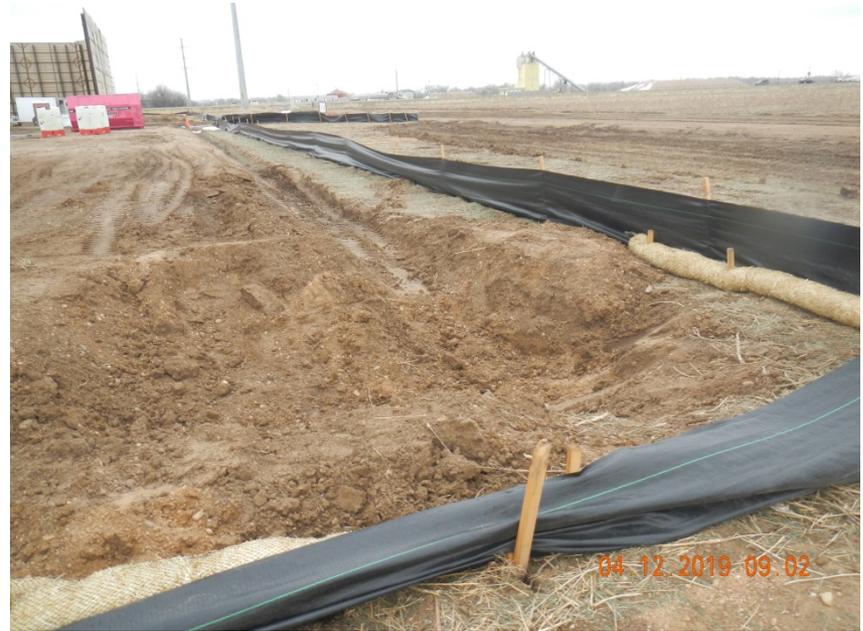
Photo 4. Photo taken from the northwestern perimeter of the location, facing East. Photo illustrates a sediment trap installed however no stabilized outlet is apparent.

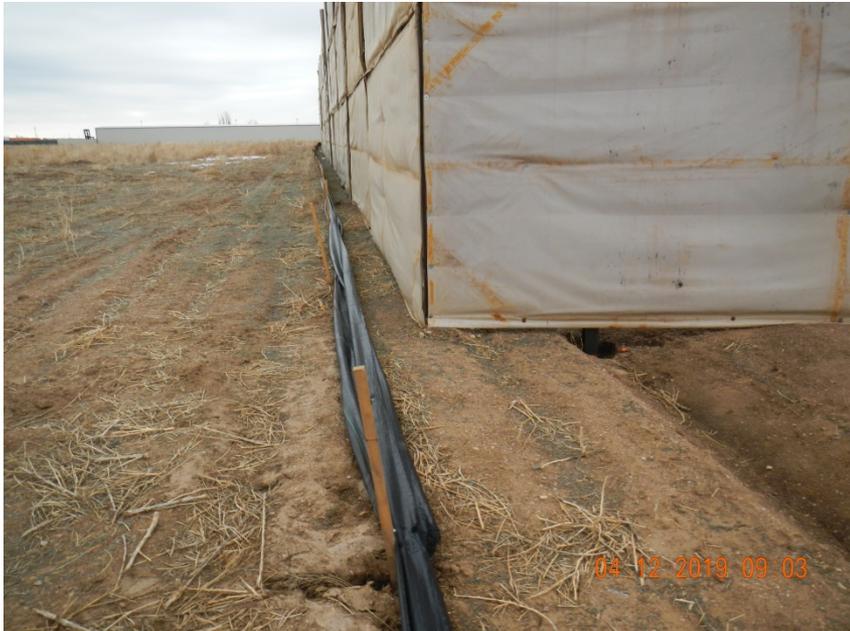
Photo 5. Photo taken from the northeastern perimeter of the location, facing North. See comments from Photo 3.

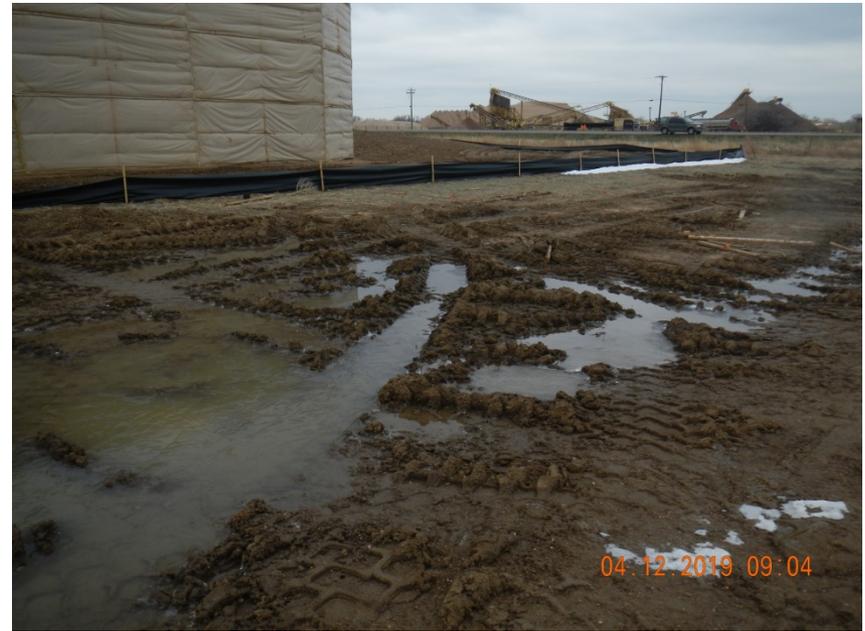
Photo 6. Photo taken from the northwestern perimeter of the location, facing East. Photo depicts the silt fence BMP that has been installed.

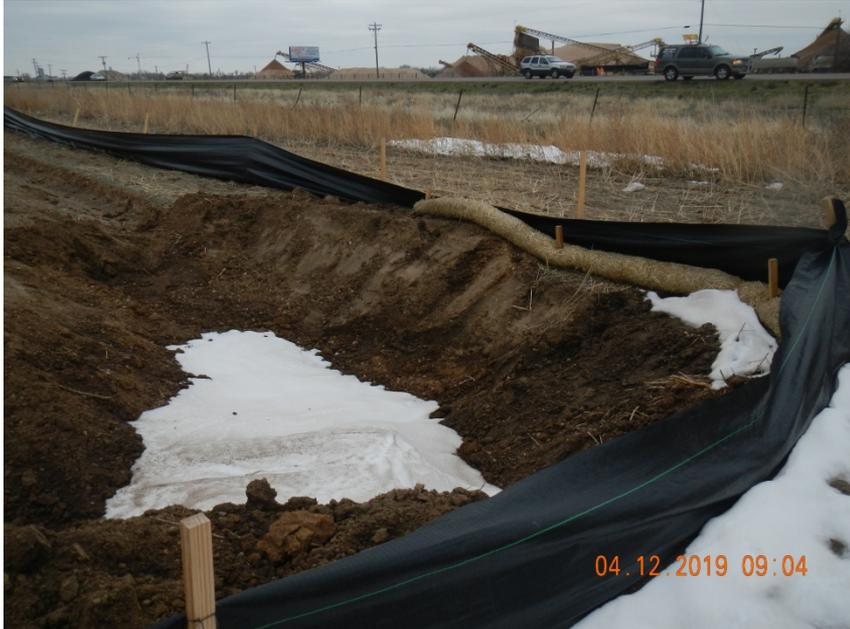
Photo 7. Photo taken from the Northwestern perimeter of the location, facing North. See comments under Photo 4.

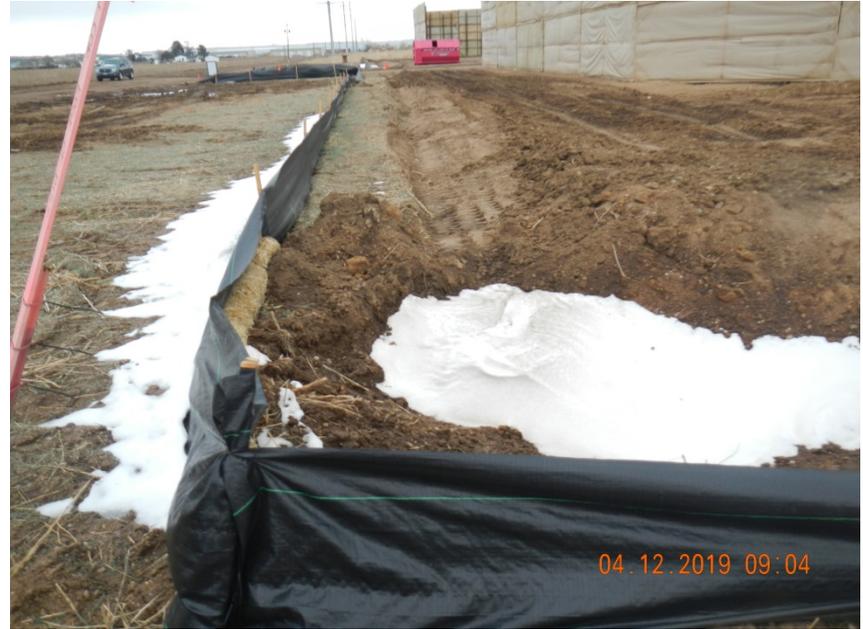
Photo 8. Photo taken from the Northwestern perimeter of the location, facing North. See comments under Photo 4.
