Final Reclamation Inspection

Operator: NOBLE ENERGY INC - #100322

Location ID: 319187

Inspection Photos
Location Name: ECKHARDT #1
Location ID: 319187

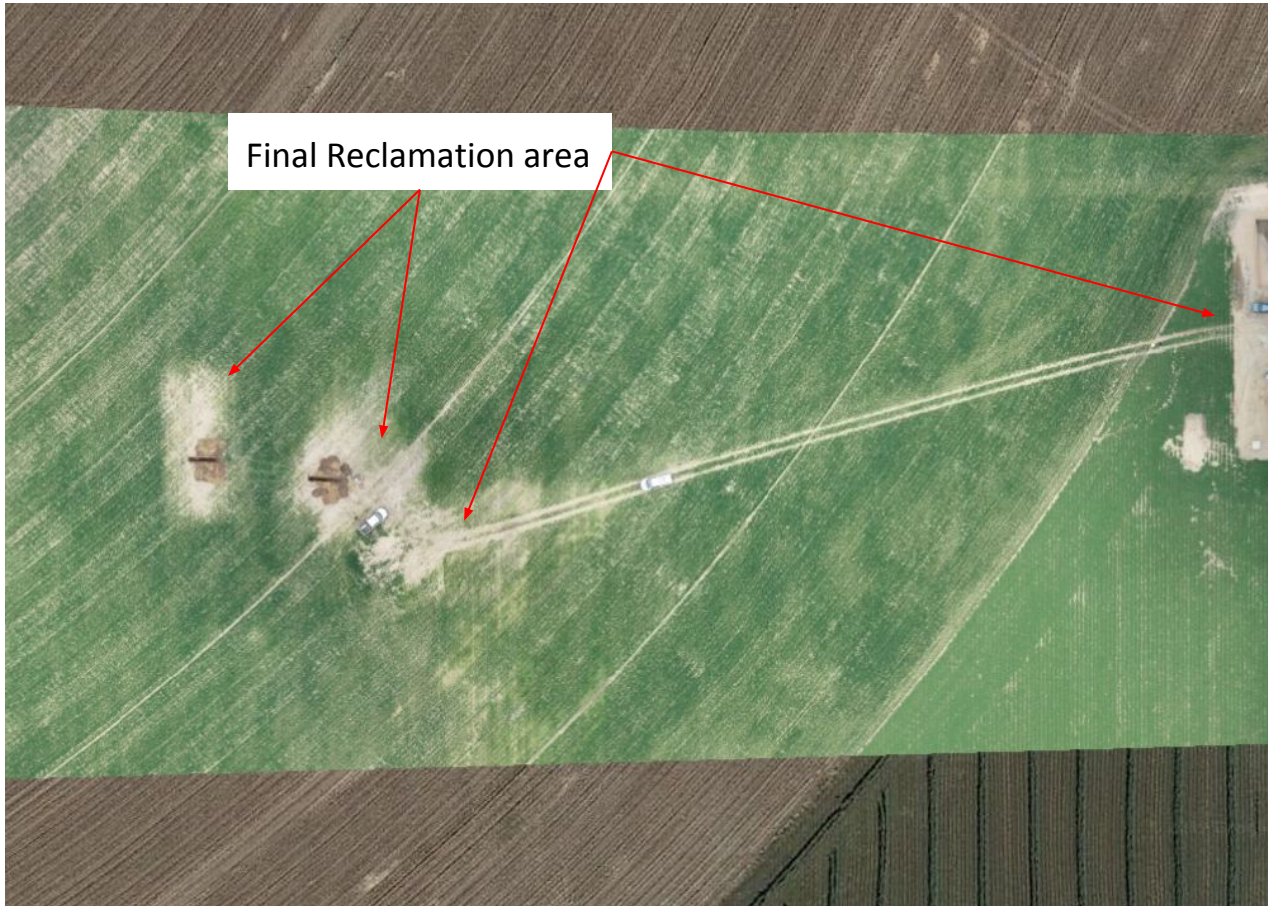
Drone aerial imagery taken on April 16, 2019. Aerial imagery shows areas around the well location (~0.25 acres of disturbance) and the access road do not meet Rule 1004 standards, as crop failure is evident. Failed areas around the well location may have been associated with old pits.

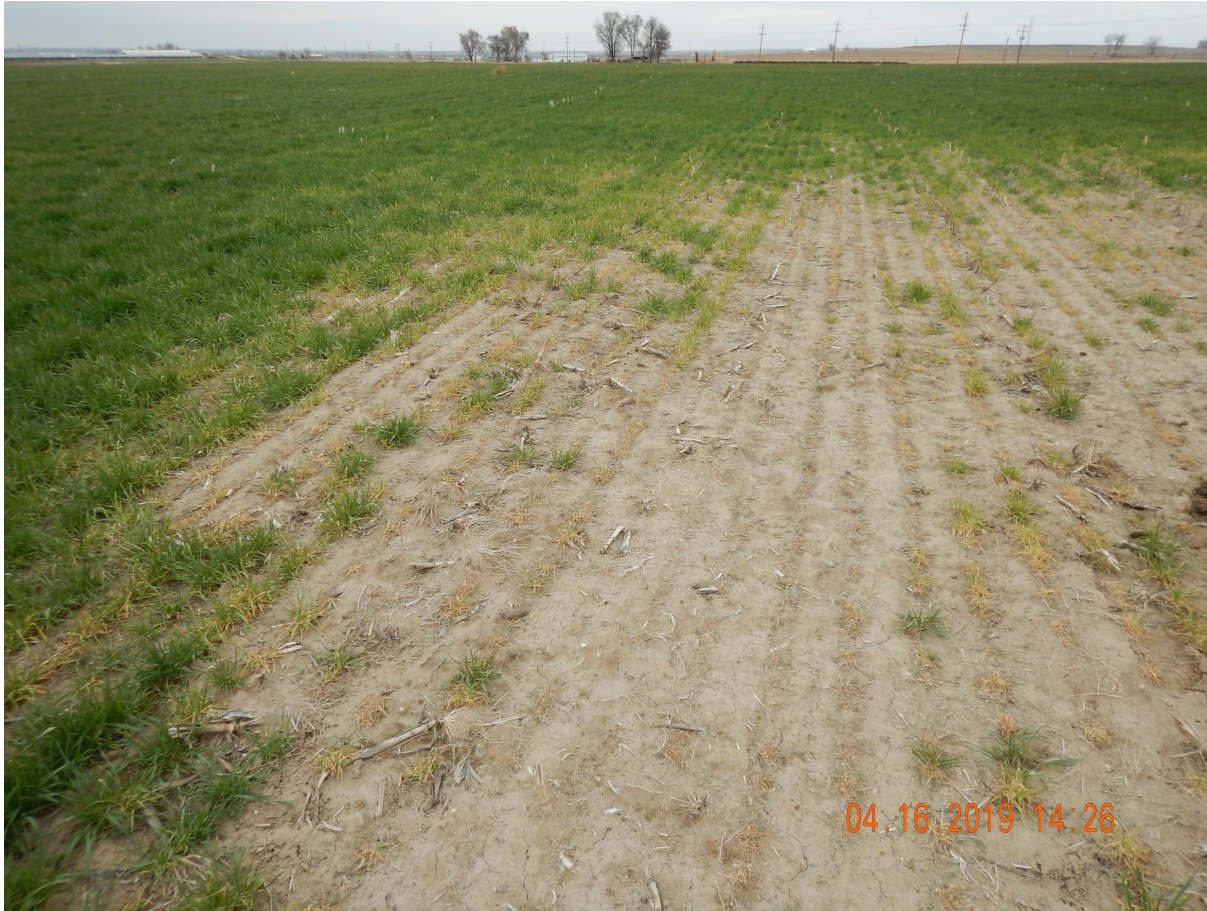
Photo 1. Photo taken from the western well location, facing North. Photo illustrates crop failure which is not representative of reference crop areas.

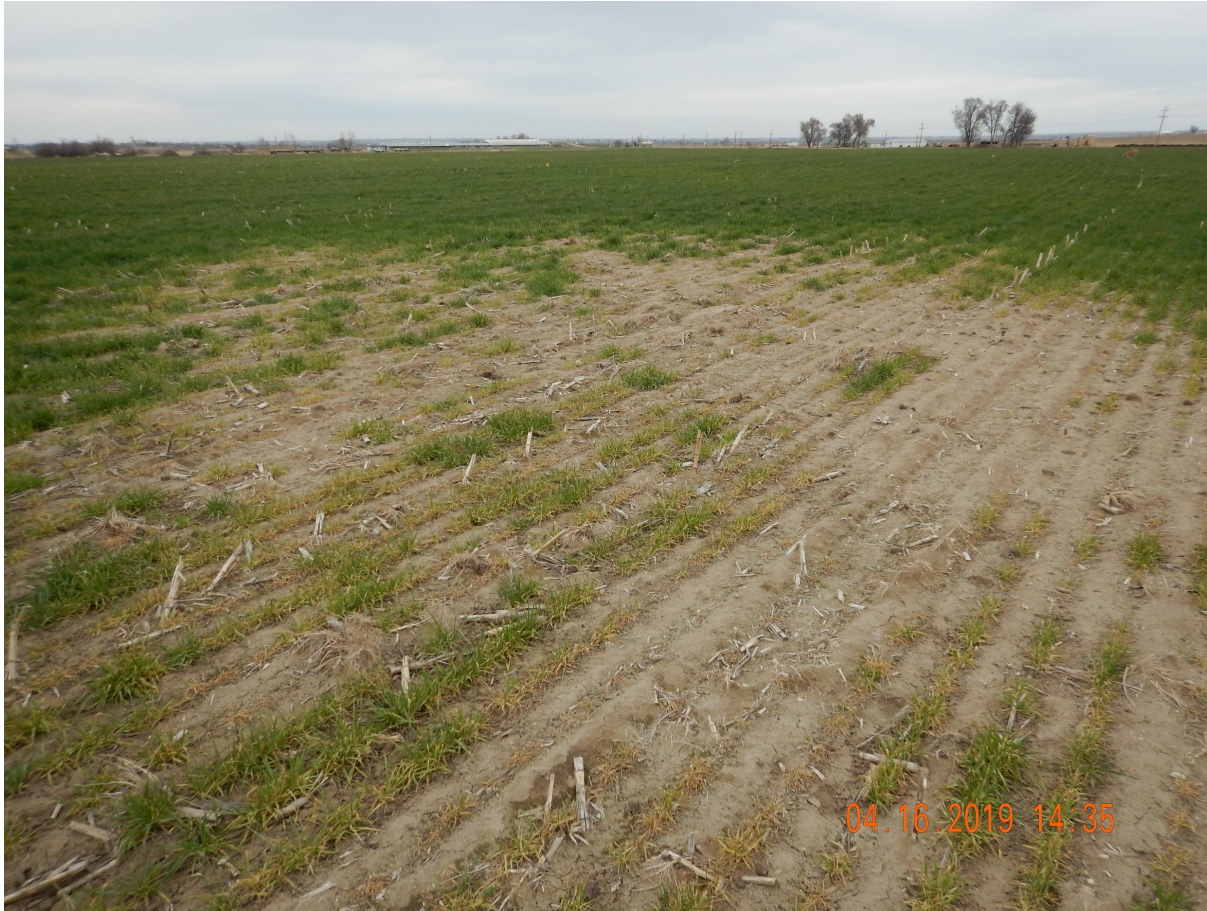
Photo 2. Photo taken from the central well location, facing Northwest. See comments under Photo 1.

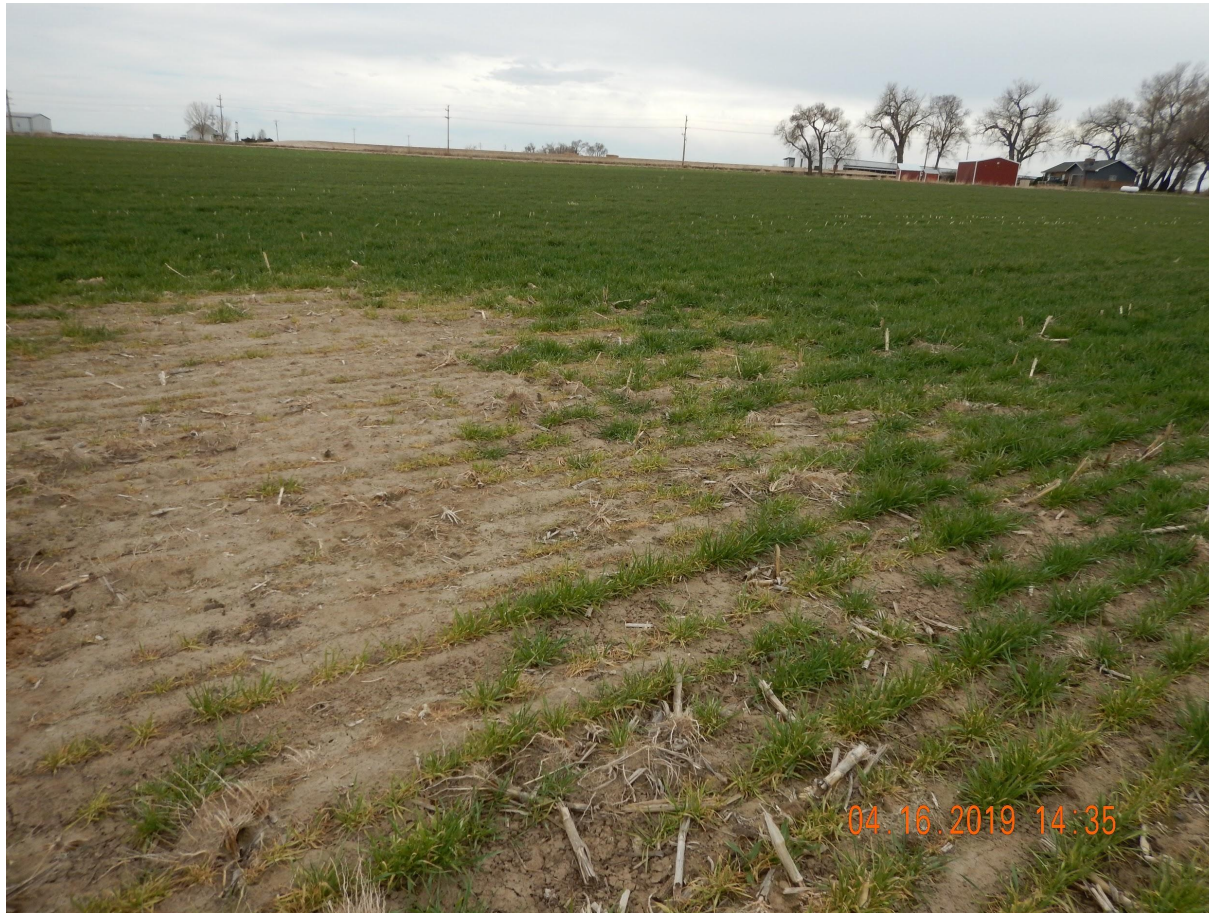
Photo 3. Photo taken from the western well location, facing South. See comments under Photo 1.

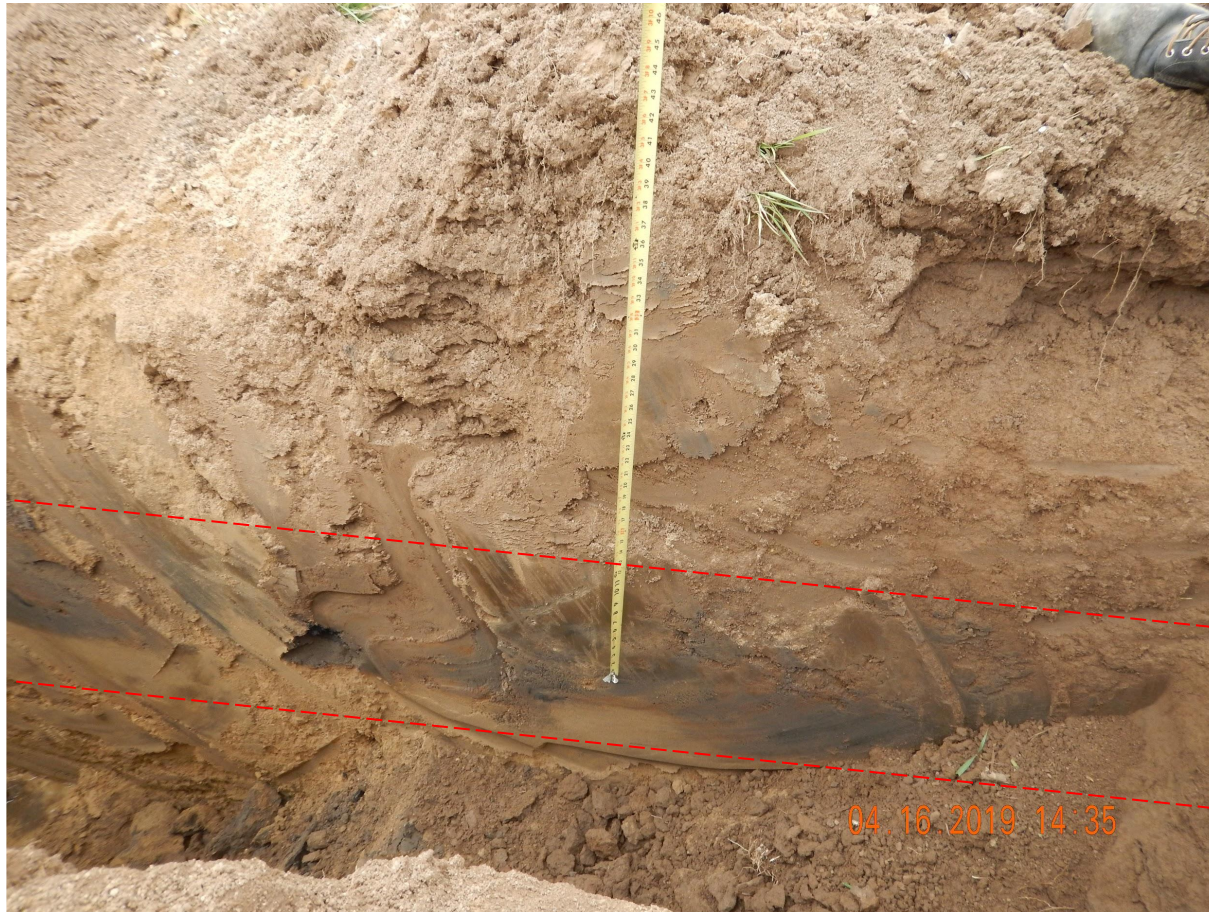
Photo 4. Photo taken from a trench dug around the well location. Photo illustrates what appears to be an impervious layer observed approximately three feet below the surface.

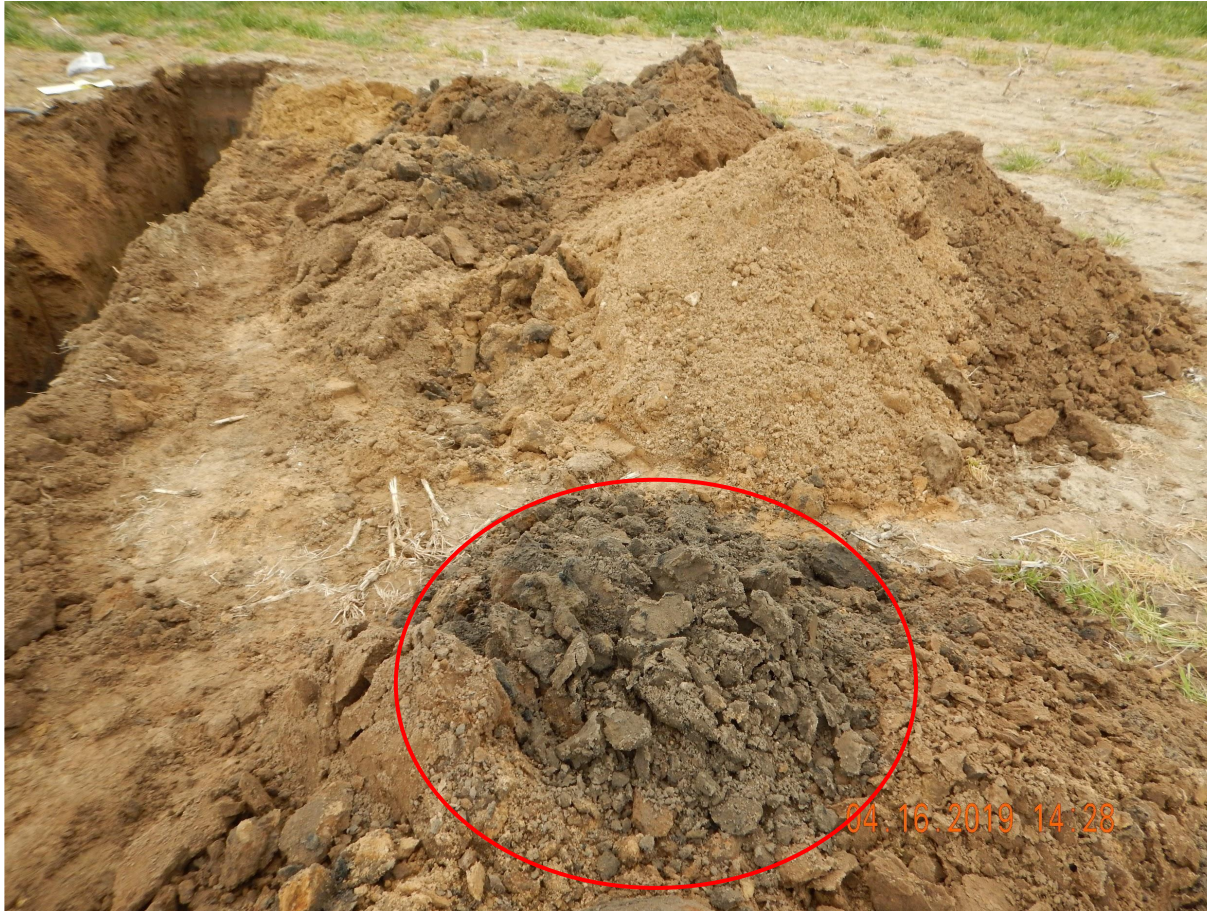
Photo 5. Photo illustrates soil taken from what appears to be an impervious soil layer observed approximately three feet below the surface.

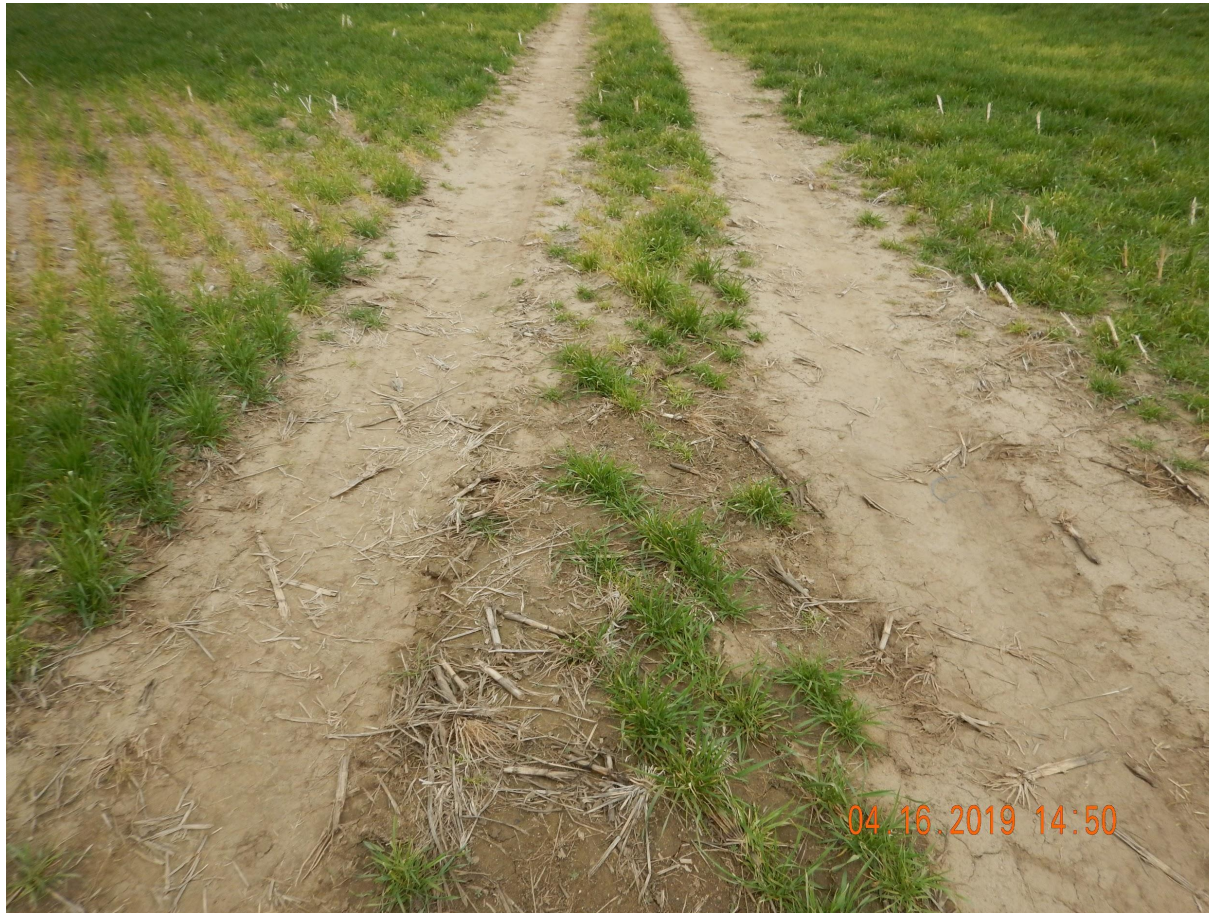
Photo 6. Photo taken from the western access road, facing East. See comments under Photo 1.

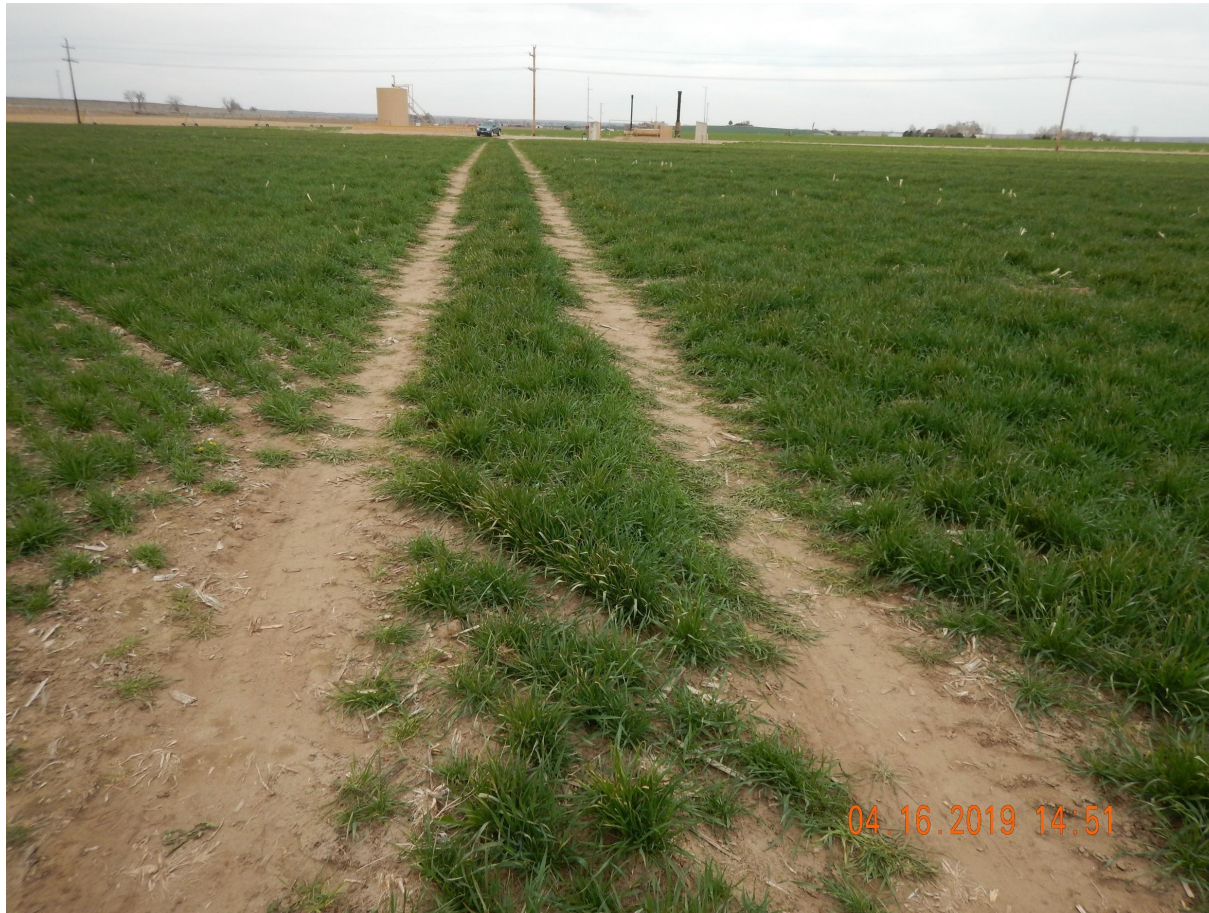
Photo 7. Photo taken along a portion of the access road, facing East. See comments under Photo 1.

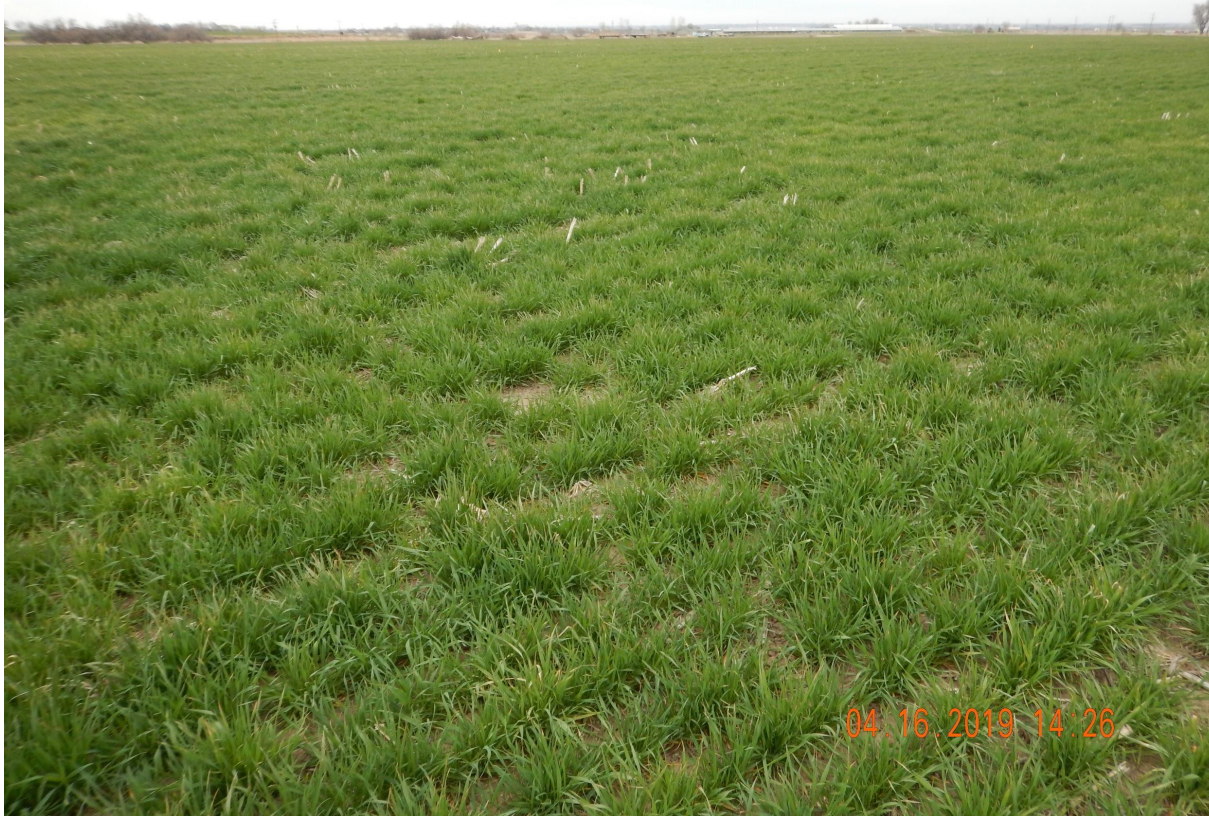
Photo 8. Reference photo taken north of the well location, facing North.
Disturbance areas are not reflective or reference crop areas.
