Inspection Photos

Operator: BISON OIL & GAS II LLC # 10661

Location ID: 452871

Inspection Doc. Number: 682504817

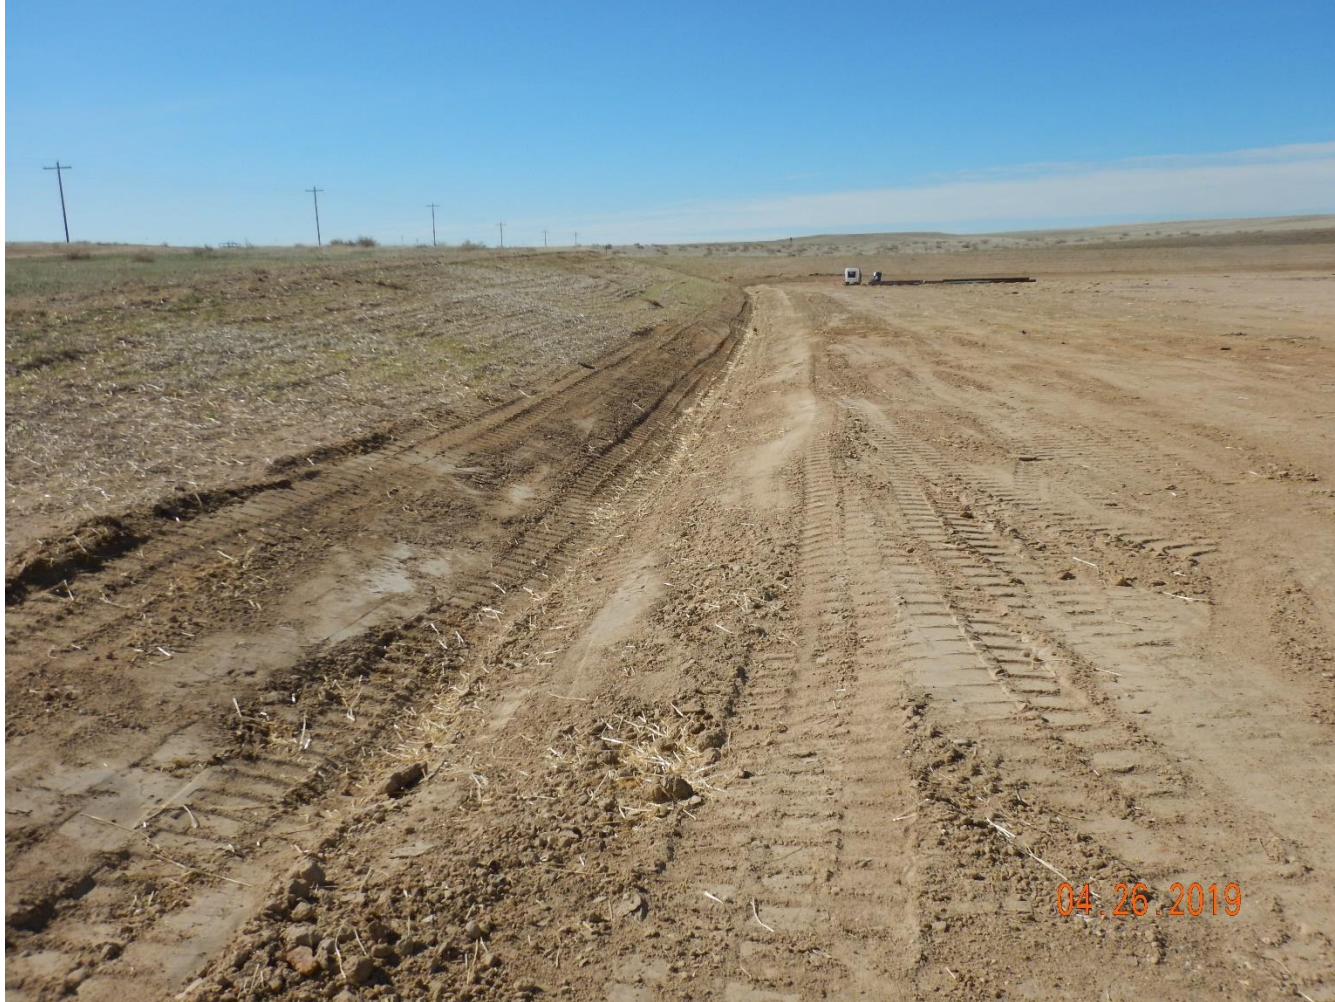
Photo 1: Photo taken from the east end of the location facing south. Photo shows operator has installed a ditch along the eastern perimeter of the pad.

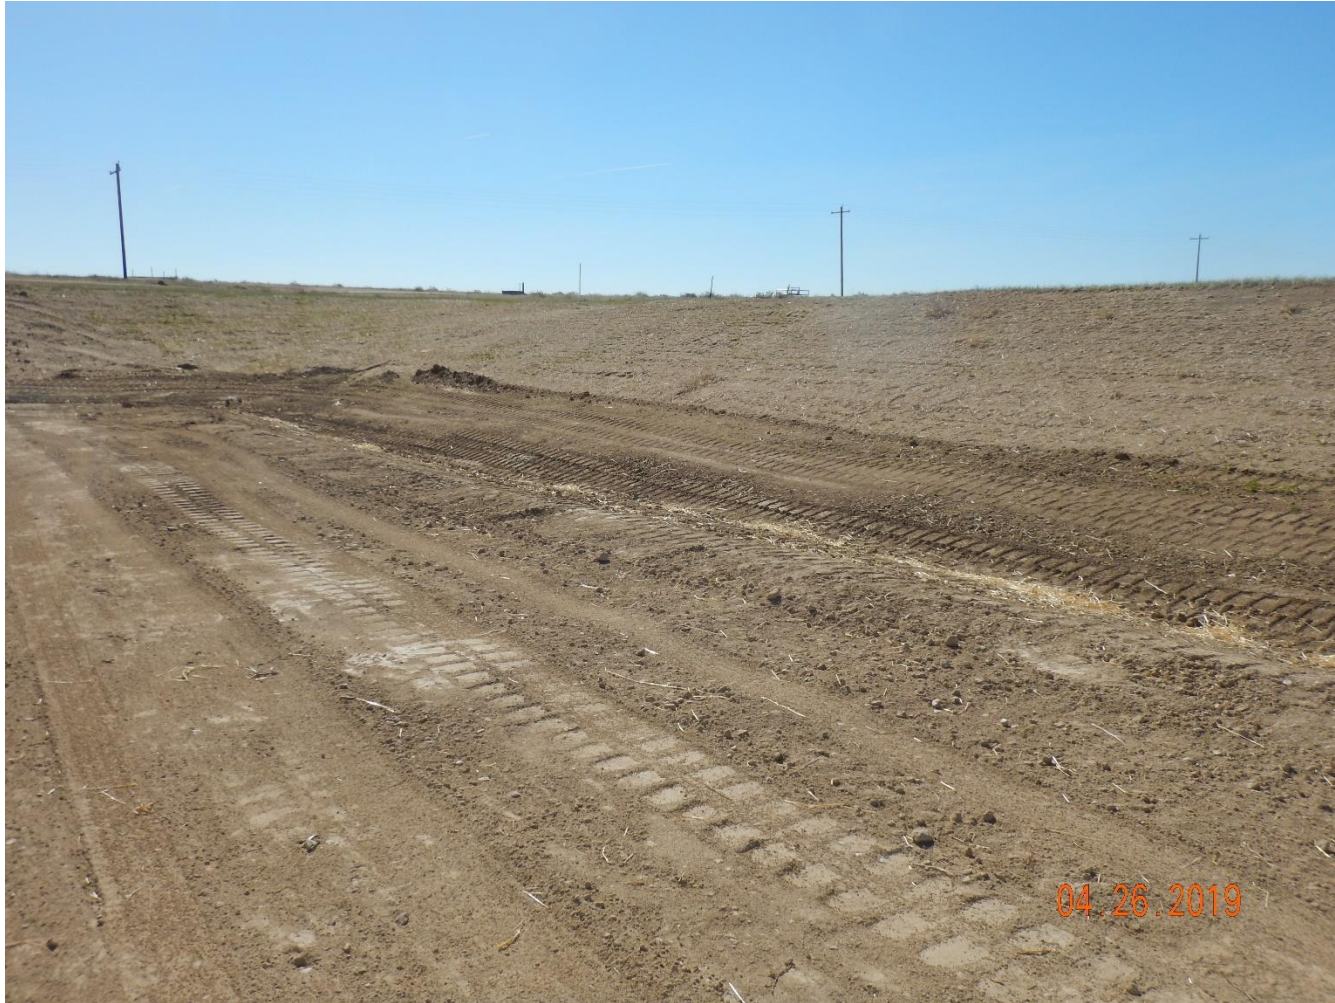
Photo 2: Photo taken from the southeast end of the location, facing southeast. Photo shows operator has installed a ditch. Photo also shows erosion degradation has been repaired and slopes appear to have been seeded/mulched.

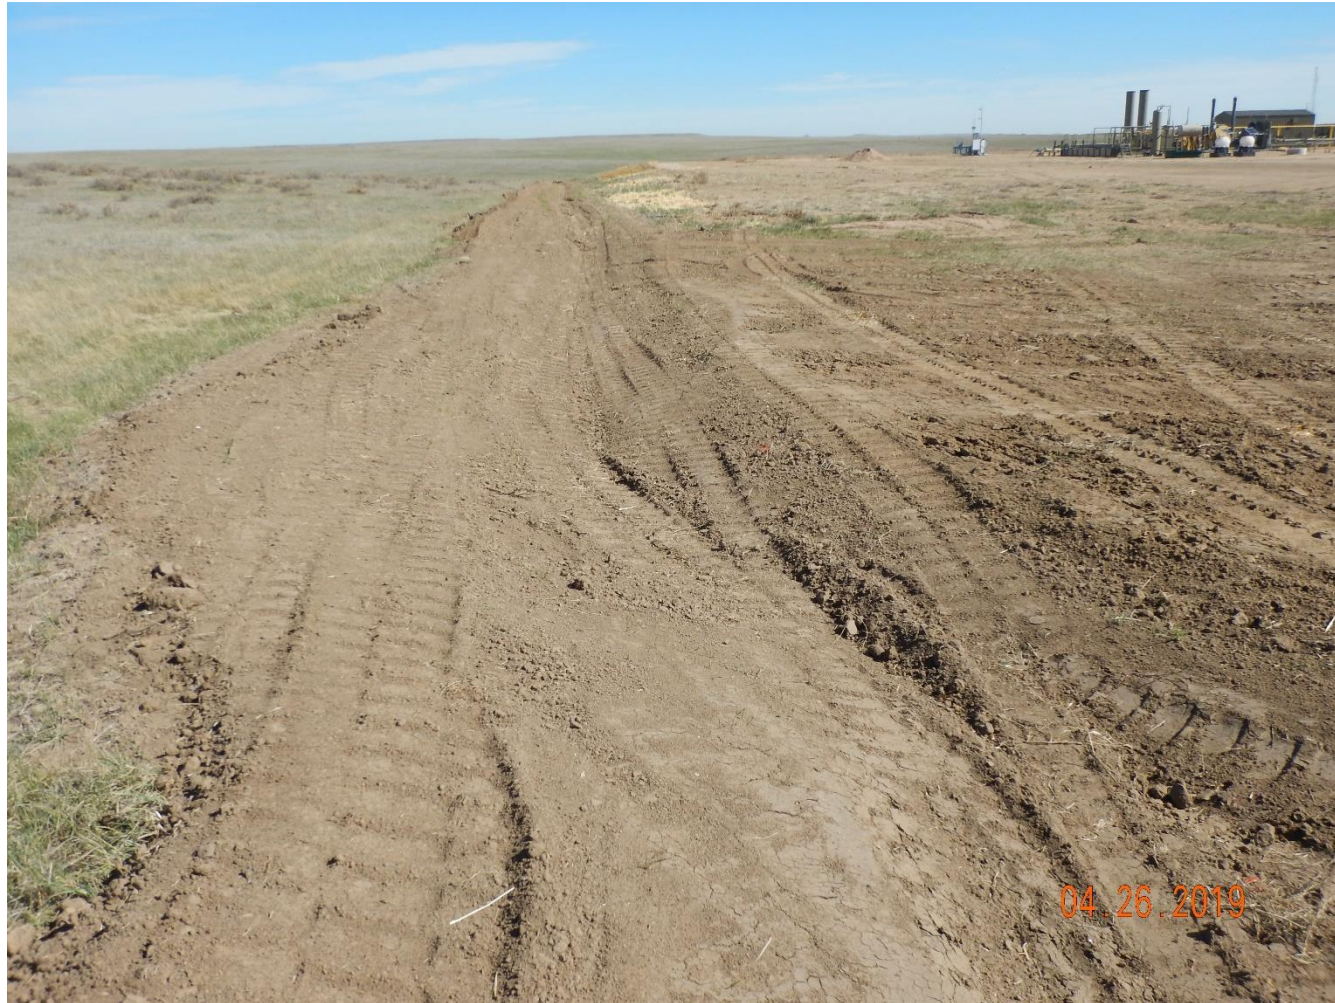
Photo 3: Photo taken from the southwest end of the pad, facing north. Photo shows operator has installed a stormwater ditch on the western perimeter of the pad.

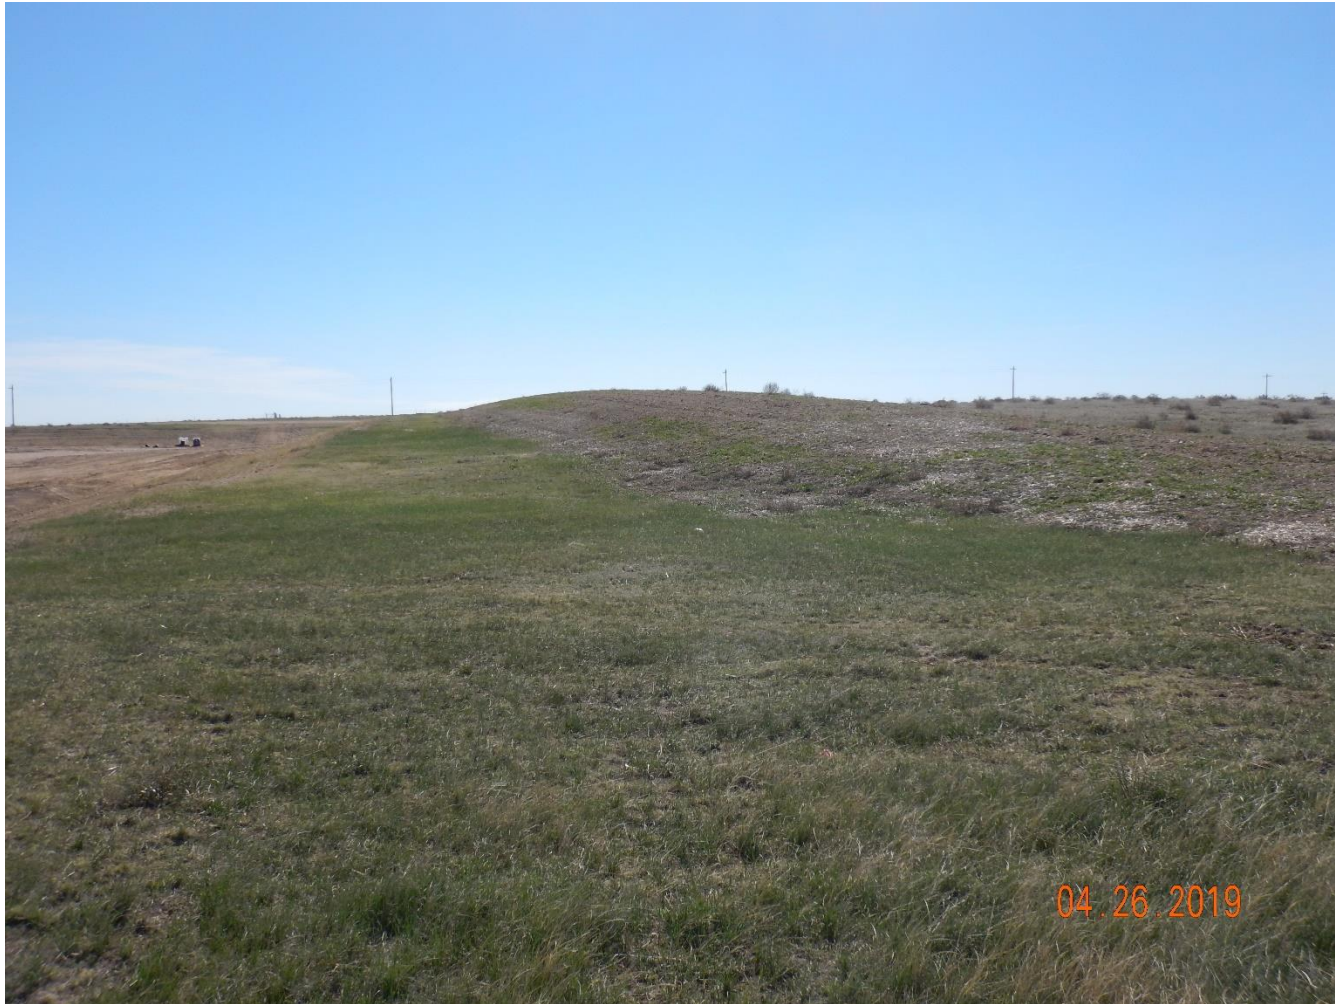
Photo 4: Photo taken from the southwest end of the pad, facing east. Photo shows operator has installed a stormwater ditch on the western perimeter of the pad. Photo shows operator appears to have conducted weed management on berm.

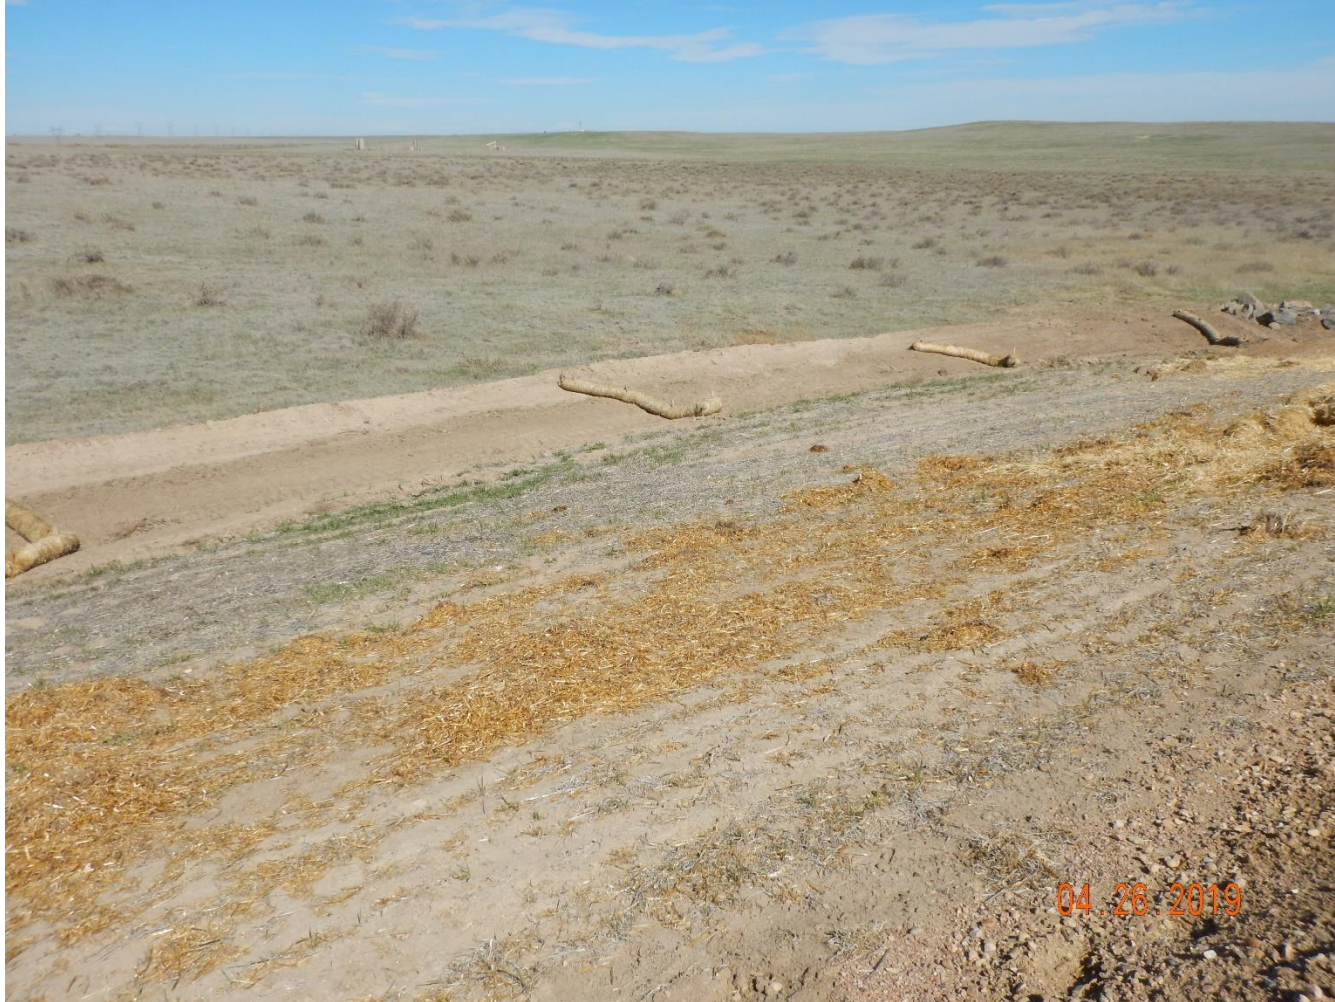
Photo 6: Photo taken from the northwest end of the location, facing northwest. Photo shows velocity checks within ditch.

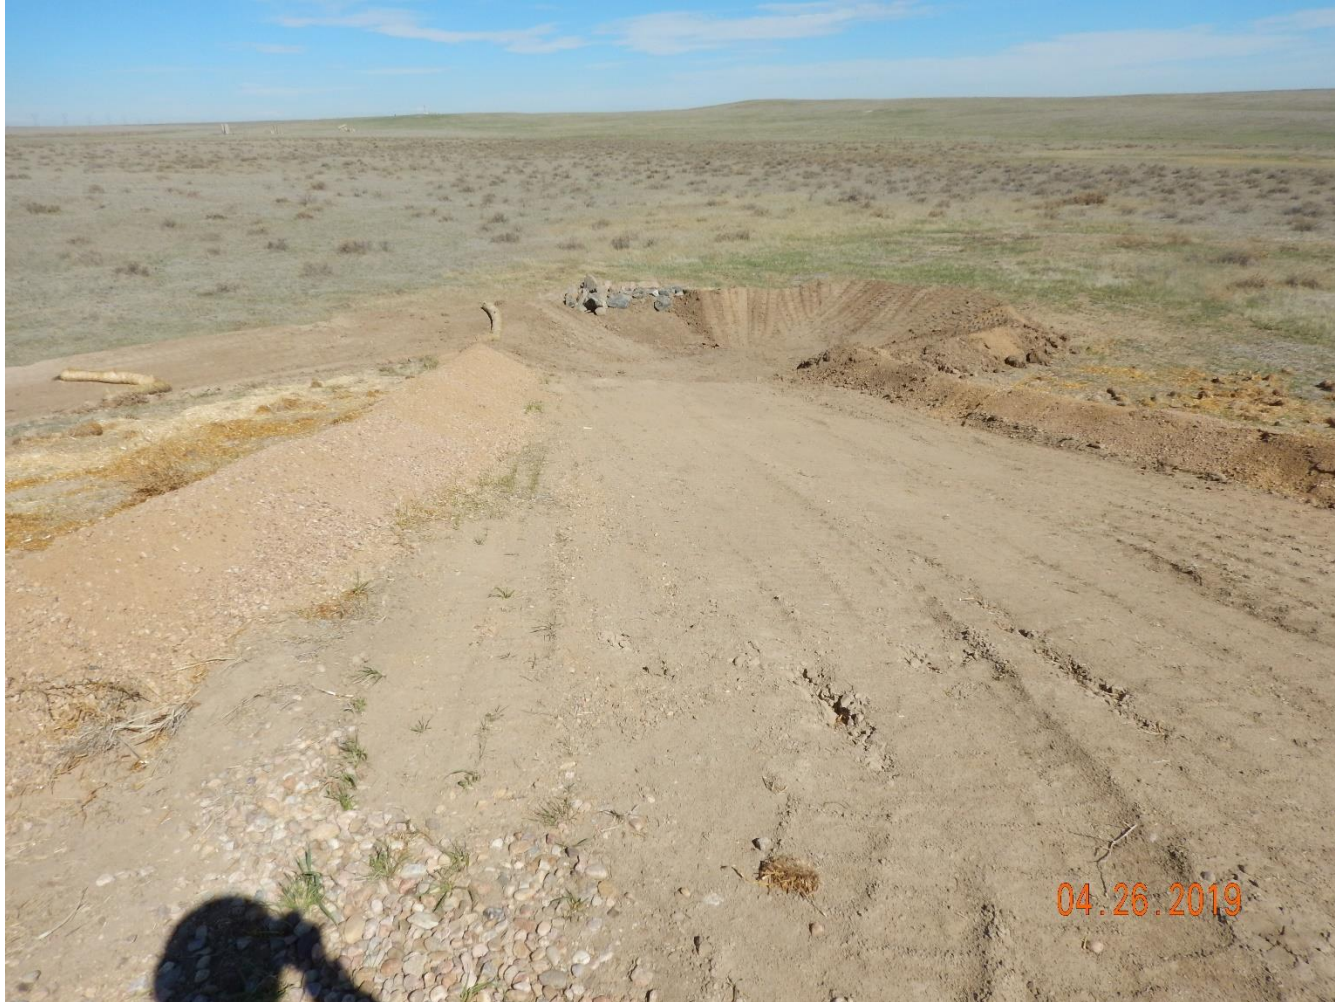
Photo 7: Photo taken from the northwest corner of the location, facing north. Photo shows operator has updated the sediment trap.

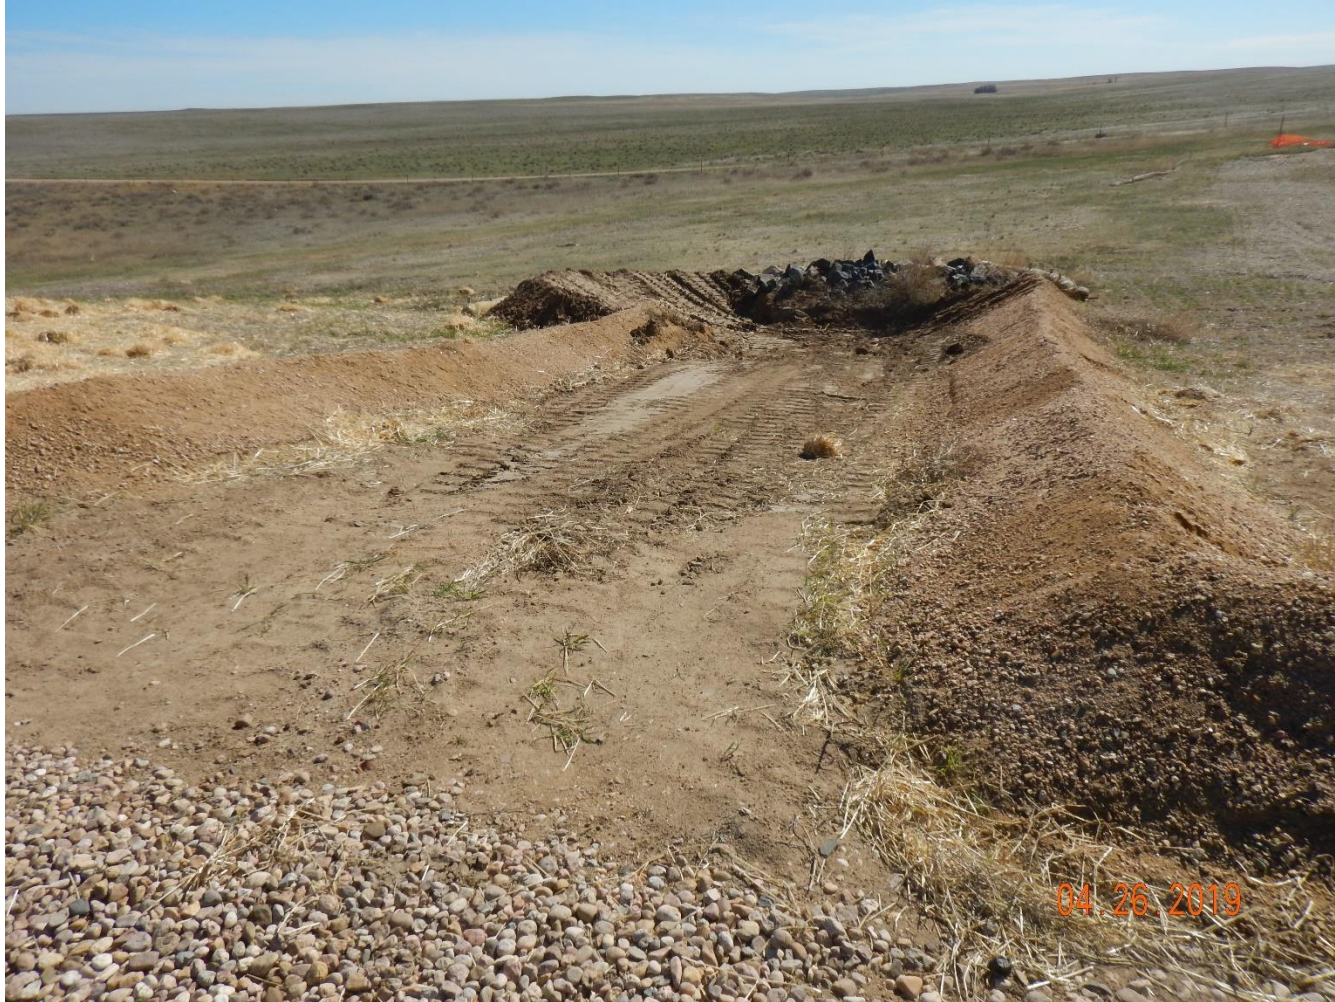
Photo 8: Photo taken from the northeast corner of the location, facing east. Photo shows operator has updated the sediment trap.

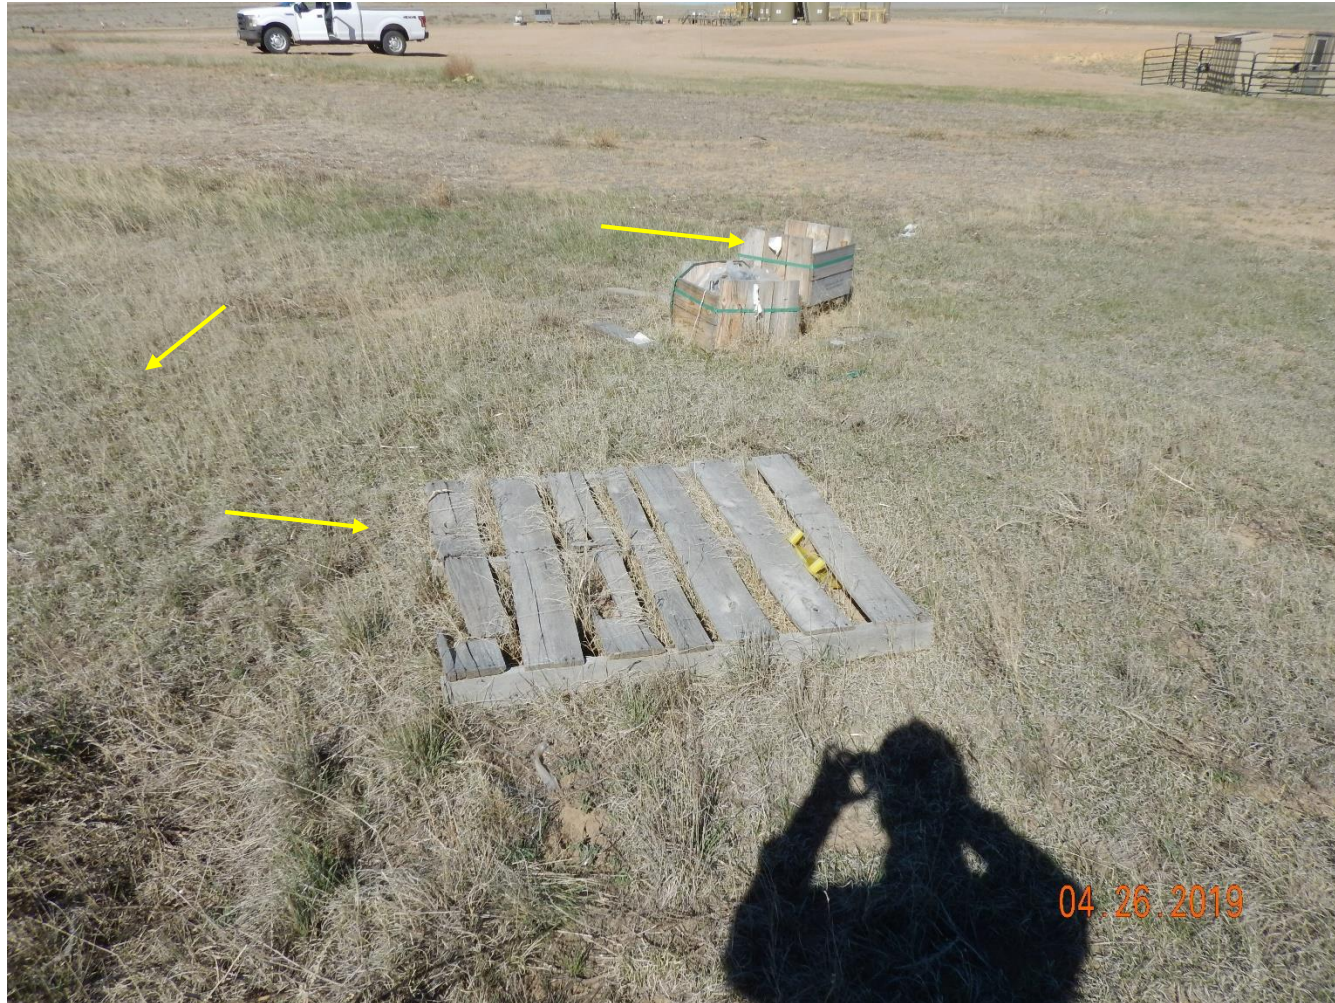
Photo 9: Photo taken from the east end of the location. Previous inspection documented various trash debris on the east end of the location, and required operator to remove and properly store in accordance with 603.f. Photo shows various debris remains.
