Inspection Photos

Operator: VERDAD RESOURCES LLC # 10651

Location ID: 457136

Inspection Doc. Number: 682504819

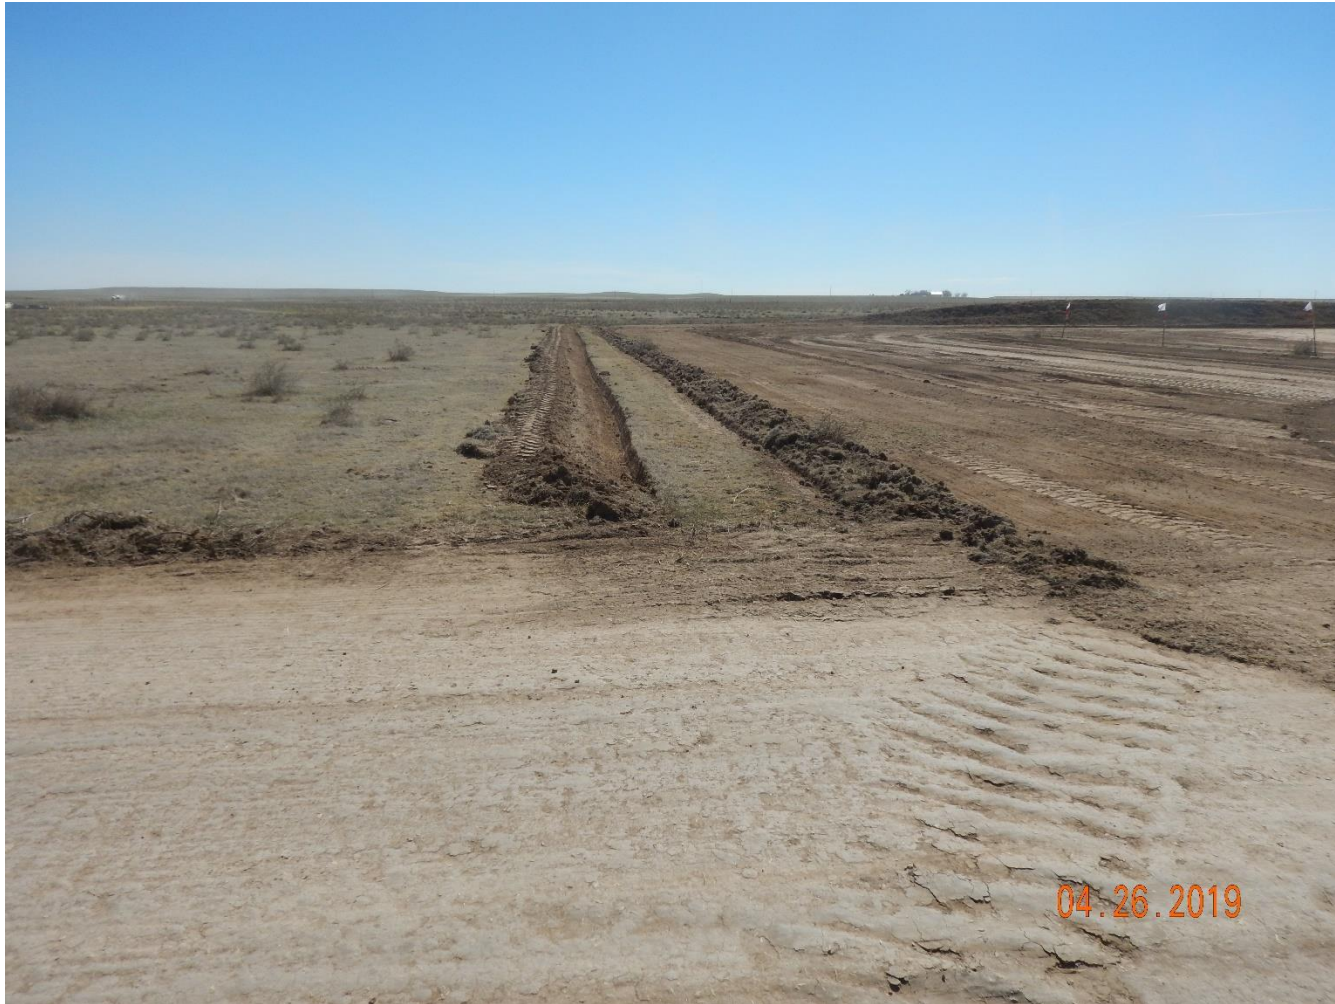
Photo 1: Photo taken from the south end of the location, facing east. Photos 1-4 provide an overview of the location from east, southeast, southwest to west. Photos show construction in process. Photo also shows operator has installed a stormwater ditch along the perimeter of the disturbance area.

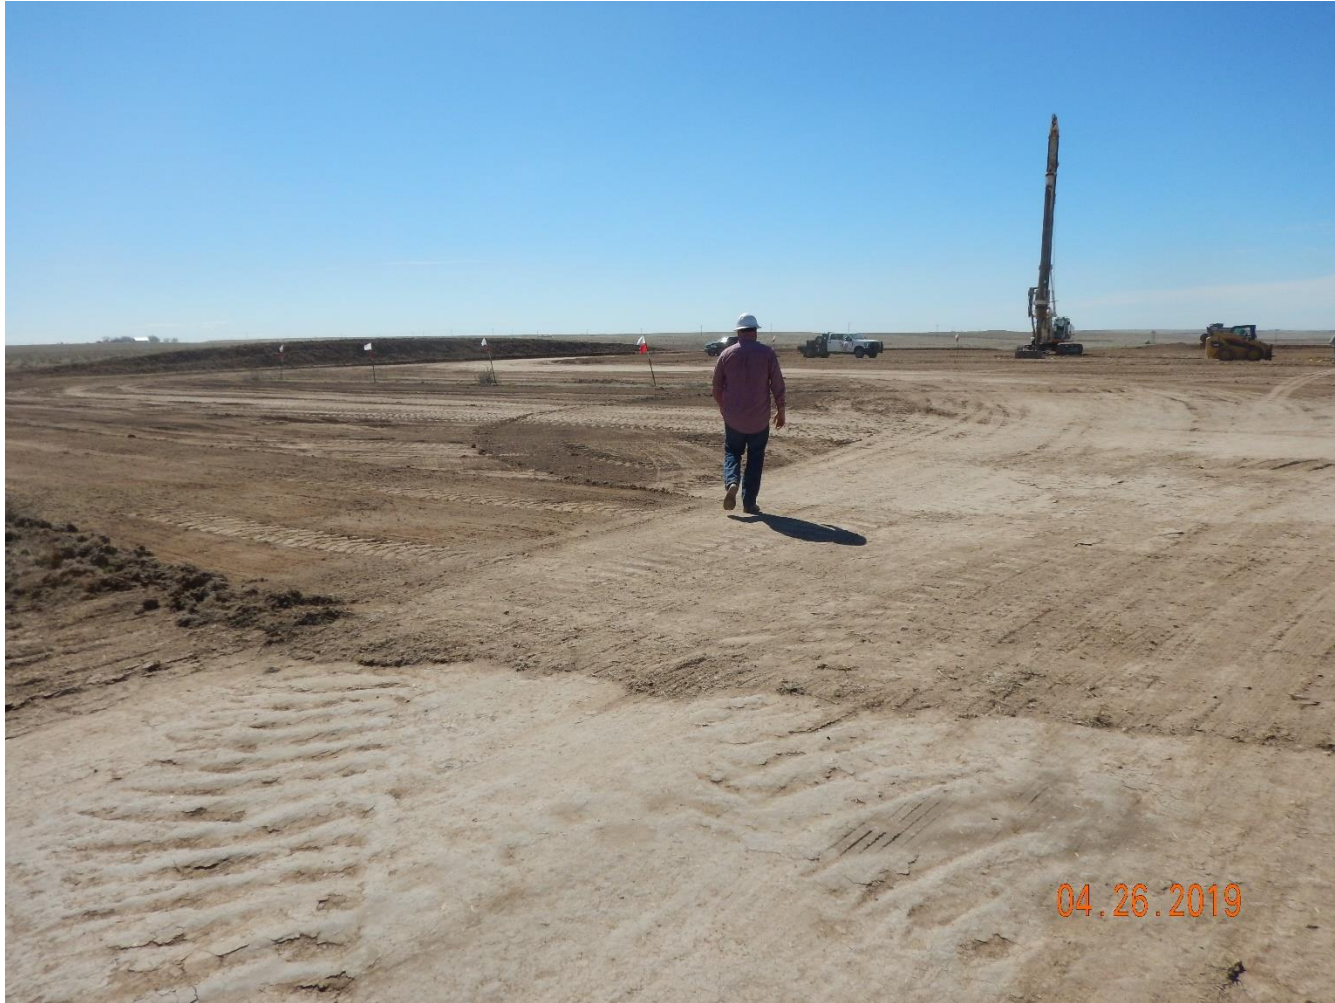
Photo 2: See comments under photo 1.

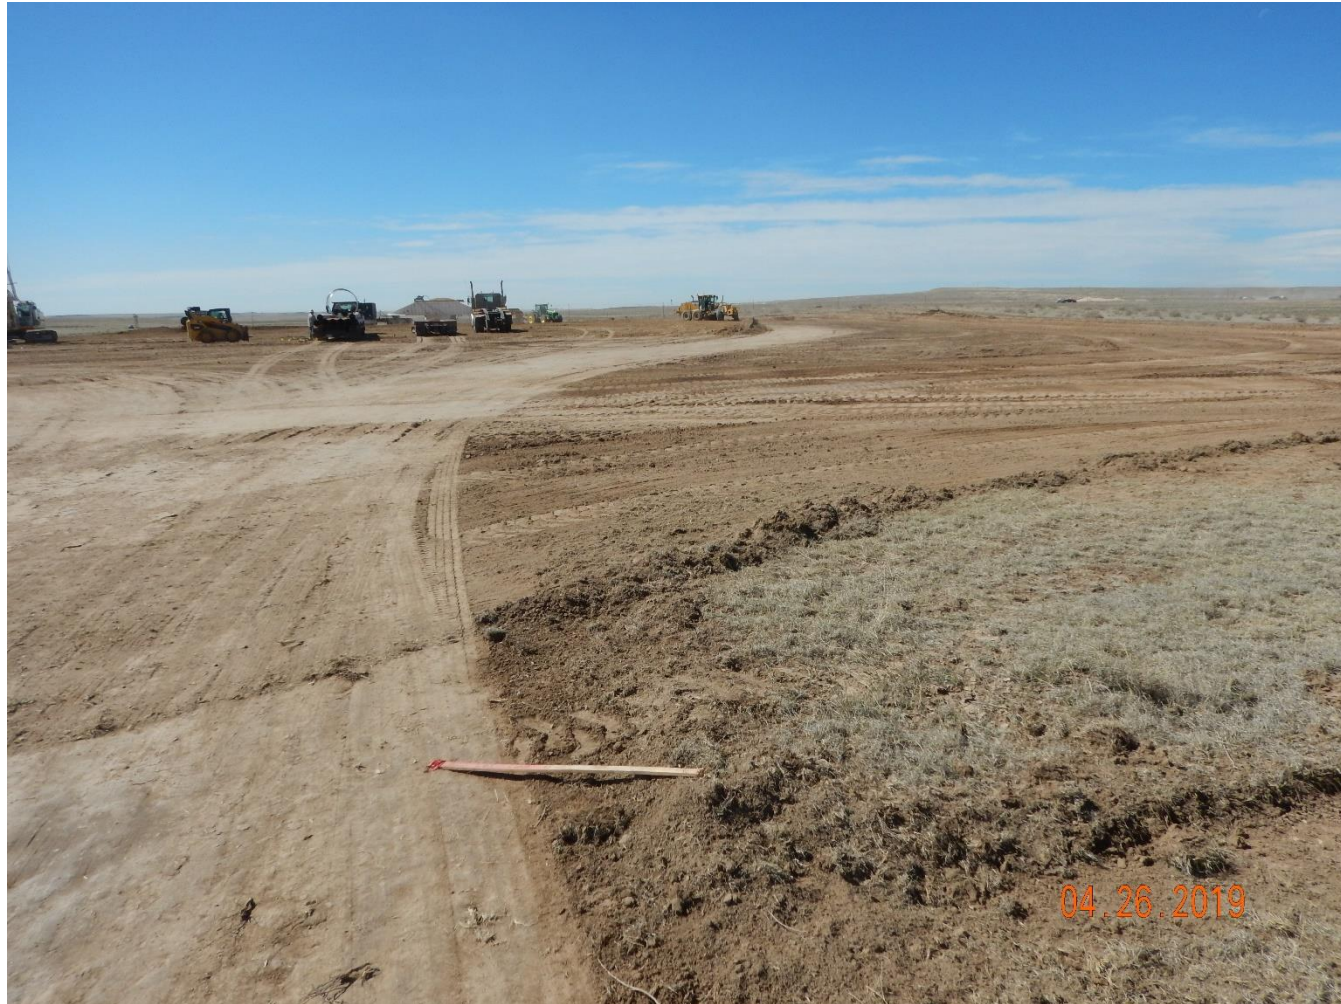
Photo 3: See comments under photo 1.

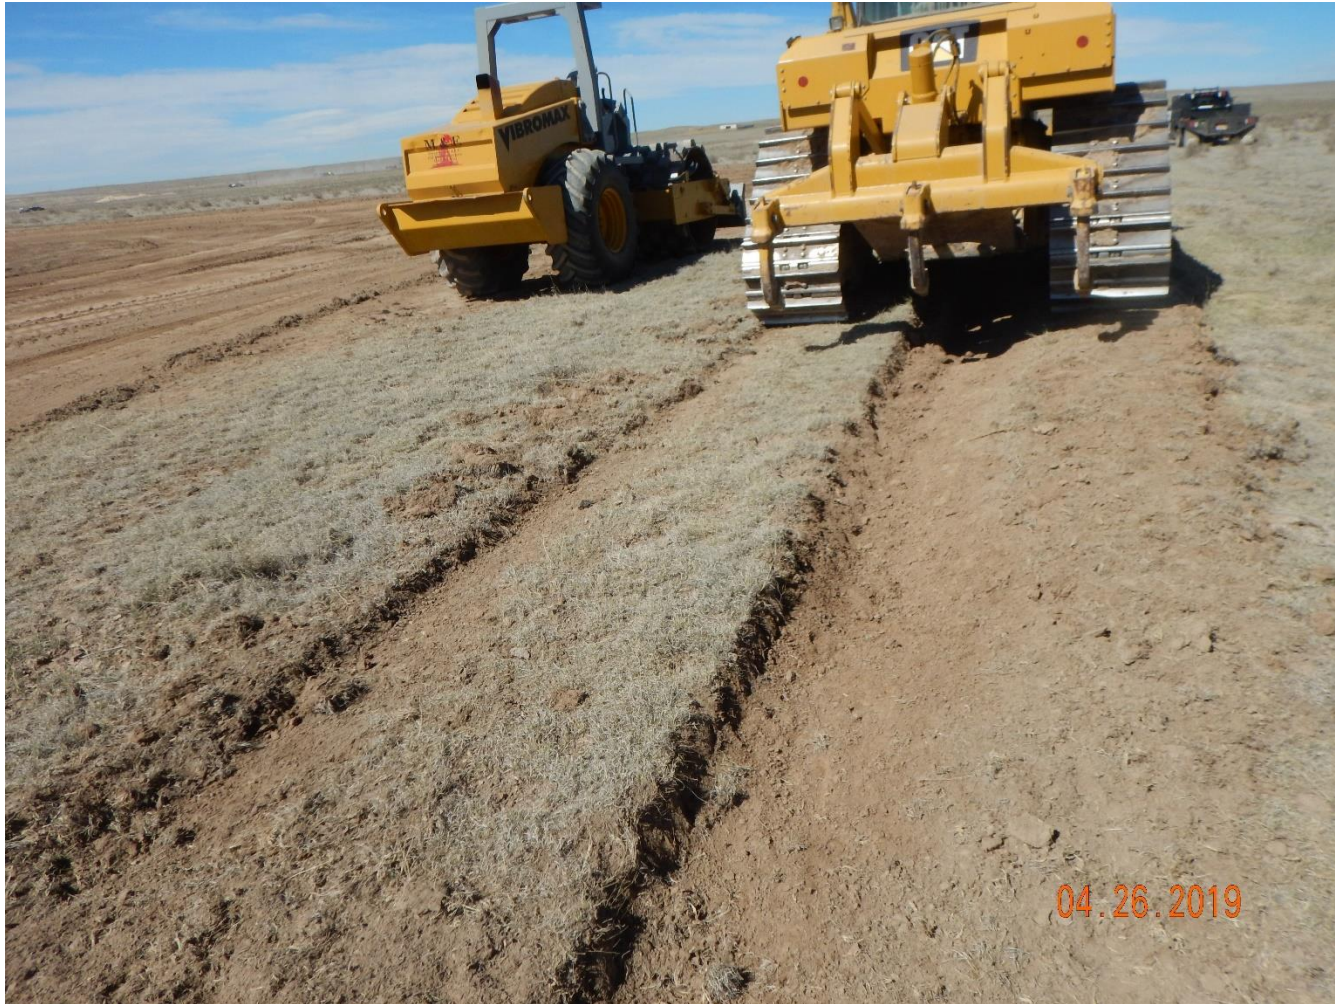
Photo 4: See comments under photo 1. Stormwater ditch does not appear to have been installed in accordance with good engineering practices; ditch appears to have been cut with a vertical grade. BMP will need to be updated once pad construction has been completed.

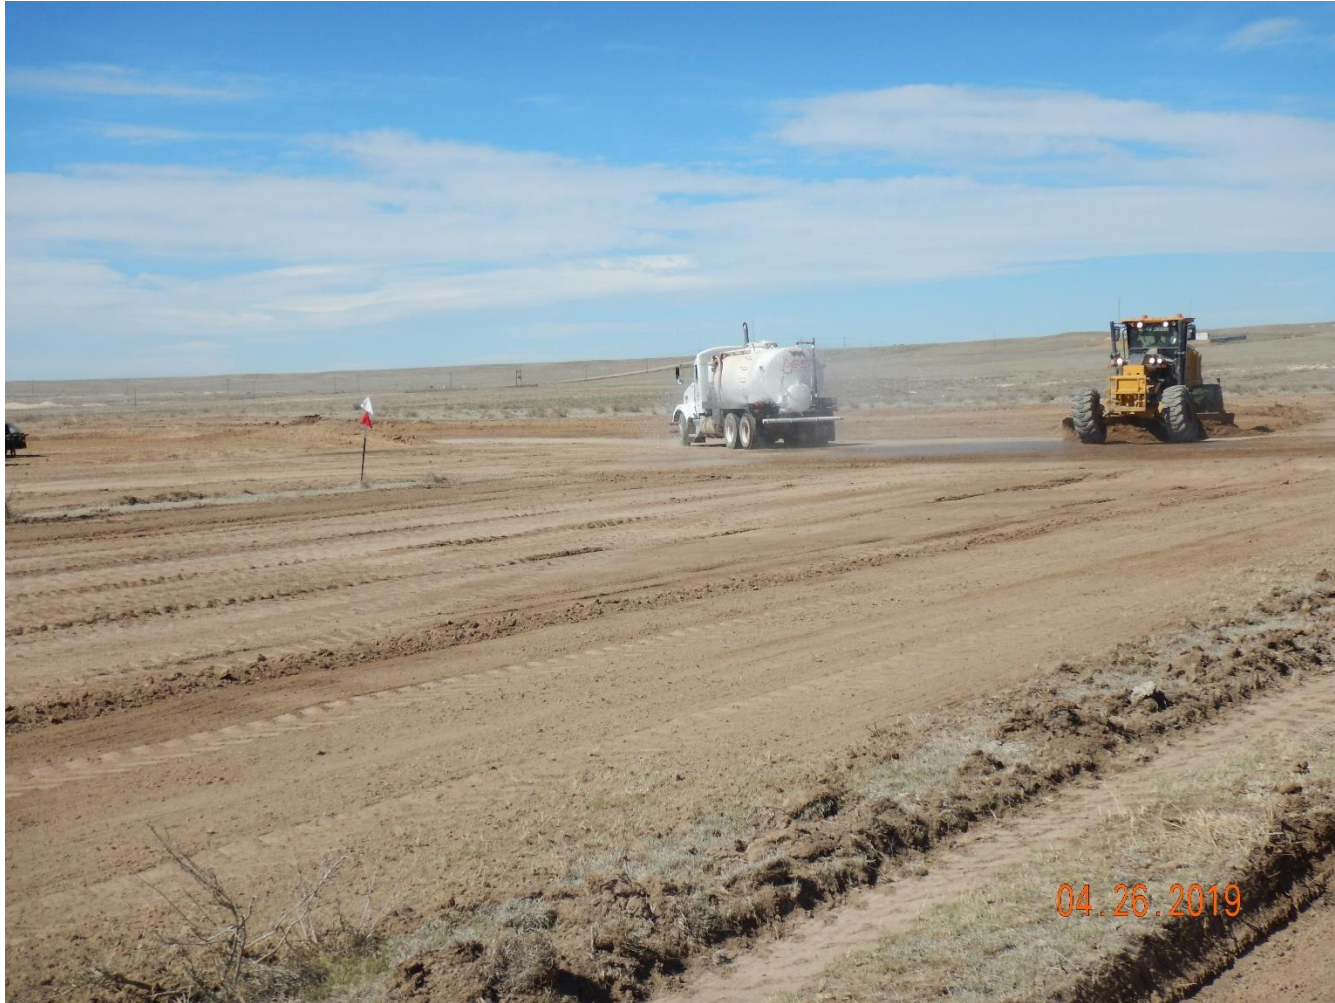
Photo 5 Photo shows operator utilizing a water truck to mitigate fugitive dust on location and access road.

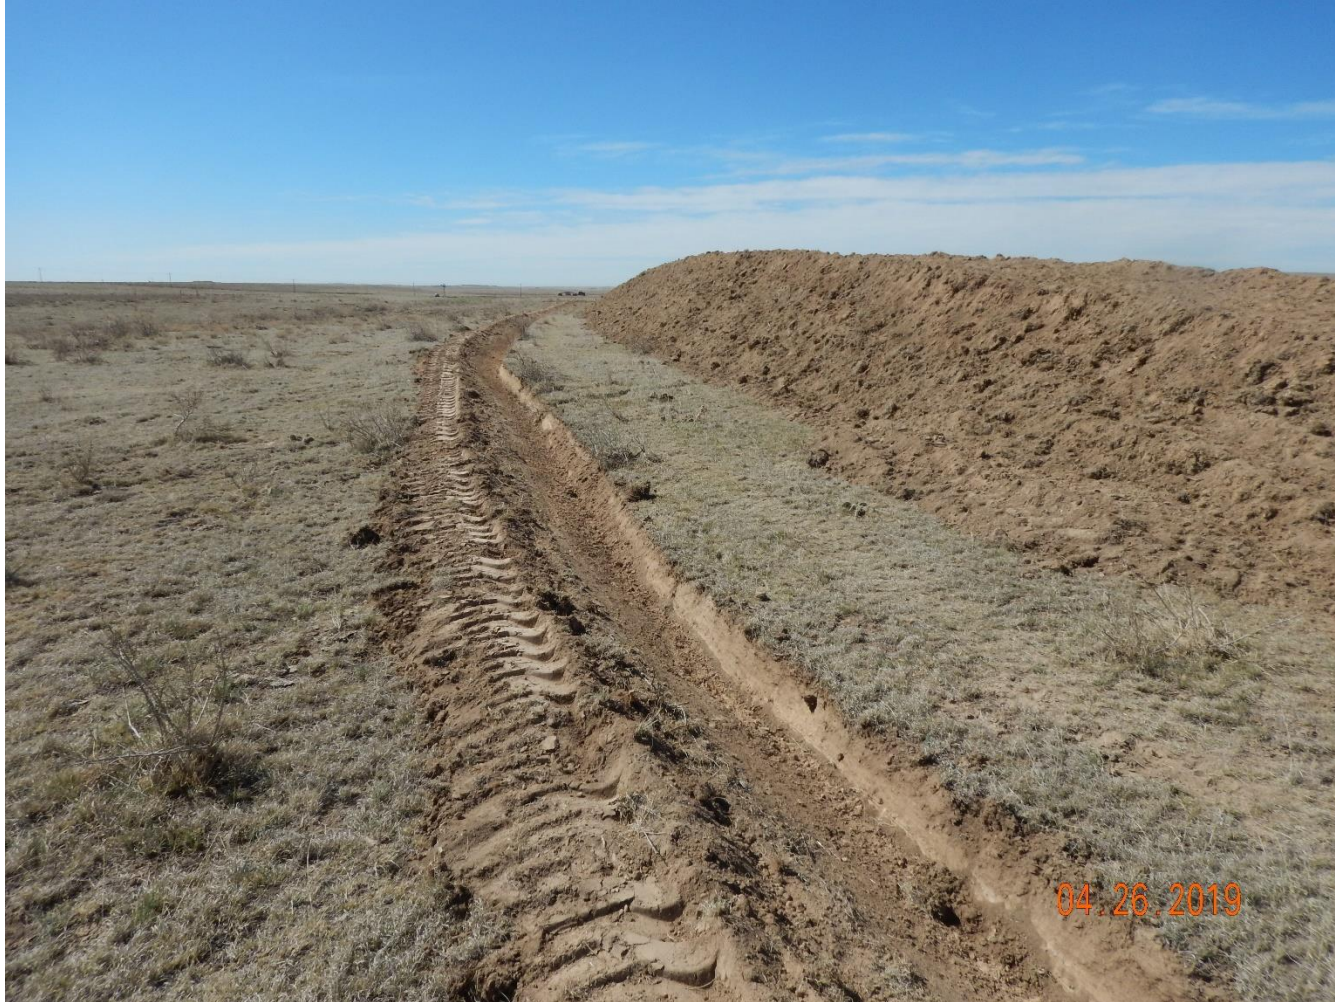
Photo 6: Photo taken from northeast corner of the location, facing south. Photo shows perimeter ditch and soil stockpile. Topsoil salvage in process at time of inspection.

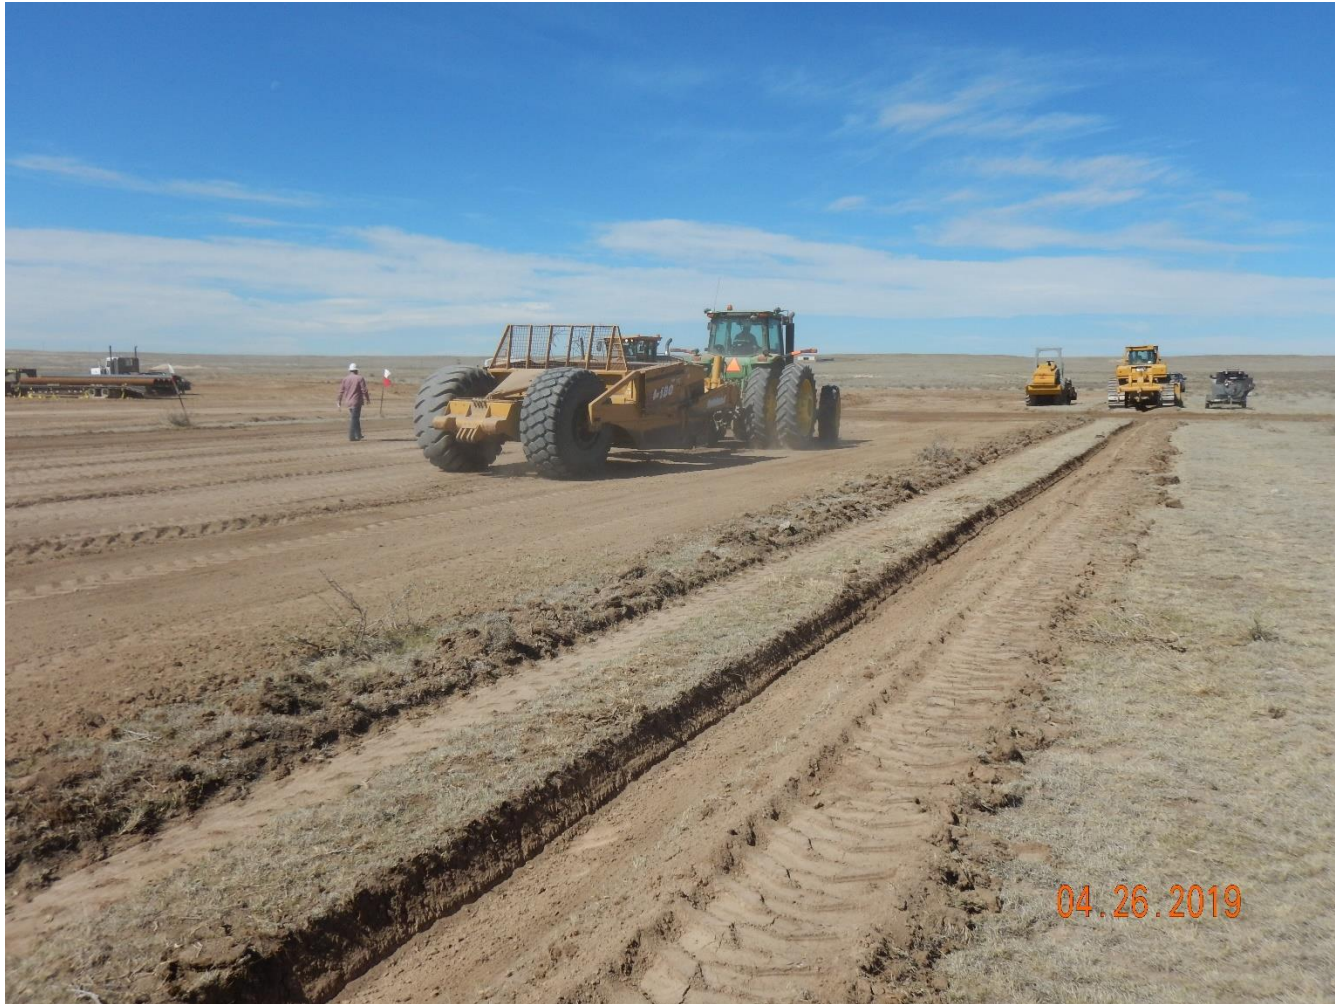
Photo 7: Photo taken from northeast corner of the location, facing west. Photo shows scraper being used to salvage soil from location.

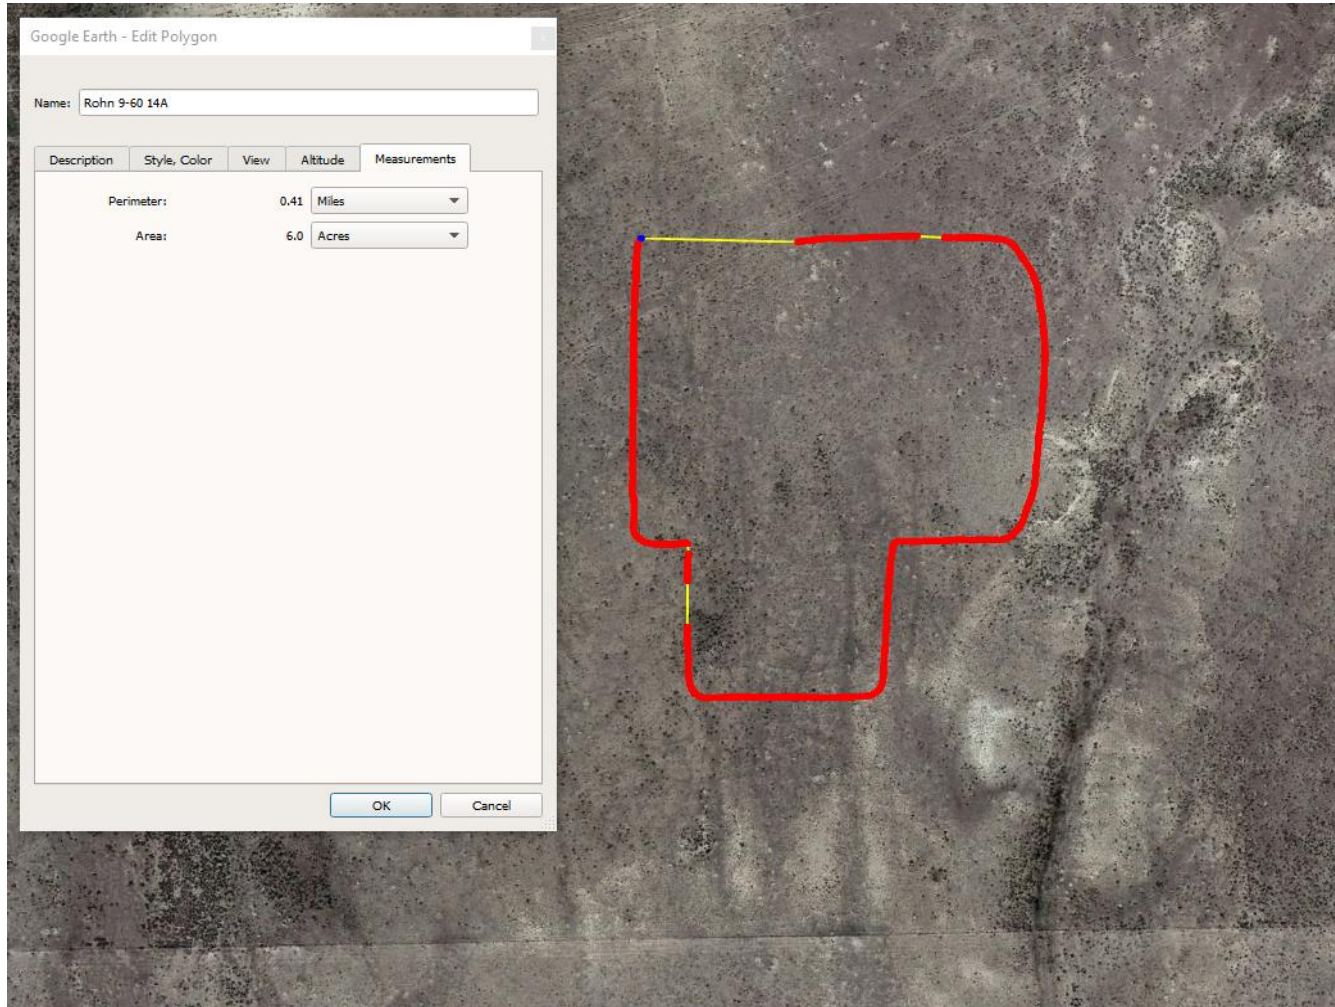
Photo 8: Photo shows a disturbance area of 6.05 acres mapped with a Trimble Juno 3B GPS unit; this appears to be in compliance with the approved Form 2A for the permitted disturbance area.
