Inspection Photos

Operator: GRAND MESA OPERATING CO - 35080

Location ID: 463808

Inspection Doc. Number: 682504833

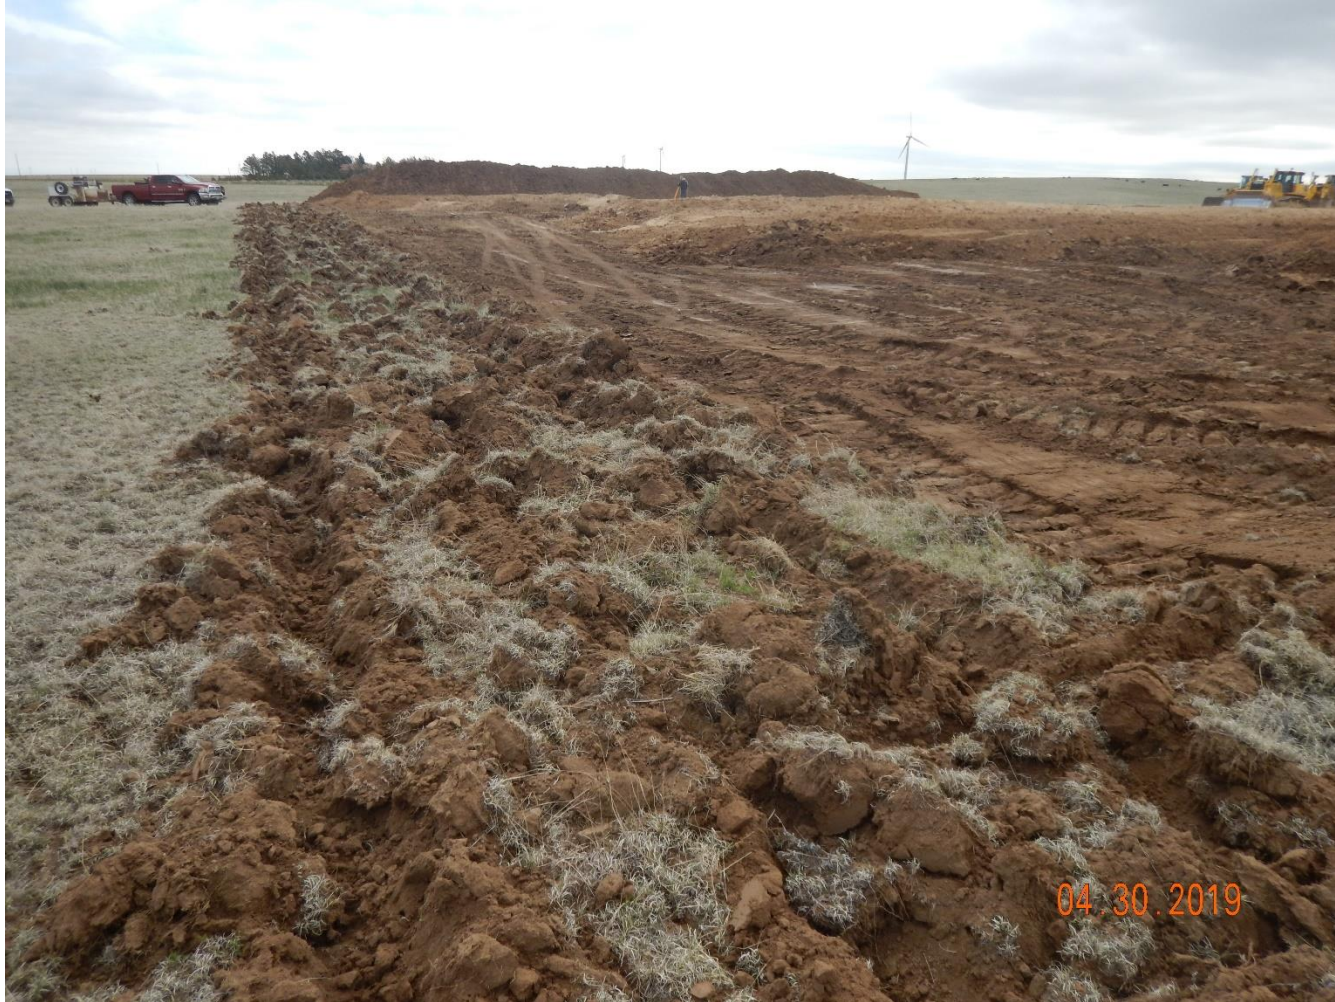
Photo 1: Photo taken from the northwest corner of the location, facing east. Photo shows construction activities in process. Photo also shows operator has installed surface roughening along perimeter of the location.

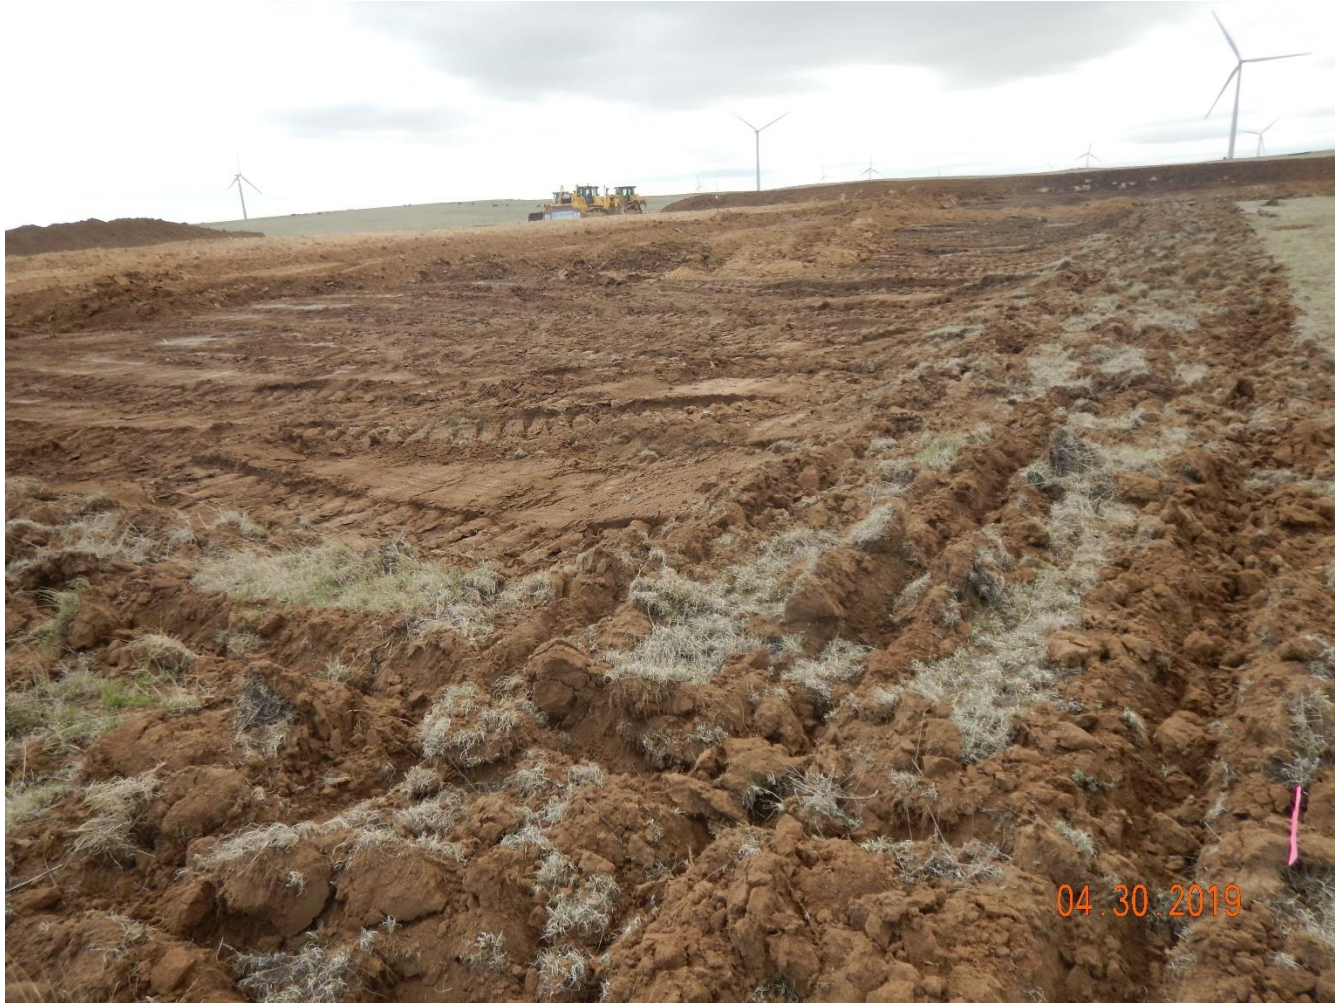
Photo 2: Photo taken from the northwest corner of the location, facing south. Photo shows construction activities in process. Photo also shows operator has installed surface roughening along perimeter of the location. .

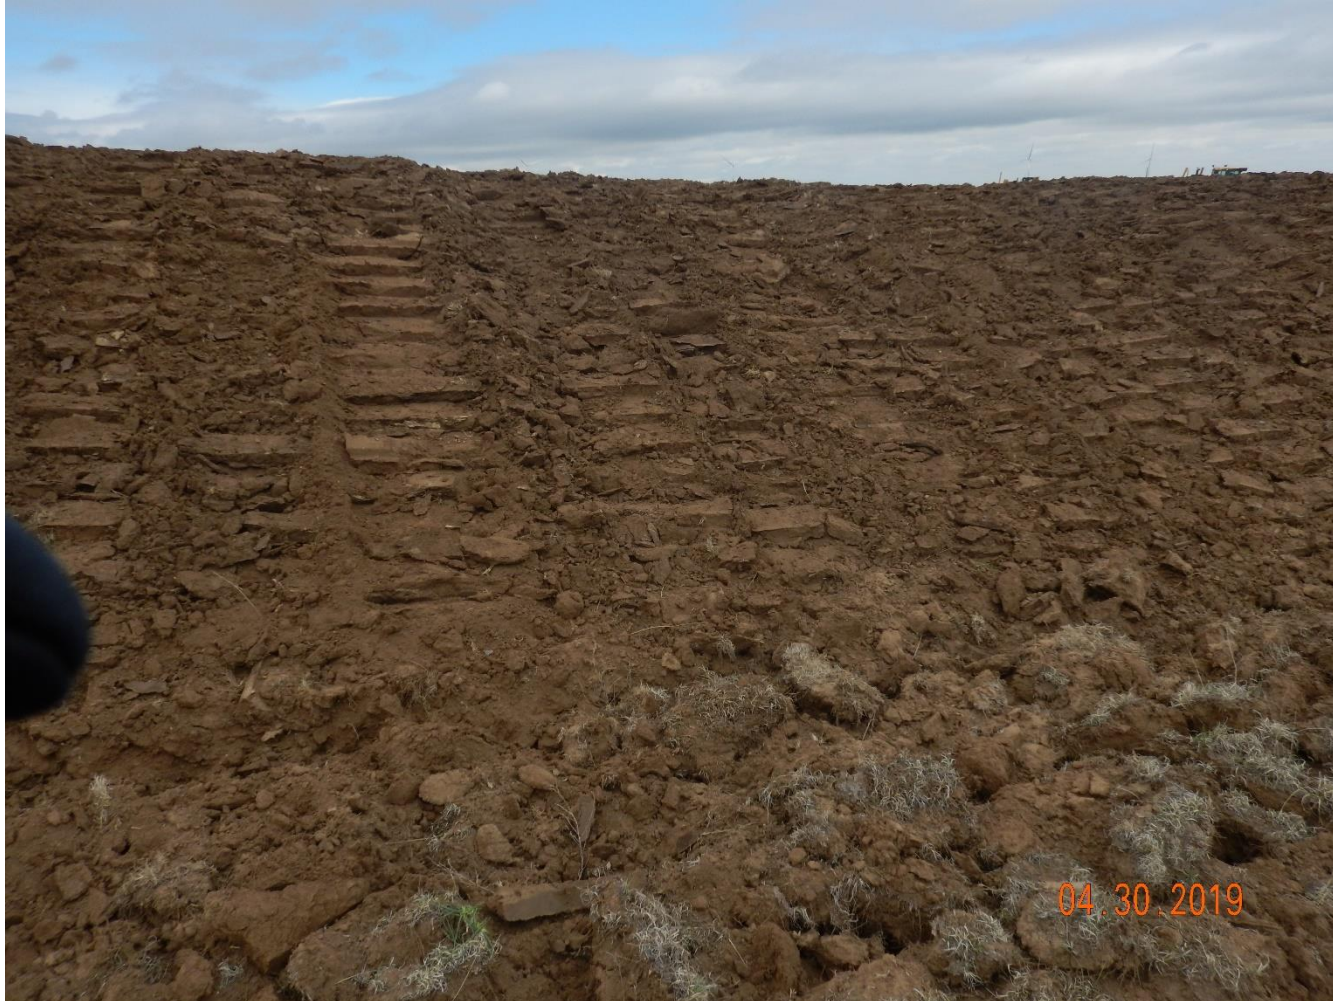
Photo 3: Photo taken from the soil stockpile on the south end of the location. Operator has implemented tracking to stabilize soil stockpiles.

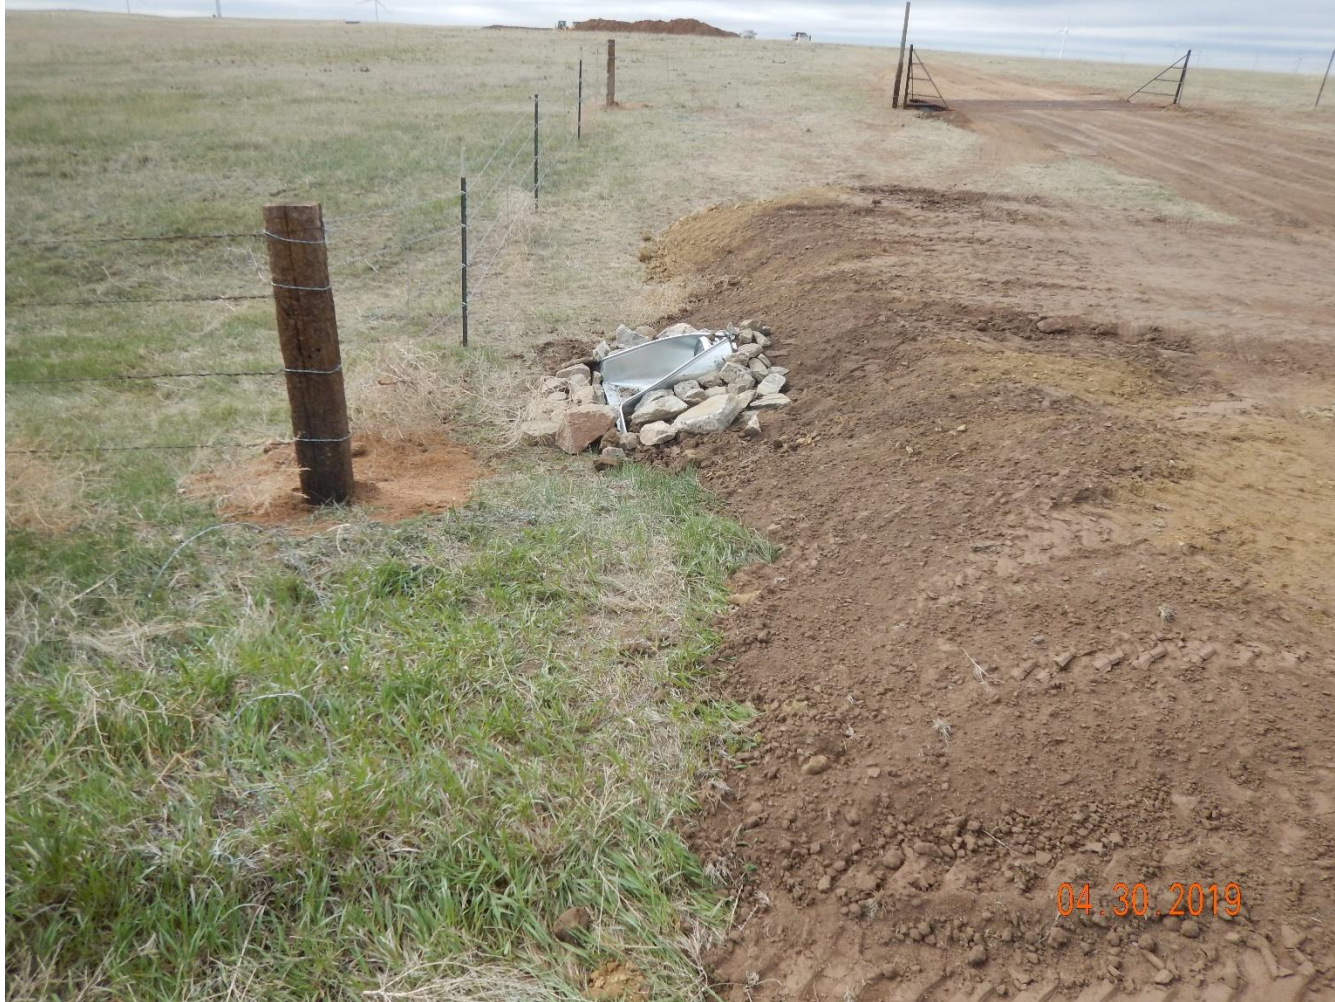
Photo 4: Photo taken from access road entrance. Photo shows culvert installed with inlet/outlet armoring.
