Inspection Photos
Operator: Noel Reynolds
Location/API #: 067-05448
Date: 4-30-2019

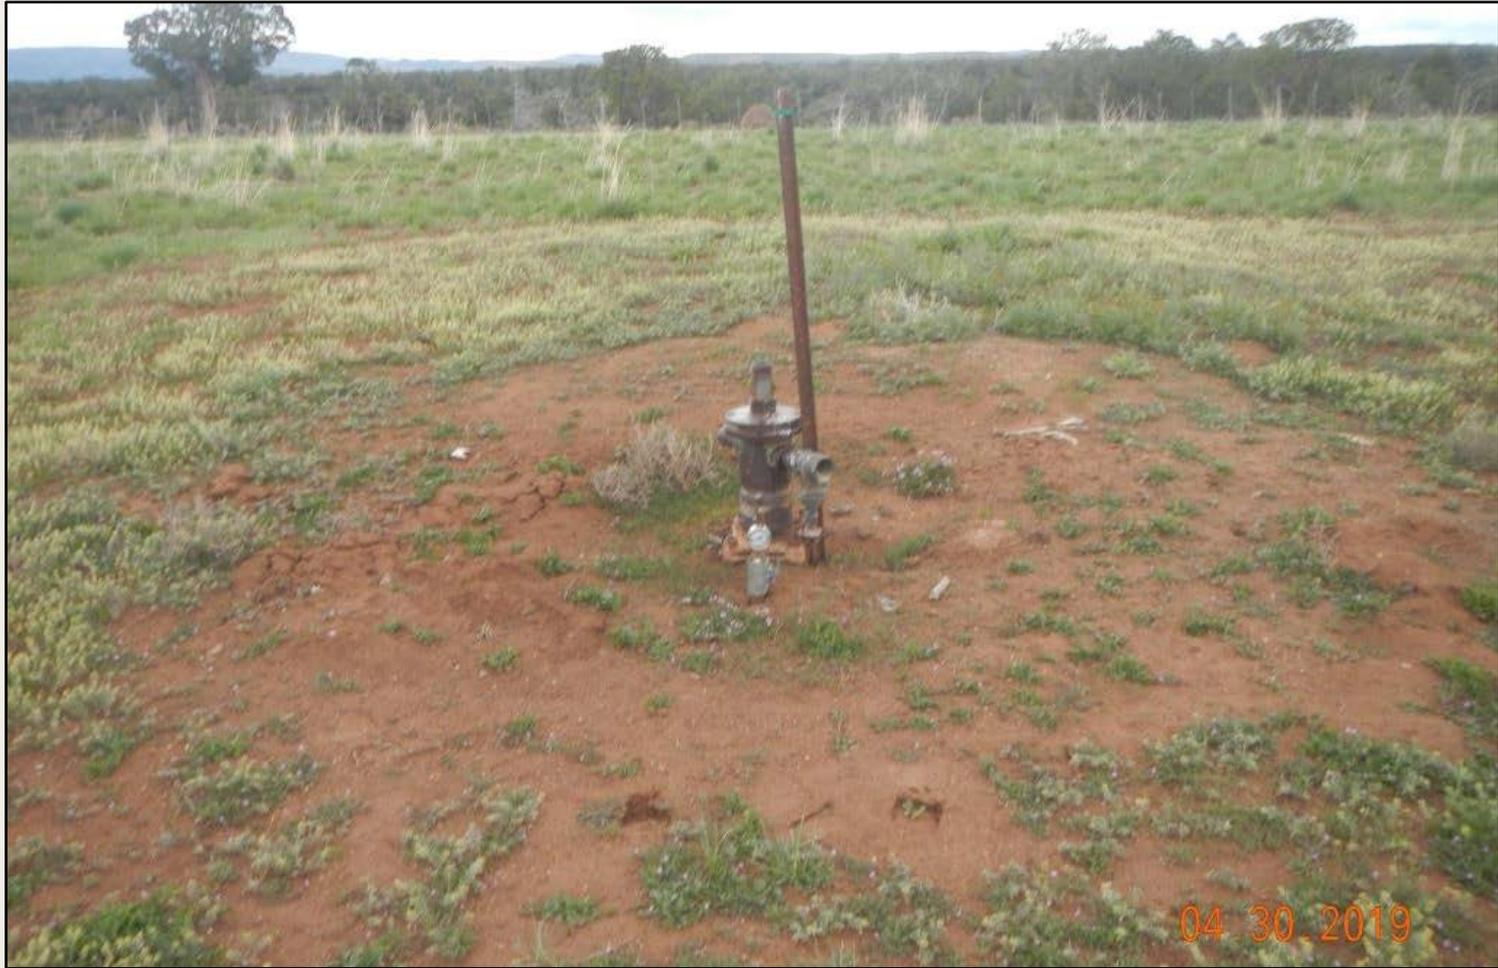
Photo 1. View of the wellhead still in place facing westward. Electrical box documented from previous inspection is no longer present.

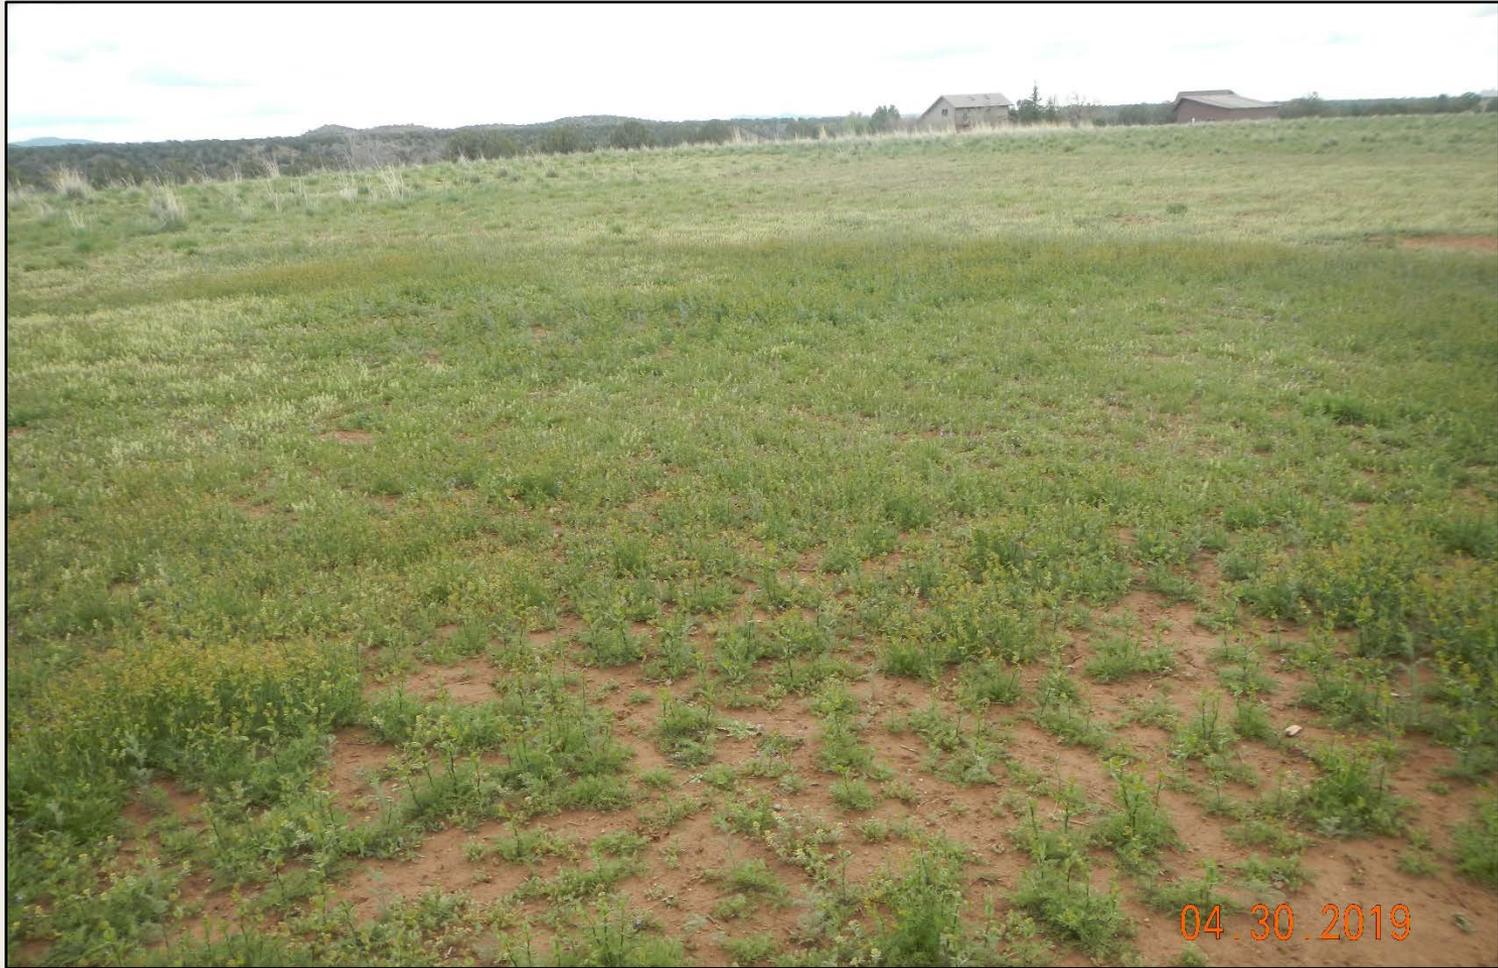
Photo 2. View of area south of the wellhead area that appears impacted by produced fluid or compacted. Vegetation in this area is largely annual weeds such as claspig pepperweed (*Lepidium perfoliatum*) and cheatgrass (*Bromus tectorum*).
