Final Reclamation Inspection

Operator: HARSH INTERNATIONAL INC - 38470

API #: 05-123-11416

Inspection Photos
Location Name: HARSH #1
API #: 05-123-11416

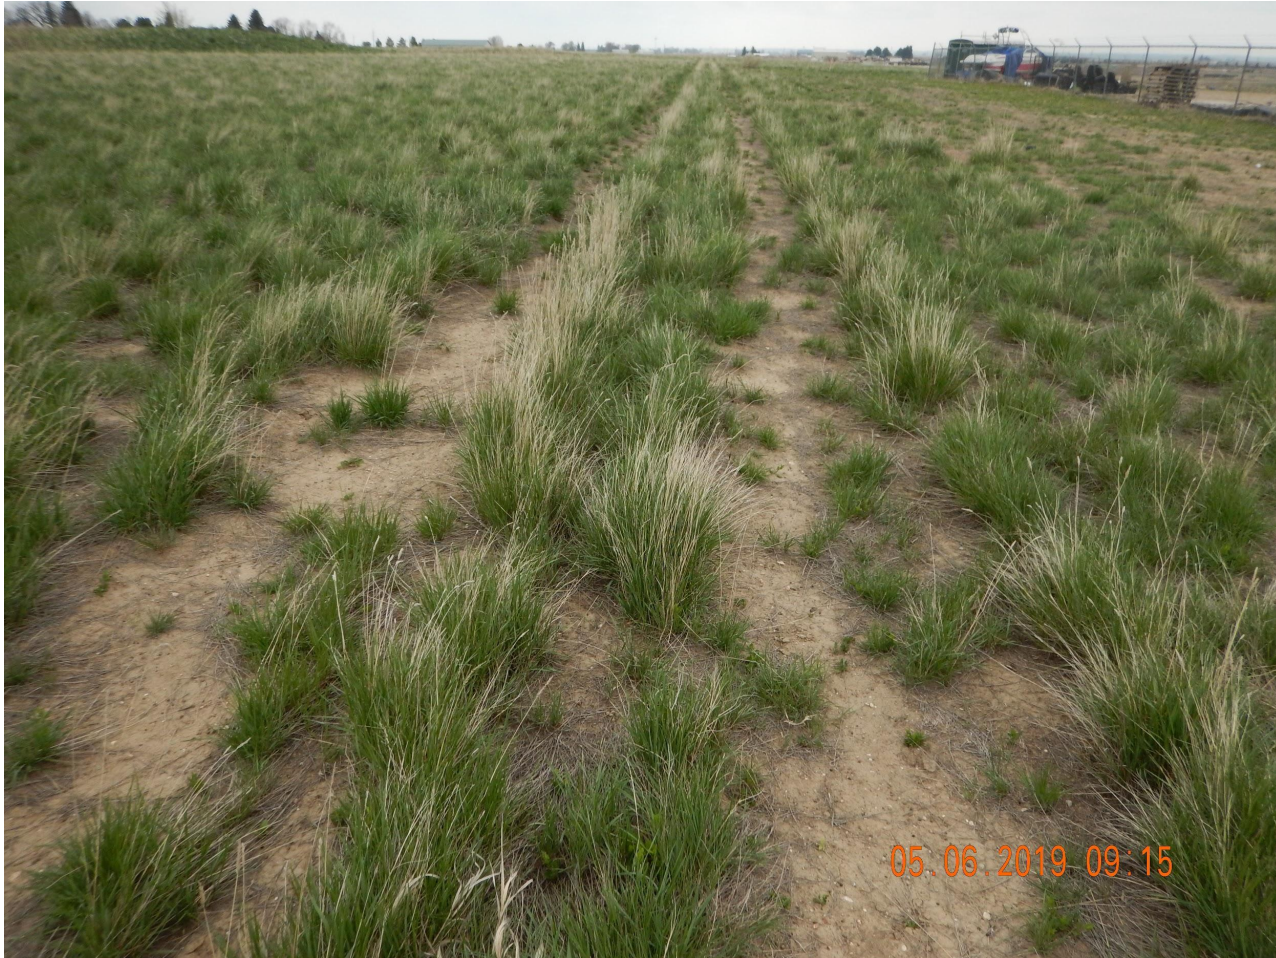
Photo 1. Photo taken from a portion of the access road, facing South. Access road is evident and has not been reclaimed per Rule 1004. It does not appear that the Operator has performed final reclamation activities throughout the access road. Reference area vegetation consists mostly of Crested wheatgrass and Smooth brome.

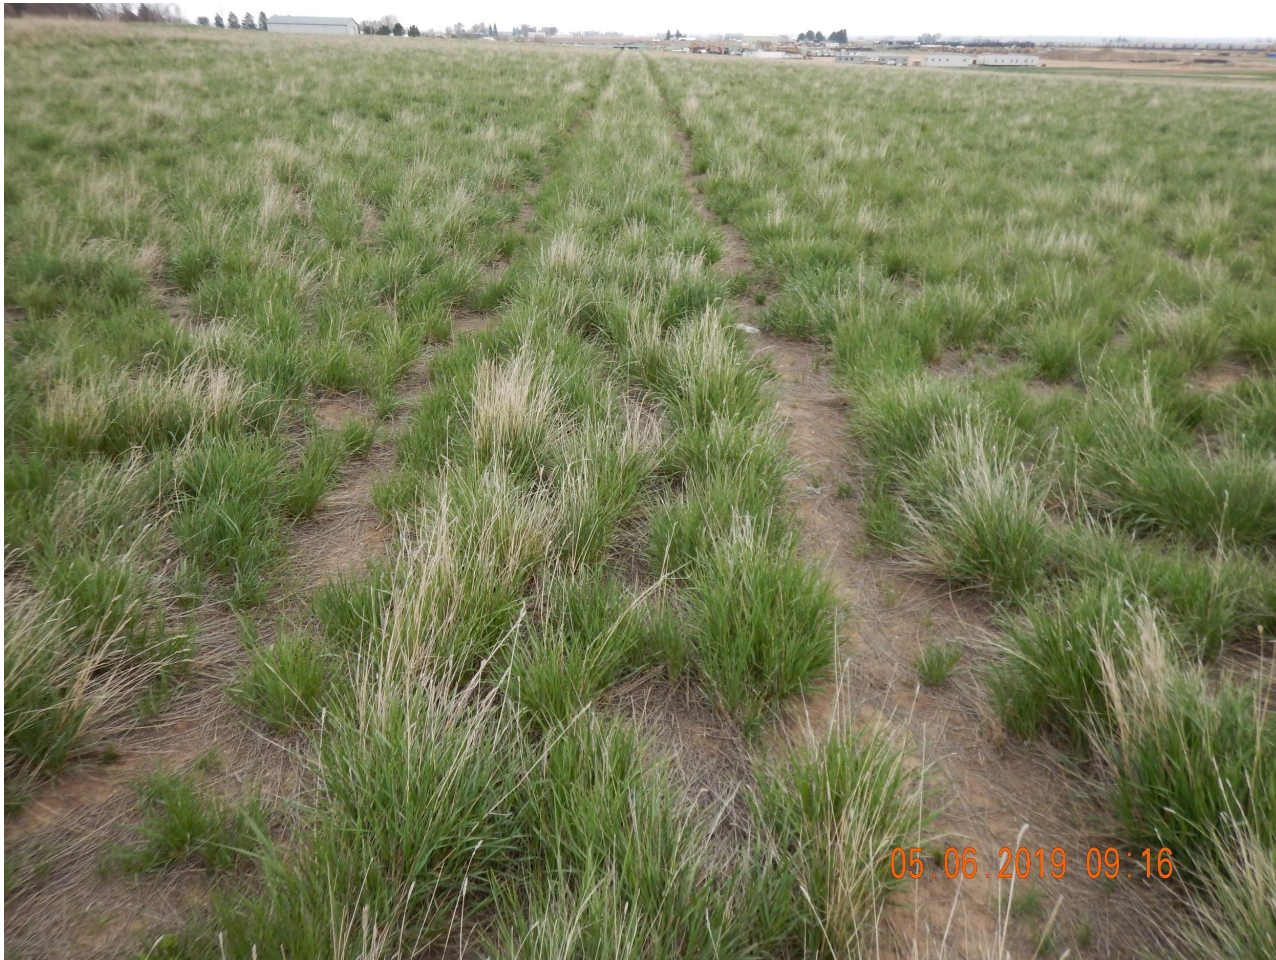
Photo 2. Photo taken from another portion of the access road, facing South. See comments under Photo 1.

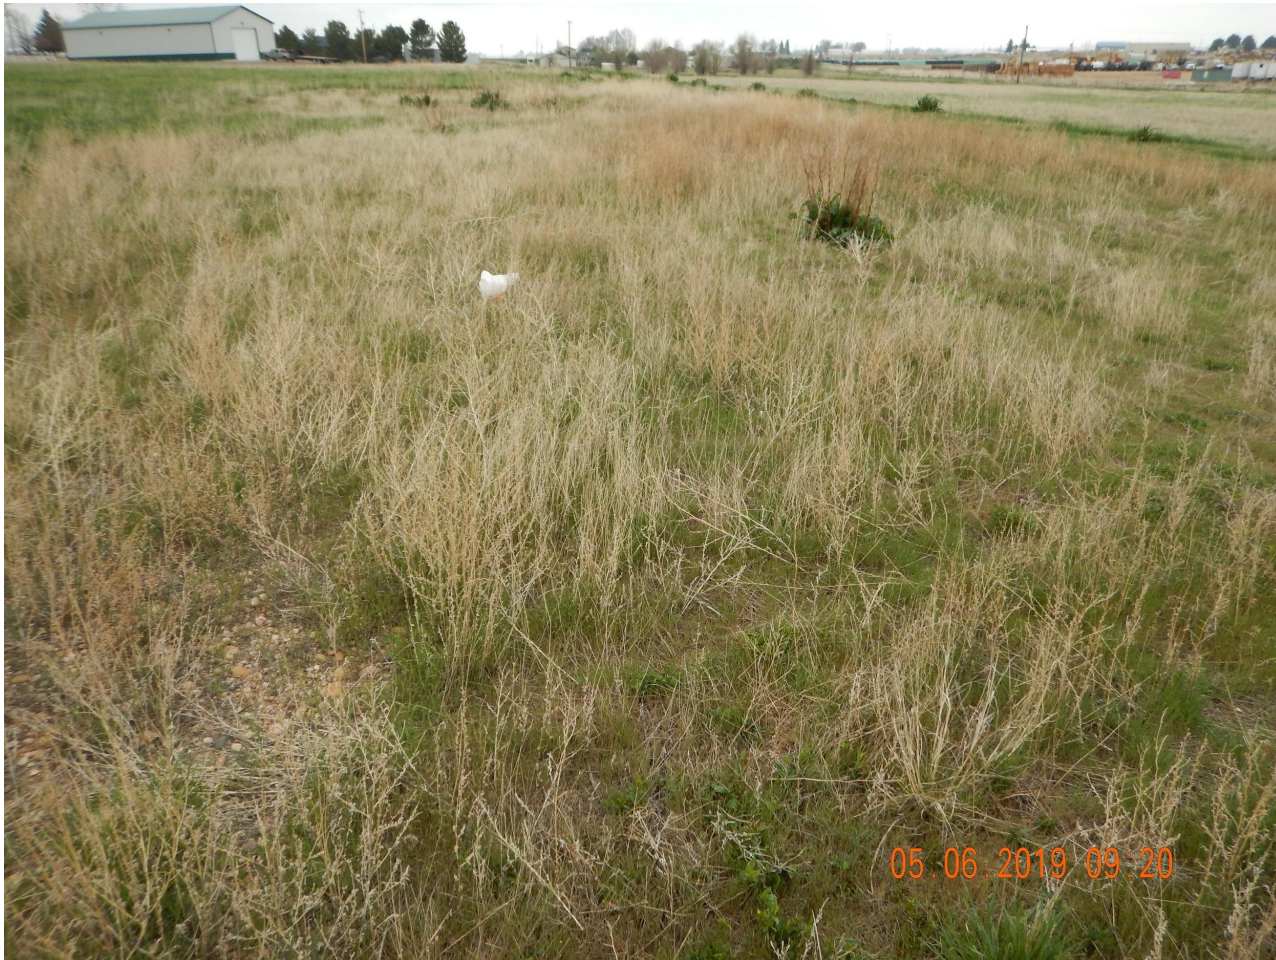
Photo 3. Photo taken from the tank battery location, facing South. Operator has failed to perform final reclamation activities at the tank battery location. Vegetation mainly consists of Cheatgrass, Kochia and Field bindweed, all undesirable species.

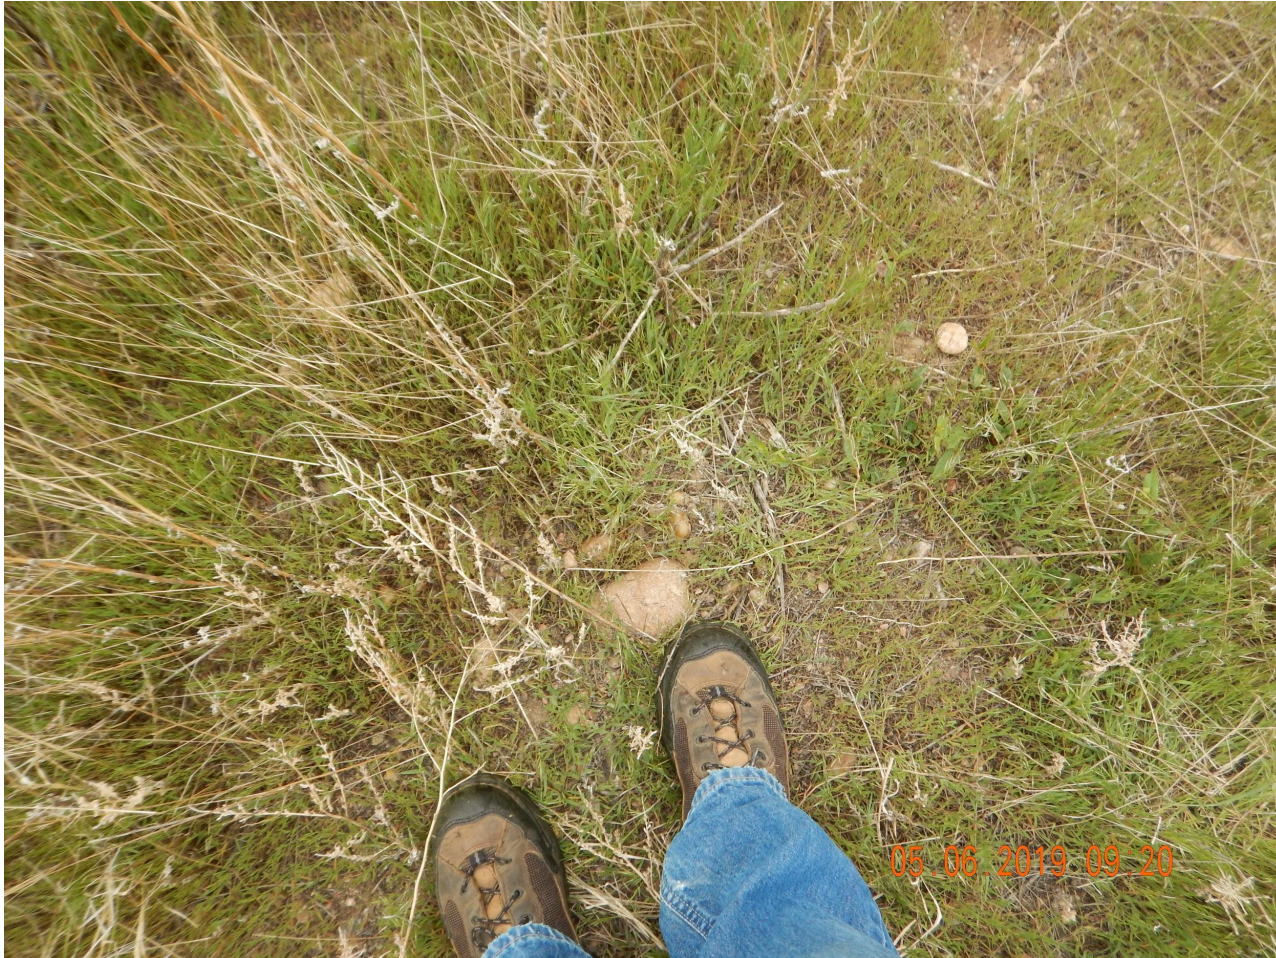
Photo 4. Photo taken from the tank battery location. Photo illustrates gravel which has not been removed from location and Cheatgrass.

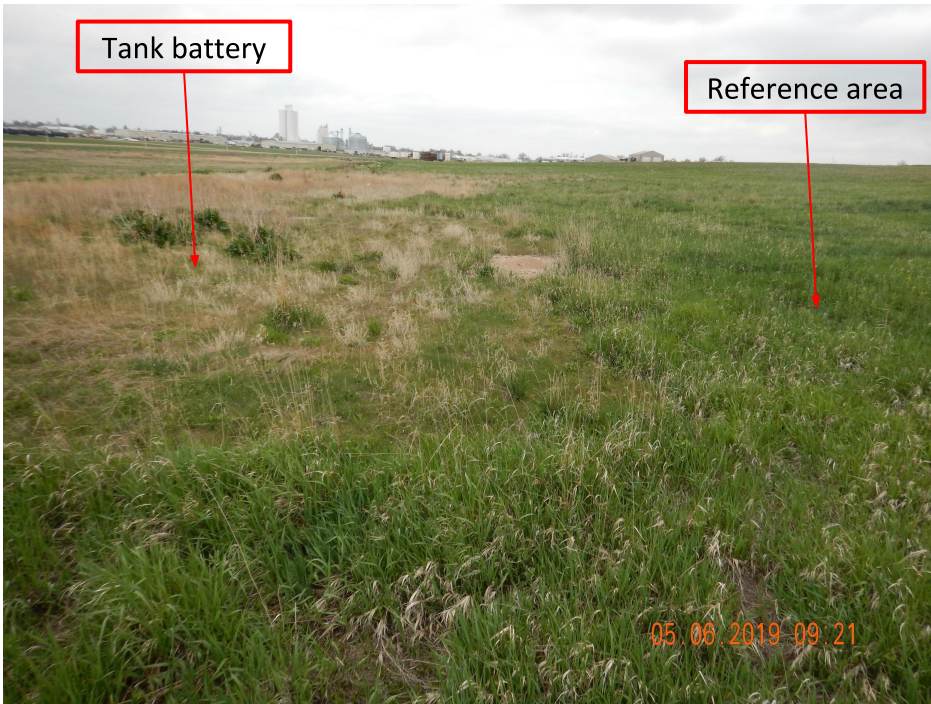
Photo 5. Photo taken from the southeastern tank battery, facing North. Photo contrasts the reference area vegetation with the tank battery vegetation.

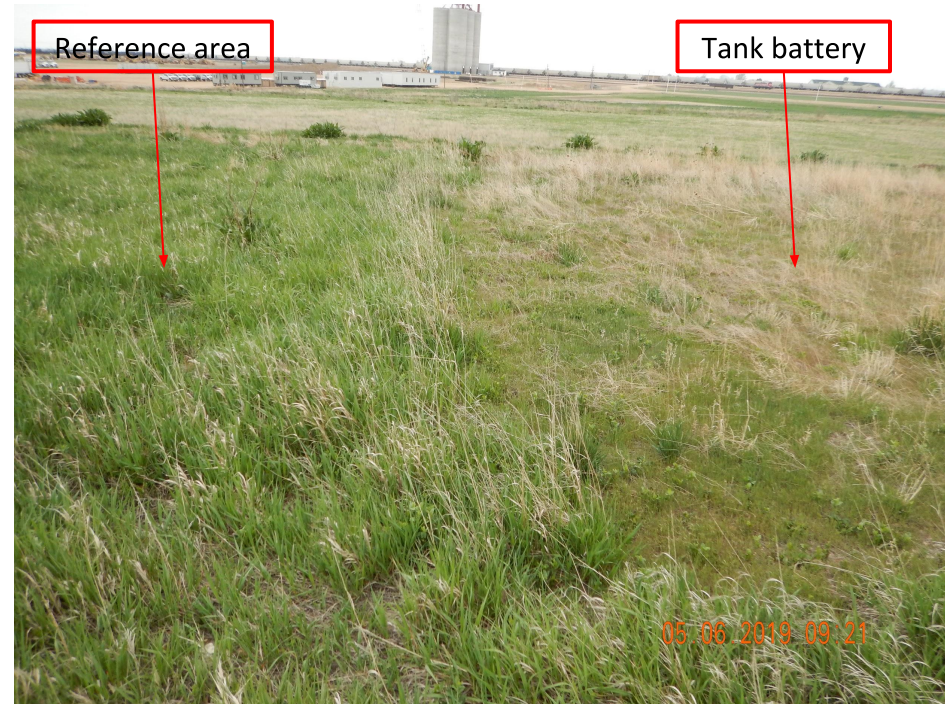
Photo 6. Photo taken from the southeastern tank battery, facing West. See comments under Photo 5.

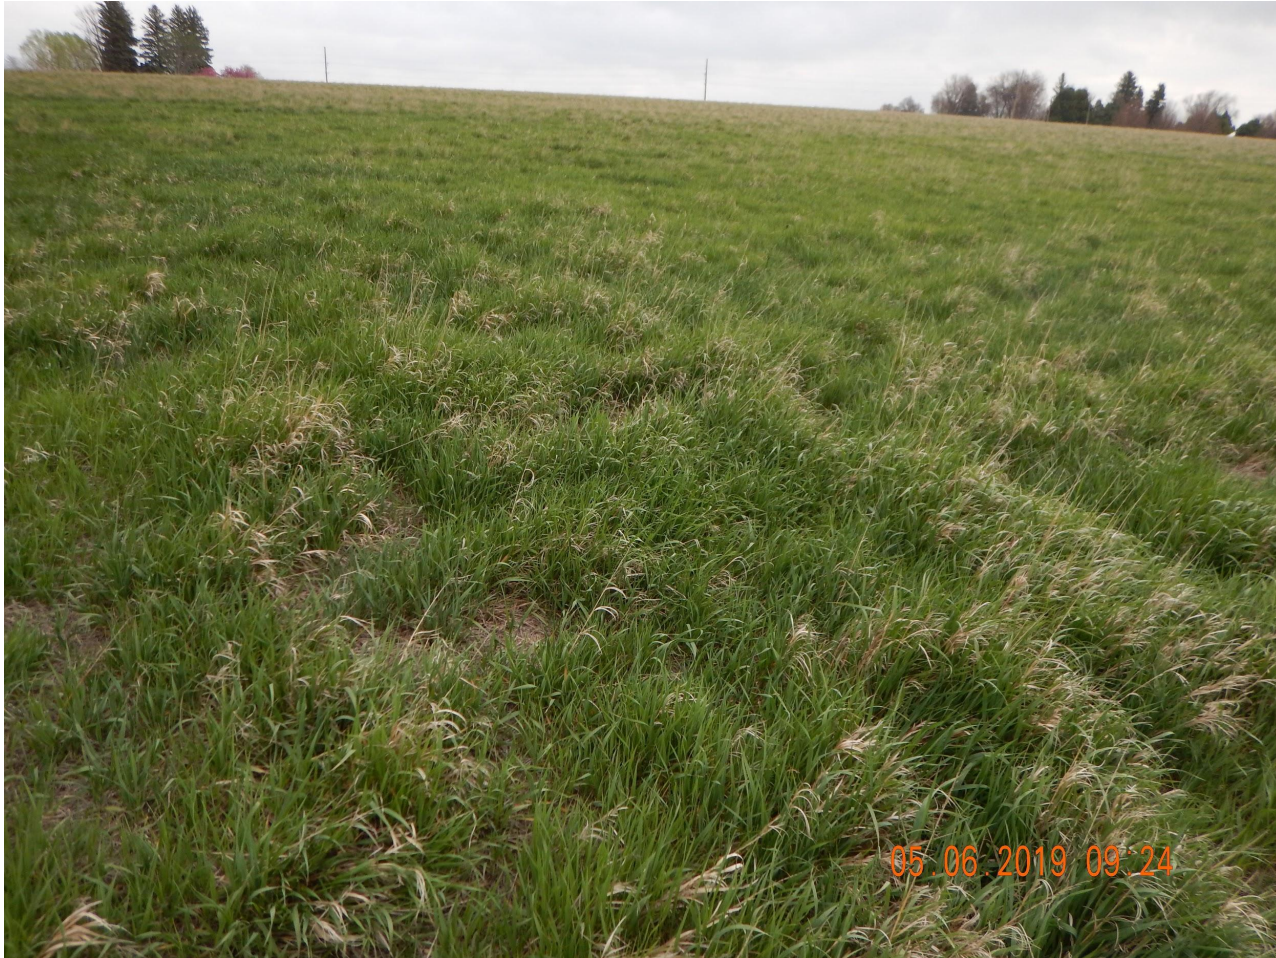
Photo 7. Reference photo taken north of the tank battery location, facing East.
