# Inspection Photos

Operator: GRAND MESA OPERATING CO #  
35080

Location ID: 463974

Inspection Doc. Number: 696200005  
Lincoln County, CO

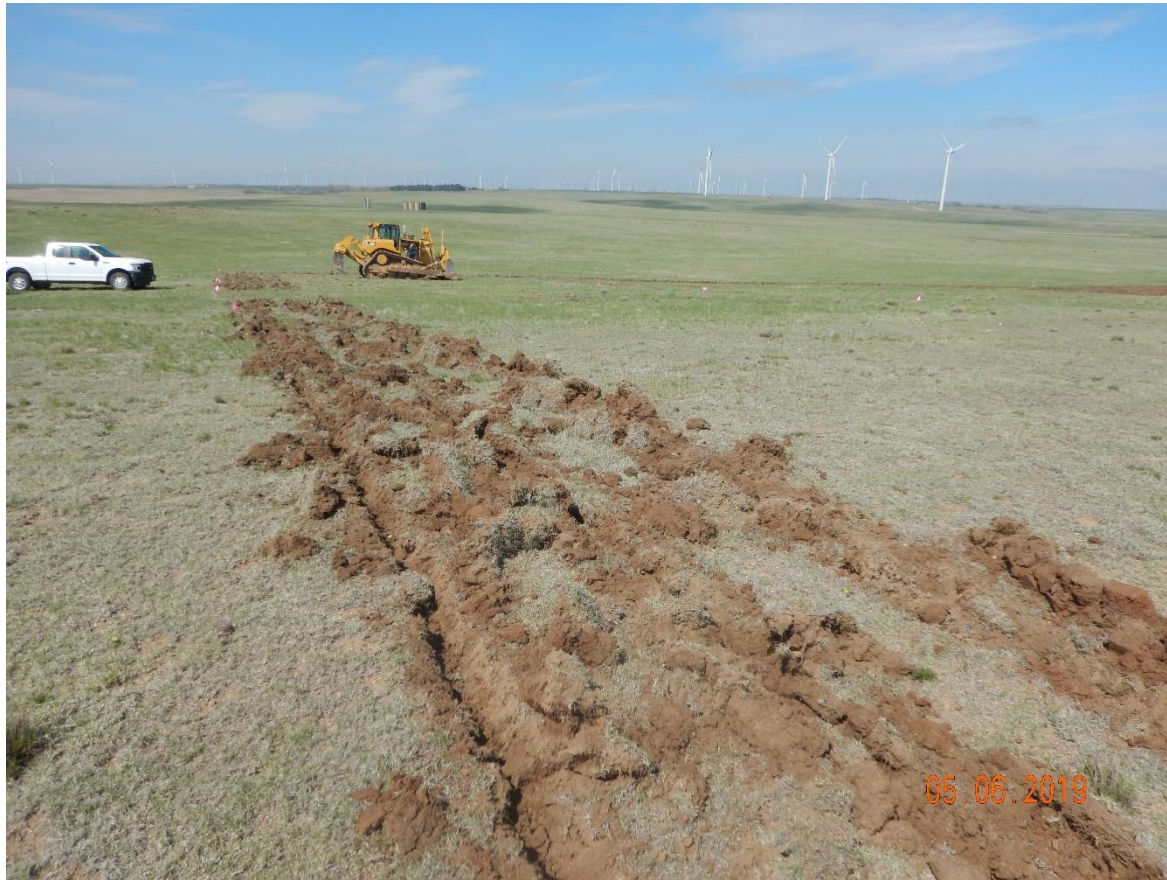
**Photo 1:** Photo taken from the south end of the location, facing west. Photos 1-4 provide an overview of the location and construction in process from west, northwest, northeast to east. Photos also show Operator has installed surface roughening along the perimeter of the disturbance area.

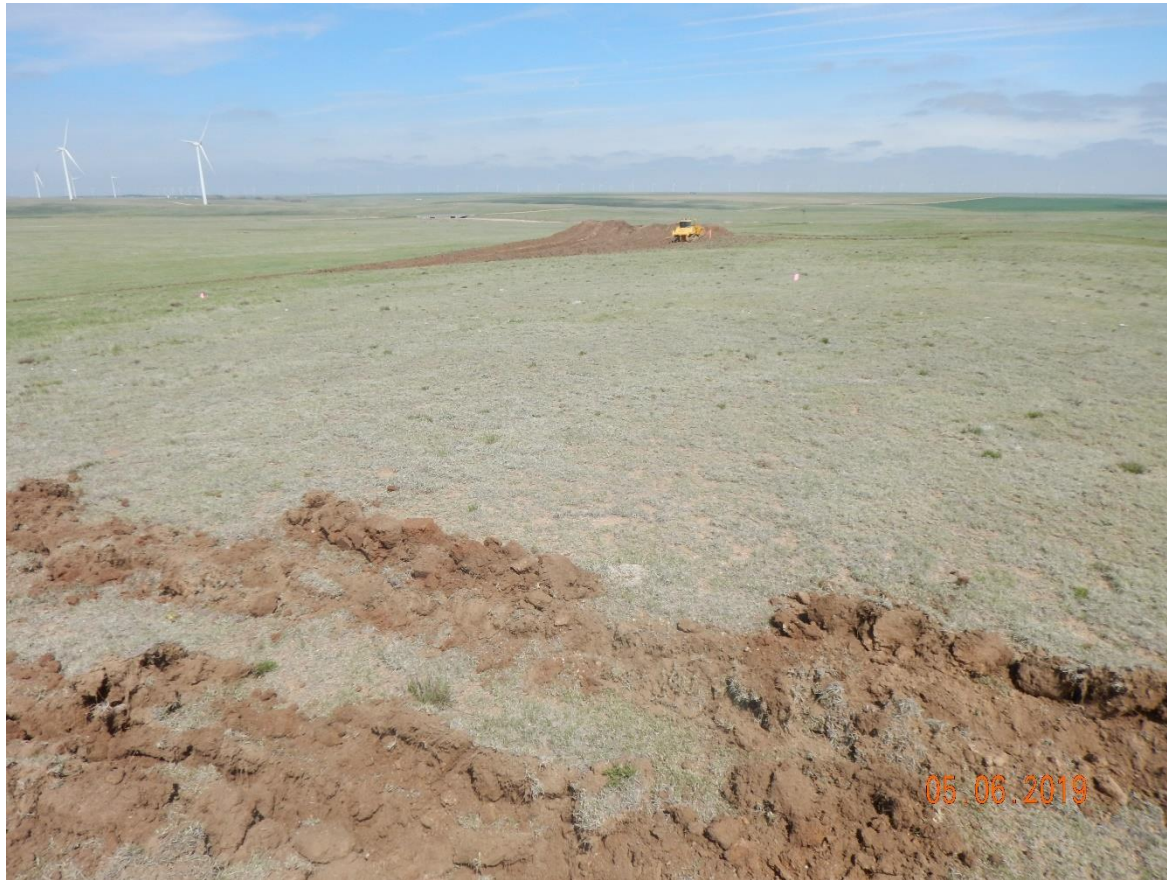
**Photo 2:** See comment under photo 1.

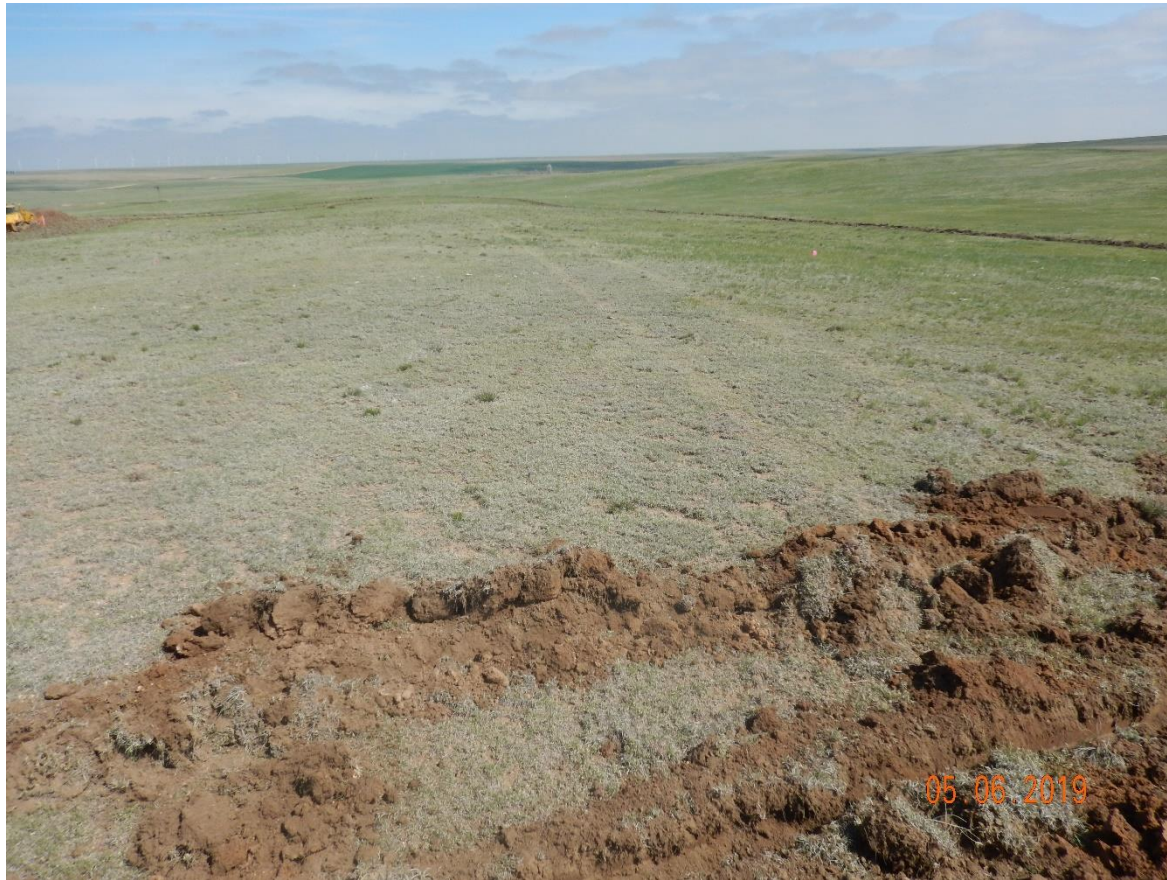
**Photo 3:** See comment under photo 1.

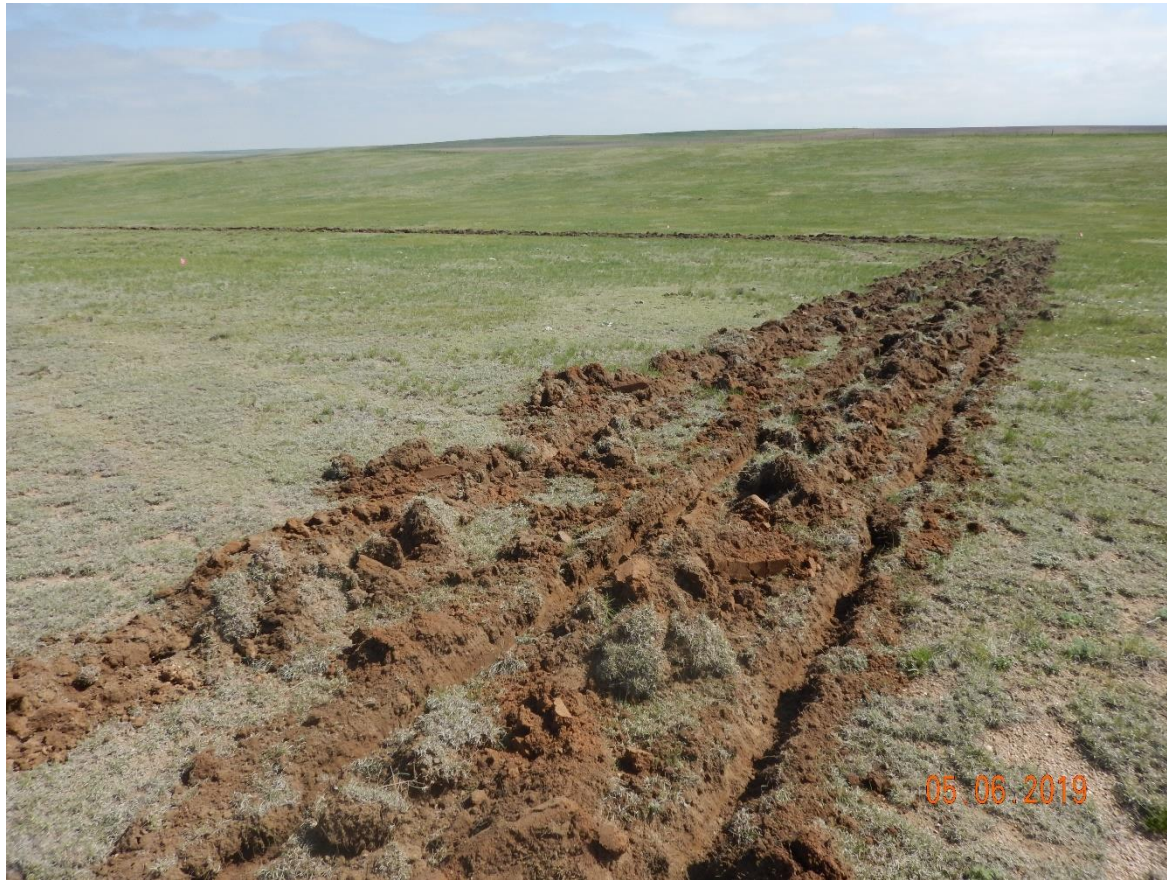
**Photo 4:** See comment under photo 1.

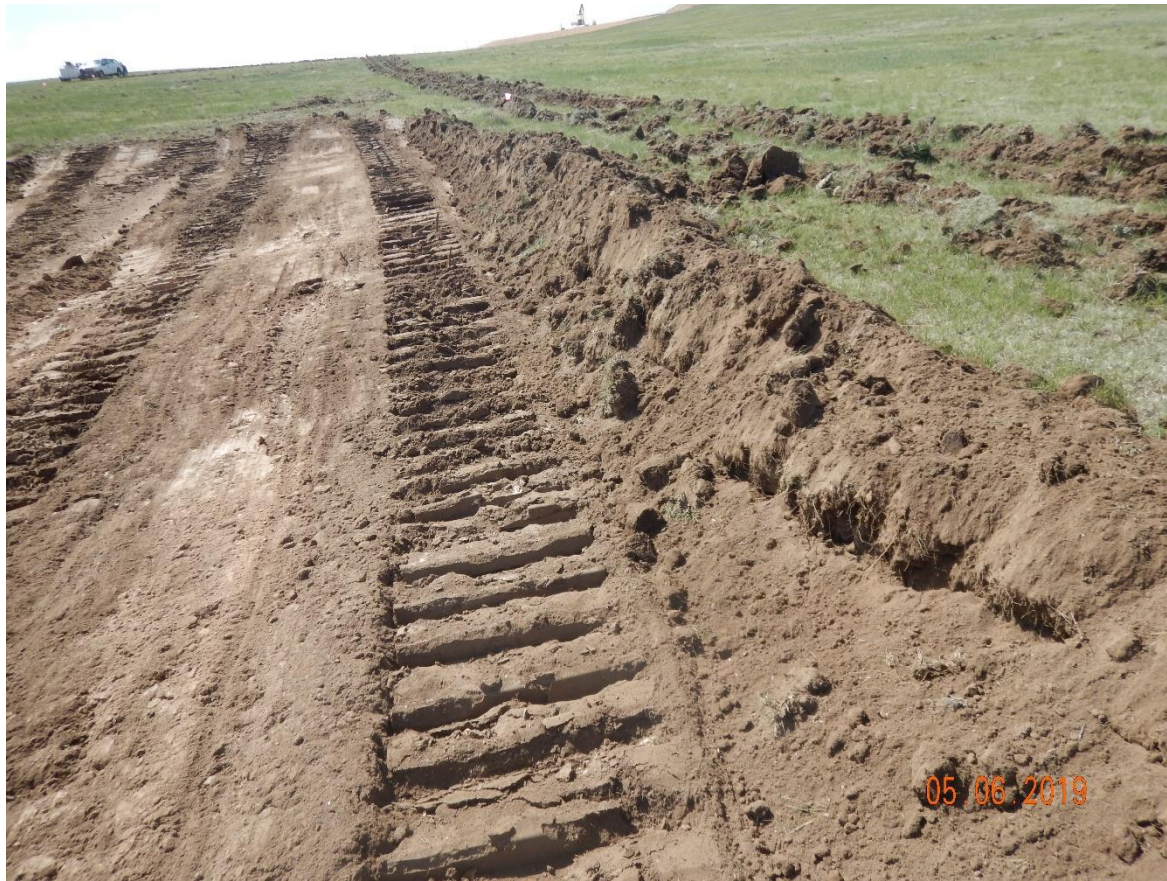
**Photo 5:** Photo taken from west end of the location. Photo shows operator is salvaging ~1 foot of soil (including topsoil) from the location.

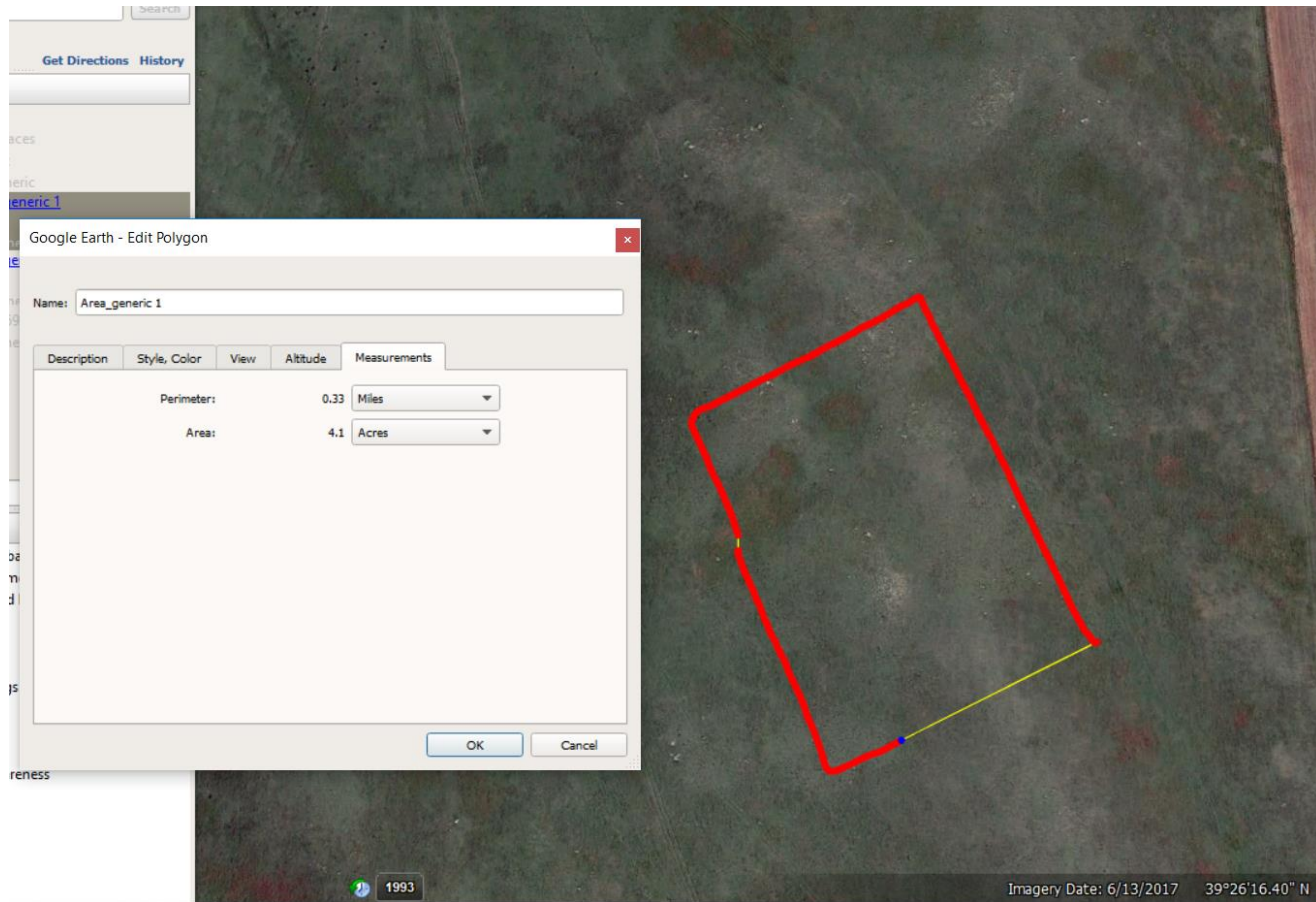
**Photo 6:** Photo shows inspector mapped the location with a Trimble GPS device and determined a disturbance area of 4.1 acres at time of inspection.
