Inspection Photos

Operator: OILFIELD SALVAGE & SERVICE CO -
65550

Location ID: 311709

Inspection Doc. Number: 696200013
Adams County, CO

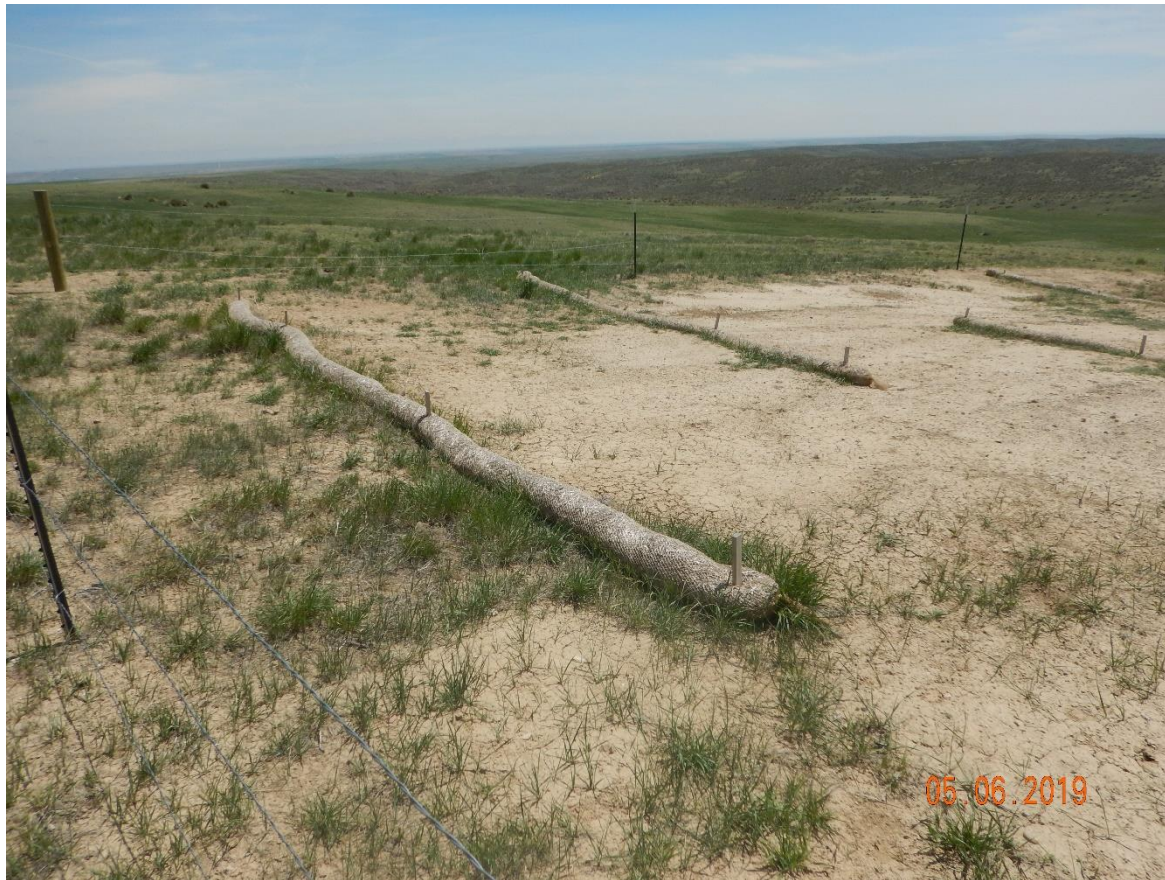
Photo 1: Photo taken from the northwest end of the location, facing east. Photo shows that location remains predominantly bare and exposed soil. Straw wattle BMPs remain insufficient and have not been installed in accordance with good engineering practices. No additional reclamation or stormwater management appears to have been conducted per corrective actions.

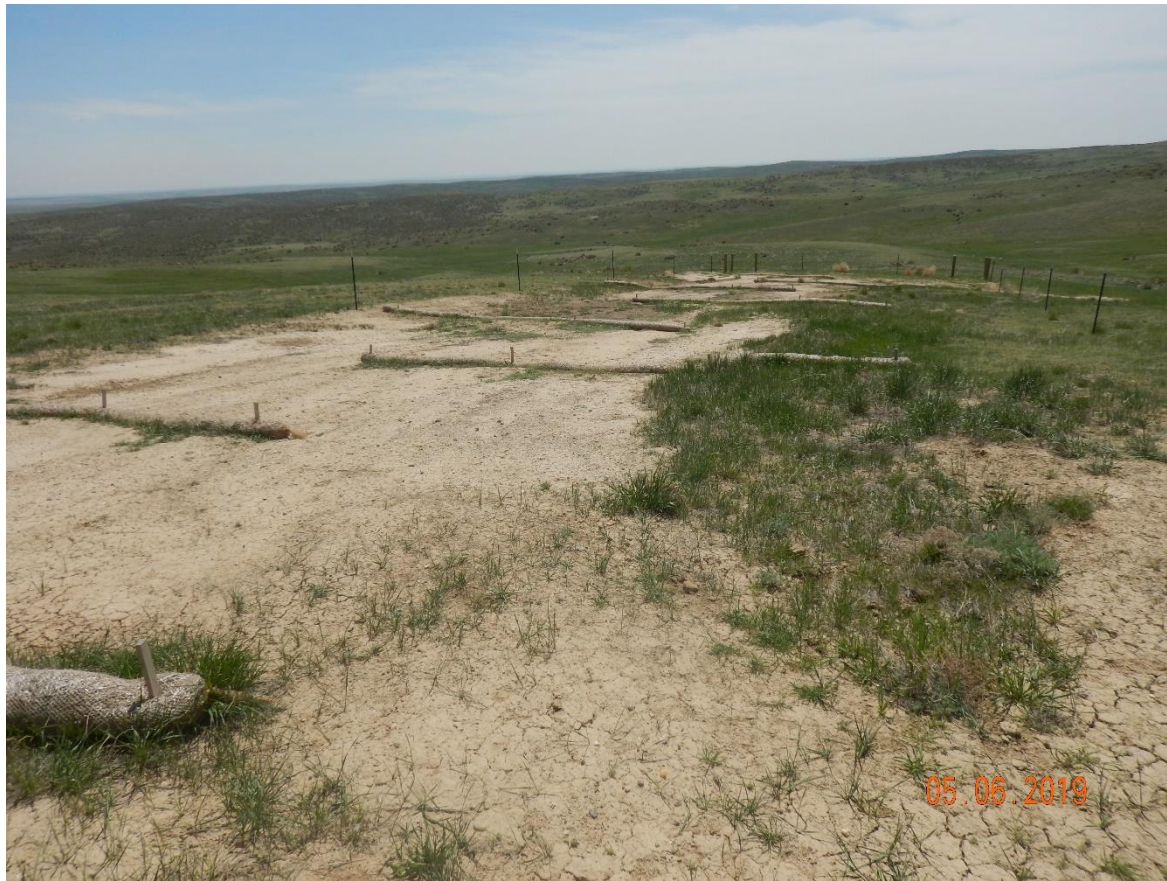
Photo 2: Photo taken from the northwest end of the location, facing south. See comments under photo 1.

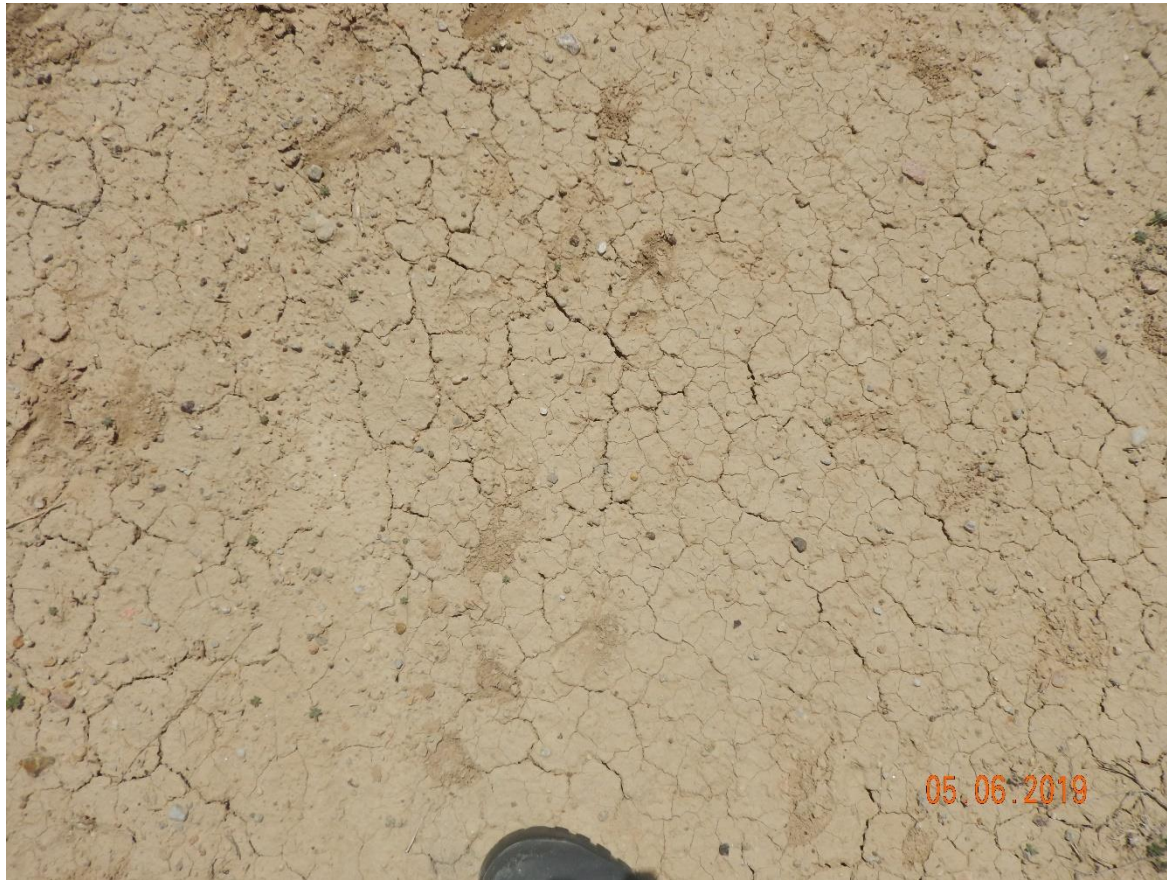
Photo 3: Photo taken from the salt kill area of the location. Photo shows that location remains predominantly bare and exposed soil. No additional reclamation or stormwater management appears to have been conducted per corrective actions.

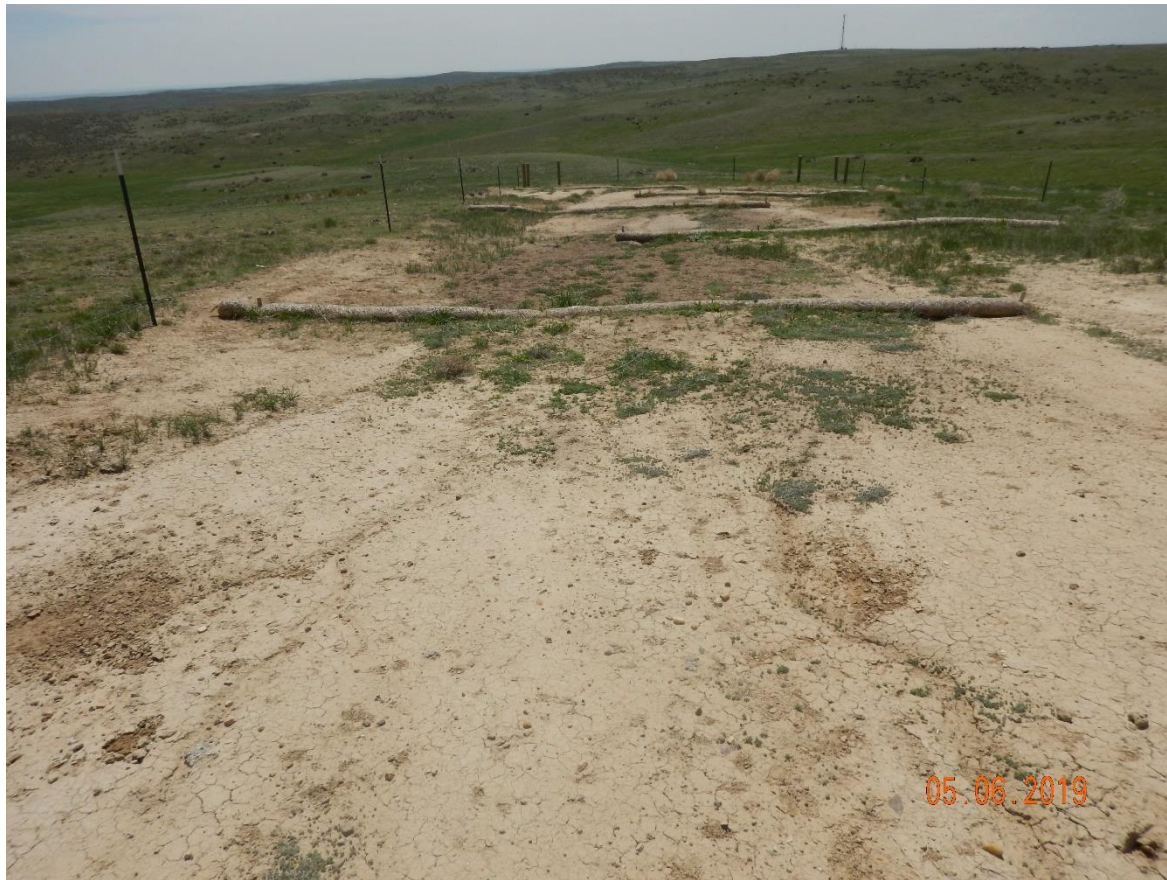
Photo 4: Photo taken from the north end of the location, facing south. Photo shows the erosion degradation on the location

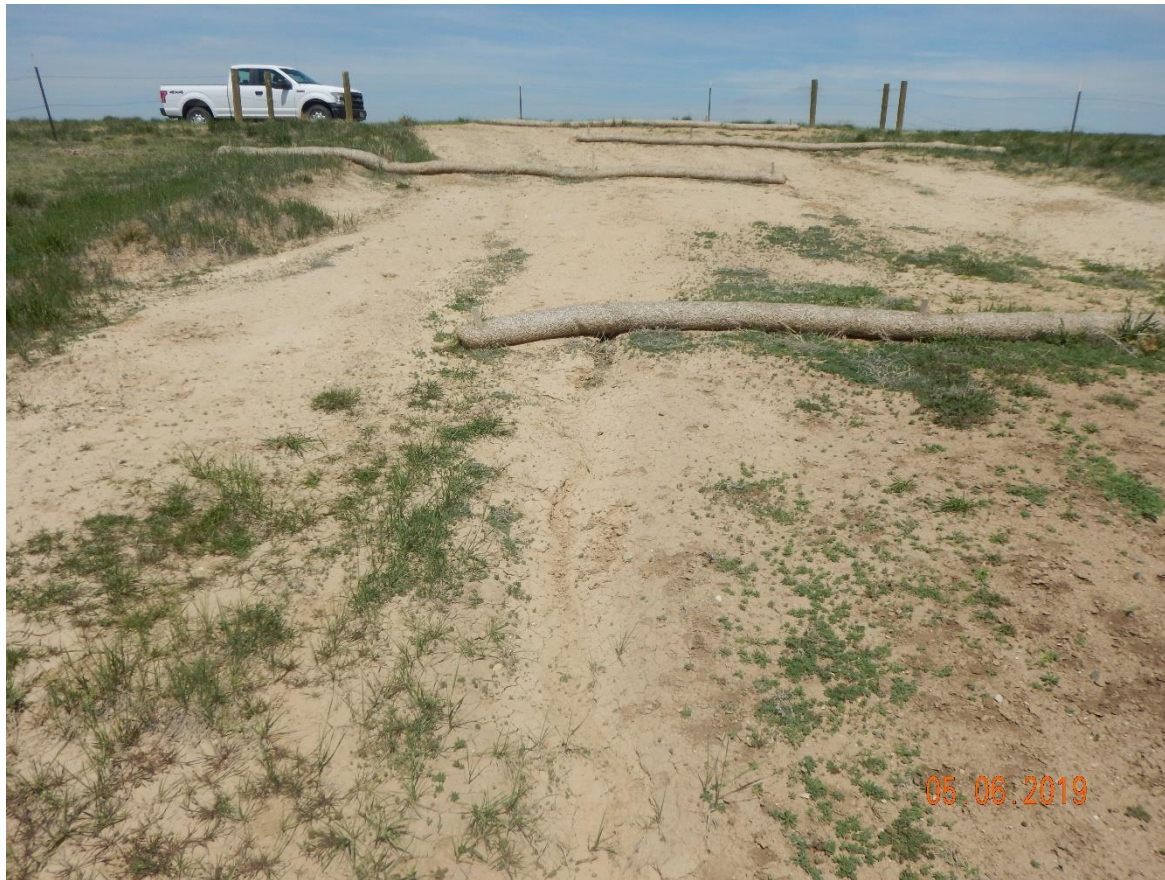
Photo 5: Photo taken from the location, facing north. Photo shows straw wattle BMPs are not in proper functioning condition, and are insufficient. Photo also shows the erosion degradation on the location.

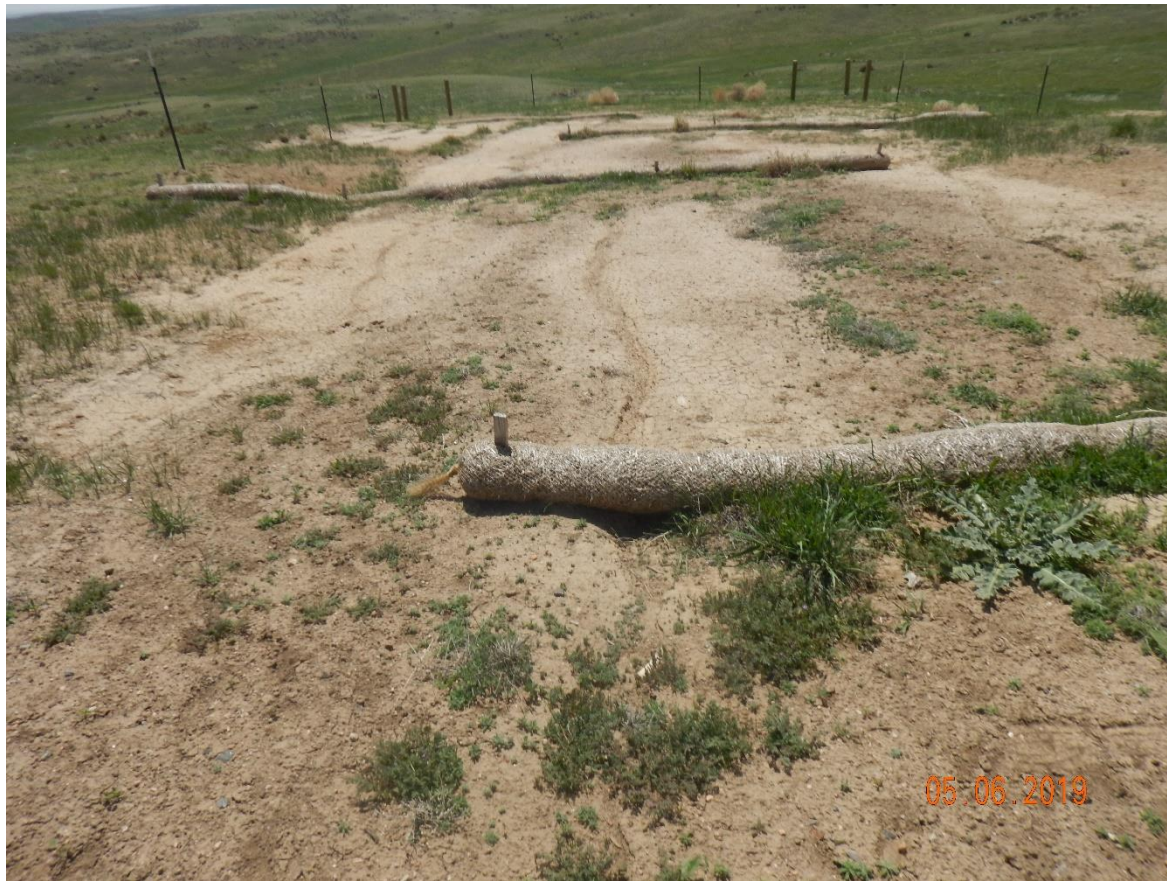
Photo 6: Photo taken from the location, facing south. See comments under photo 5.

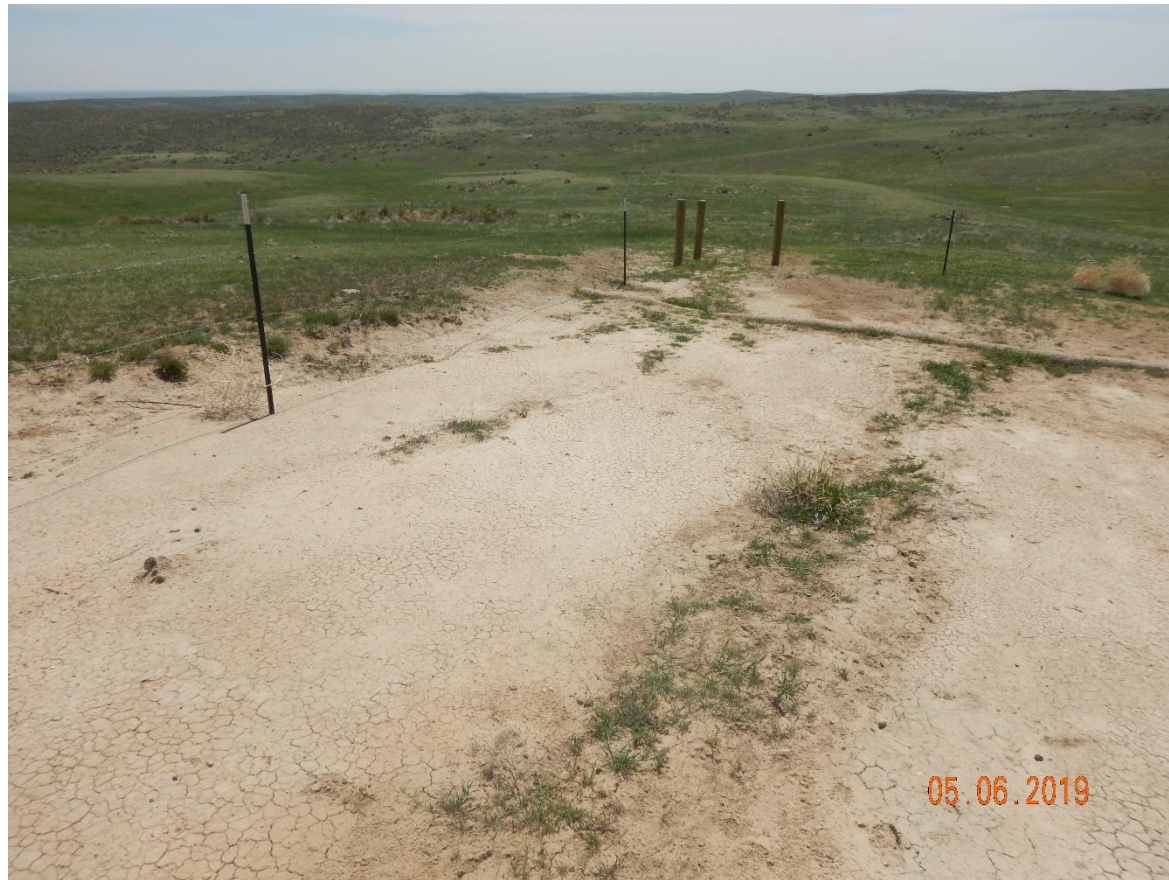
Photo 7: Photo taken from the south end of the location, facing south. See comments under photo 5

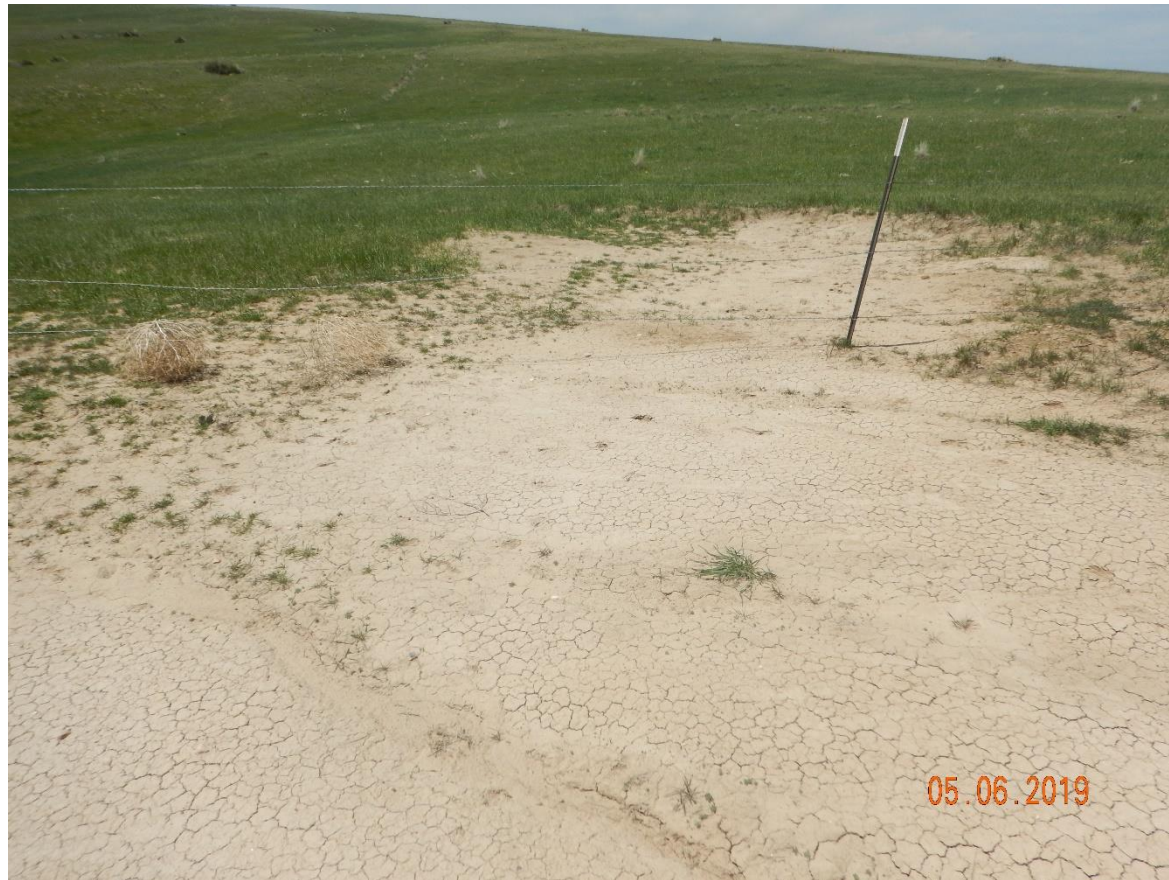
Photo 8: Photo taken from the south end of the location, facing west. Photo shows areas of sediment deposition due to stormwater runoff from the location.

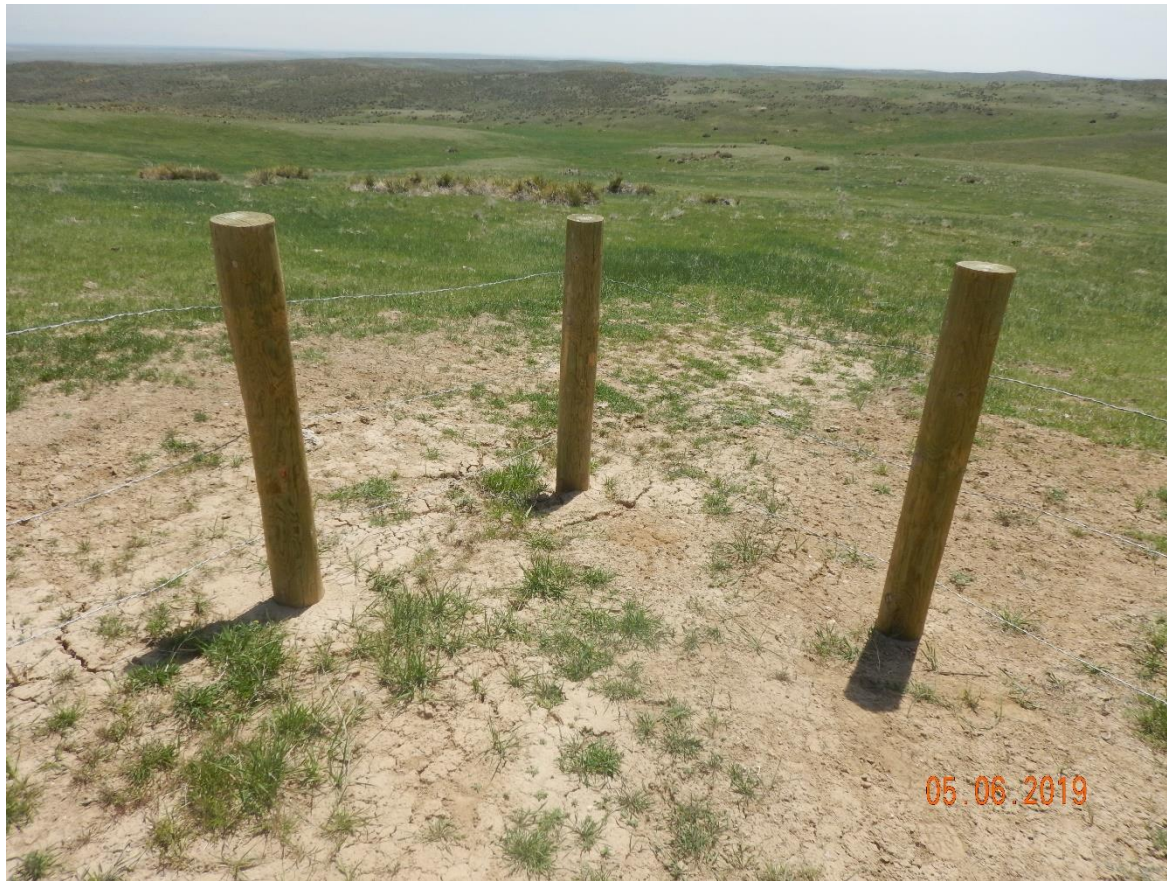
Photo 9: Photo taken from the south end of the location, facing south. Photo shows areas of sediment deposition due to stormwater runoff from the location.

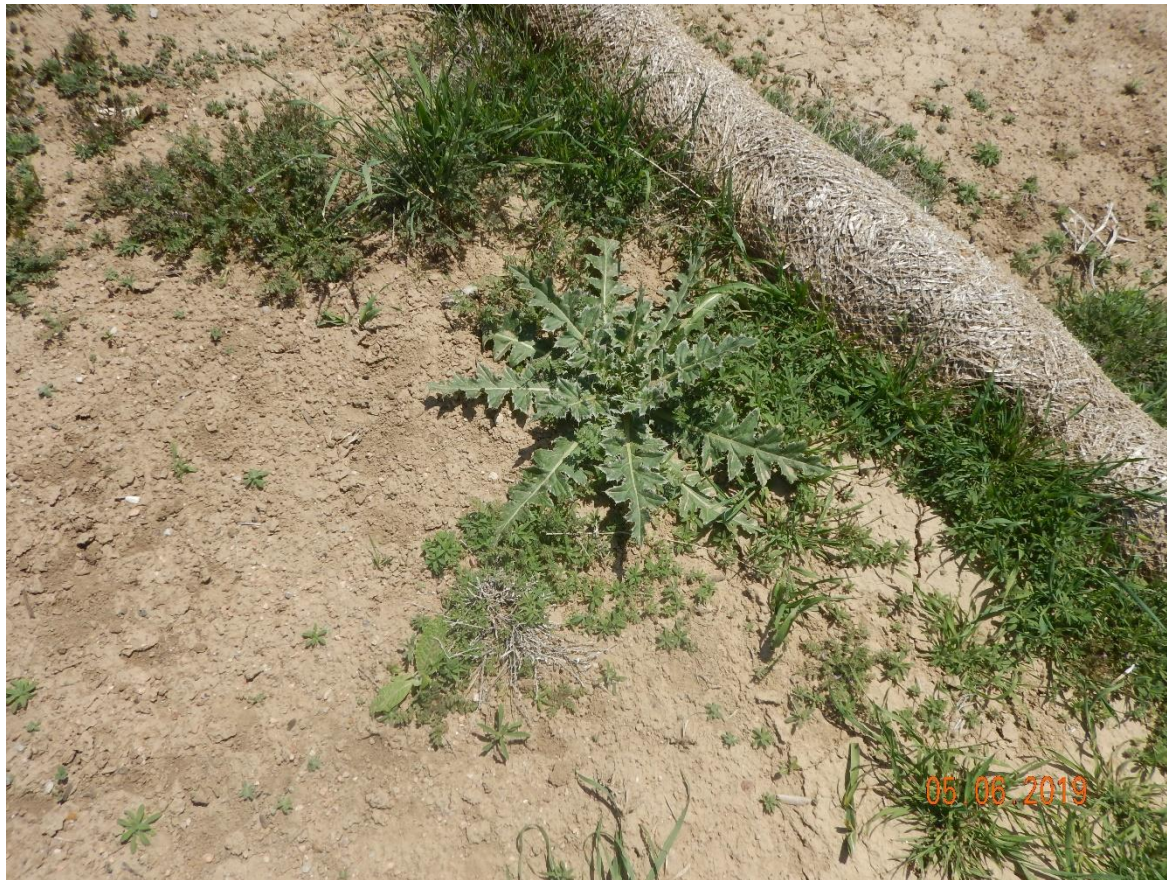
Photo 10: Photo taken from the north end of the location. Photo shows what appears to be a Scotch Thistle rosette growing on location. This is a Colorado State listed noxious weed.
