Inspection Photos

Operator: PCR OPERATING LLC - 10657

Location ID: 454195

Inspection Doc. Number: 696200040

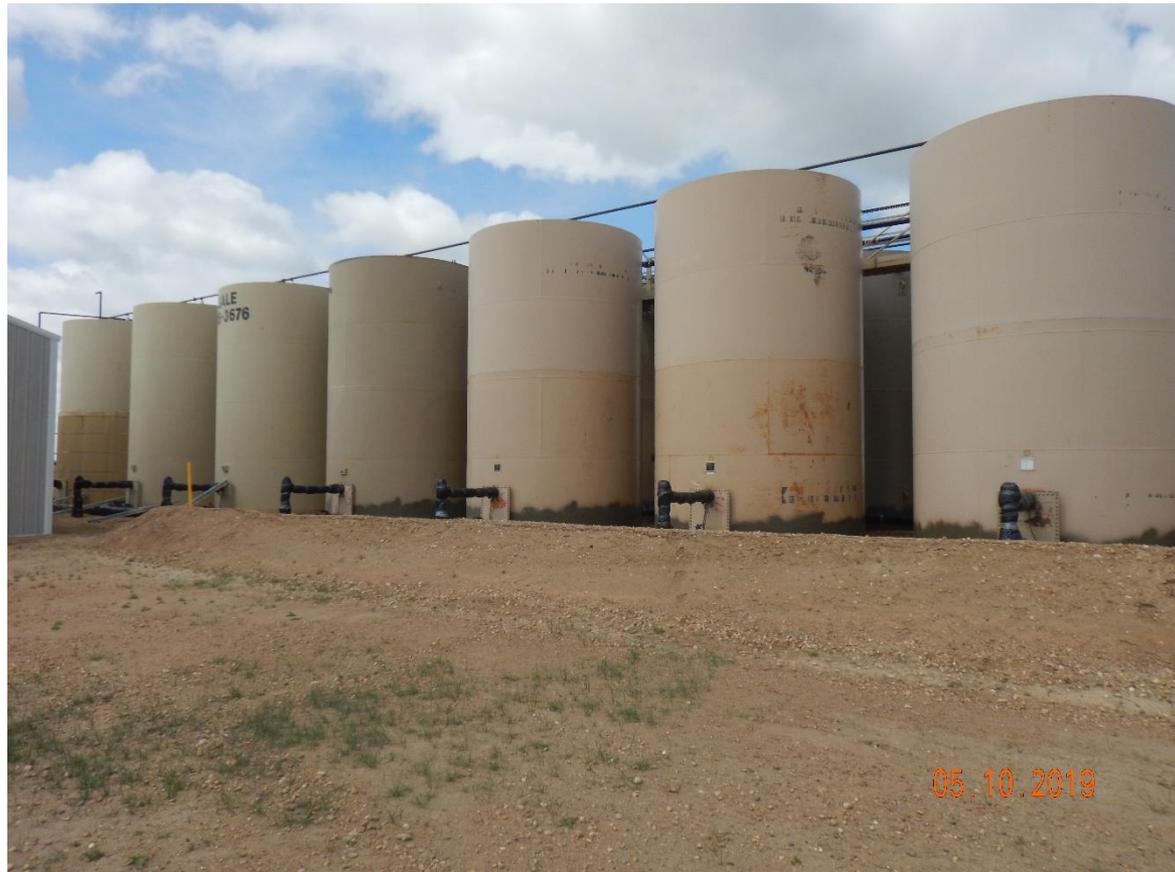
Photo 1: Photo taken from the northeast end of the tank battery, facing southwest. Photo shows insufficient signage/labeling on tanks in accordance with 210.d

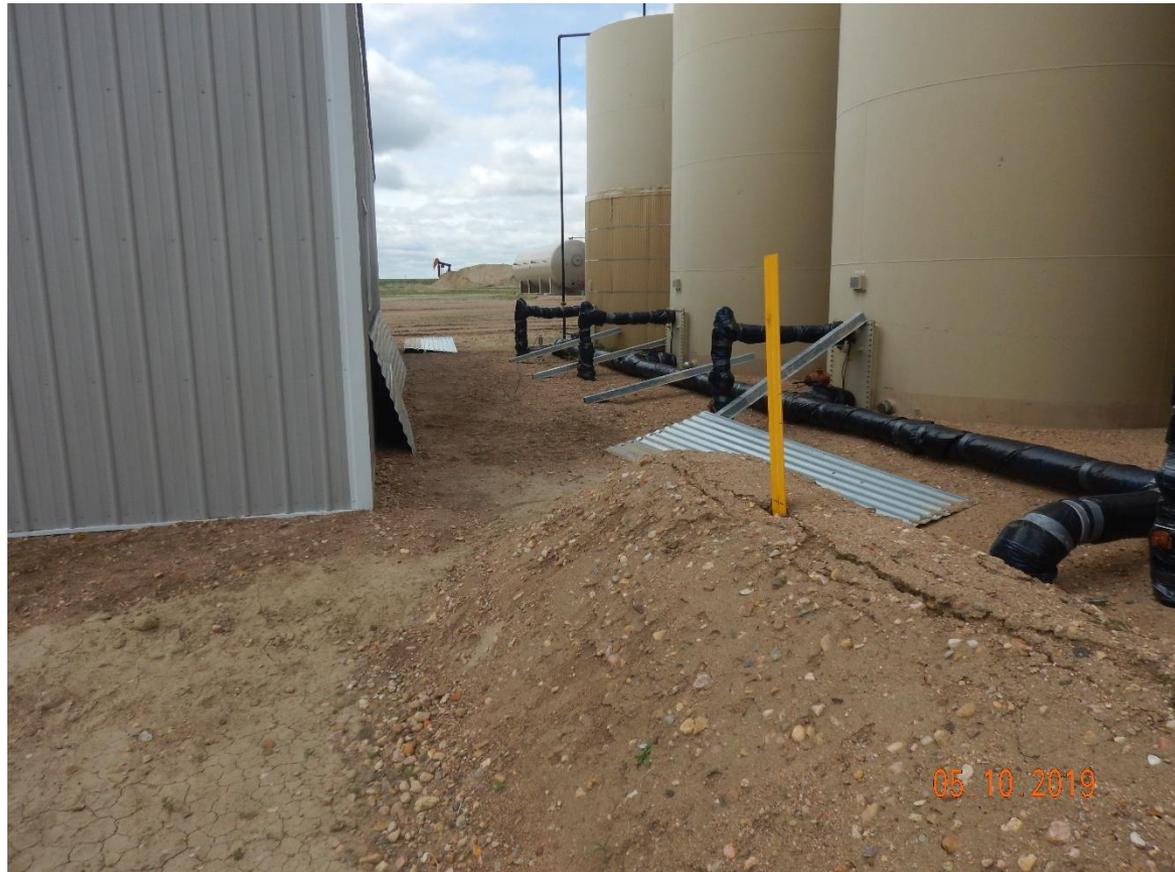
Photo 2: Photo taken from the east end of the tank battery, facing south. Photo shows insufficient secondary containment at tanks.

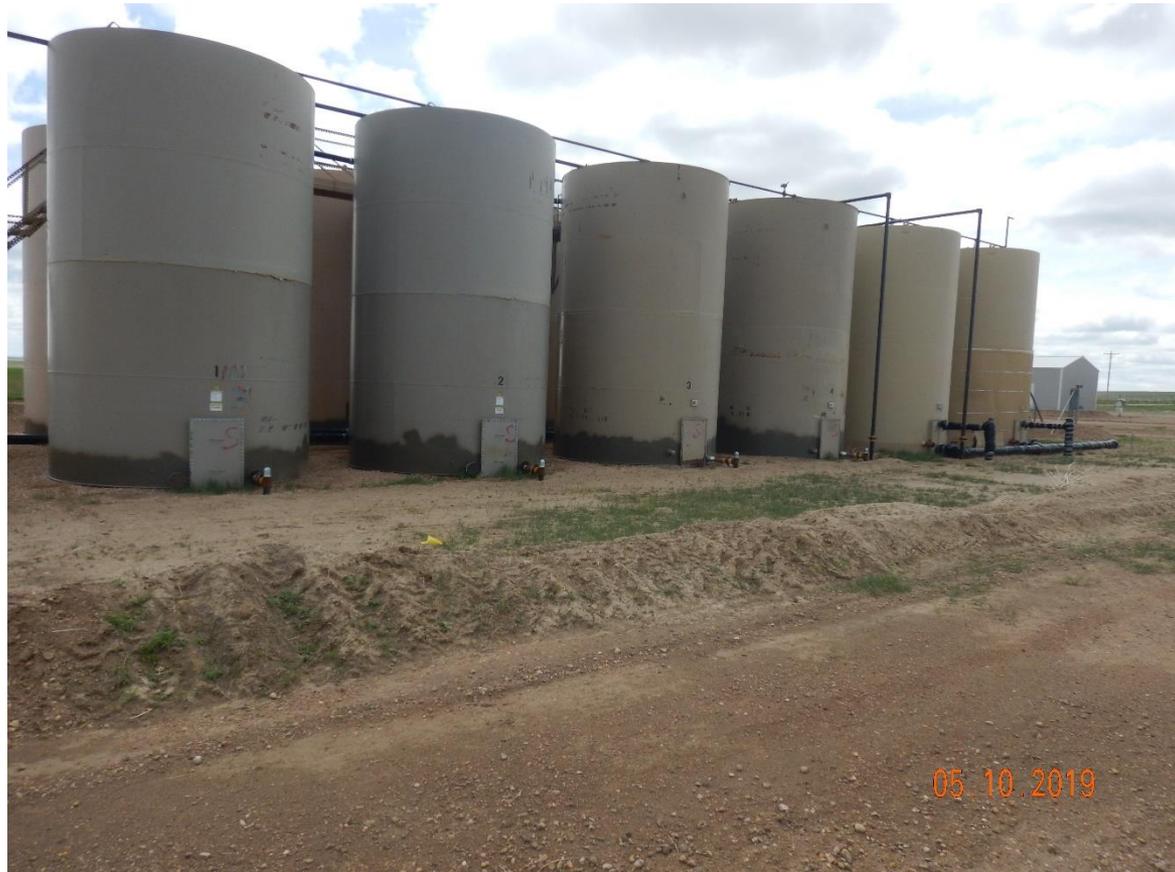
Photo 3: Photo taken from the west end of the tank battery, facing southeast. Photo shows insufficient secondary containment at tanks. Photo shows insufficient signage/labeling on tanks in accordance with 210.d. Photo also shows insufficient secondary containment at tanks.

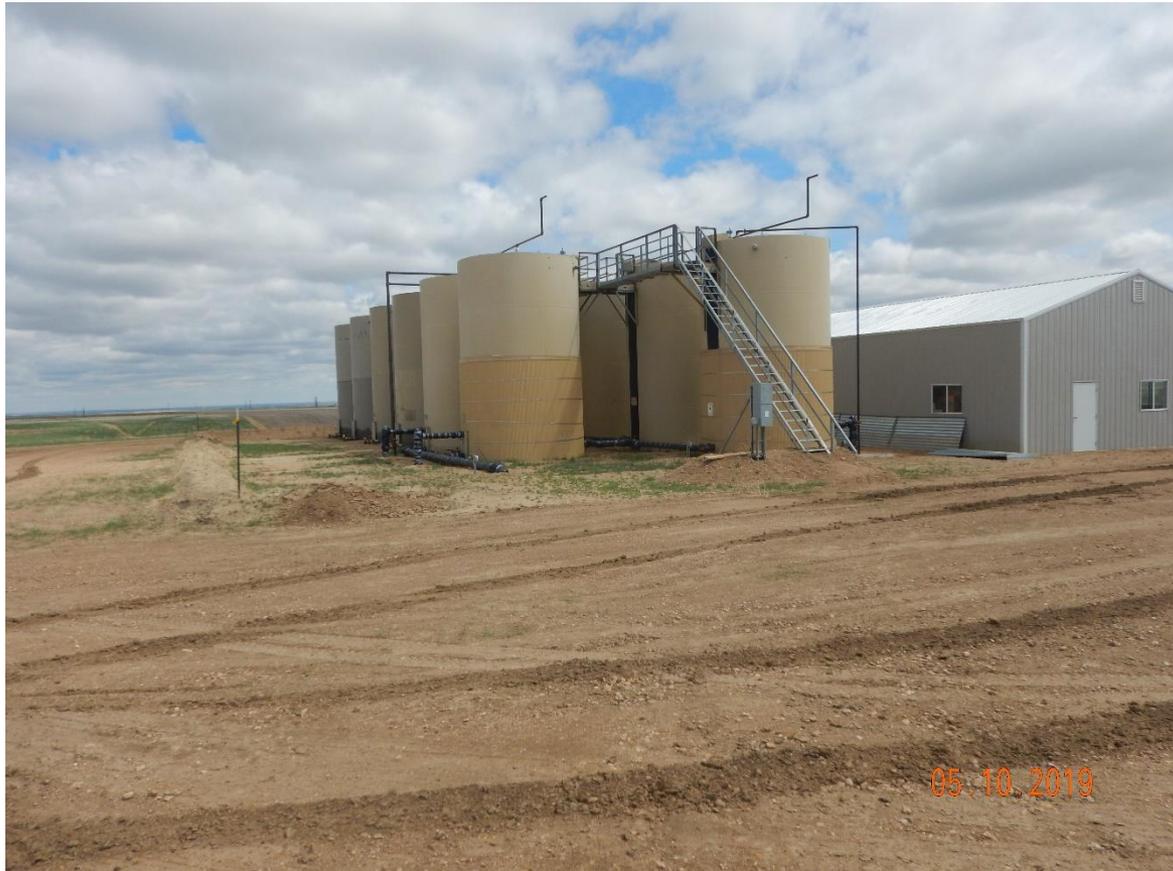
Photo 4: Photo taken from the south end of the tank battery, facing northeast. Photo shows insufficient secondary containment at tanks. Photo shows insufficient signage/labeling on tanks in accordance with 210.d. Photo also shows insufficient secondary containment at tanks.

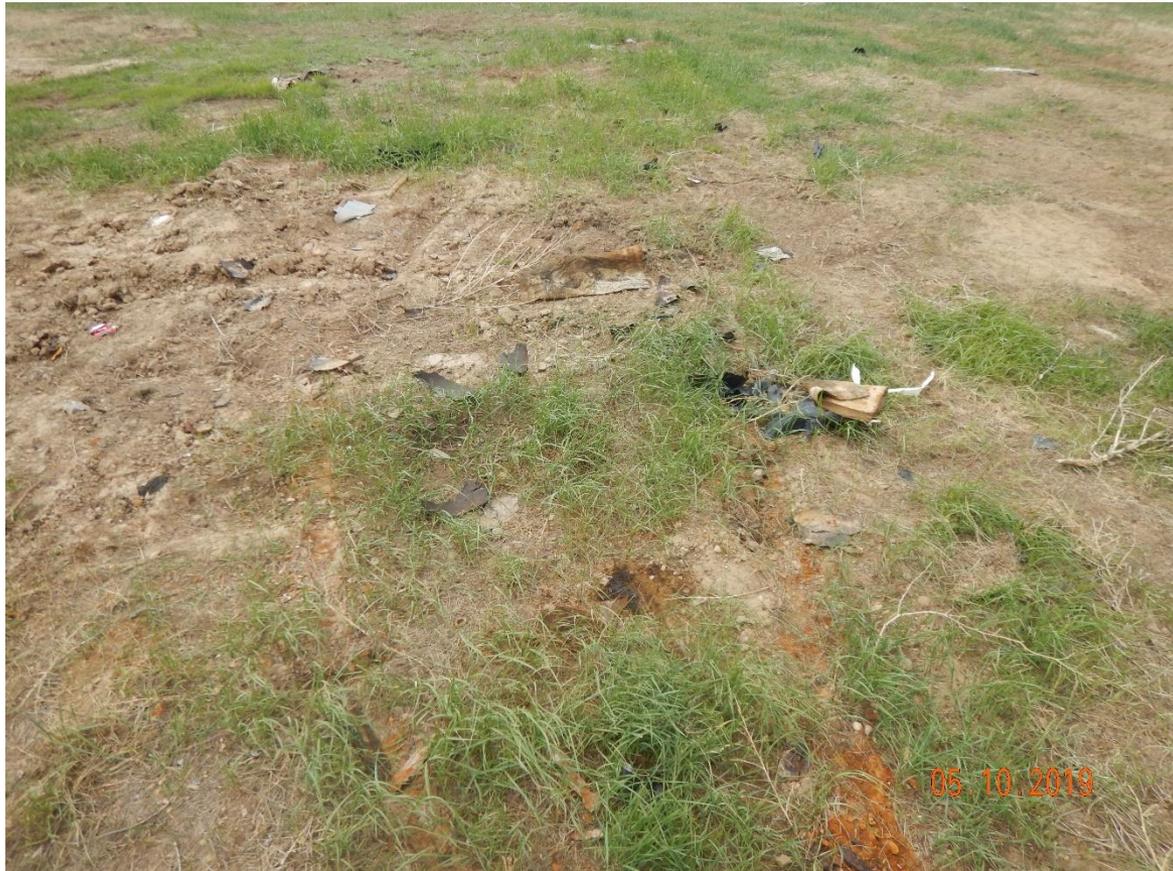
Photo 5: Photo taken from the west end of the location. Photo of various trash debris observed on location.

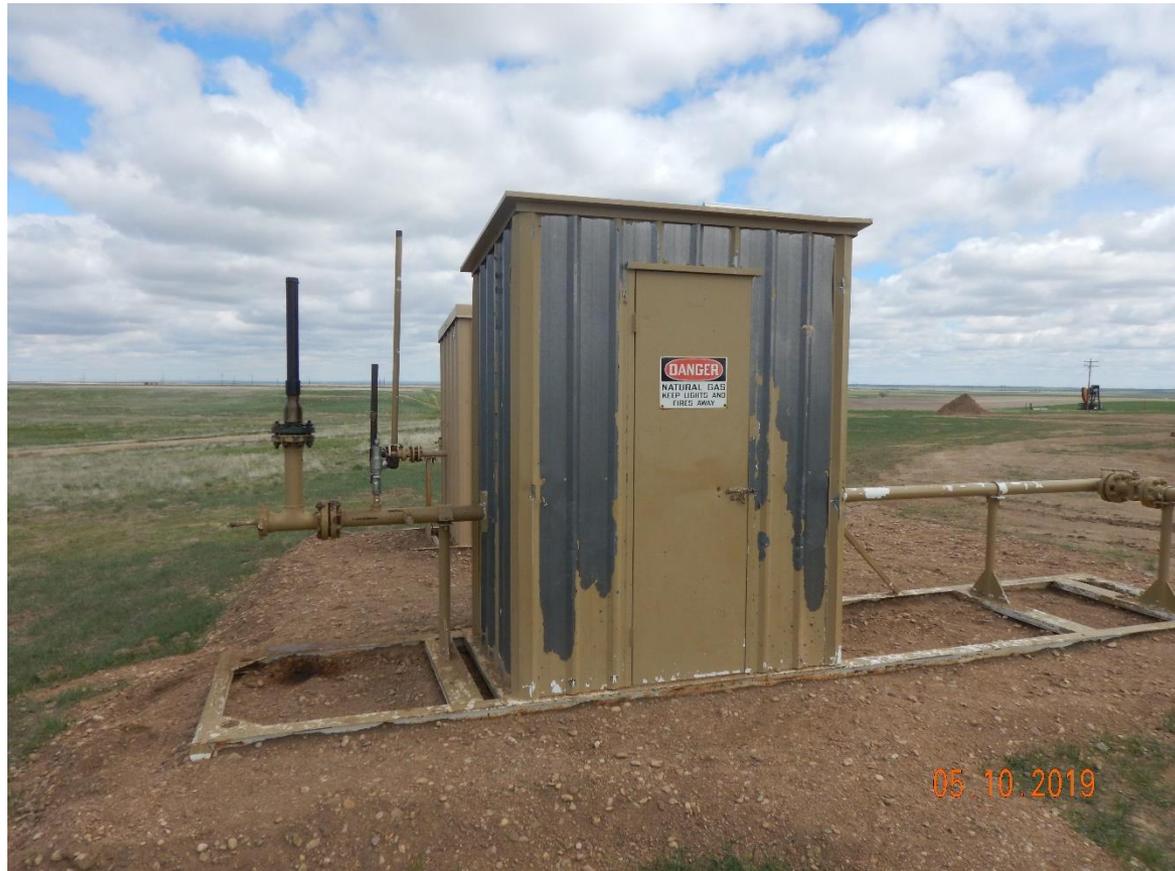
Photo 6: Photo taken from the west end of the location. Photo of shows meter run. Inspector audibly detected what appear to be gas freely venting from meter run. Inspector confirmed with PCR that gas venting was being conducted.
