Final Reclamation Inspection

Operator: PDC ENERGY INC - 69175

API: 05-001-08667

Inspection Photos
Location Name: DEGENHART #3
API: 05-001-08667

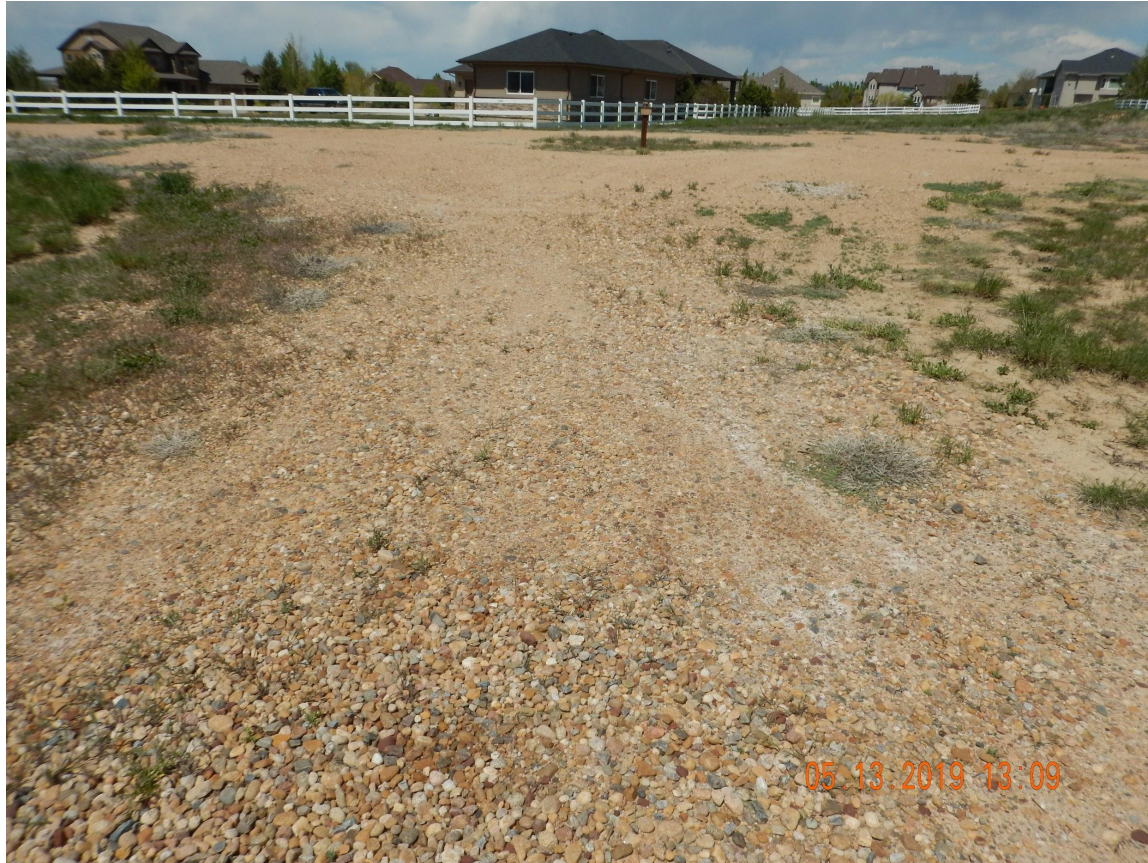
Photo 1. Photo taken from the entrance of location, facing North. Operator has failed to perform final reclamation activities. Photo illustrates gravel which remains at location.

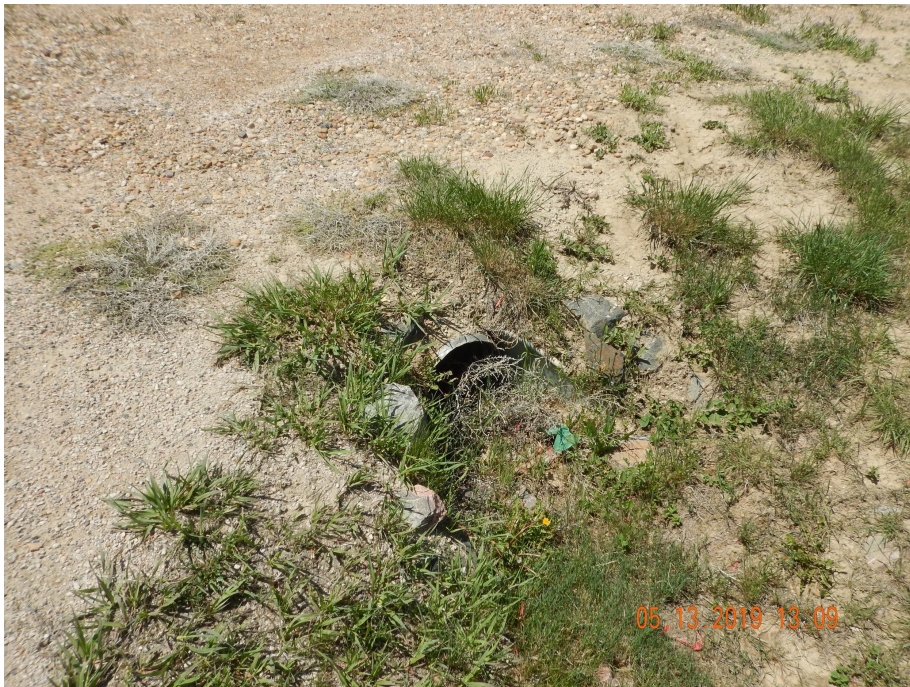
Photo 2. Photo taken from the entrance of location. Photo illustrates a culvert which remains at location.

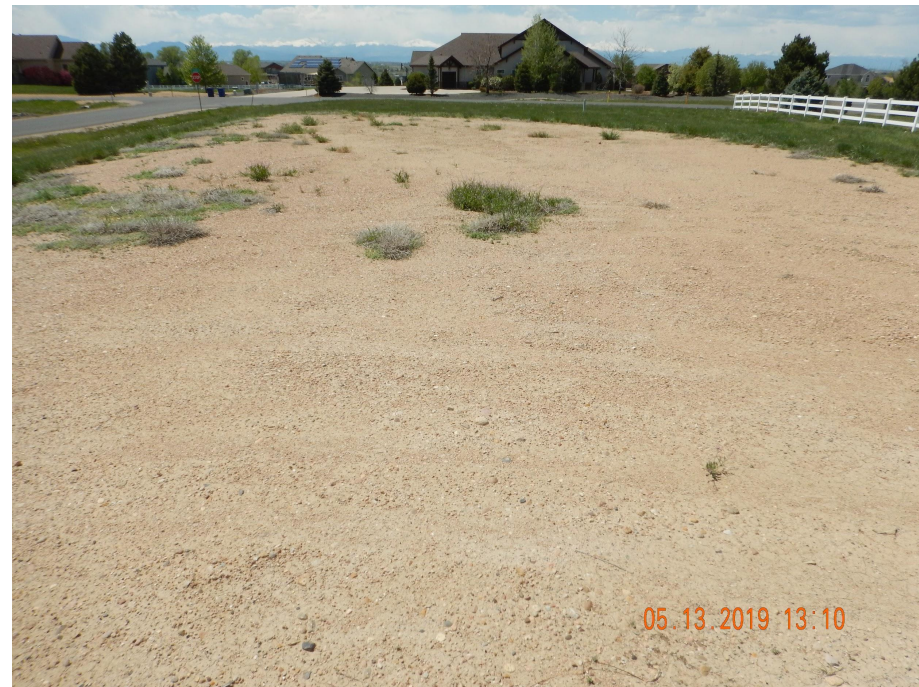
Photo 3. Photo taken from the central location, facing West. See comments under Photo 1. Also, there was unmanaged weeds (Kochia) observed at Location.

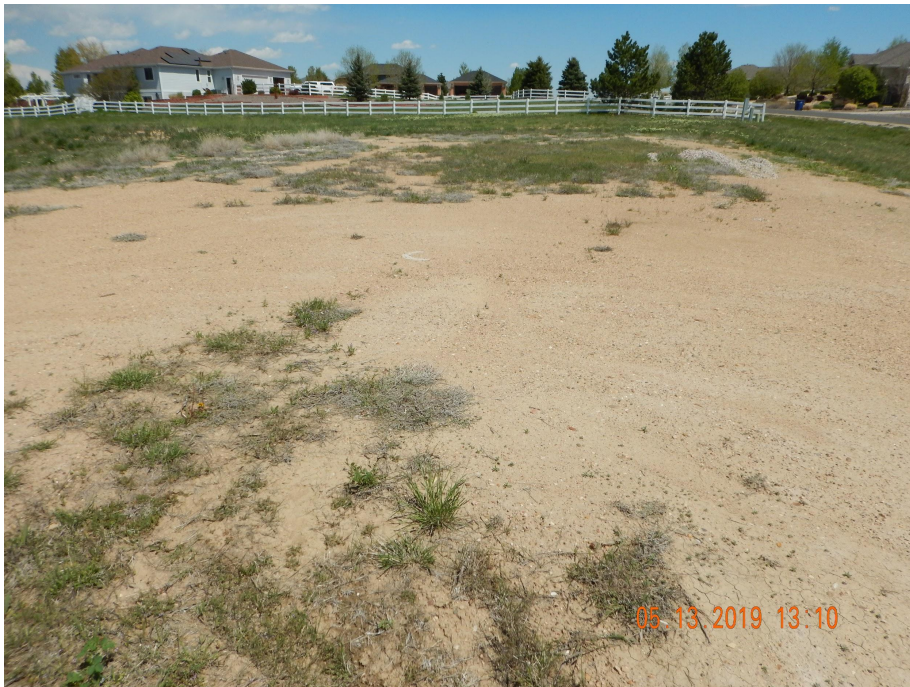
Photo 4. Photo taken from the central location, facing East. See comments under Photo 1.

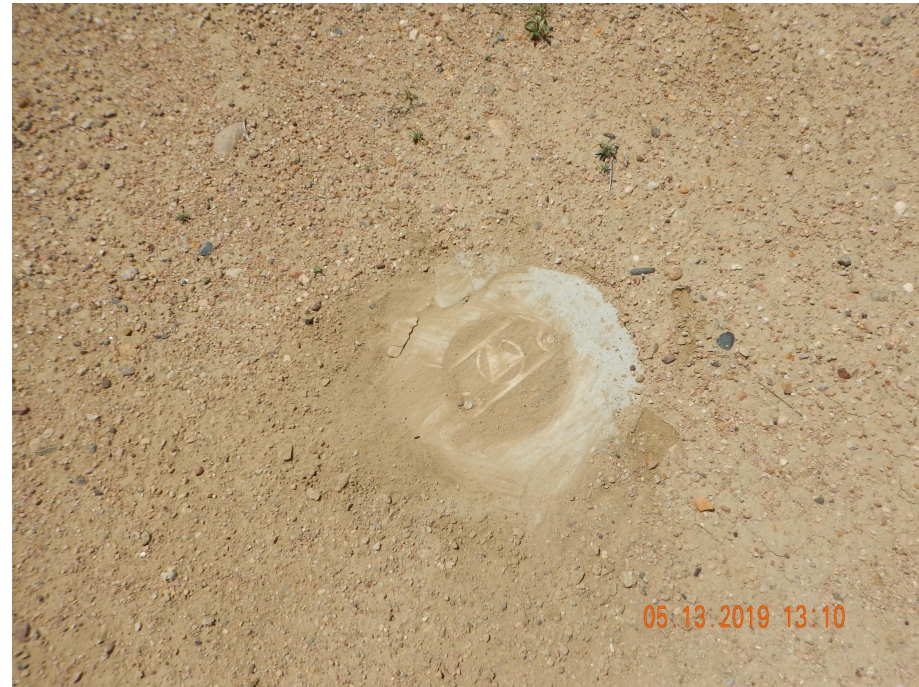
Photo 5. Photo taken from the central location. Photo illustrates what appears to be a groundwater monitoring well. Other monitoring wells were observed at location.
