Inspection Photos

Operator: PCR OPERATING LLC - 10657

Location ID: 454154

Inspection Doc. Number: 696200047

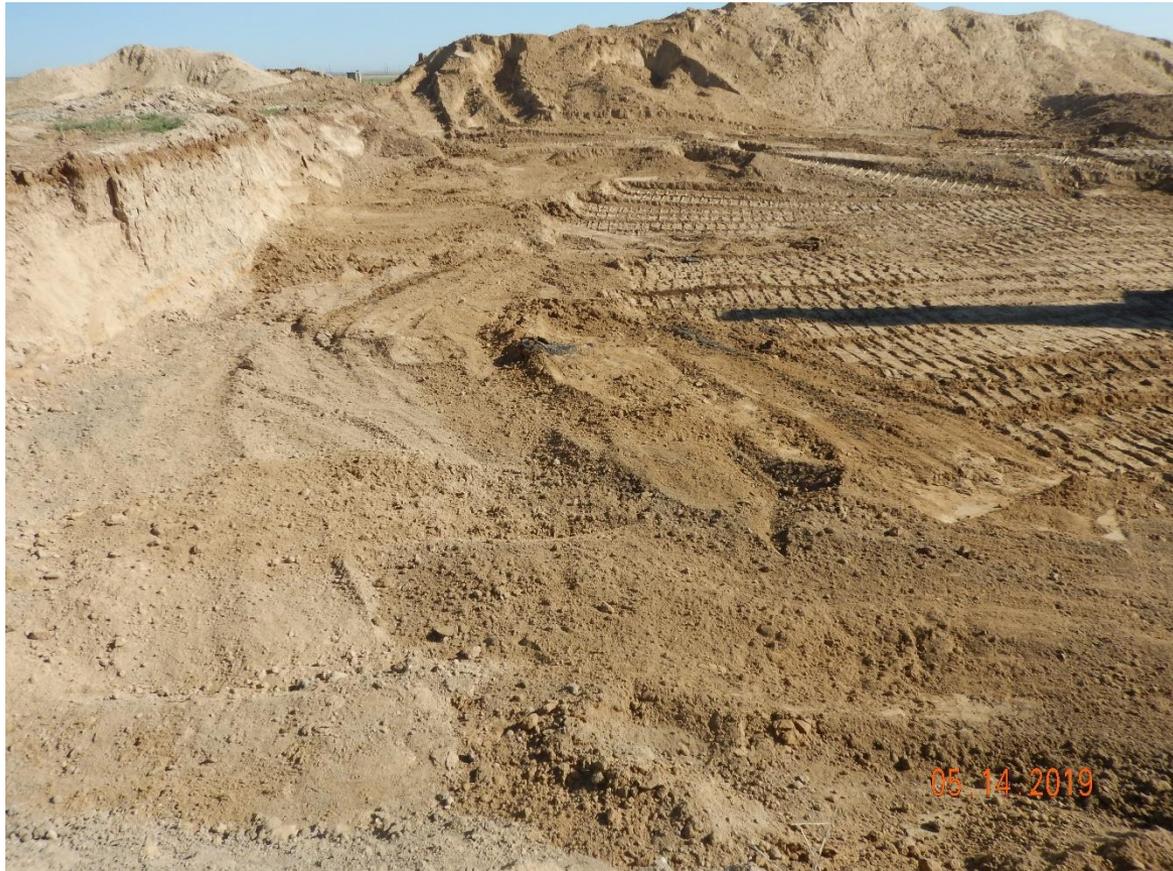
Photo 1: Photo taken from the south end of the drill pit, facing north. Contractor was on site at time of inspection removing material from pit. Photo shows work in process.

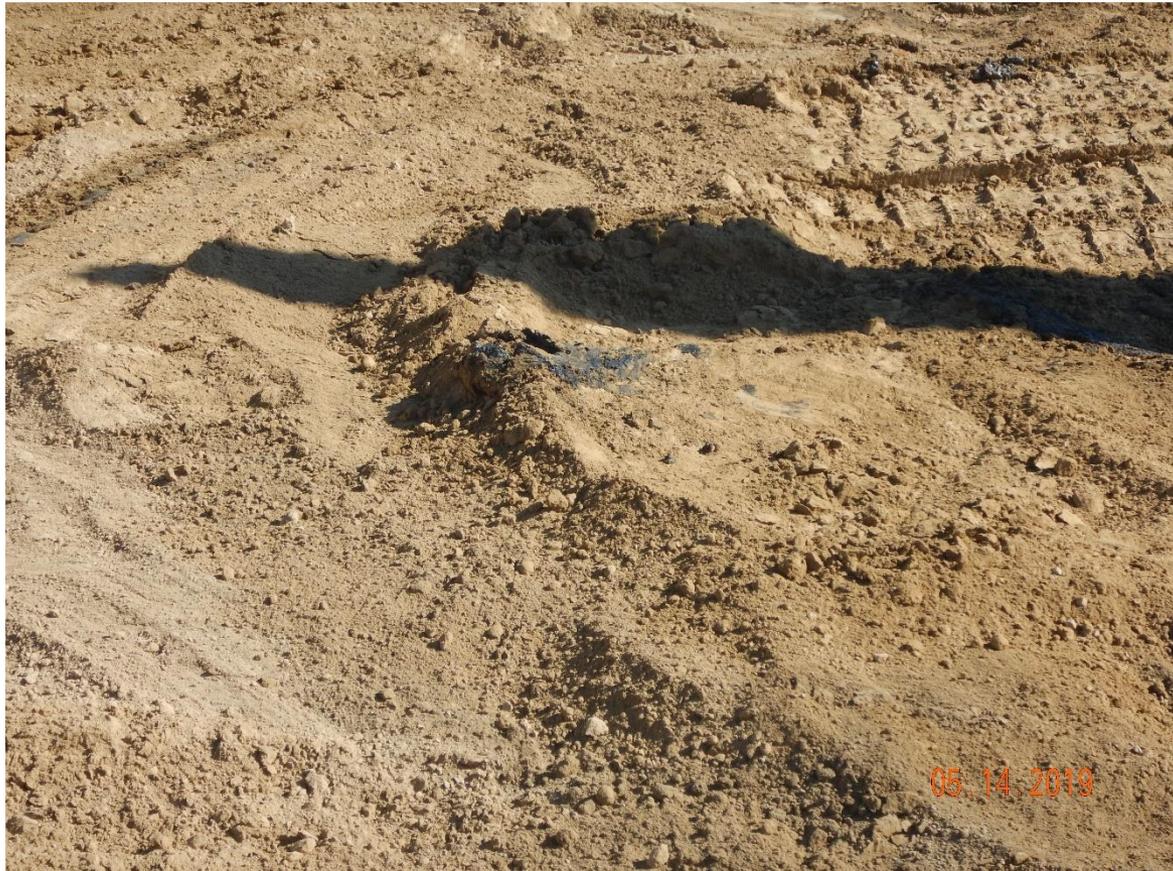
Photo 2: Continued from photo 1.

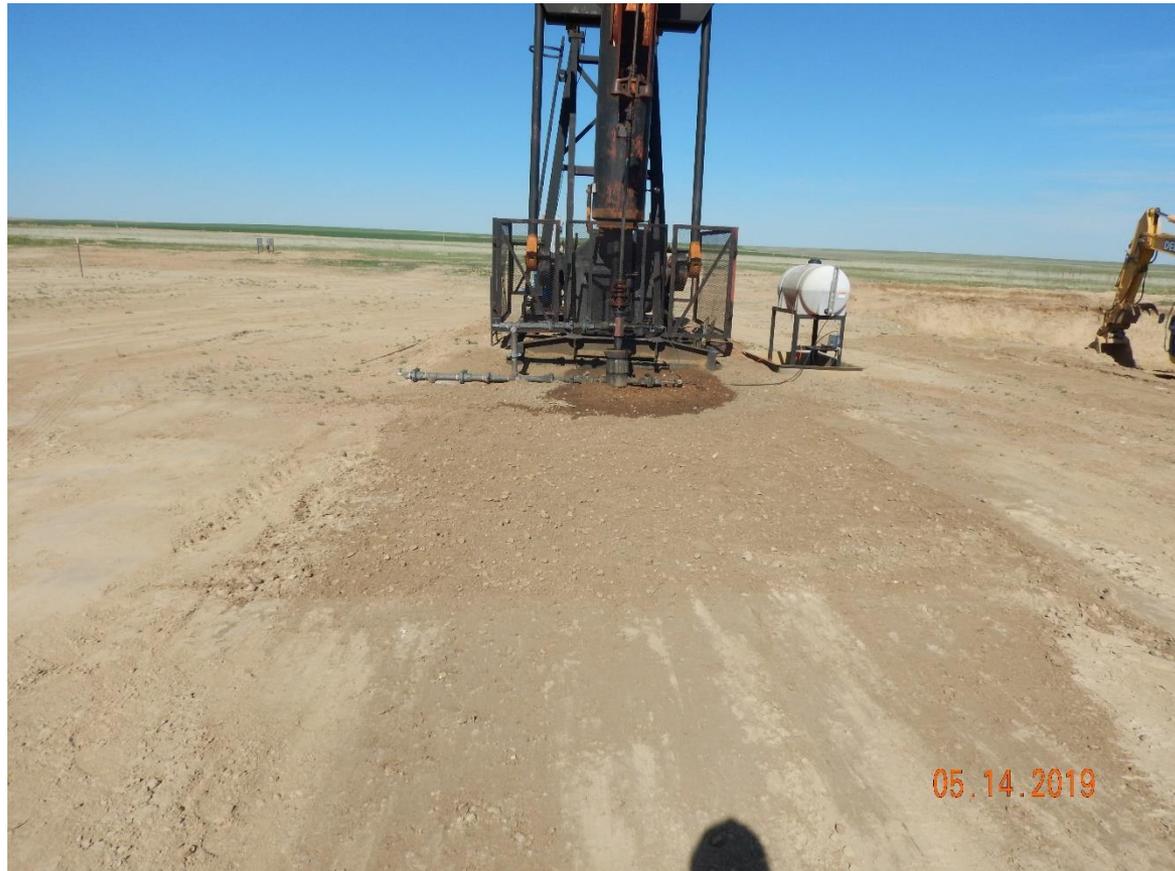
Photo 3: Photo taken from the well, facing west. Previous inspection documented a fluid spill at the wellhead. Operator was provided a 24 hour notices to control/contain fluid spill and clean up stained soils in accordance with 906.a. Photo shows stained soils appear to have been removed, however, Operator has failed to control/contain the fluid spill at the well head. Fluids were observed actively discharging from the pump rod contaminating approximately a 5 ft. x 6 ft. area at the well head.

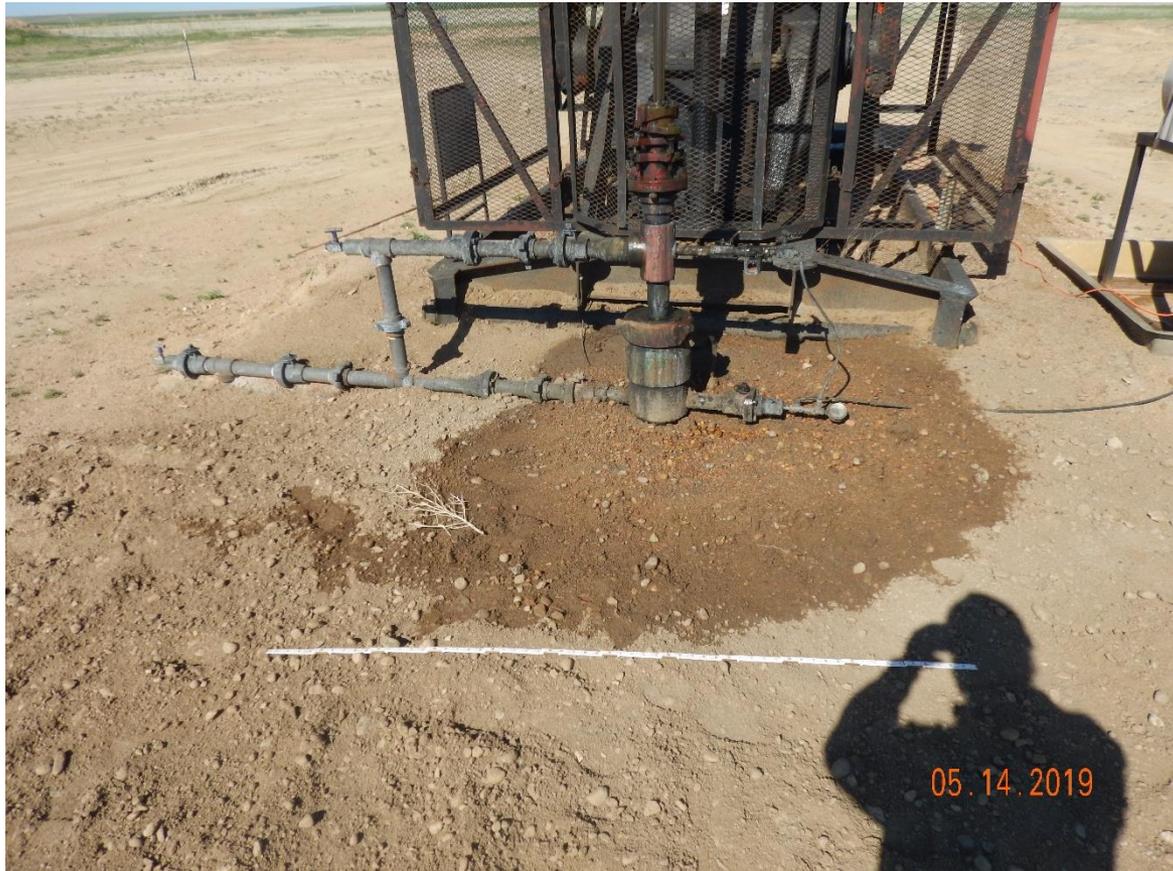
Photo 4: Continued from photo 3. Photo shows fluids observed discharging from the pump rod have re-contaminating approximately a 5 ft. x 6 ft. area at the well head. 6 foot measuring stick for reference.

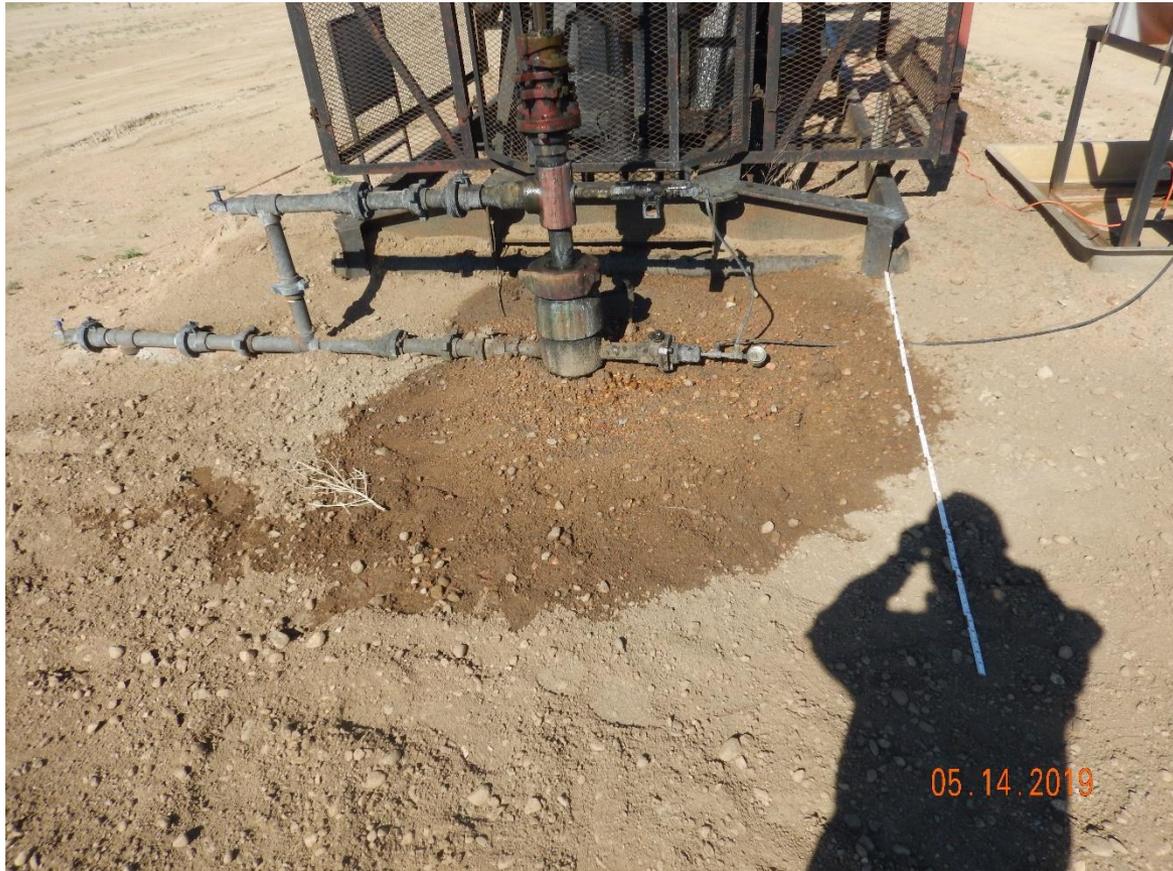
Photo 5: Continued from photo 3. Photo shows fluids observed discharging from the pump rod have re-contaminating approximately a 5 ft. x 6 ft. area at the well head. 6 foot measuring stick for reference.
