Final Reclamation Inspection

Operator: GREAT WESTERN OPERATING COMPANY LLC- #10110

API: 05-001-09086

Inspection Photos
Location Name: WIERMAN #43-7 (1)
API: 05-001-09086

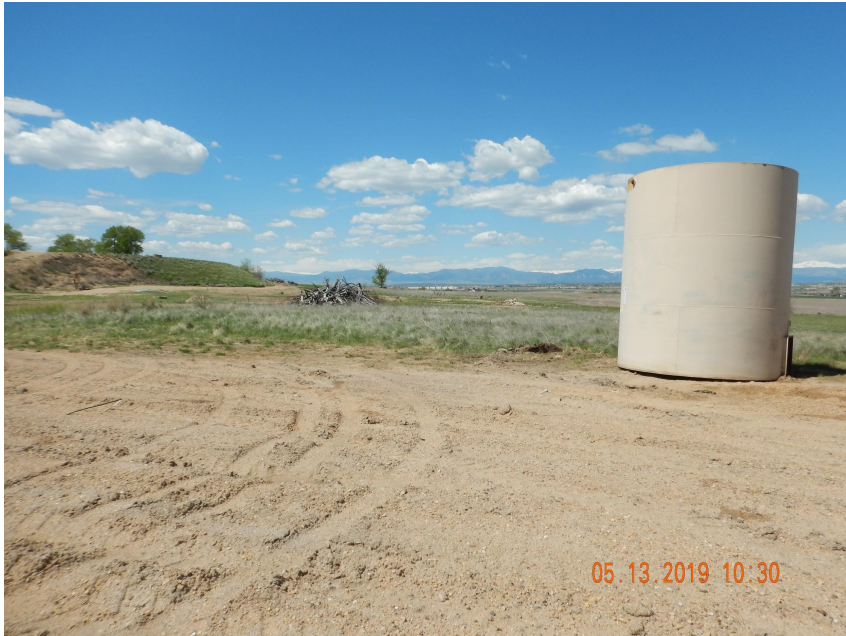
Photo 1. Photo taken from the facility/well location, facing West. Well was plugged 2/28/2019. Operator shall remove all equipment within 3 months of plugging (5/28/2019).

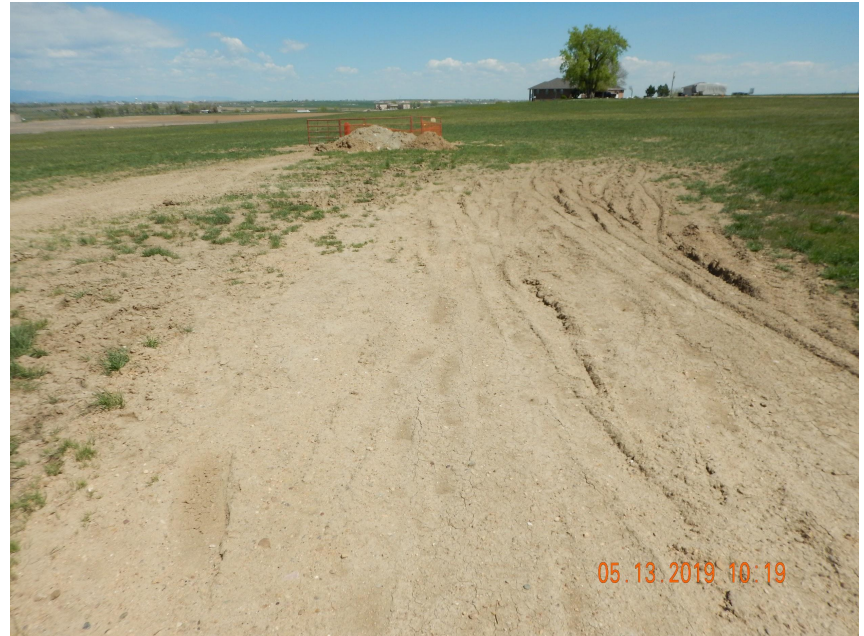
Photo 2. Photo taken from the facility/well location, facing North. See comments under Photo 1.

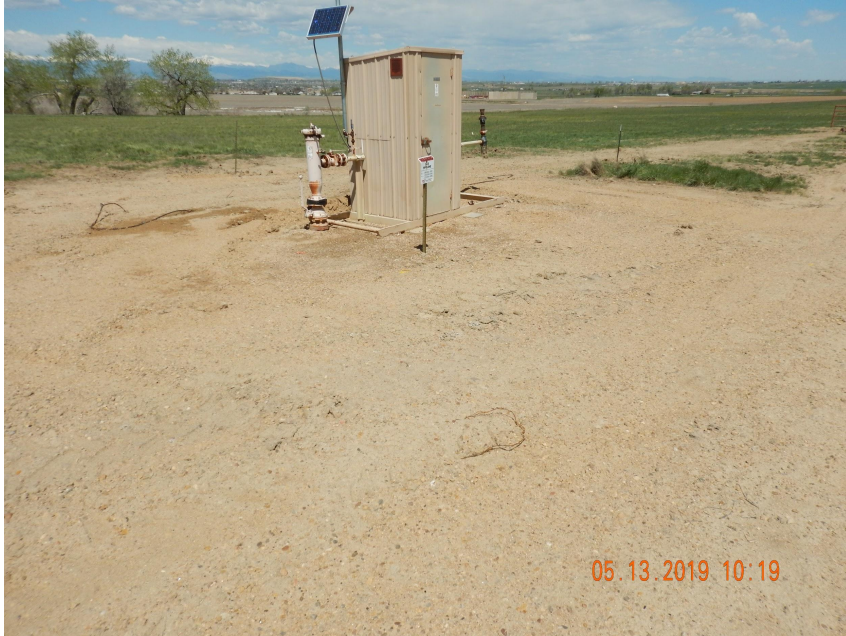
Photo 3. Photo taken from the facility/well location, facing Northwest. See comments under Photo 1.

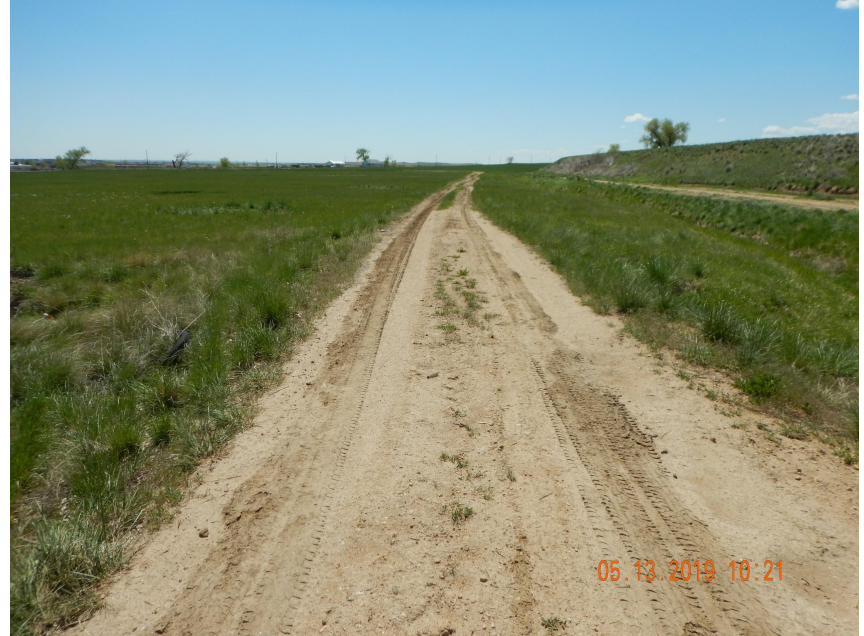
Photo 4. Photo taken from the northern well access road, facing South. Operator shall comply with Rule 1004 to remove the access road.
