Final Reclamation Inspection

Operator: GREAT WESTERN OPERATING COMPANY LLC- #10110

API: 05-001-06862

Inspection Photos
Location Name: GREAT WESTERN FRONT
RANGE #2
API: 05-001-06862

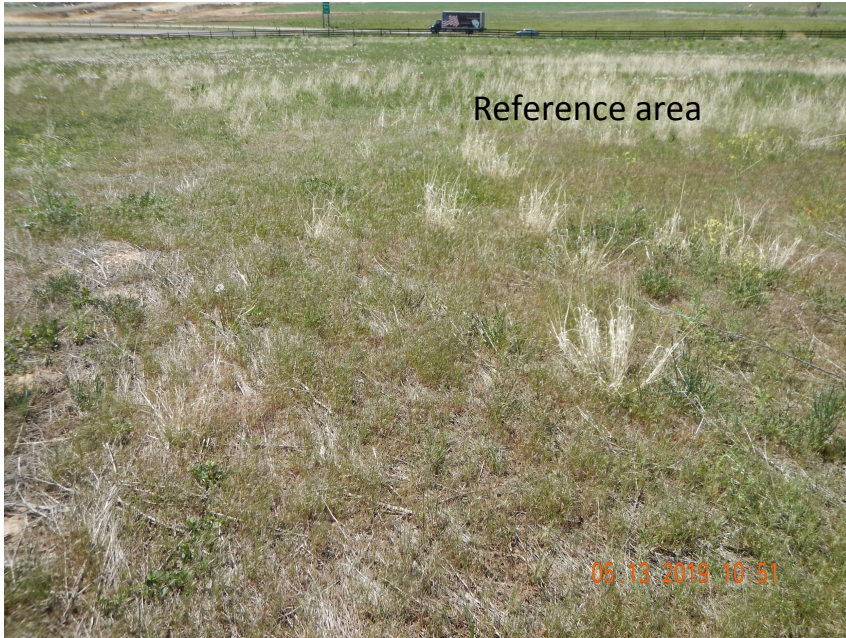
Photo 1. Photo taken from the well location, facing South. Location will remain in-process as it does not meet Rule 1004 standards. Cheatgrass was observed in high densities throughout the well location which is not reflective of reference area vegetation. Reference area vegetation mainly consists of Sand dropseed.

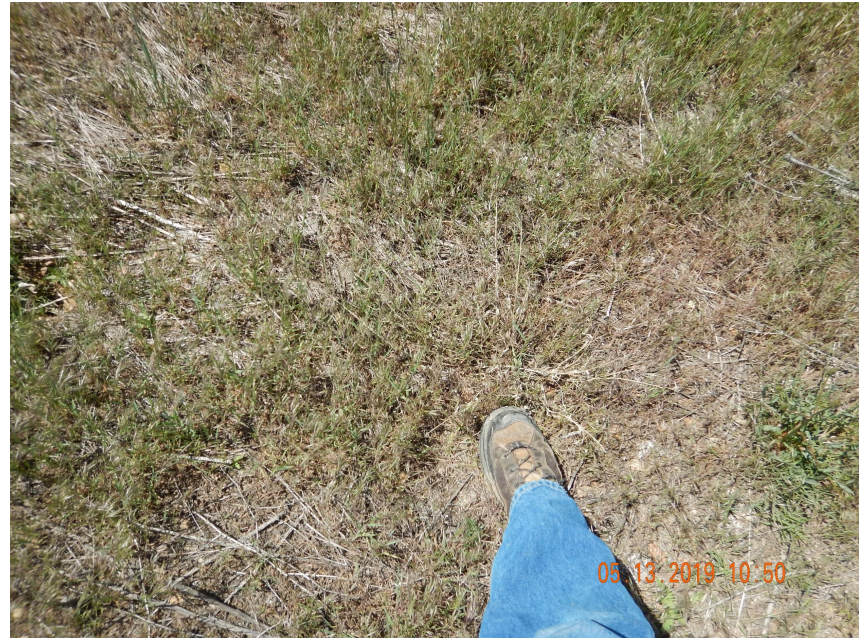
Photo 2. Photo taken from the well location. Photo illustrates weedy annual growth of Cheatgrass.
