Inspection Photos

Location Name: JAMIE LEE 33-7-9 #3B

API #: 05-067-09612

INSP. #:695100642

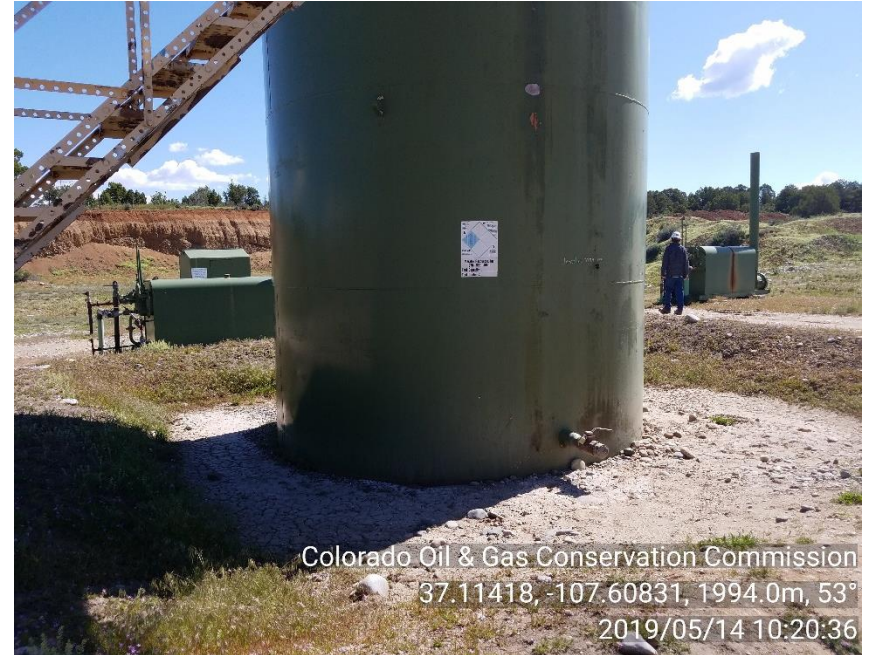
PHOTO 2: TANK BATTERY/ NFPA STICKER IS
FADED AND IS NOT LEGIBLE. **Install sign to
comply with Rule 210. CA DATE 6/21/19**

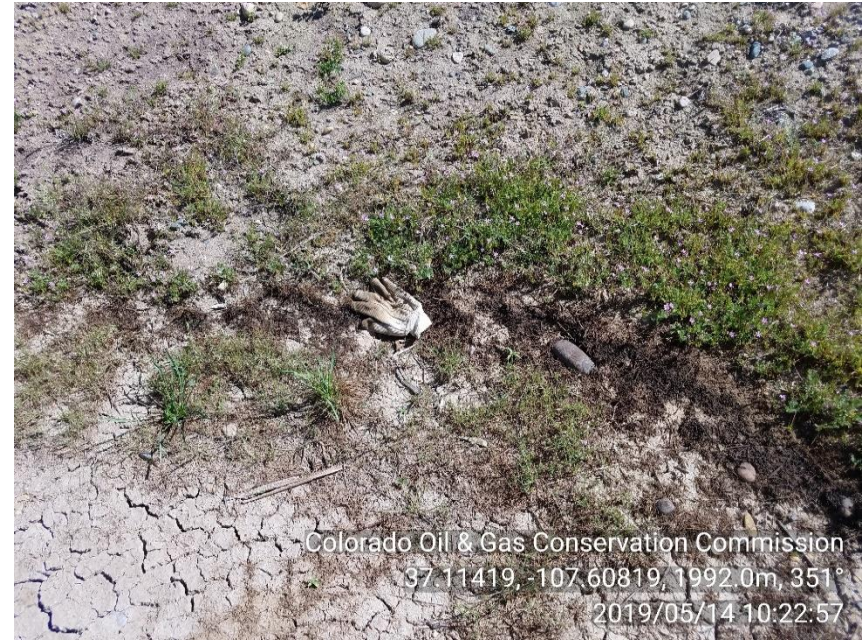
**PHOTO 4: TRASH INSIDE BERM FOR
PRODUCED WATER TANK. REMOVE TRASH TO
COMPLY WITH RULE 603.f. CA DATE 6/21/19**

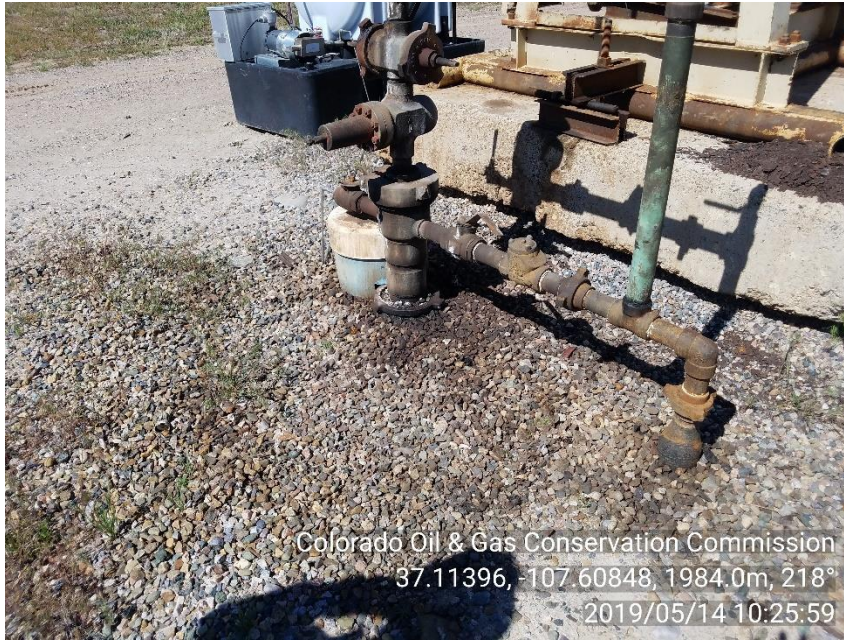
PHOTO 5: IMPACTED SOIL AROUND THE 33-7-9 #1 WELLHEAD. Remove and dispose impacted material in approved manner, service and maintain equipment and self inspect to prevent recurrence of conditions per 1002.f(2) and 907" CA DATE 6/21/19

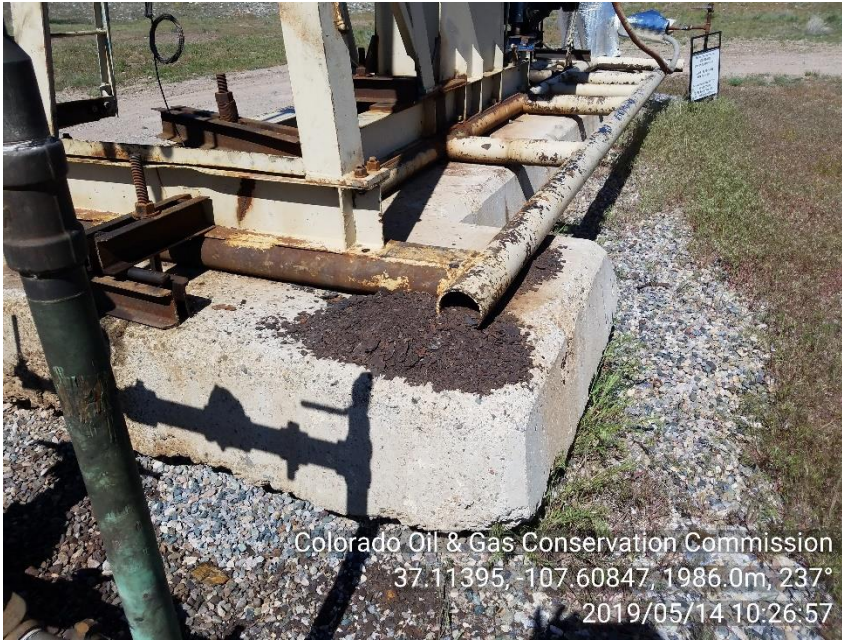
PHOTO 7: APPEARS TO BE RUST OR SCALE PILED NEXT TO PUMPJACK SKID ON THE 33-7-9 #3B WELL. REMOVE TRASH TO COMPLY WITH 603.f. CA DATE 6/21/19

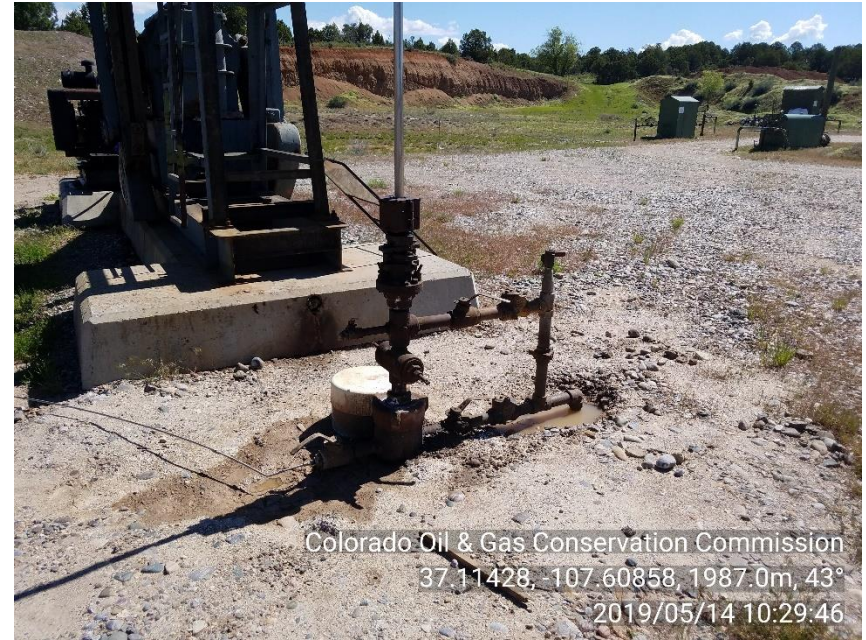
PHOTO 8: IMPACTED SOIL AROUND EAST OF THE 33-7-9 #3B WELLHEAD. Remove and dispose impacted material in approved manner, service and maintain equipment and self inspect to prevent recurrence of conditions per 1002.f(2), 907 & 906" CA DATE 6/21/19

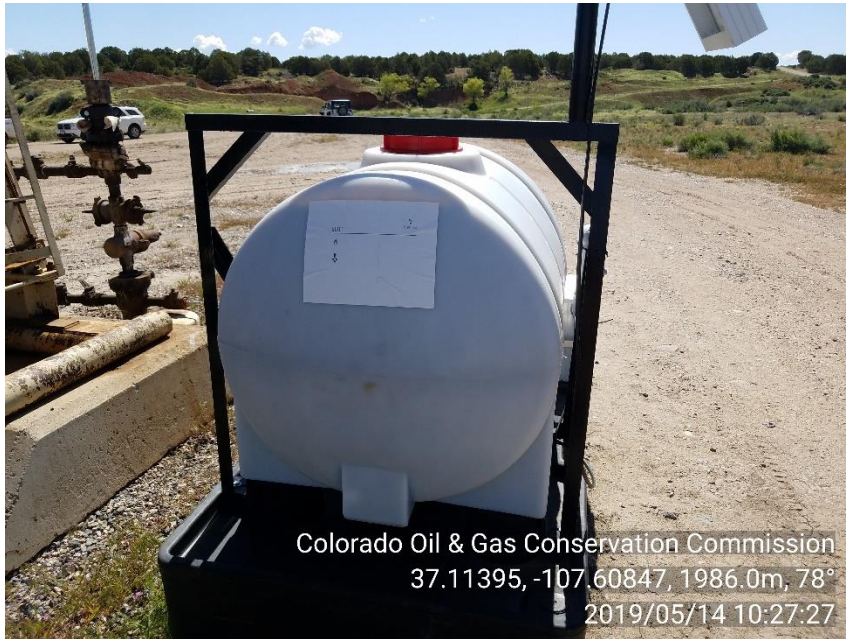
PHOTO 9: LABEL ON CHEM. CONTAINER NEAR WELL 33-7-9 #3B IS FADED AND NOT LEGIBLE. COMPLY WITH RULE 210. CA DATE 6/21/19

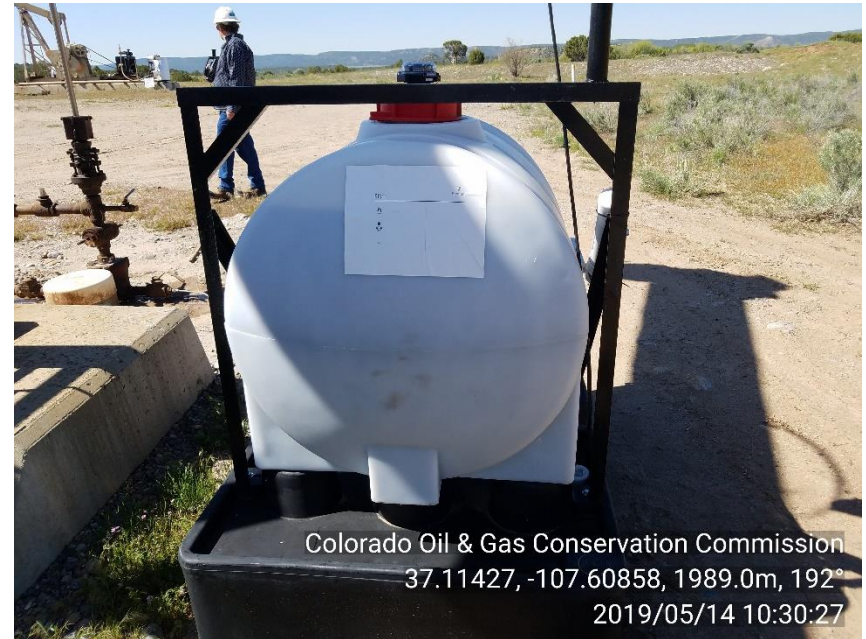
PHOTO 10: LABEL ON CHEM. CONTAINER NEAR WELL 33-7-9 #1 IS FADED AND NOT LEGIBLE. COMPLY WITH RULE 210. CA DATE 6/21/19

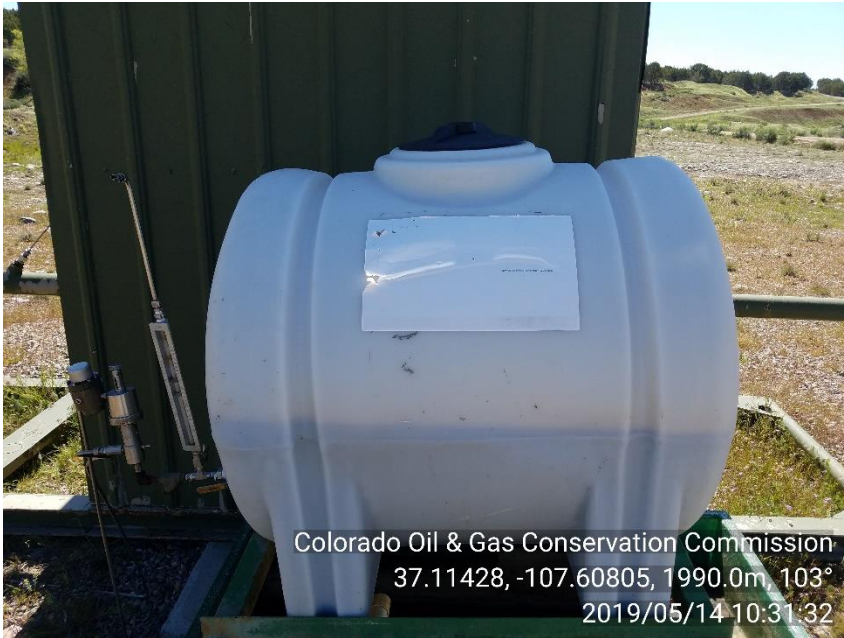
PHOTO 11: LABEL ON CHEM. CONTAINER NEAR METER HOUSE ON NORTHEAST EDGE OF LOCATION IS FADED AND NOT LEGIBLE. COMPLY WITH RULE 210. CA DATE 6/21/19

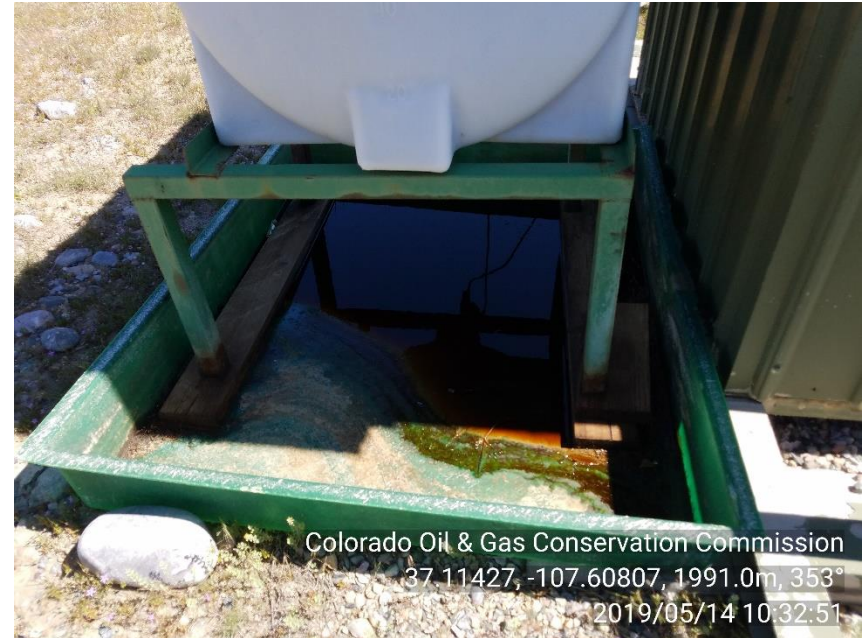
PHOTO 12: There is a dark oily fluid in the spill prevention by the meter house. **Comply with SB-181 and general provisions of the oil and gas act for wildlife protection. CA date 5/21/19.**
