Inspection Photos
Location Name: ALABASTER 11-8
API #: 05-071-08642
INSP. #:695100657

Colorado Oil & Gas Conservation Commission
37.18951, -104.81147, 2190.0m, 311°
2019/05/20 12:33:29

Location Name: ALABASTER 11-8

INSP. #:695100657

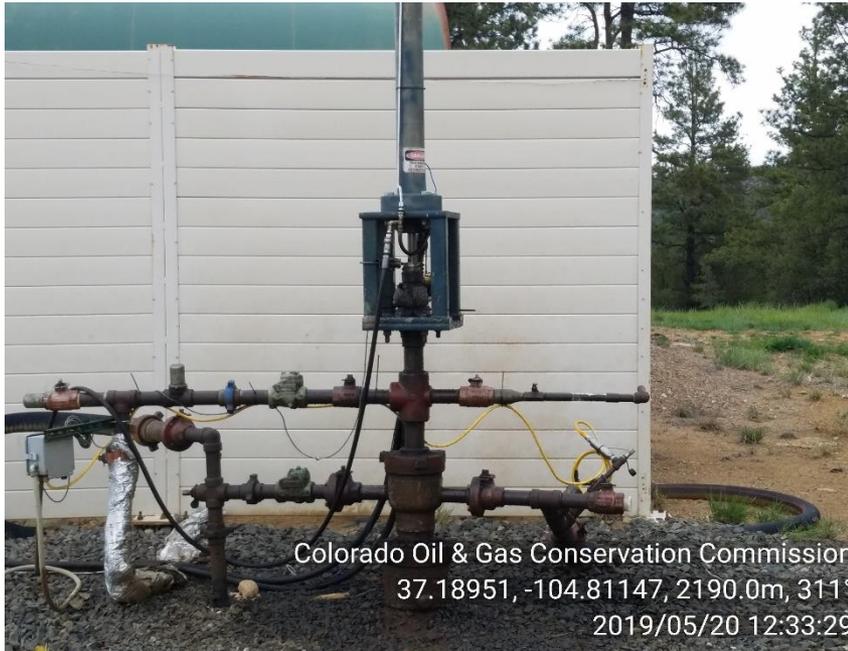
PHOTO 1: WELLHEAD

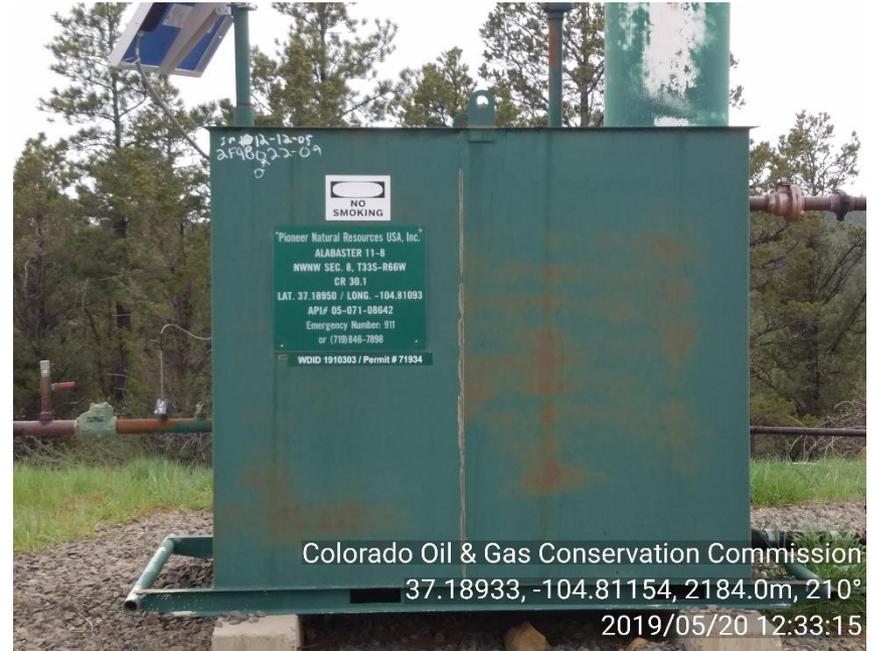
PHOTO 2: WELL SIGN DOES NOT DEPICT CURRENT OPERATOR. COMPLY WITH RULE 210. CA DATE 7/20/19

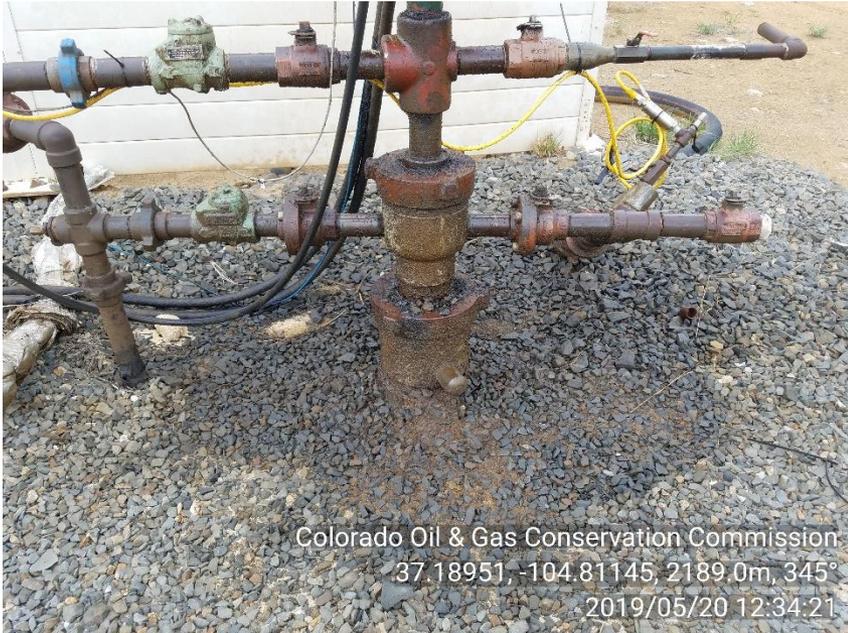
PHOTO 3: Hydraulic Stained soil at base of wellhead approx 6'x 3'. Securely fasten all valves, pipes, and fittings to ensure good mechanical condition, inspect at regular intervals and maintain in good mechanical condition per Rule 605.d. Remove or remediate stained soil. Ca date 6/20/19

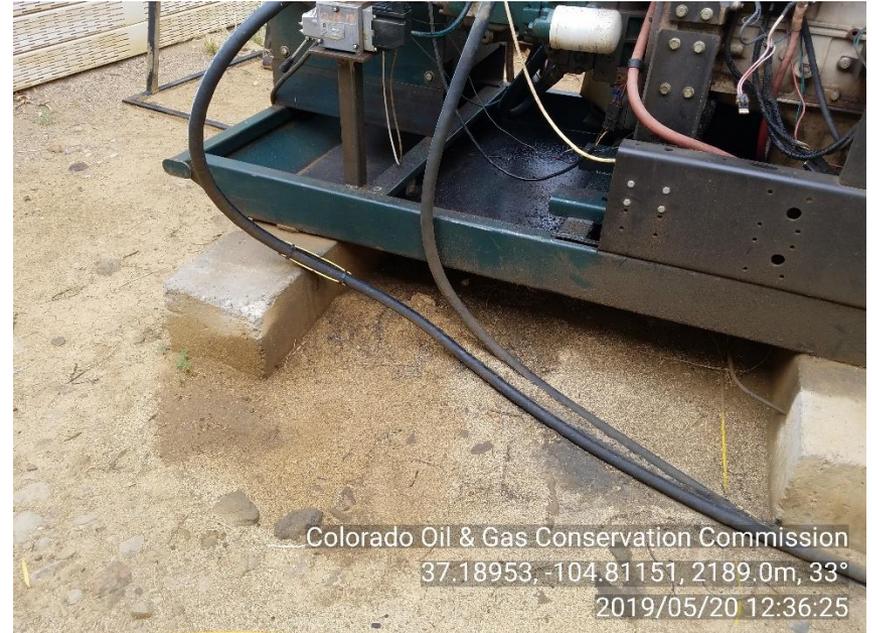
PHOTO 4: Engine skid stained soil around skid. Securely fasten all valves, pipes, and fittings to ensure good mechanical condition, inspect at regular intervals and maintain in good mechanical condition per Rule 605.d. Remove or remediate stained soil. Ca date 6/20/19

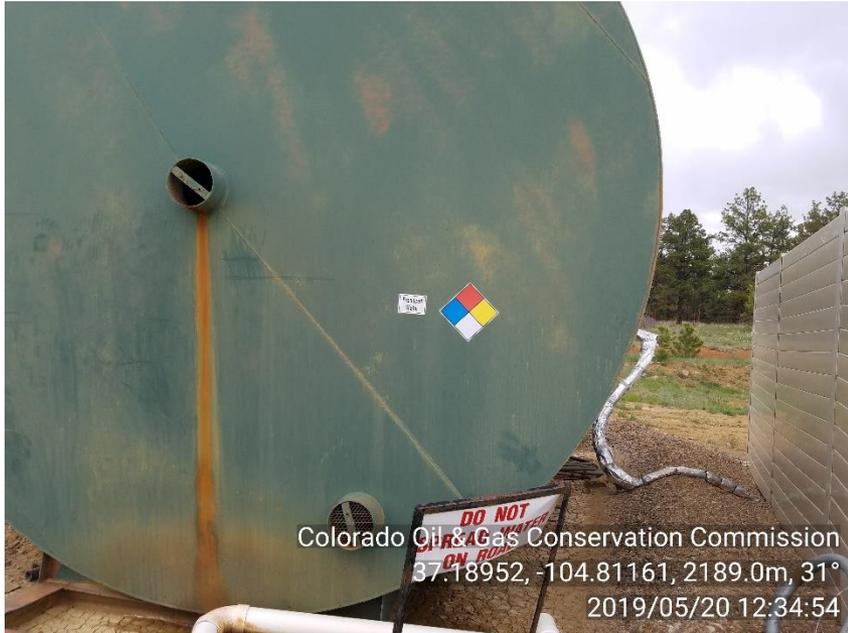
PHOTO 5: Sign or label not posted or information inaccurate on tanks or containers or sign/label too small to read at distance or installed in place where not visible. No capacity posted NFPA sign has no numbers. **Install sign to comply with Rule 210.d. ca date 7/20/19**
