Construction and Stormwater Inspection

Operator: EXTRACTION OIL & GAS INC - #10459

Location ID: 456769

Inspection Photos
Location Name: NORTHWEST A PAD
Location ID: 456769

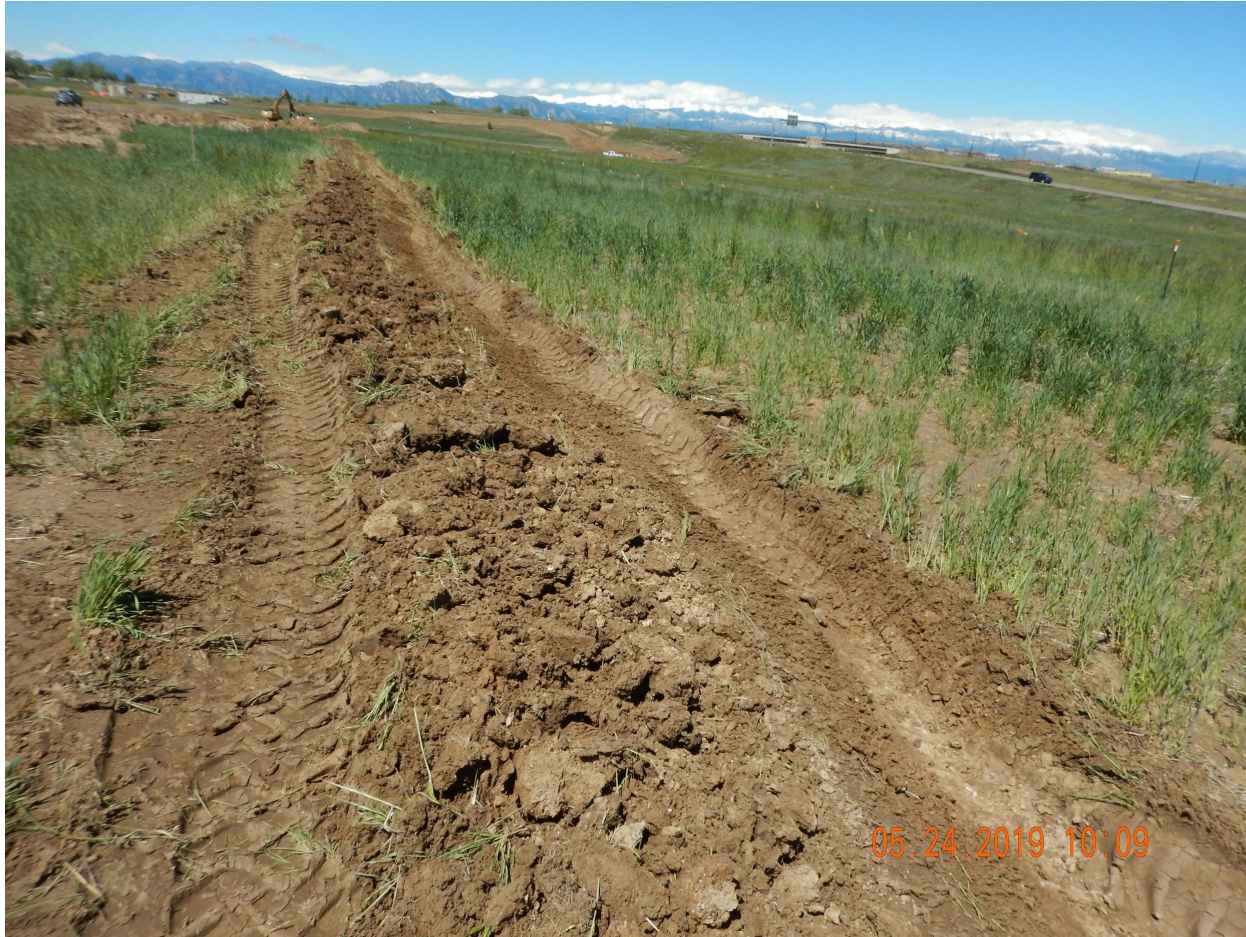
Photo 1. Photo taken from the southwestern perimeter of the location, facing West. A berm BMP has been installed around the perimeter of the location but it has not been installed with good engineering practices. The berm BMP has not been stabilized. Note: Other disturbances in the foreground are not associated with oil and gas operations.

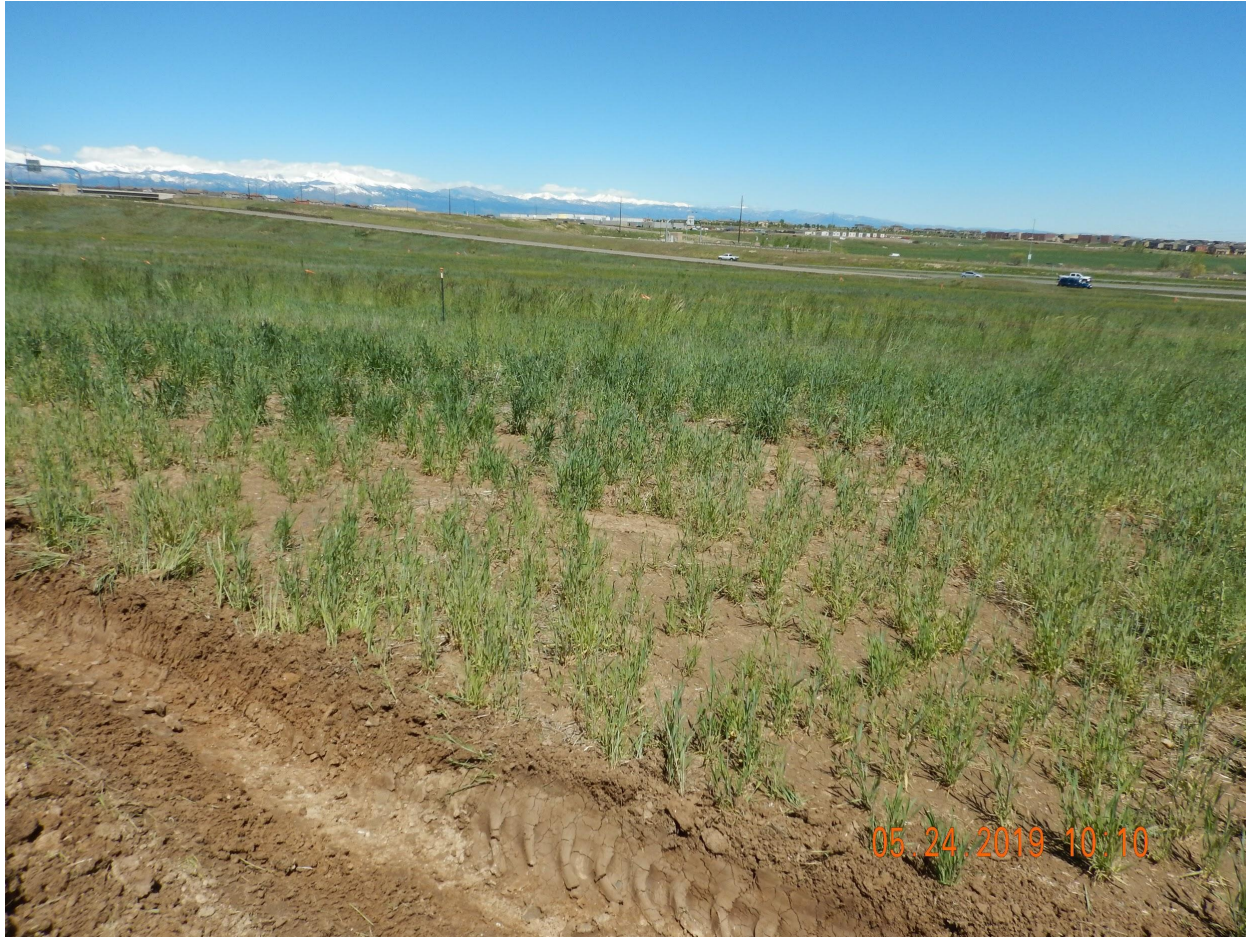
Photo 2. Photo taken from the southwestern perimeter of the location, facing Northwest. Operator has only initiated stormwater implementation and has not yet started topsoil salvage operations.
