Inspection Photos  
Location Name: THE PRIMUS 43-34  
API #: 05-071-08755  
INSP. #:695100721

Location Name: THE PRIMUS 43-34

API #: 05-071-08755

INSP. #:695100721

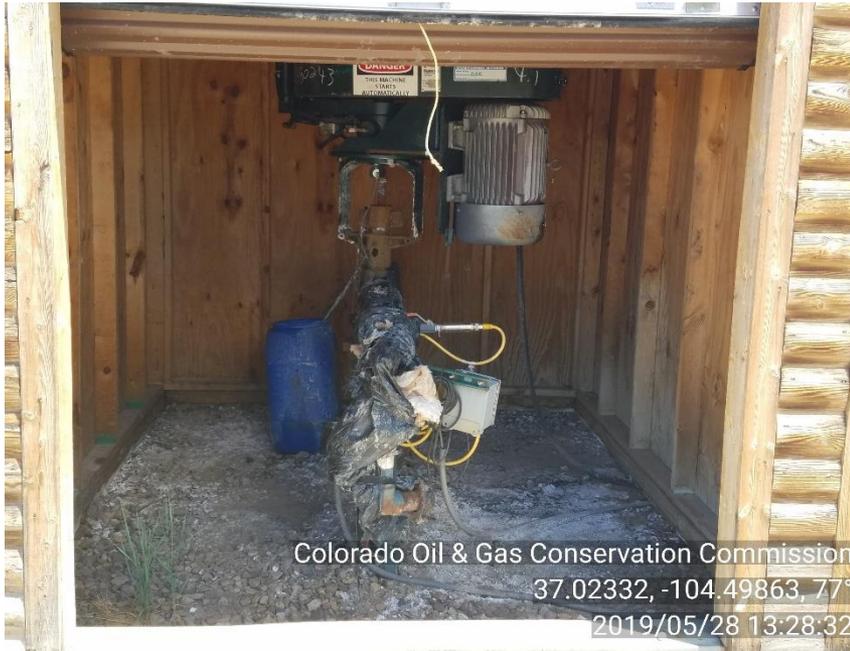
**PHOTO 1: WELLHEAD**

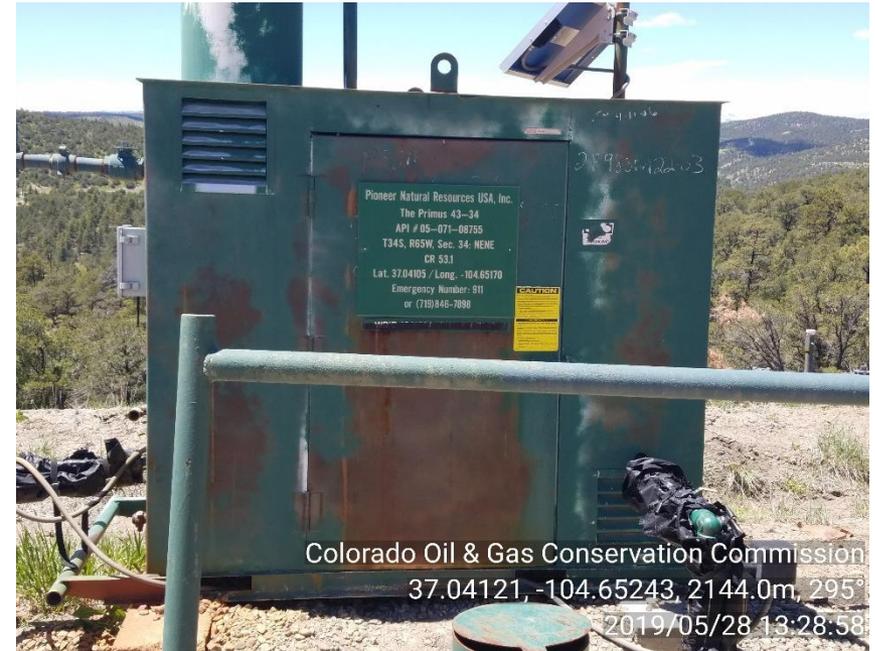
**PHOTO 2: CURRENT OPERATOR NOT POSTED ON WELL SIGN.  
CHANGE OPERATOR NAME TO CURRENT OPERATOR IN  
ACCORDANCE WITH RULE 210. CA DATE 7/28/19**

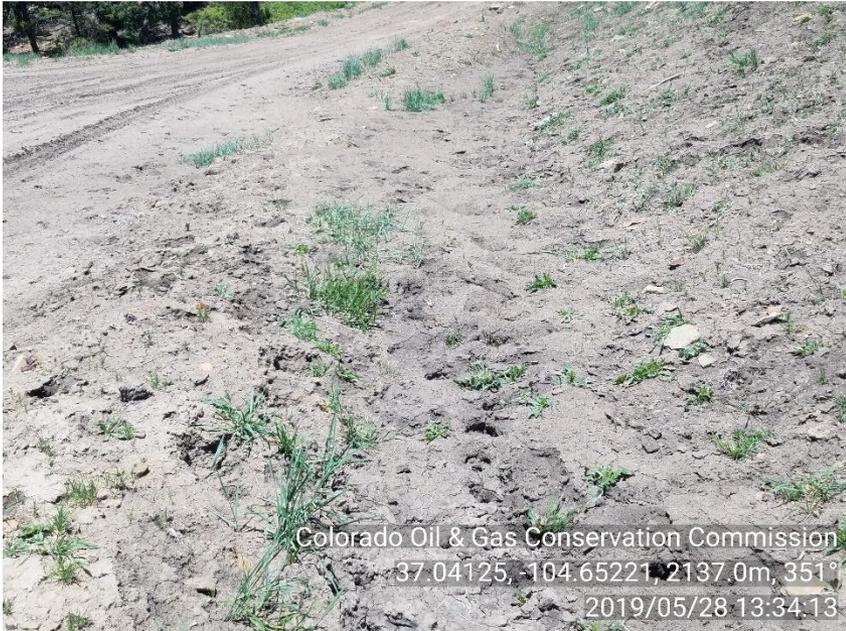
**PHOTO 3: RUN ON BMP NEAR ENTRANCE OF LOCATION IS FULL OF SEDIMENT. CLEAN SEDIMENT AND INSPECT BMP'S IN ACCORDANCE WITH 1002 RUL SERIES. CA DATE 6/28/19**
