# Final Reclamation Inspection

Operator: KERR MCGEE OIL & GAS ONSHORE LP #47120

Location ID: 330815

Inspection Photos  
Location Name: HSR PANORAMA #4-12  
Location ID: 330815

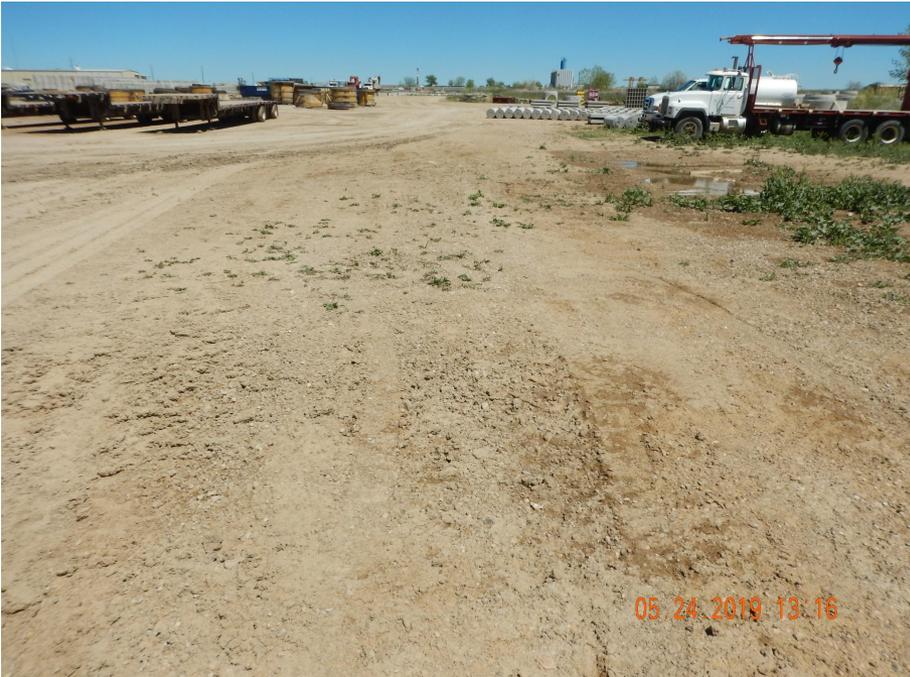
**Photo 1.** Photo taken from the well location, facing East. Unable to find evidence of oil and gas activities and/or disturbances. Well location is part of an active yard for a building company.

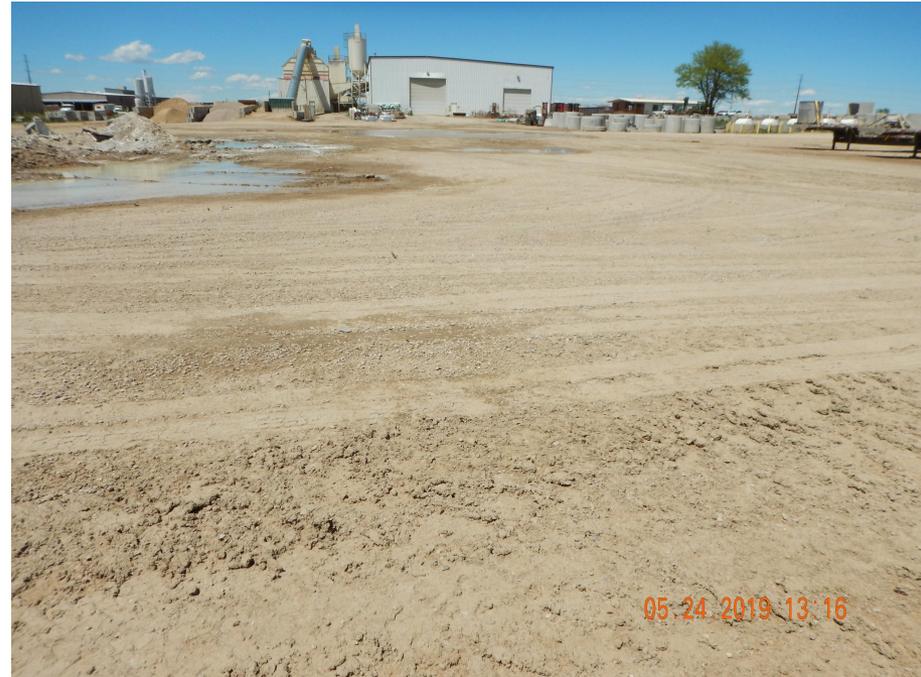
**Photo 2.** Photo taken from the well location, facing North. See comments under Photo 1.

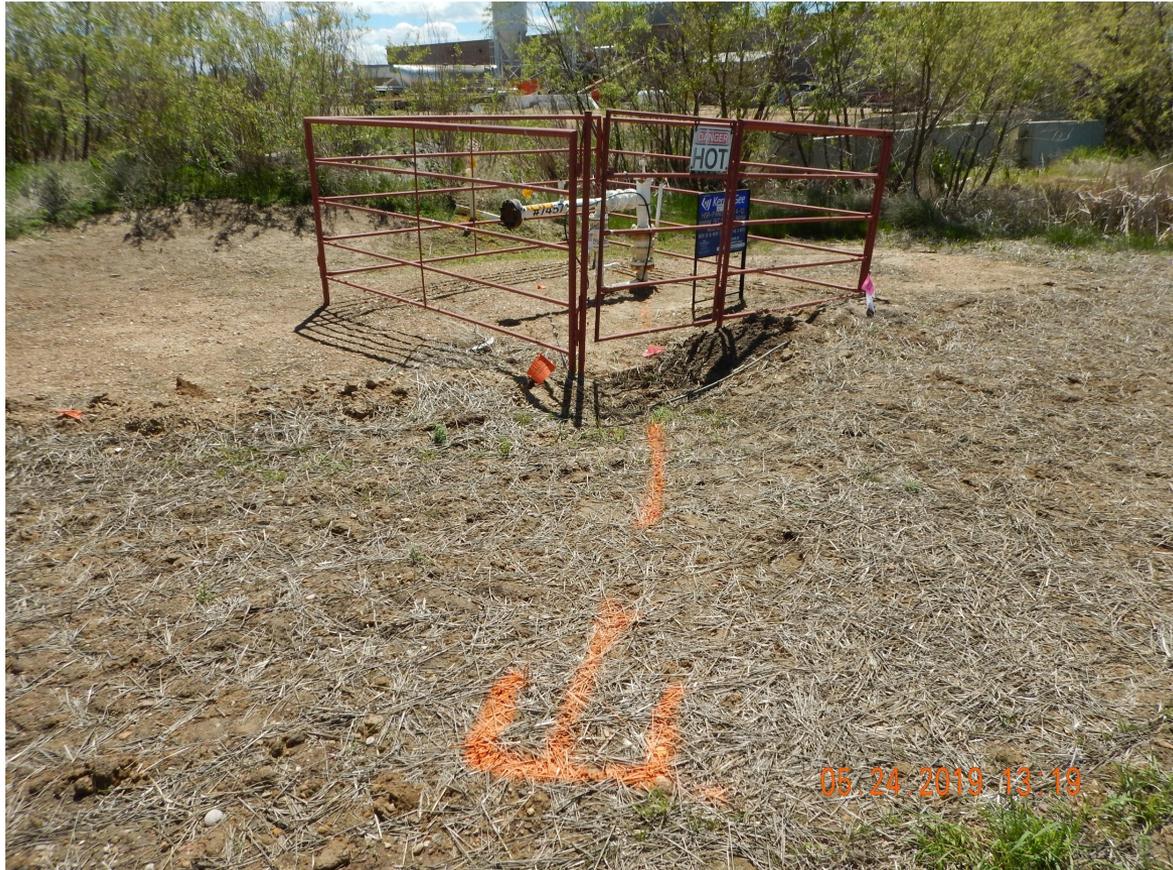
**Photo 3.** Photo taken from the southwest offsite tank battery location, facing South. Operator has failed to remove all equipment per Rule 1004.

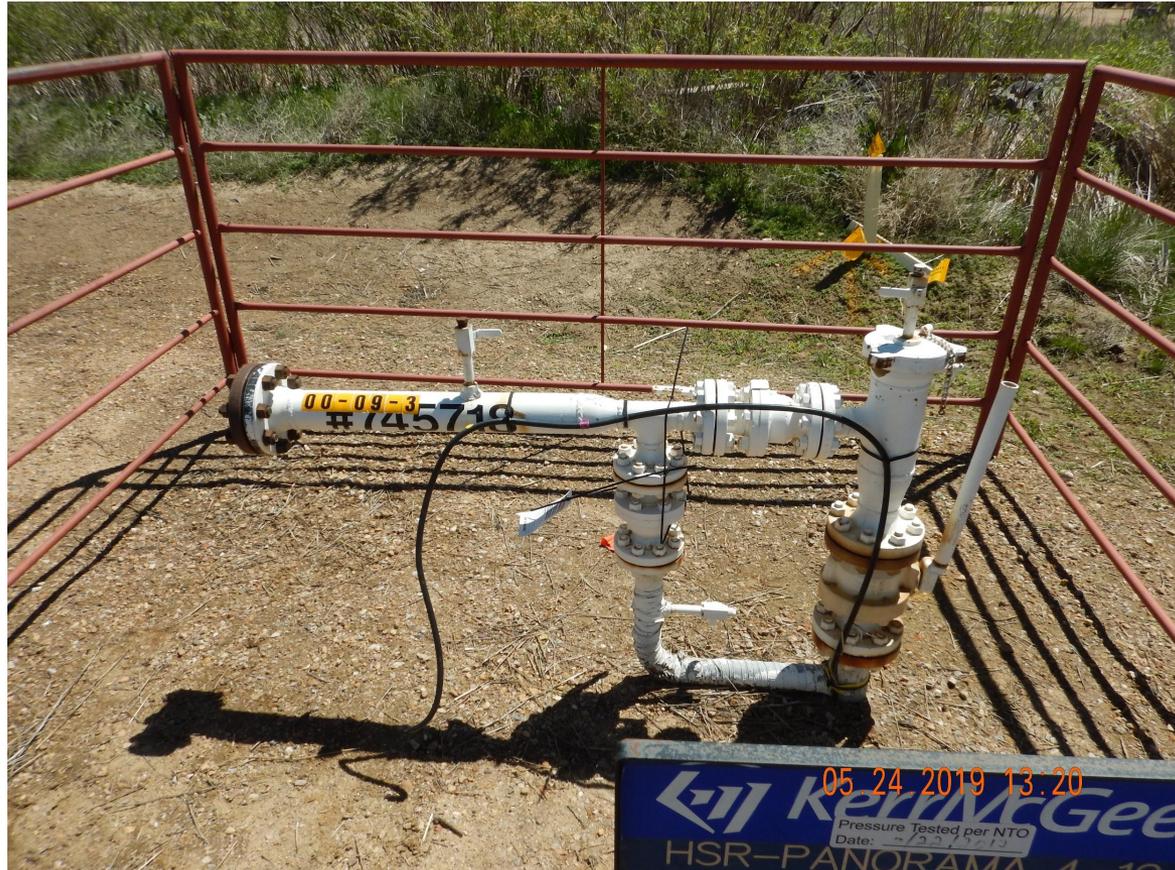
**Photo 4.** Photo taken of the equipment left at the tank battery location- see comments under Photo 3.

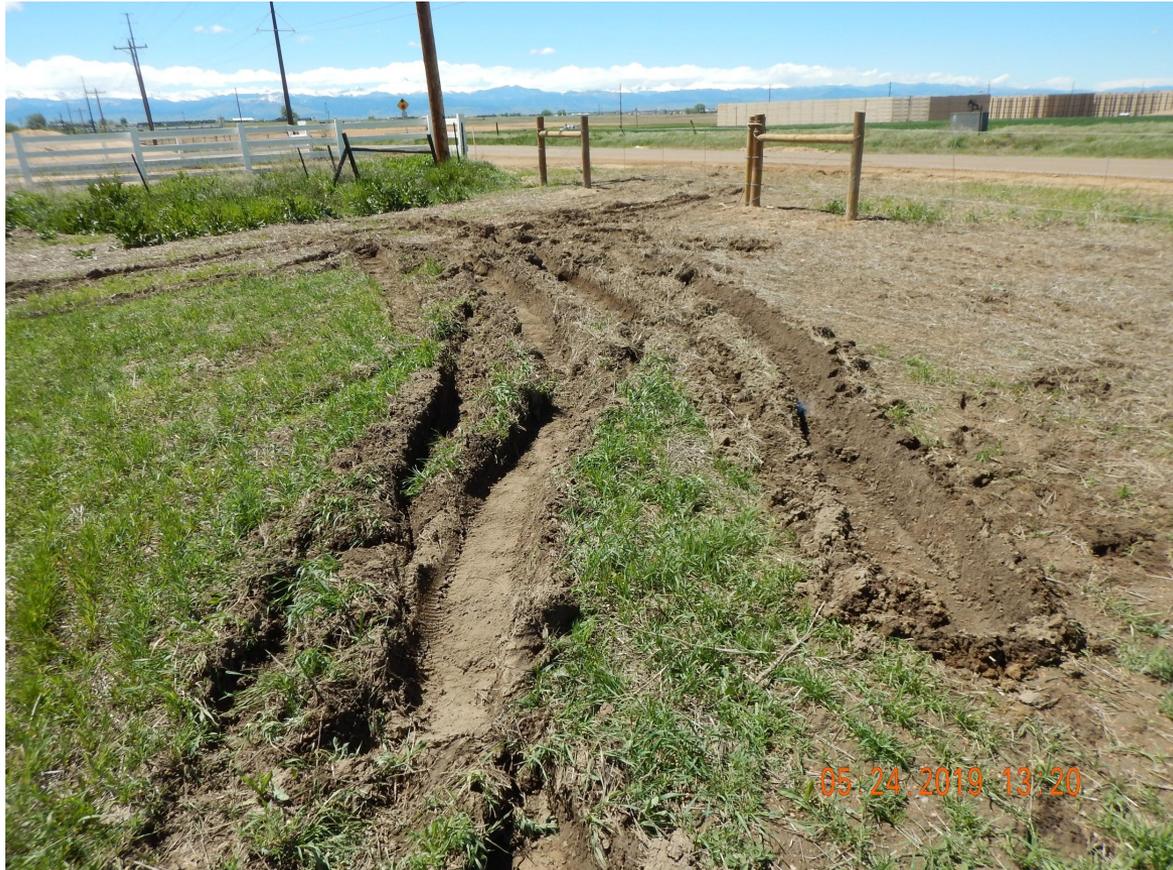
**Photo 5.** Photo taken from the western tank battery location, facing Northwest. Operator shall make repairs to ruts and any other associated disturbance when removing the remaining equipment.
