Final Reclamation Inspection

Operator: KERR MCGEE OIL & GAS ONSHORE LP #47120

Location ID: 318702

Inspection Photos
Location Name: Cochran USX UU #11-8
Location ID: 318702

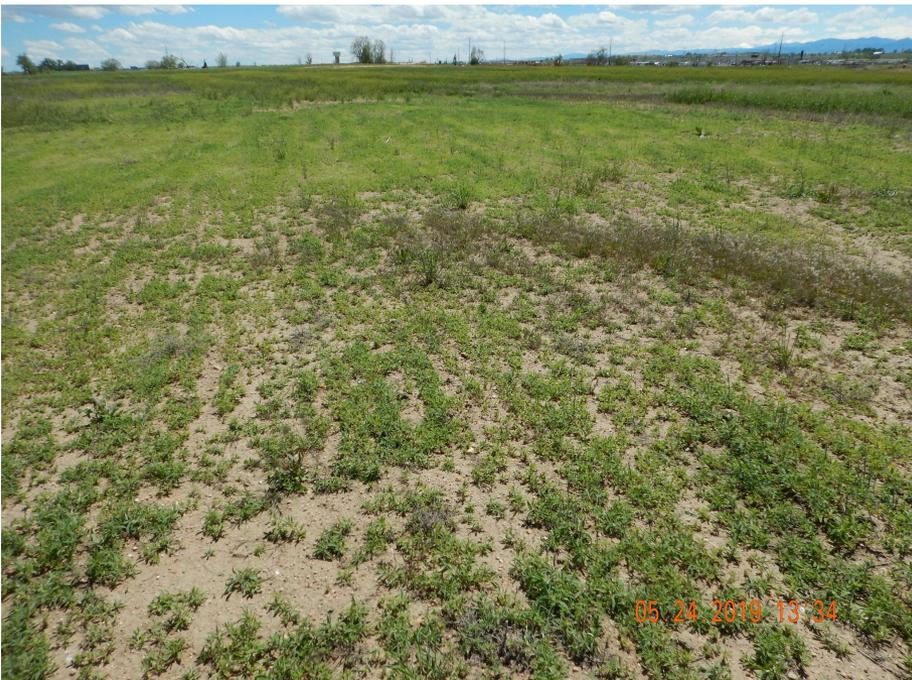
Photo 1. Photo taken from the well/facility location, facing East. This location is not in compliance with Rule 1004 vegetative standards. Location is dominated by weedy, annual vegetation (Kochia).

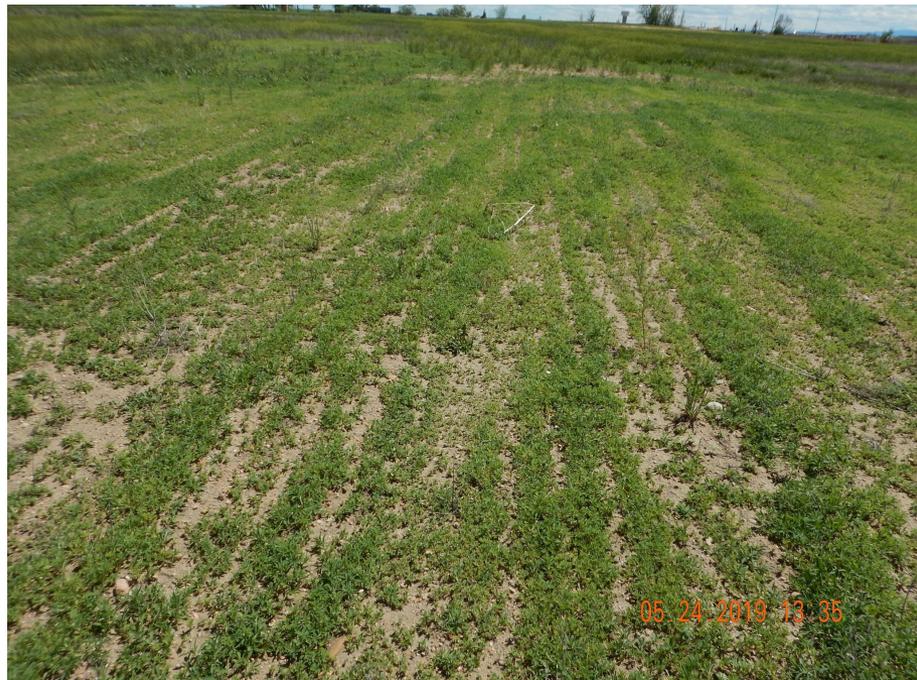
Photo 2. Photo taken from the well/facility location, facing South. See comments under Photo 1.

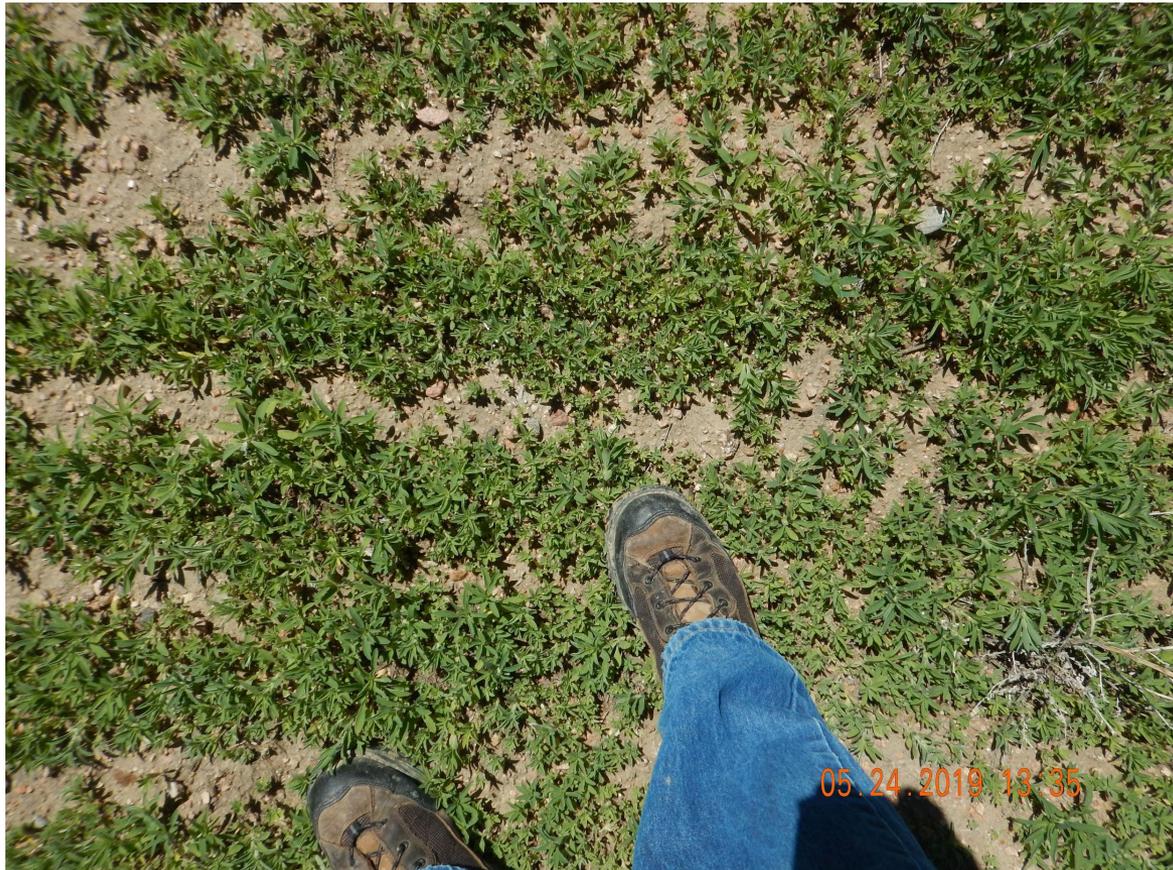
Photo 3. Close up photo of weedy, annual vegetation (Kochia).

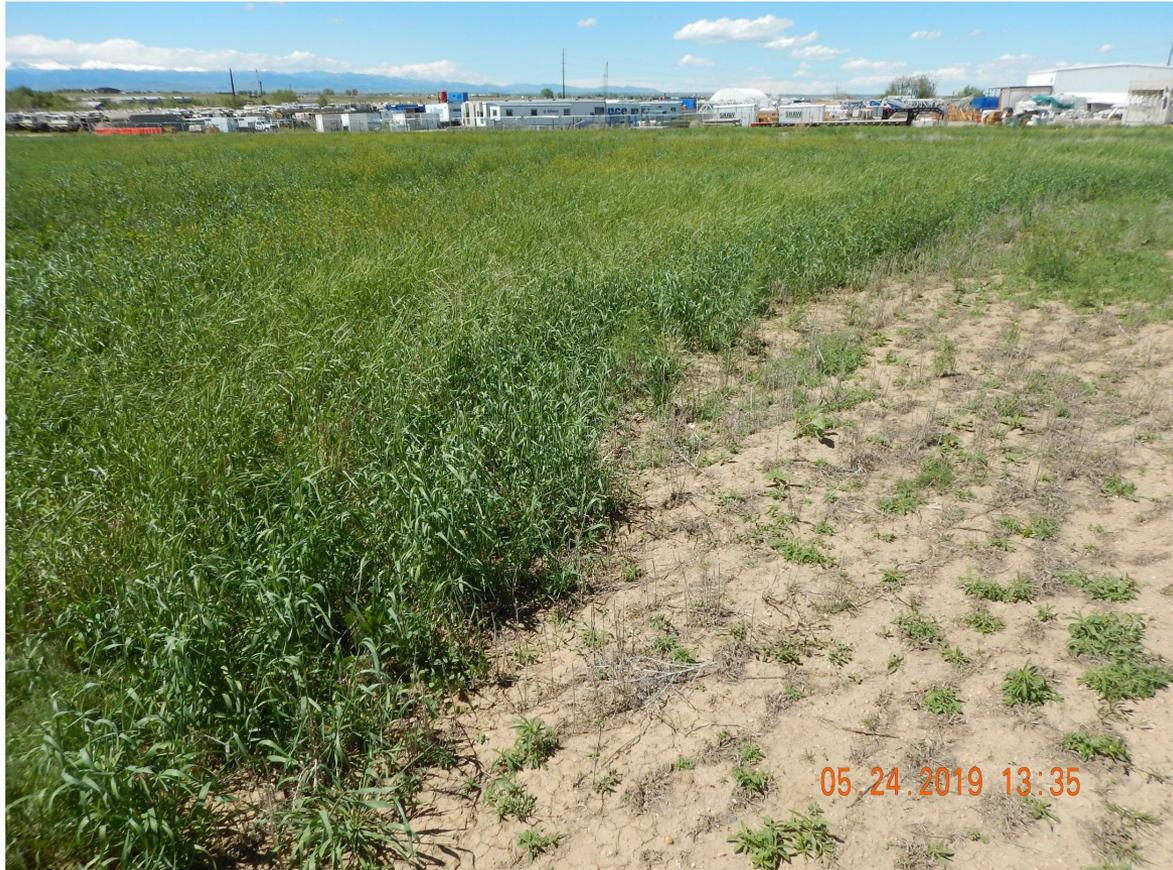
Photo 4. Photo taken from the western well/facility location, facing Northwest. Photo illustrates reference area vegetative conditions which is not reflective of disturbance areas.

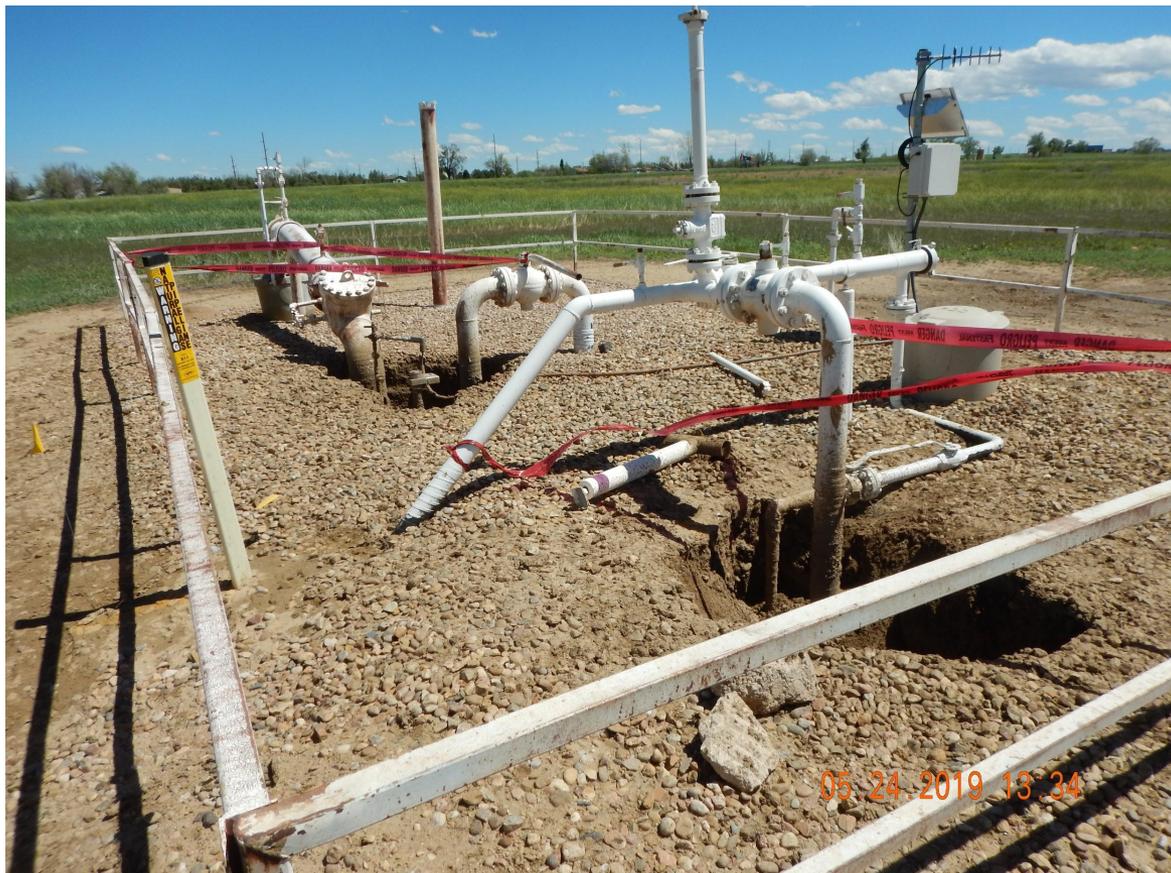
Photo 5. Photo taken from the northeastern well/facility location, facing East. Operator has failed to remove equipment from location.
