Inspection Photos
Operator: BP America
Location/API #: 067-09822
Date: 5-23-2319

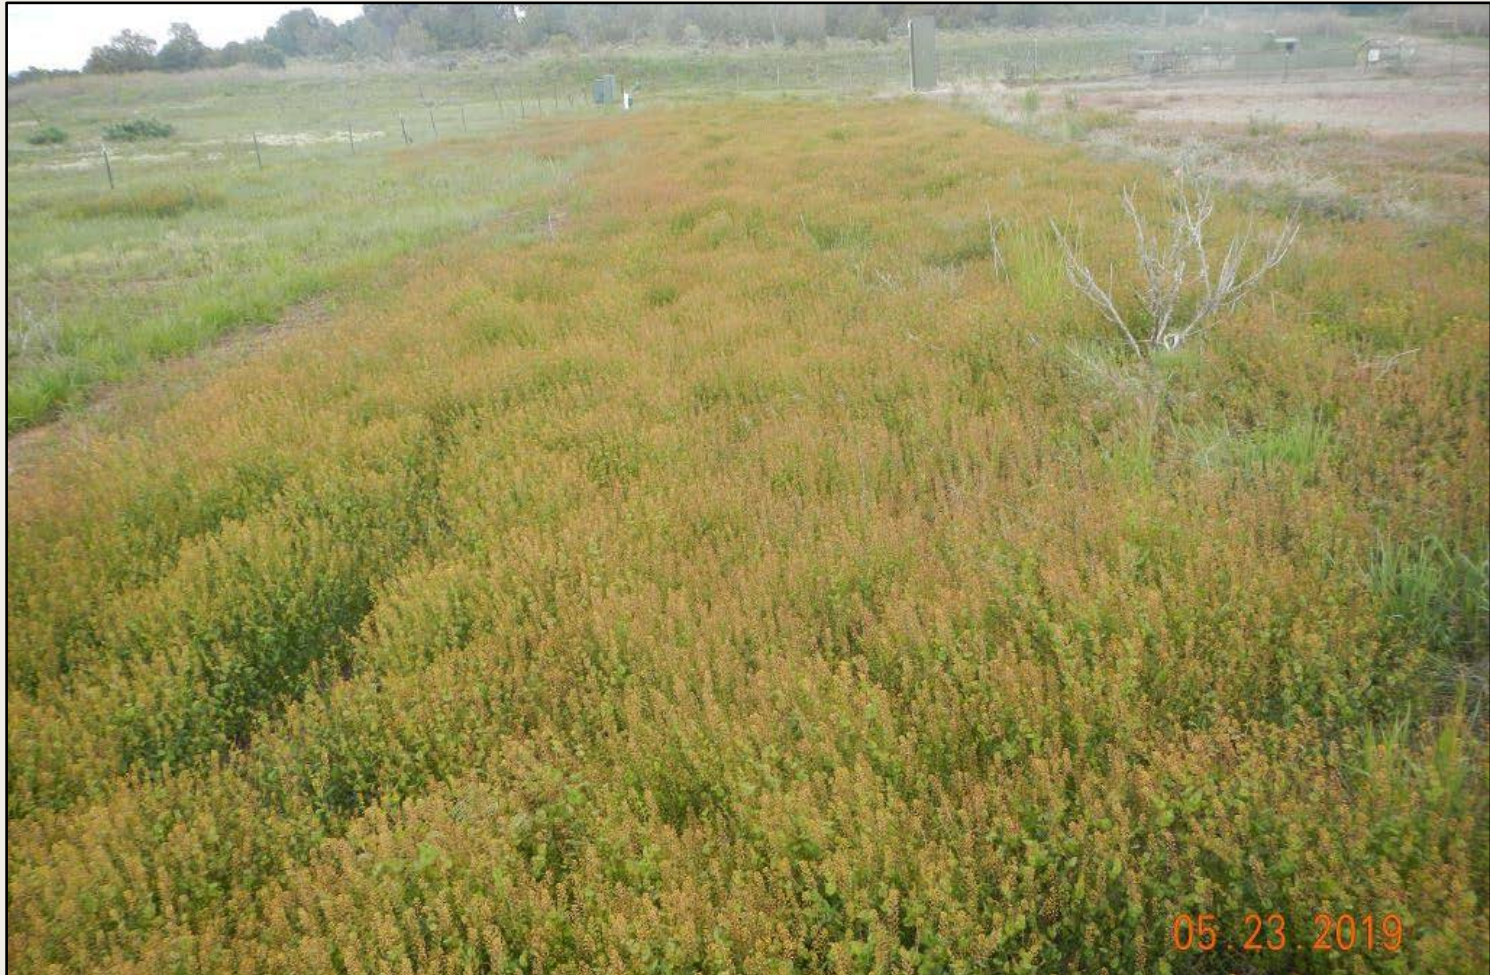
Photo 1. View of the northern project area from the northwestern corner facing eastward. Vegetation is dominated by a dense population of claspig pepperweed (*Lepidium perfoliatum*) that is competing with desirable vegetation established and needs to be controlled.

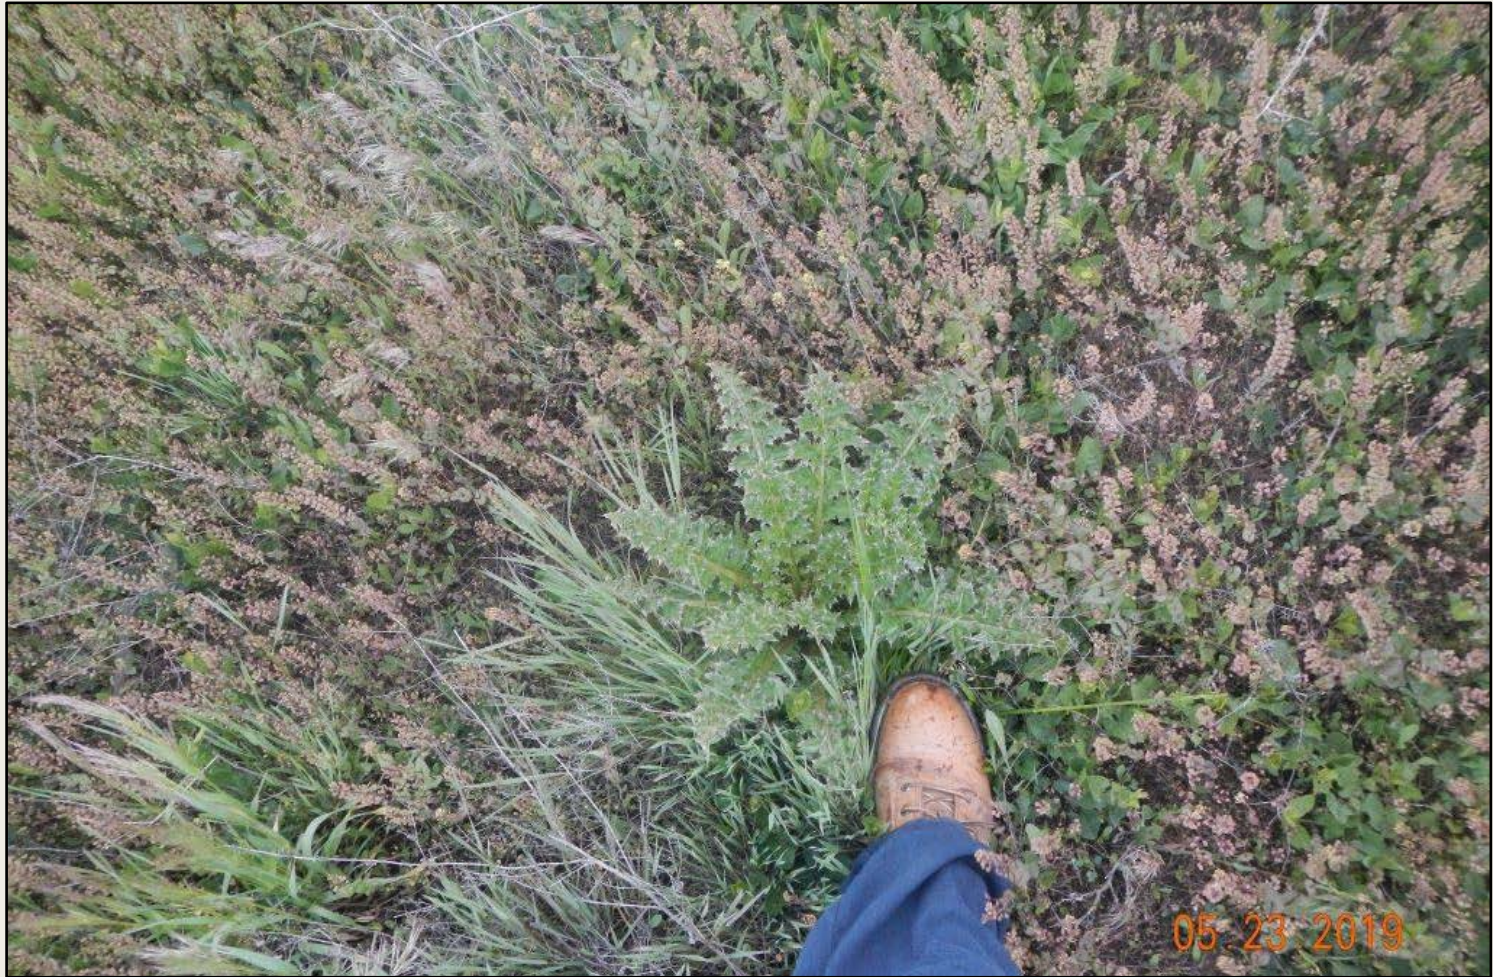
Photo 2. View of musk thistle (*Carduus nutans*) within the interim reclamation area.
