Inspection Photos
Location Name: LITTLE JOE 32-26
API #: 05-071-07871
INSP. #:695100731

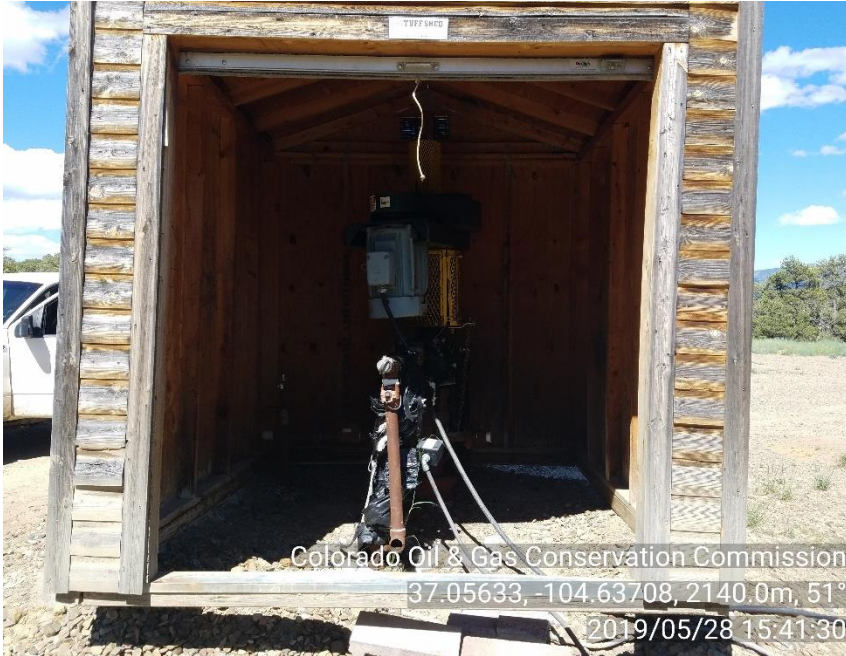
PHOTO 1: WELLHEAD

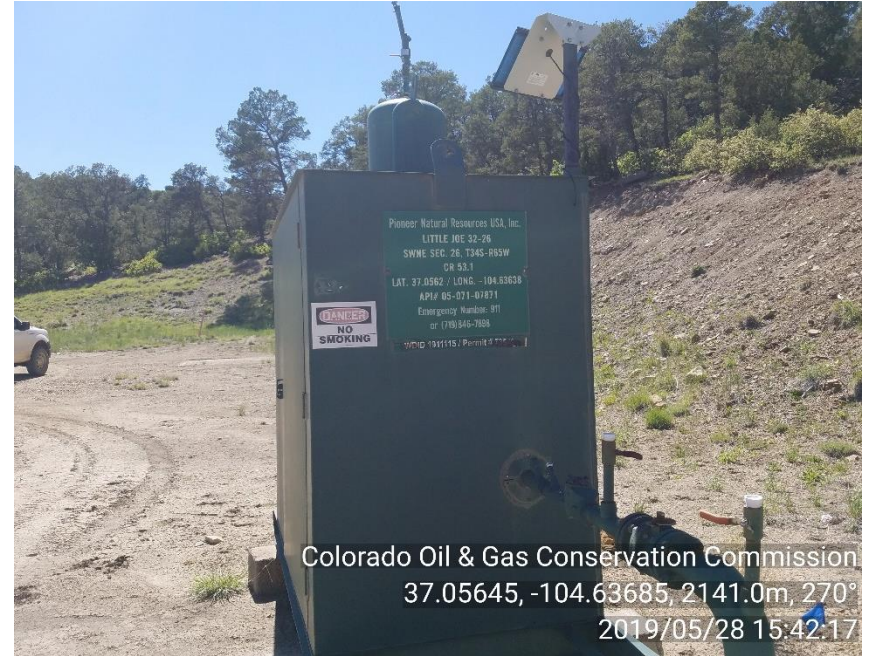
PHOTO 2: CURRENT OPERATOR NOT POSTED ON WELL SIGN.
CHANGE OPERATOR NAME TO CURRENT OPERATOR IN
ACCORDANCE WITH RULE 210. CA DATE 7/28/19

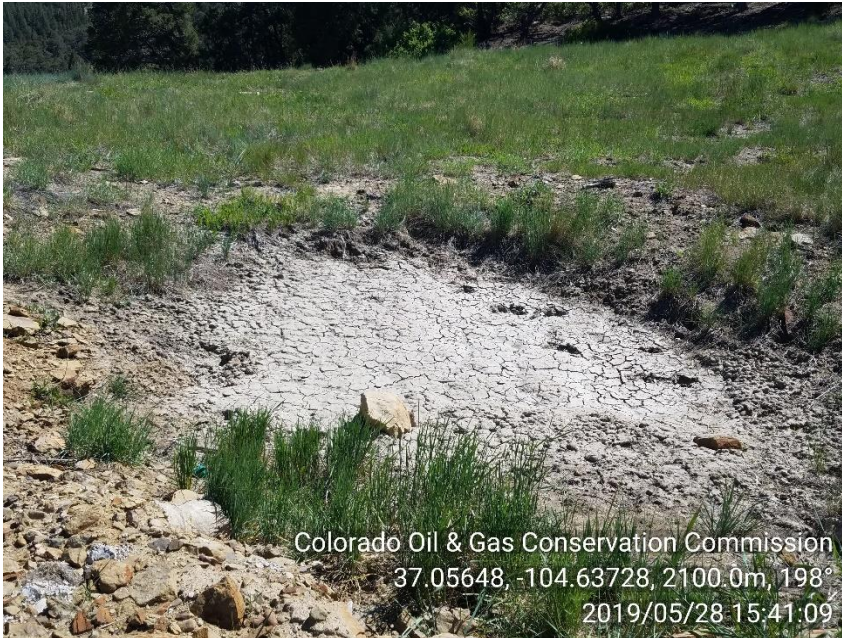
PHOTO 3: PIT APPEARS TO BE INADEQUATE TO MAINTAIN A 2' FREEBOARD. RECLAIM OR DEEPEN PIT TO MAINTAIN 2' FREEBOARD WHILE IN USE IN ACCORDANCE WITH 902 SERIES RULES. 7/28/19.
