Inspection Photos
Location Name: OSTRICH 12-5
API #: 05-071-06828
INSP. #:695100780

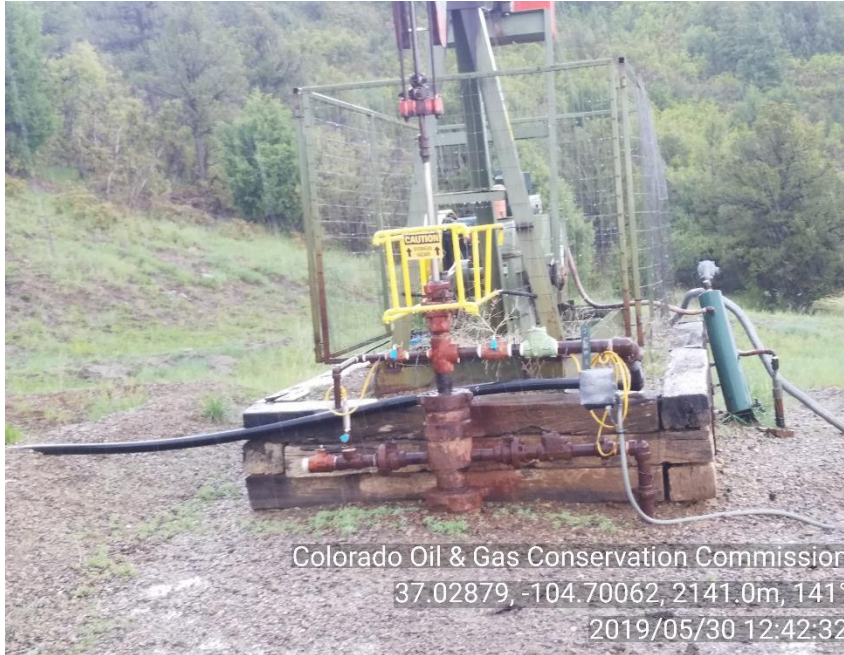
PHOTO 1: WELLHEAD

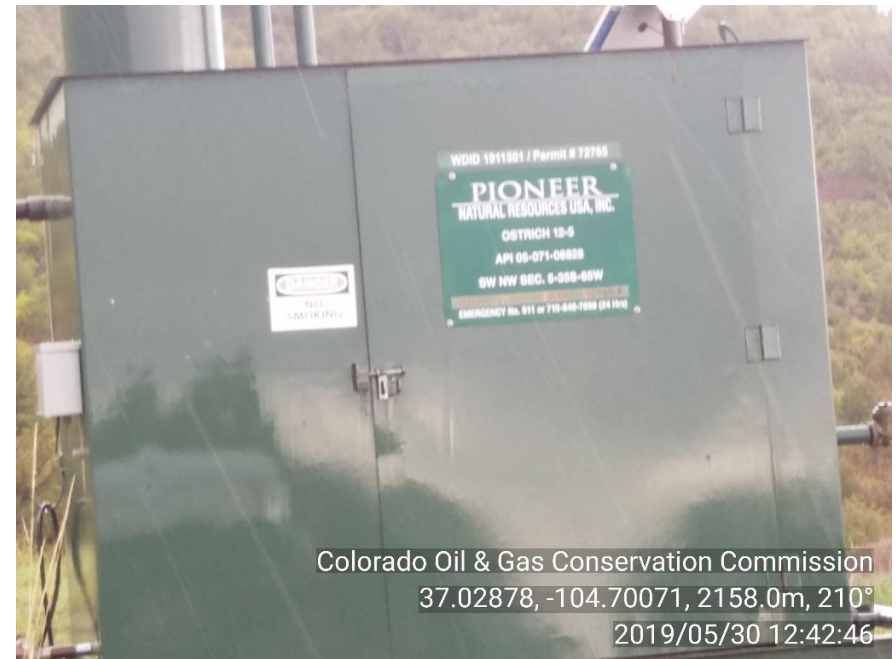
PHOTO 2: CURRENT OPERATOR NOT POSTED ON WELL SIGN.
CHANGE OPERATOR NAME TO CURRENT OPERATOR IN
ACCORDANCE WITH RULE 210. CA DATE 7/30/19

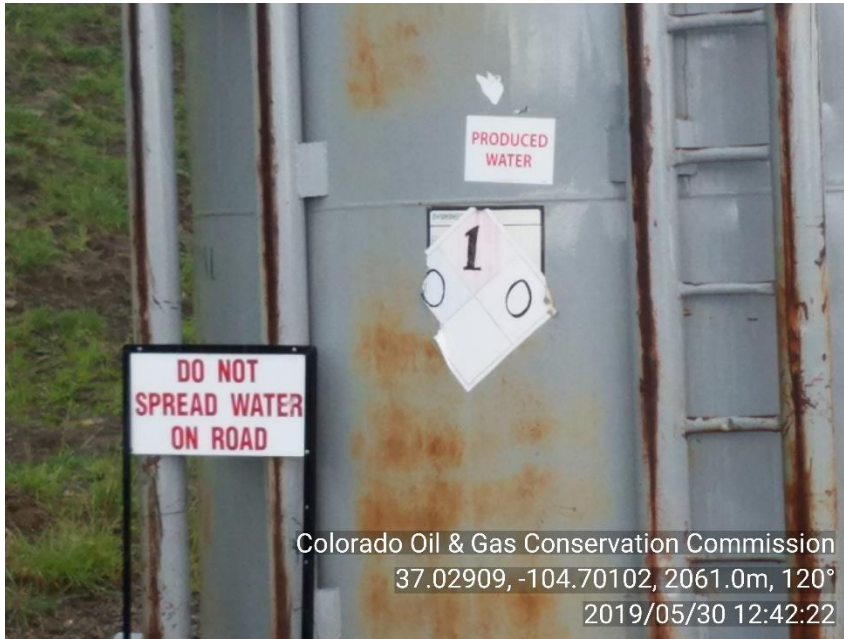
**PHOTO 3: NFPA STICKER ON PRODUCED WATER TANK IS
FADED AND WORN. REPLACE NFPA STICKER TO COMPLY
WITH 210 SERIES RULES. CA DATE 6/30/19**
