# Inspection Photos

Operator: FOUNDATION ENERGY  
MANAGEMENT LLC - 10112

Location ID: 331849

Inspection Doc. Number: 696200157  
Weld County, CO

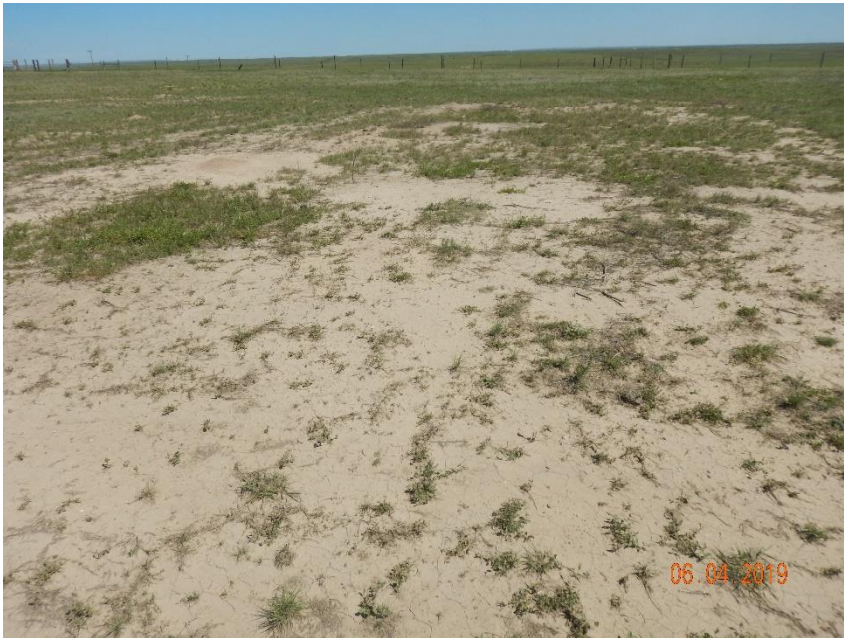
**Photo 1:** Photo taken from well location, facing north. Photo shows location remains predominantly bare and exposed soil. Unable to find evidence that additional reclamation has been conducted at the well site.

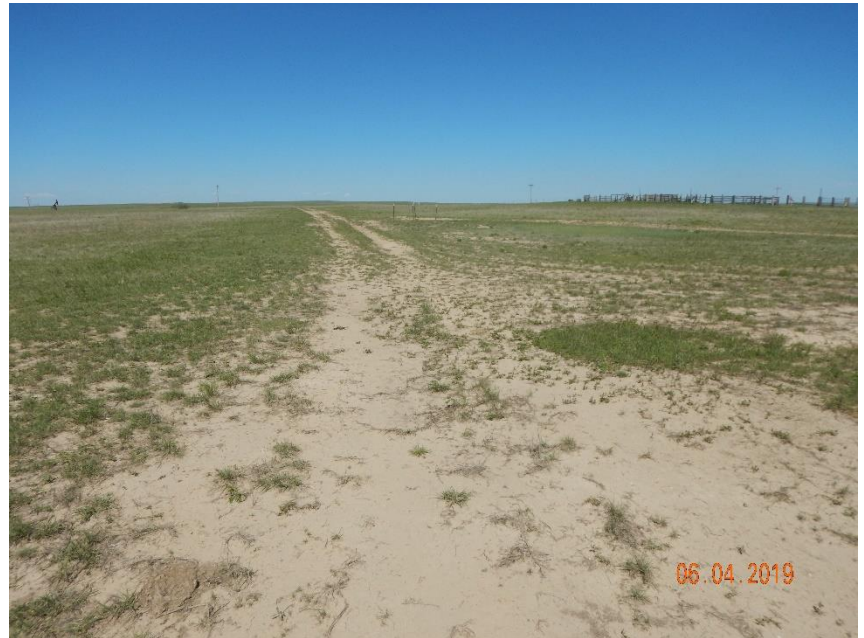
**Photo 2:** Photo taken from well location, facing west. Photo shows access road has not been reclaimed.

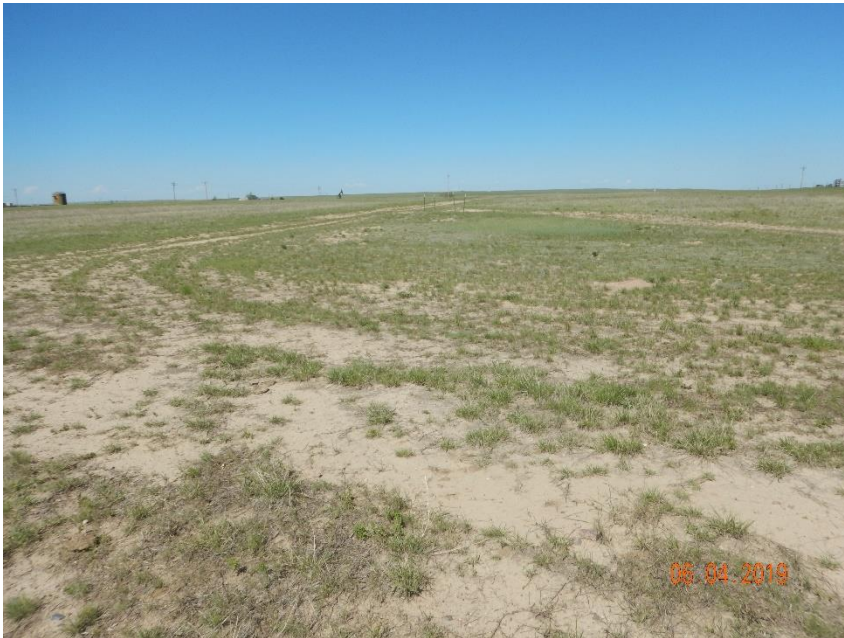
**Photo 3:** Photo taken from well location, facing west. Photo shows the access road “turn-around”. Photo shows access road has not been reclaimed.

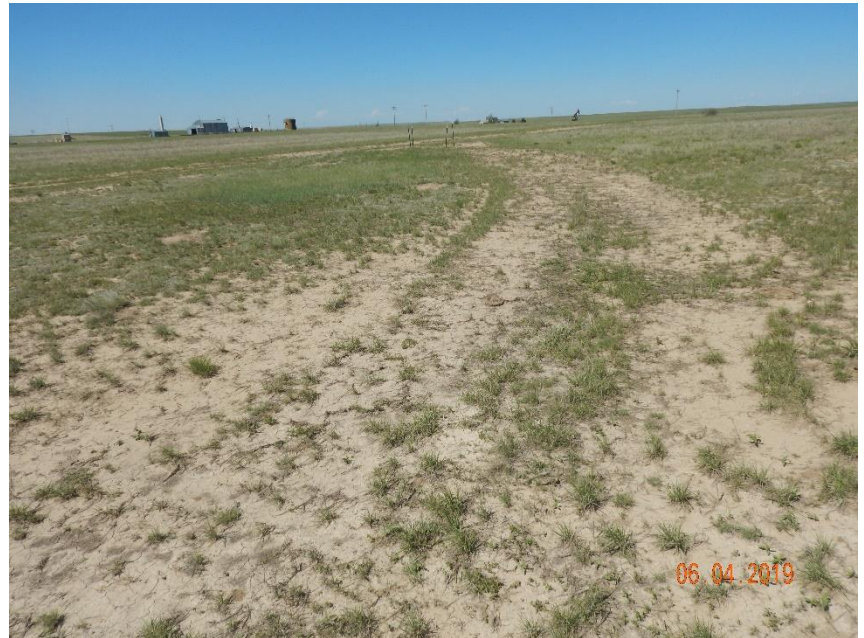
**Photo 4:** Photo taken from well location, facing west. Photo shows the access road “turn-around”. Photo shows access road has not been reclaimed.

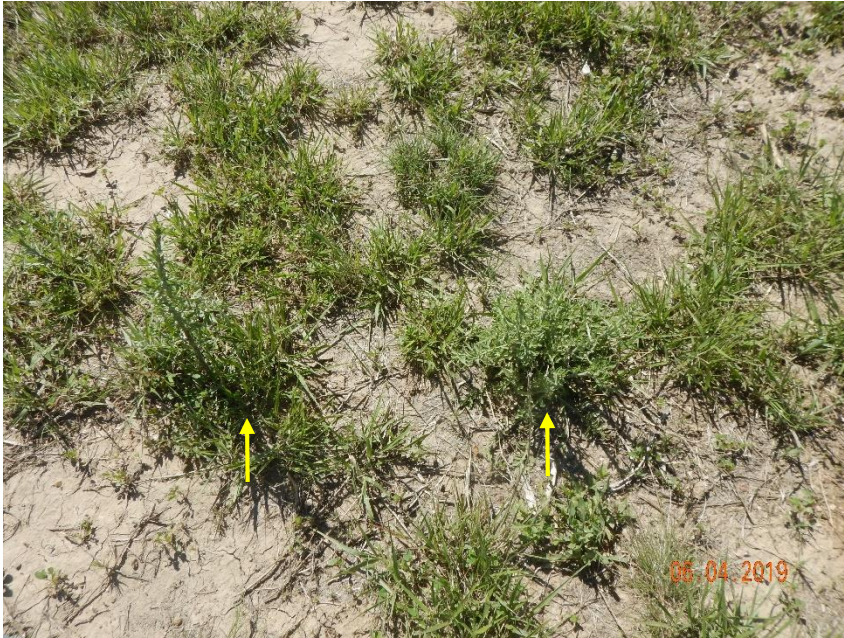
**Photo 5:** Photo taken from well location. Photo shows areas where Diffuse Knapweed is maturing and remains established on the location.

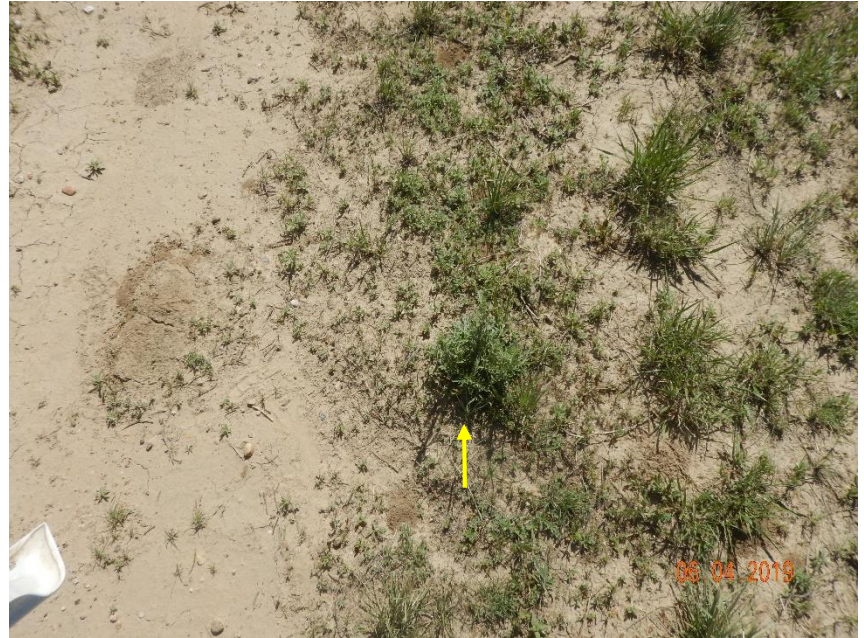
**Photo 6:** Photo taken from well location. Photo shows areas where Diffuse Knapweed is maturing and remains established along the access road.

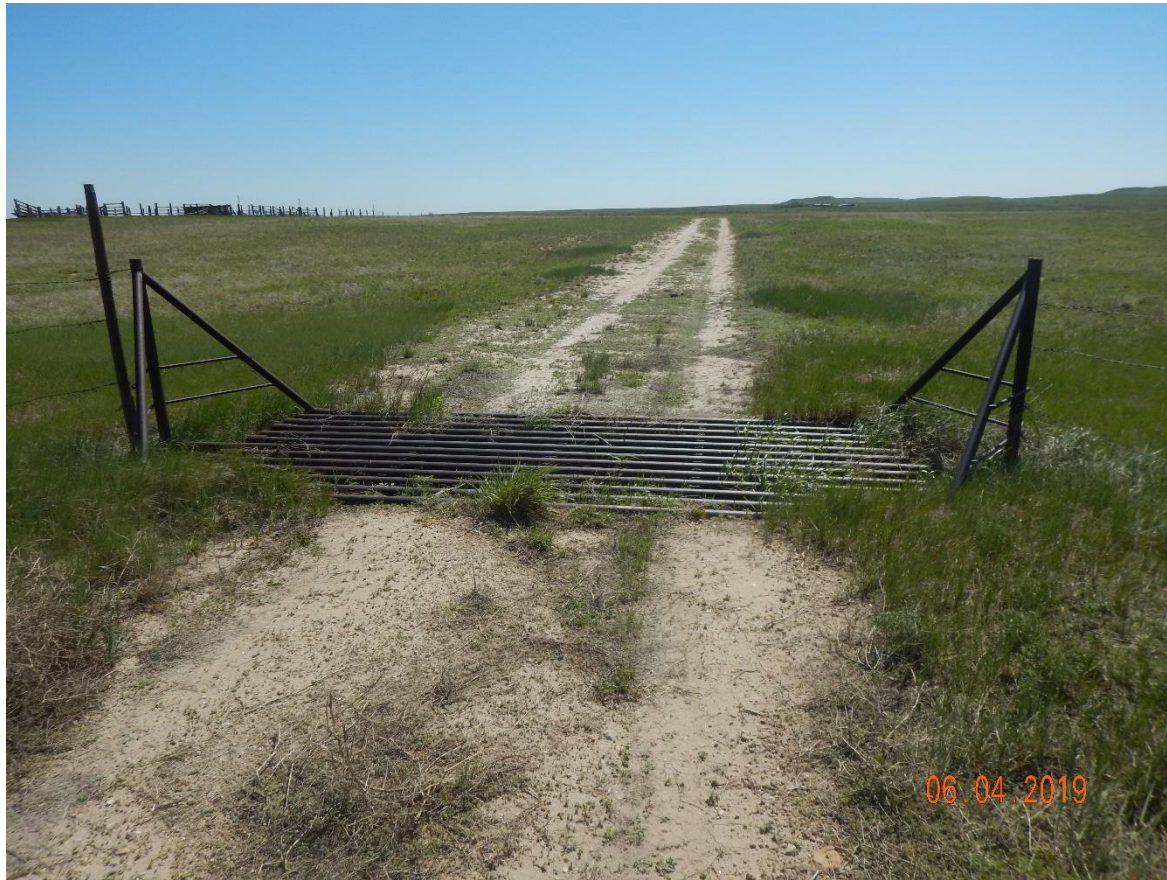
**Photo 7:** Photo taken from the access road entrance, facing east. Photo shows cattle guard remains. Photo also shows access road has not been reclaimed in accordance with COGCC 1000 series reclamation rules.
