# Inspection Photos

Operator: CRUMLEY\* JACK - 21750

Location ID: 403355

COGCC

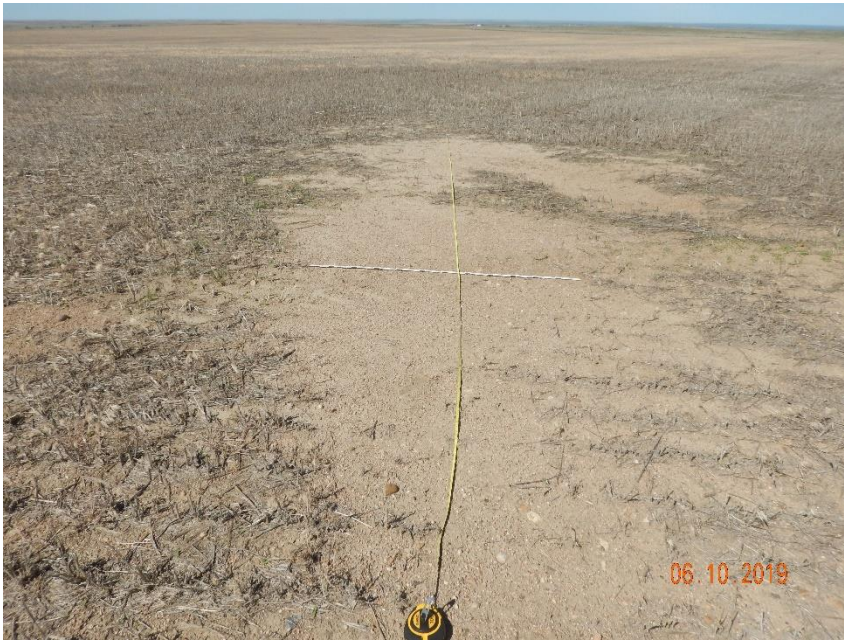
**Photo 1:** Photo taken from well location, facing west. Photo an area approximately 35' at its longest, and 10' at its widest, where vegetation does not appear to be establishing. Additional reclamation will likely be needed to facilitate crop establishment over the well location.

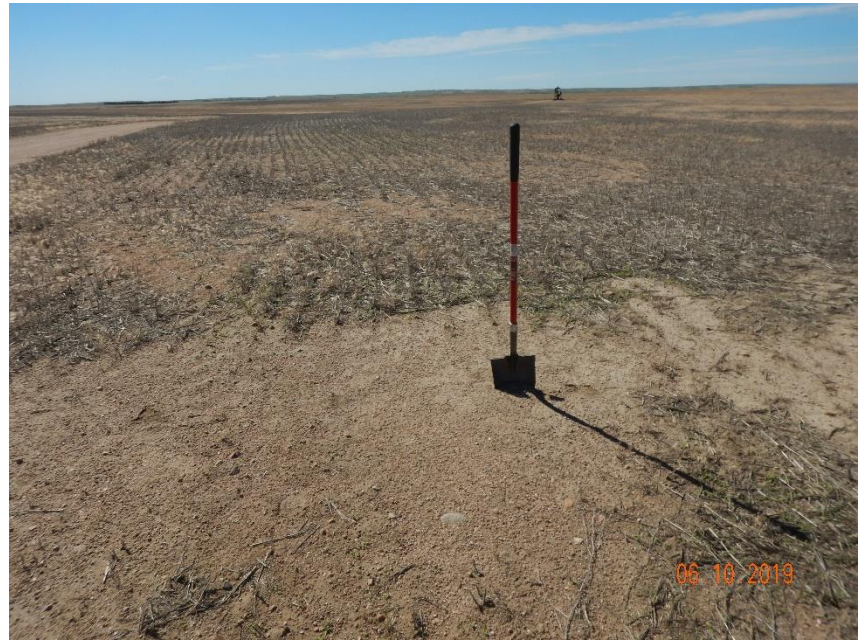
**Photo 2:** Photo taken from well location, facing west. Photo shows inspector was only able to easily penetrate the top few inches of soil on the location. Compaction concerns may exist.

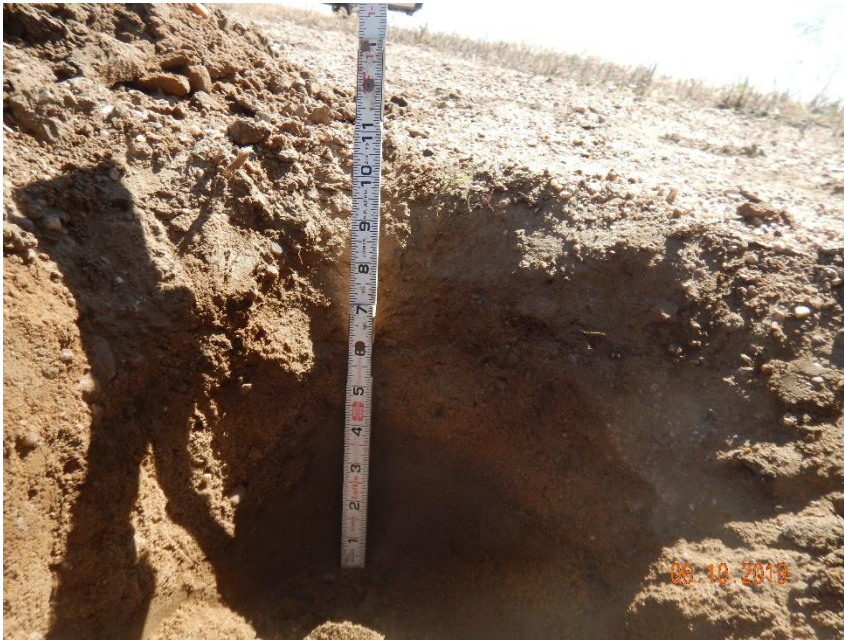
**Photo 3:** Photo shows inspector dug a compaction test pit. Photo shows possible compaction zone.

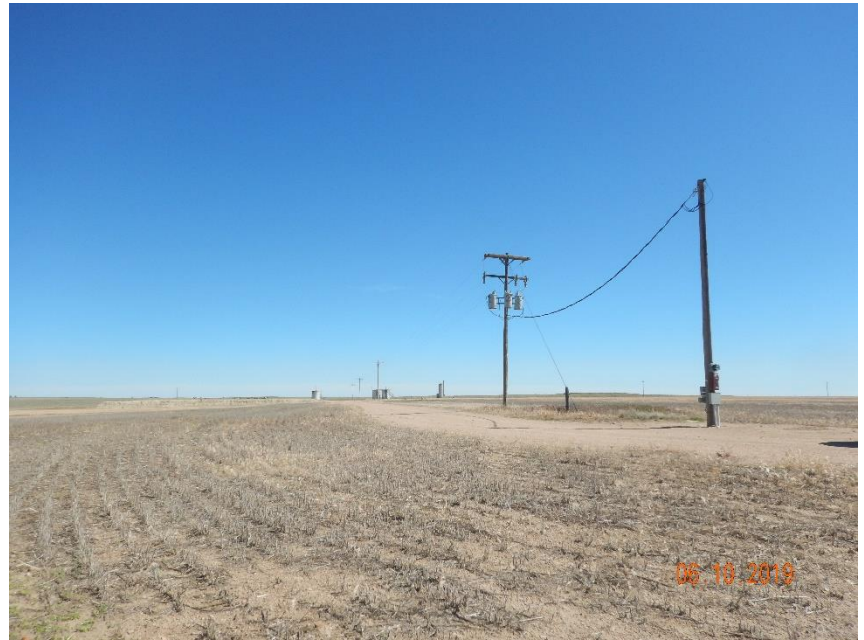
**Photo 4:** Photo taken from well location, facing north. Photo shows utility lines that end at the well location. Inspector confirmed with Impetrol Resources LLC that lines travel underground to the Ruth Walker 1, to the south
