Inspection Photos

06/10/2019

Operator: ADKINS OIL CO # 650

Location ID: 393754

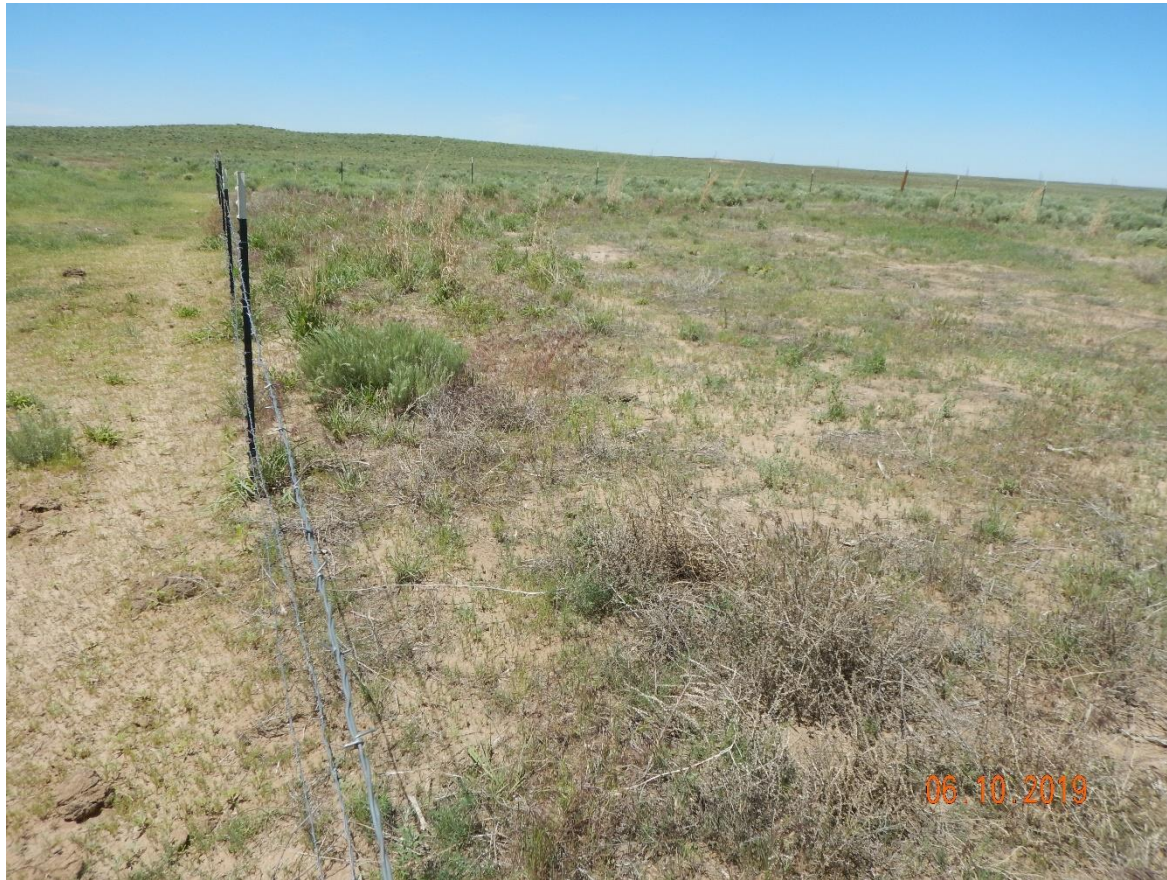
Photo 1: Photo taken from the southeast end of the location, facing west. Photos 1-2 provide an overview of the location.

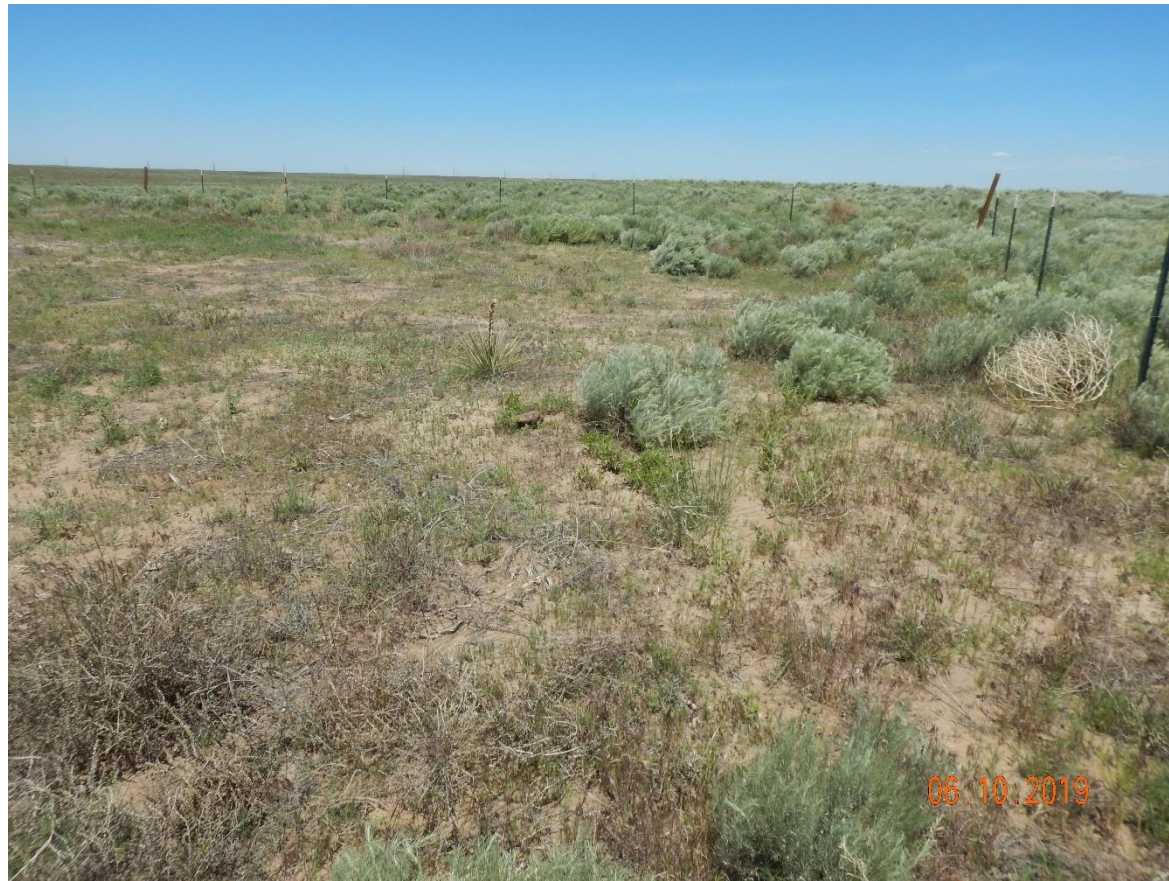
Photo 2: Photo taken from the southeast end of the location, facing north. Photos 1-2 provide an overview of the location.

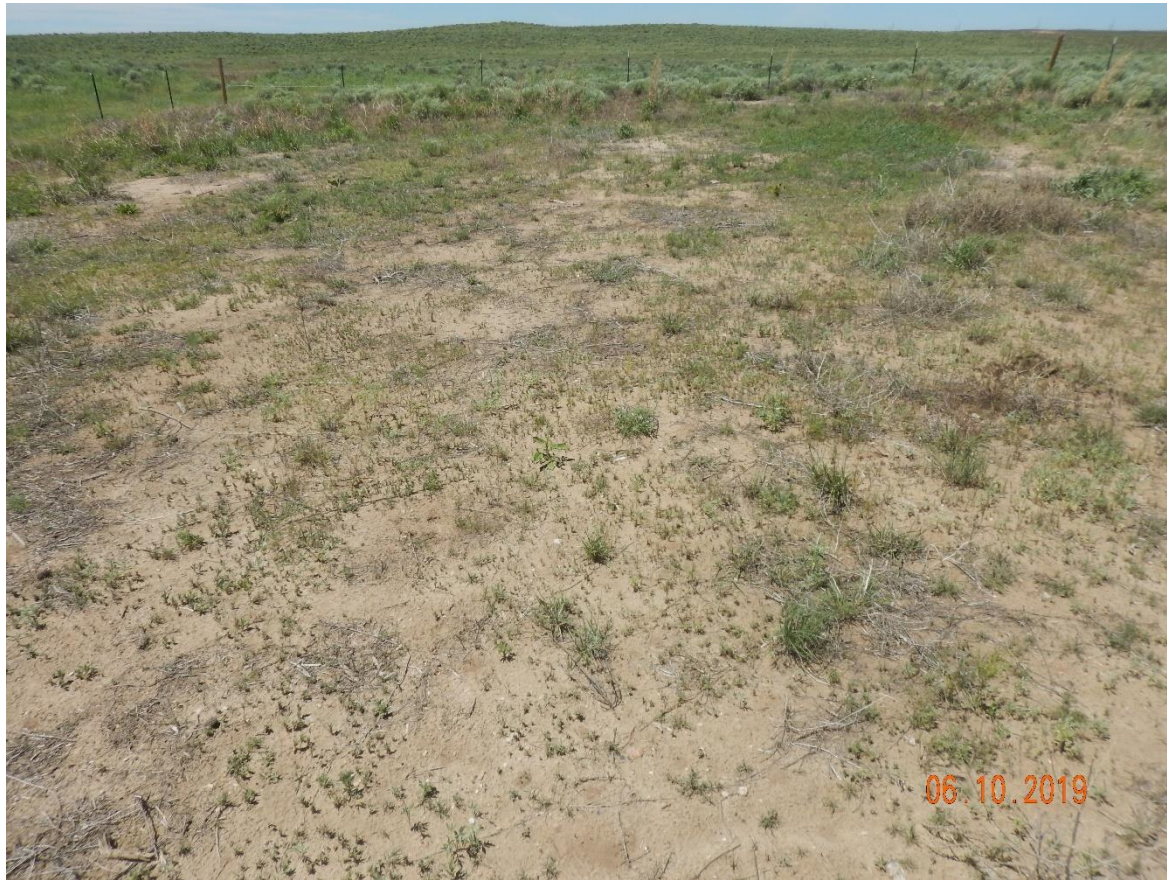
Photo 3: Photo taken from the east end of the location, facing west. Vegetation observed towards the central area of the location is predominantly undesirable weedy plant species. Little desirable vegetative establishment evident within these areas. Interseeding may be needed to facilitate reclamation.

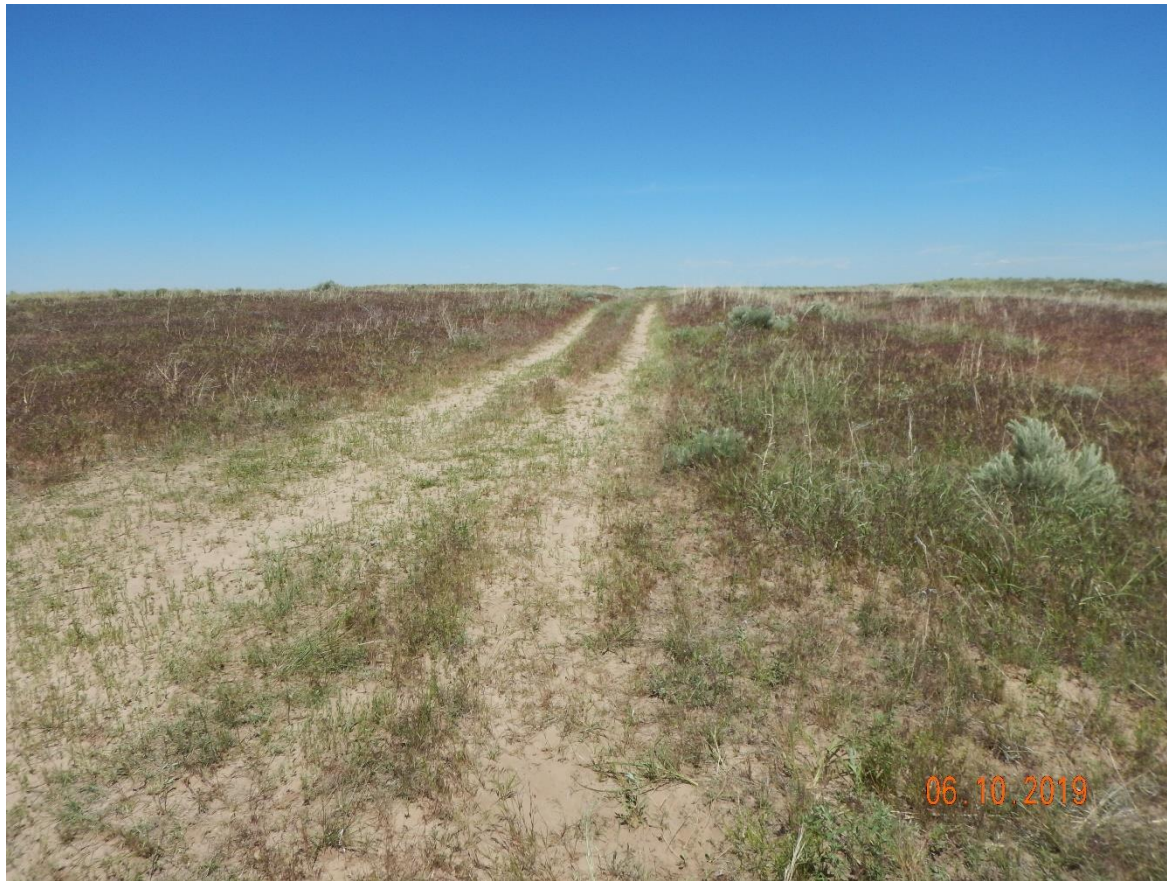
Photo 4: Photo taken from the access road. Photo shows areas where previous seeding was conducted has been re-disturbed. Surface owner appears to be utilizing access road.

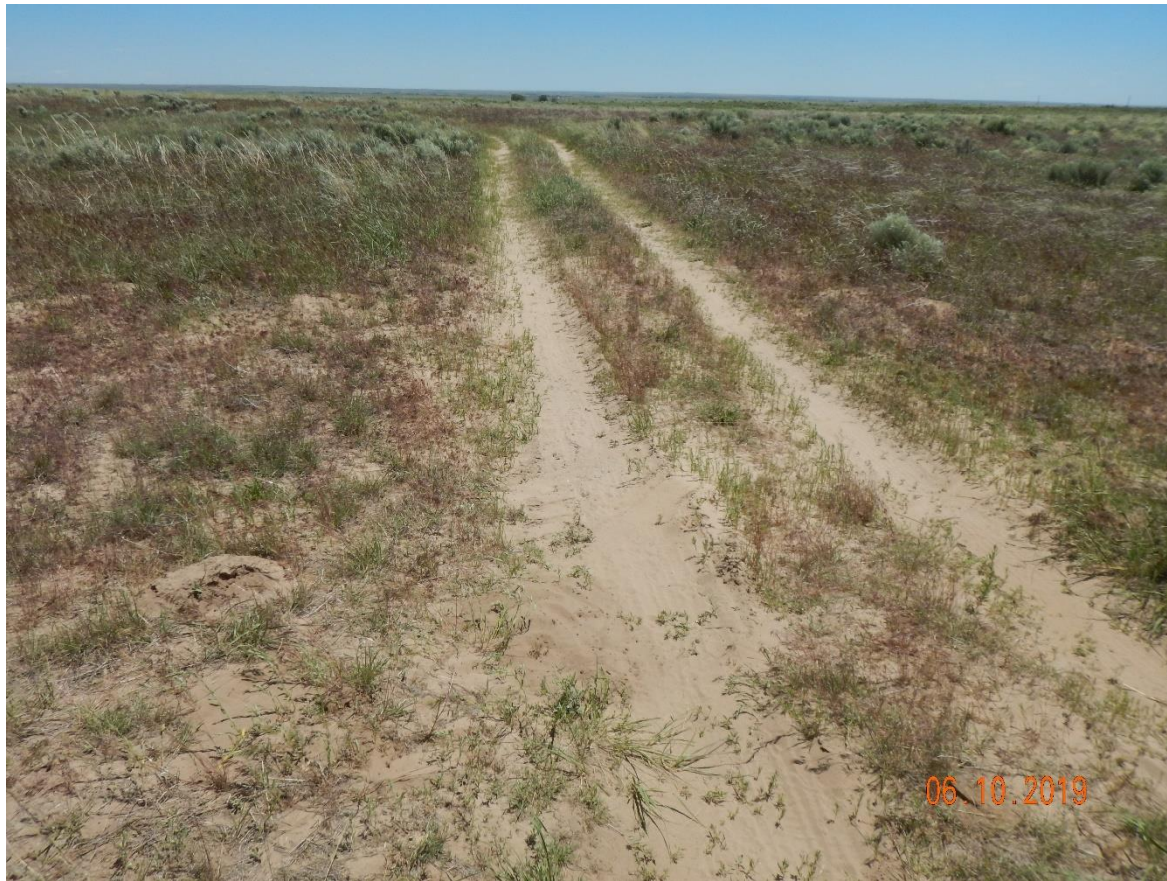
Photo 5: Photo taken from the access road. Photo shows areas where previous seeding was conducted has been re-disturbed. Surface owner appears to be utilizing access road.
