Construction and Stormwater Inspection

June 4, 2019

Operator: EXTRACTION OIL & GAS INC - #10459

Inspection Photos
Location Name: NORTHWEST A PAD
Location ID: 456769

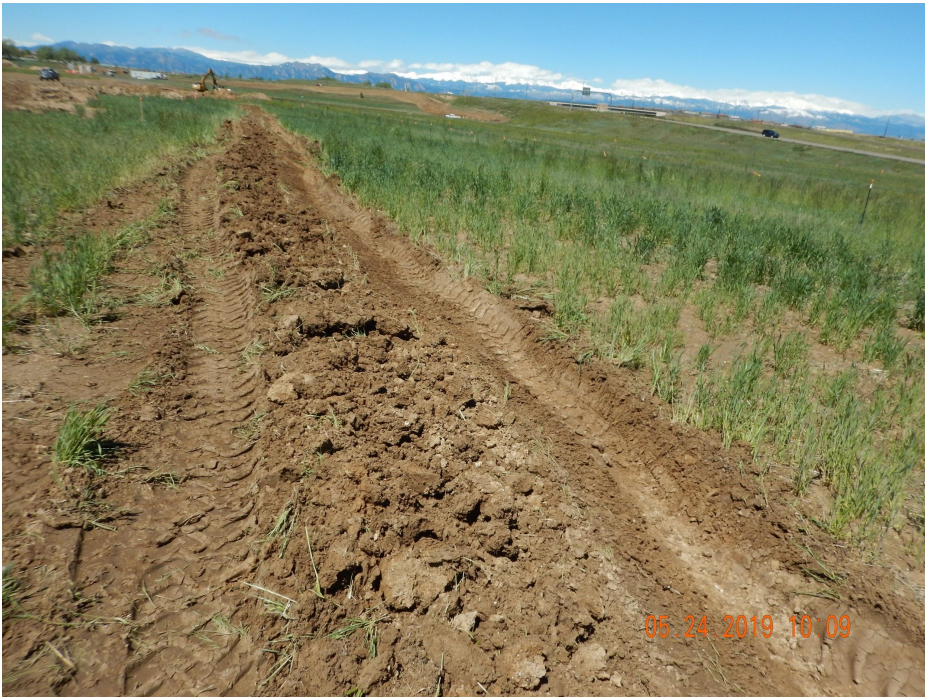
Photo 1. Photo taken from the southwestern perimeter of the location on 5/24/19, facing West. A berm BMP has been installed around the perimeter of the location but it has not been installed with good engineering practices. The berm BMP has not been stabilized. Note: Other disturbances in the foreground are not associated with oil and gas operations.

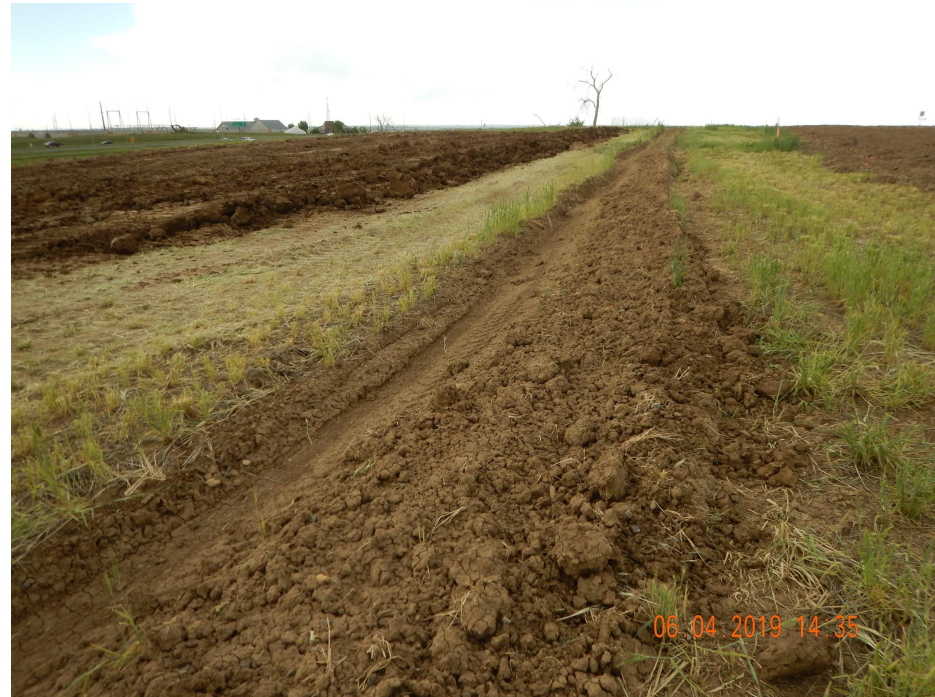
Photo 2. Photo taken from the southwestern perimeter of the location on 6/4/19, facing East. Operator has started major construction activities (i.e., storing topsoil) prior to properly installing the perimeter BMP. Appears the Operator has not made any improvements to the BMPs since the previous inspection.

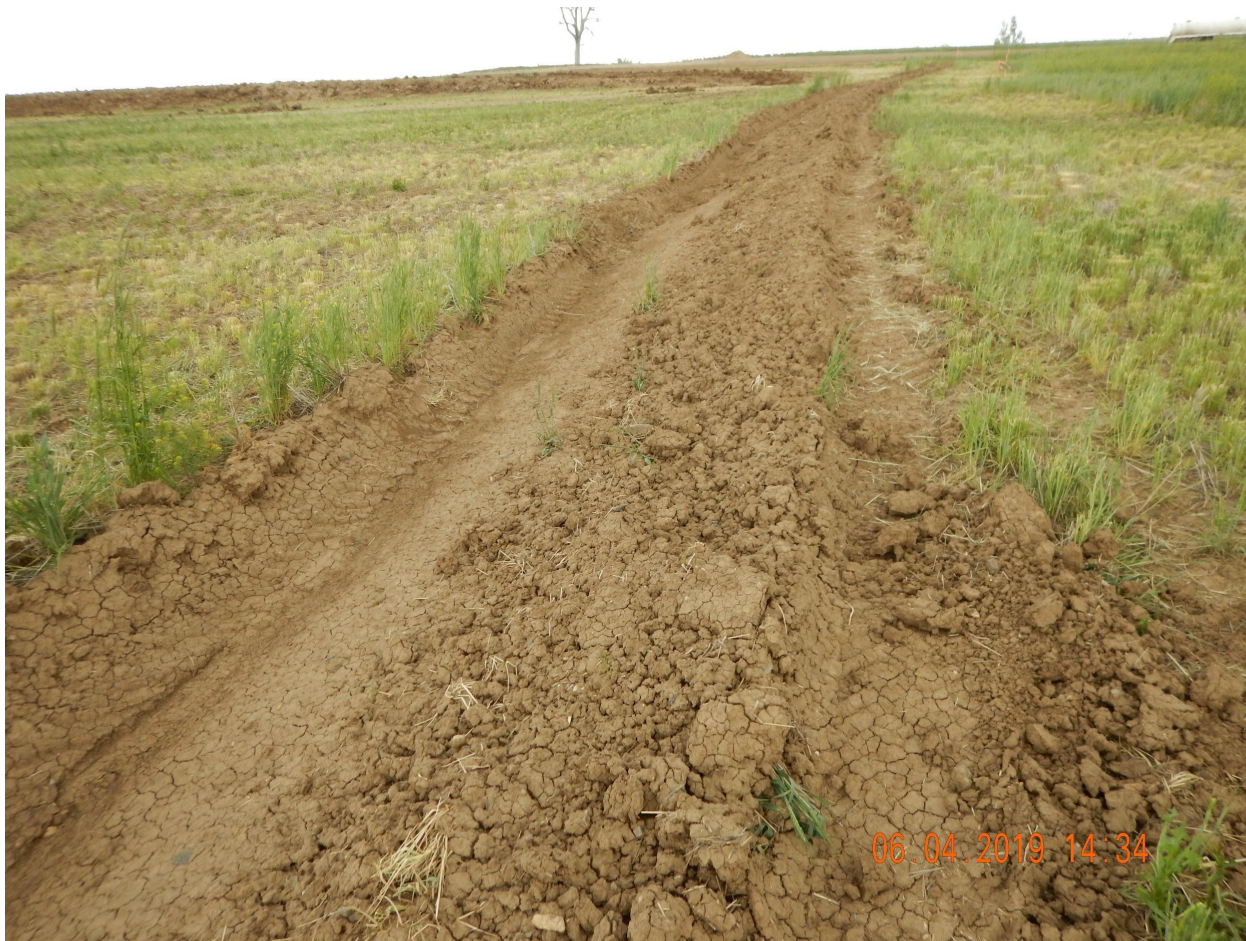
Photo 3. Photo taken from the western perimeter of the location on 6/4/19, facing South. See comments under Photo 2.

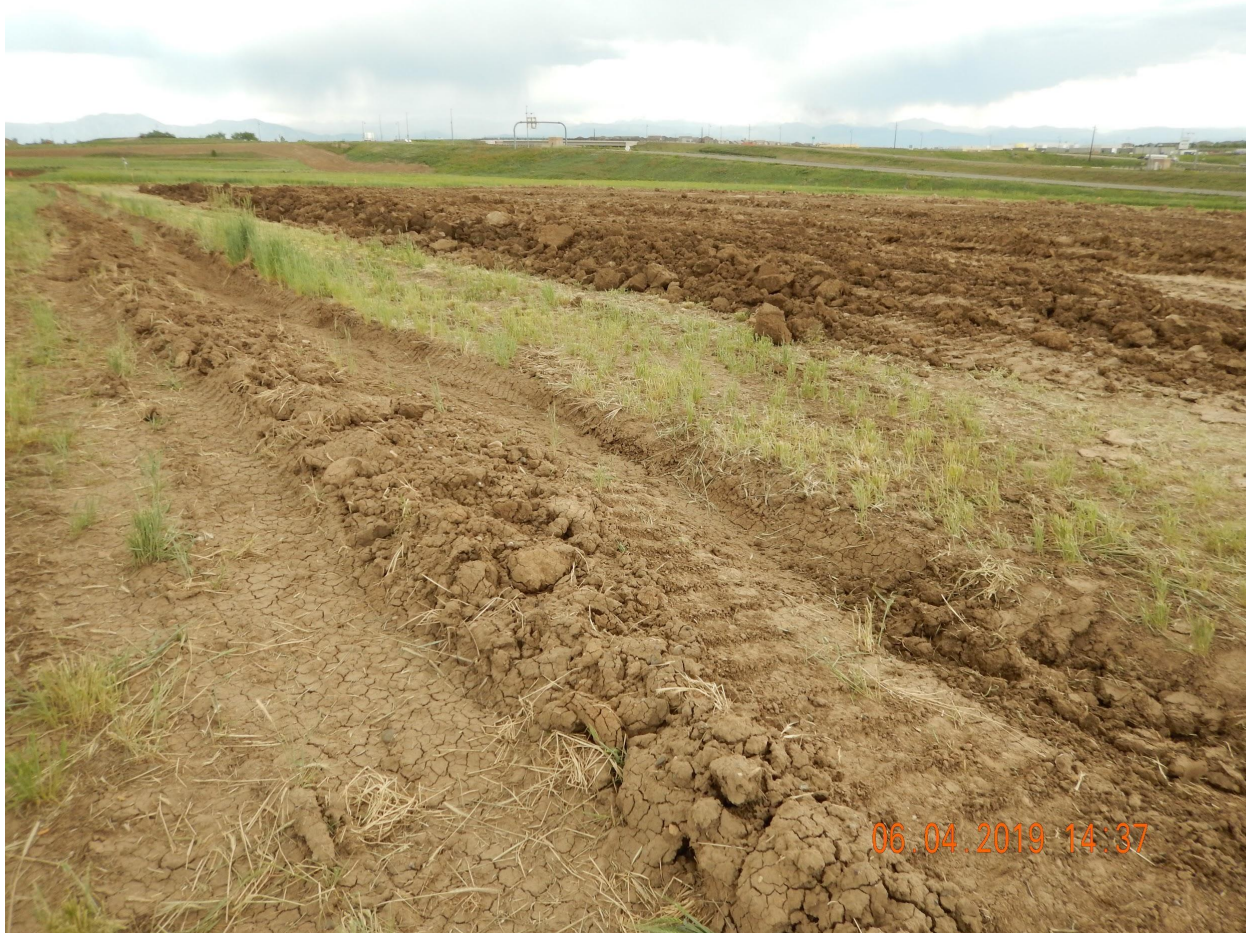
Photo 4. Photo taken from the southern perimeter of the location on 6/4/19, facing West. See comments under Photo 2.
