Inspection Photos

Location Name: COTTONTAIL PASS UNIT 31-2

API#: 05-071-06386

INSP. #: 695100854

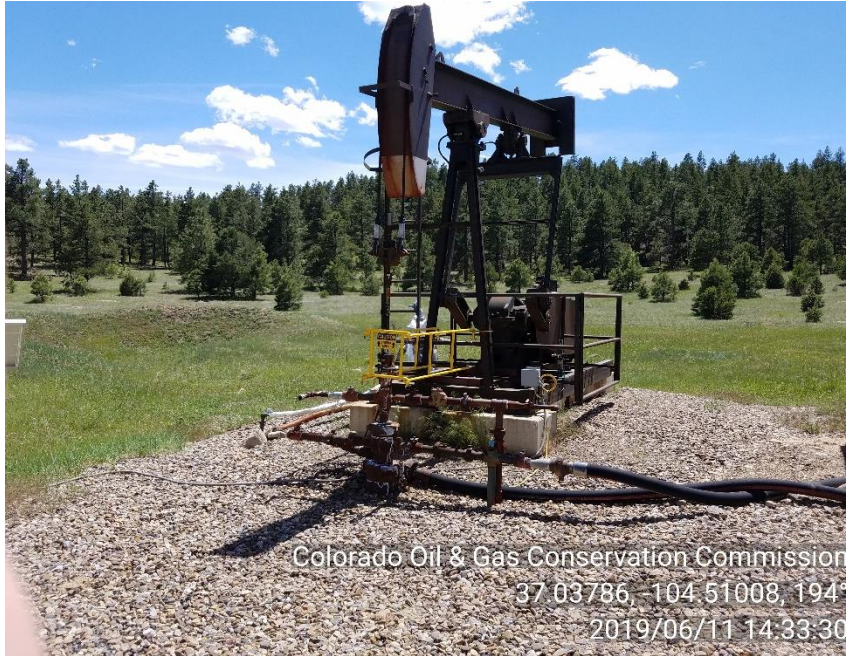
PHOTO 1: WELLHEAD

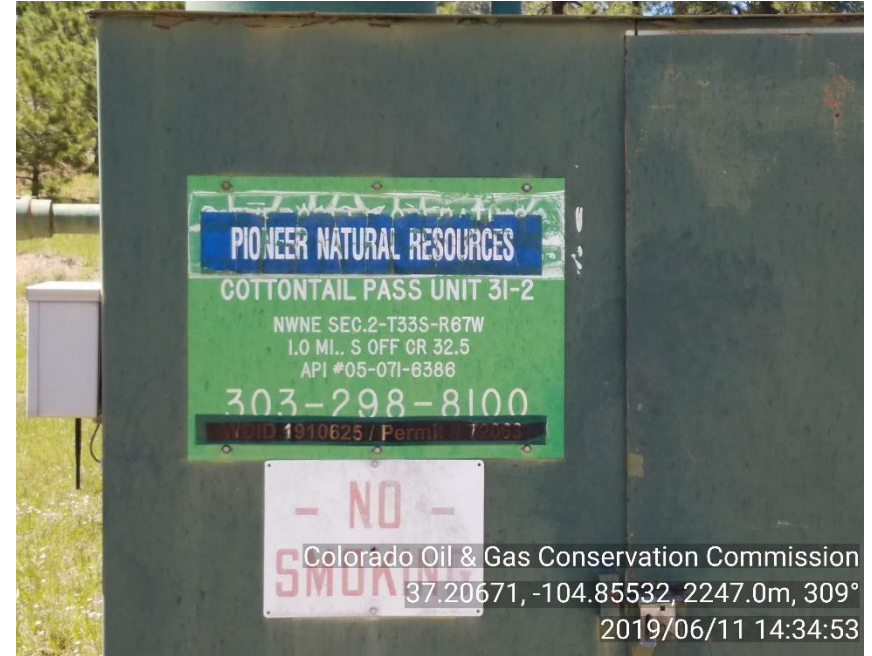
PHOTO 2: WELL SIGN/ CURRENT OPERATOR IS NOT POSTED ON WELL SIGN. 911 IS NOT INCLUDED IN EMERGENCY CONTACT. COMPLY WITH 210.b. CA DATE 7/11/19.

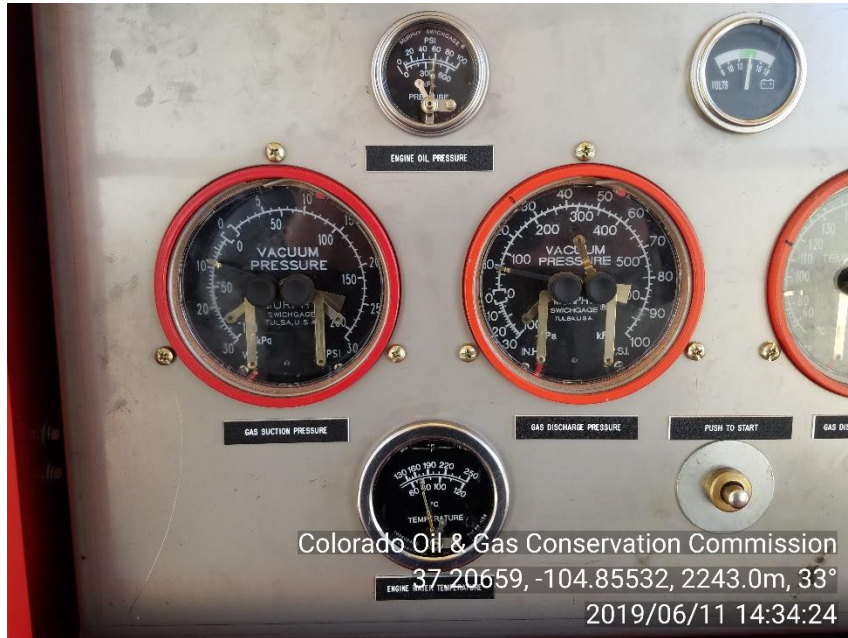
PHOTO 3: Vacuum pump observed on well without COGCC approval. Provide COGCC with documentation showing approval of use of vacuum pump. CA DATE 6/26/19
