# Interim Reclamation and Stormwater Inspection

June 3, 2019

Operator: ENERPLUS RESOURCES (USA) CORPORATION - #10177

Location ID: 449800

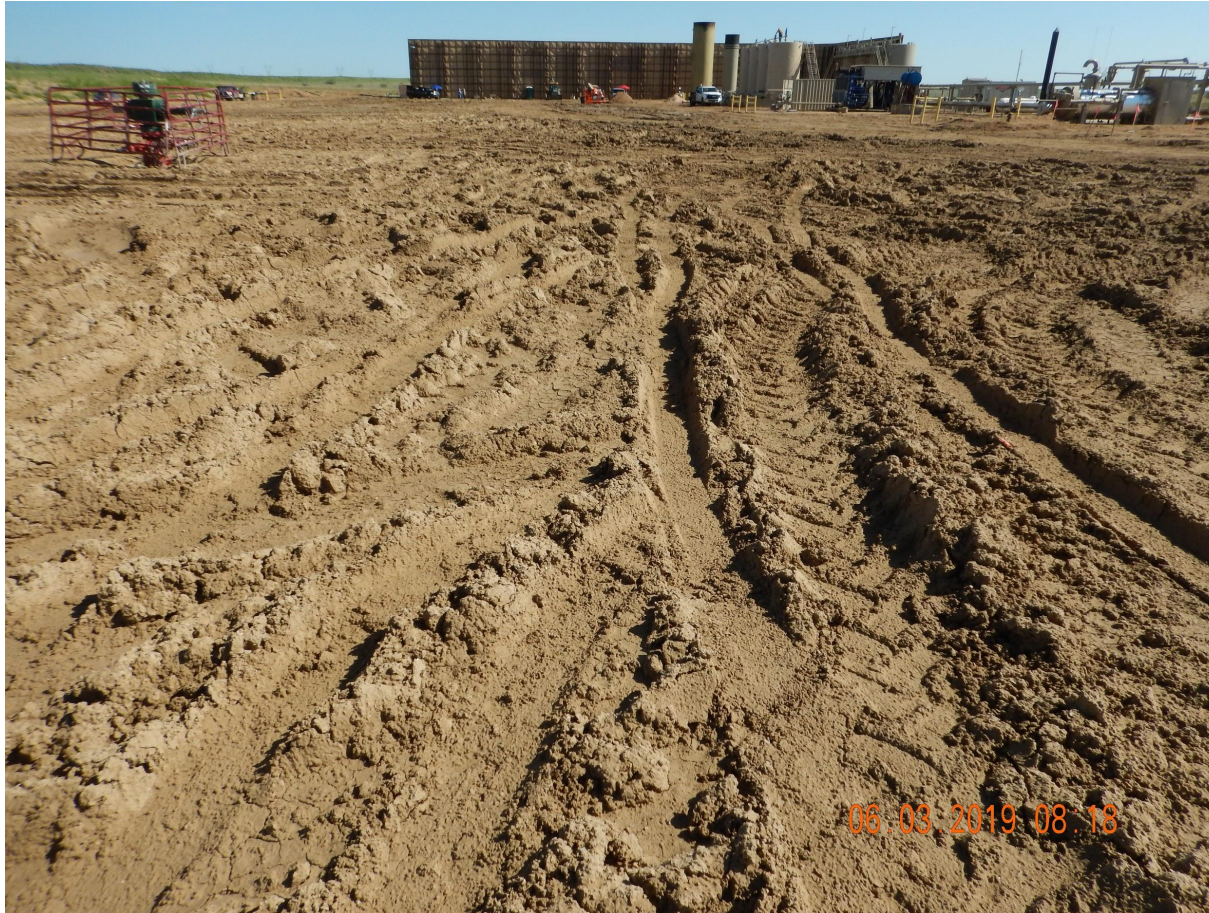
**Photo 1.** Photo taken from the approximate wellhead, facing North. This location has not been properly constructed and maintained so as to reasonably minimize erosion and removal of surface material. Ruts were over one foot in depth and vehicles are tracking sediment offsite.

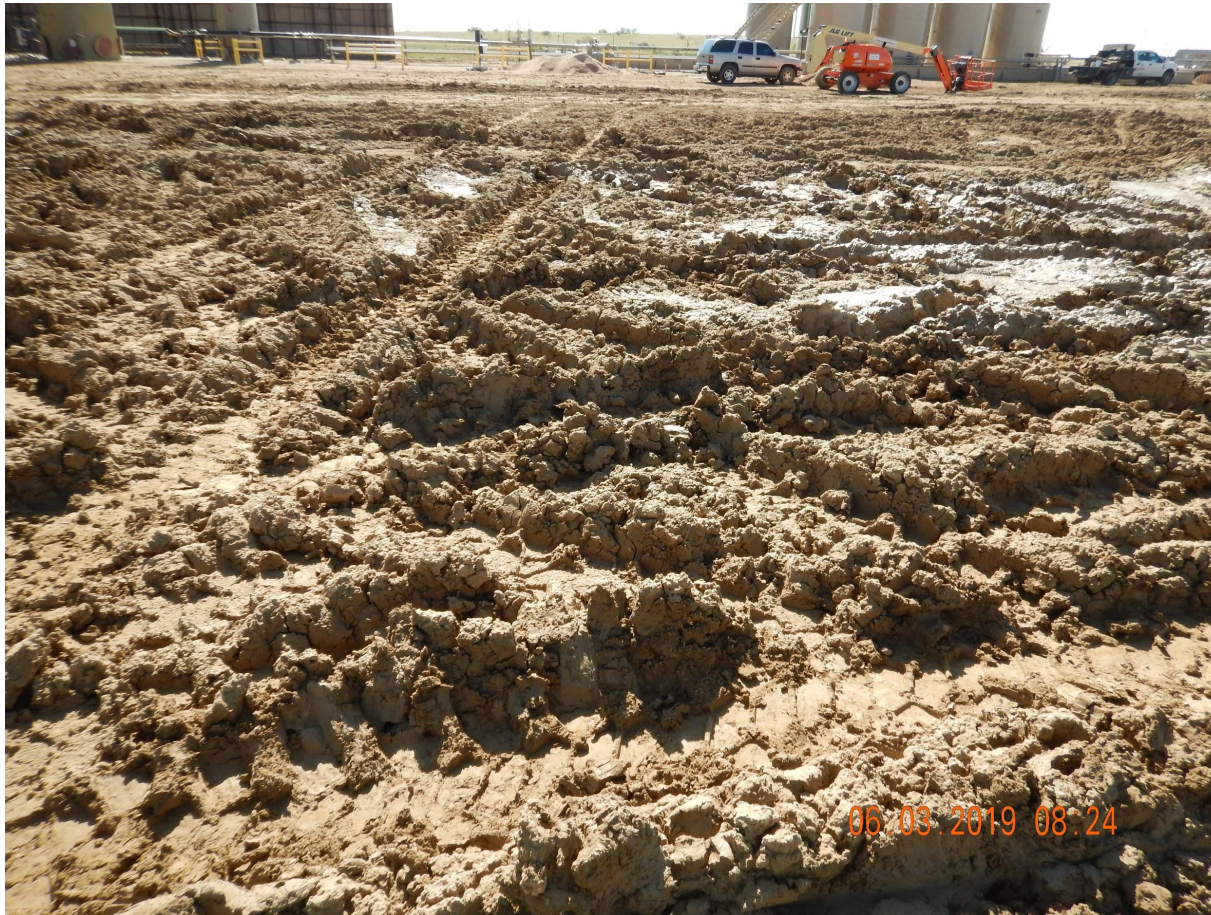
**Photo 2.** Photo taken from the northern location, facing East. See comments under Photo 1.

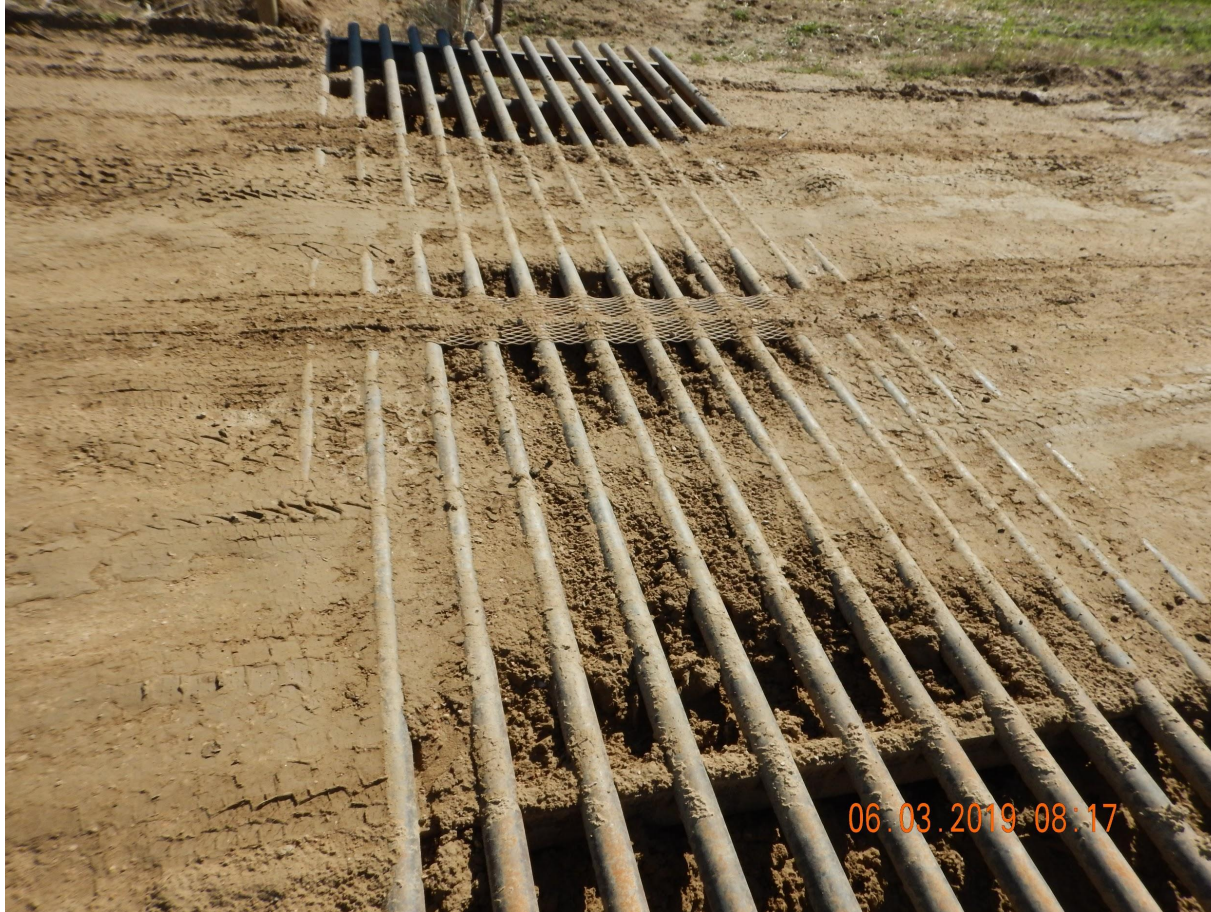
**Photo 3.** Photo taken from the entrance of location, facing East. Appears maintenance is required as sediment has accumulated in the tracking device BMP and is no longer properly functioning.

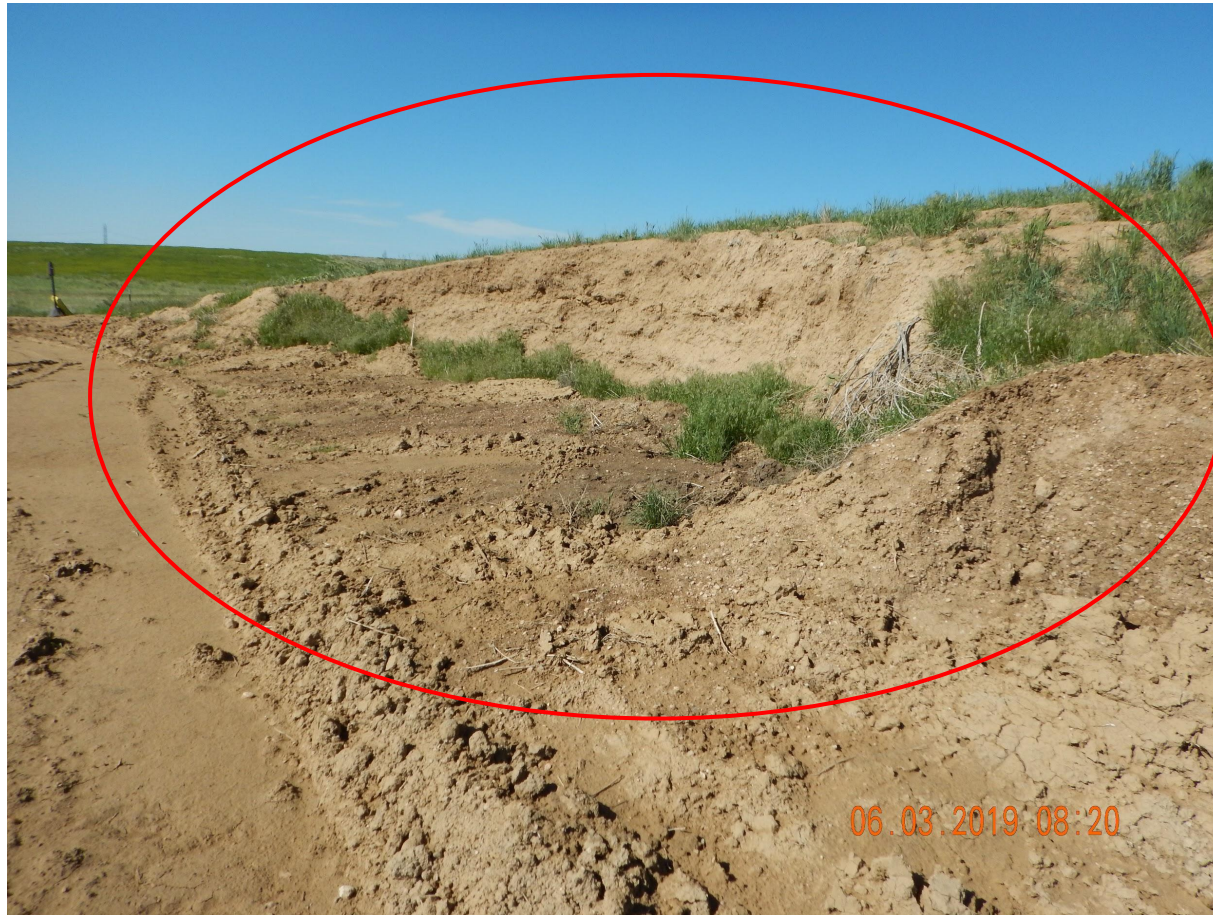
**Photo 4.** Photo taken from the southern topsoil stockpile, facing South. Appears the Operator has used topsoil but has not yet performed interim reclamation. Topsoil shall only be used to facilitate subsequent reclamation.

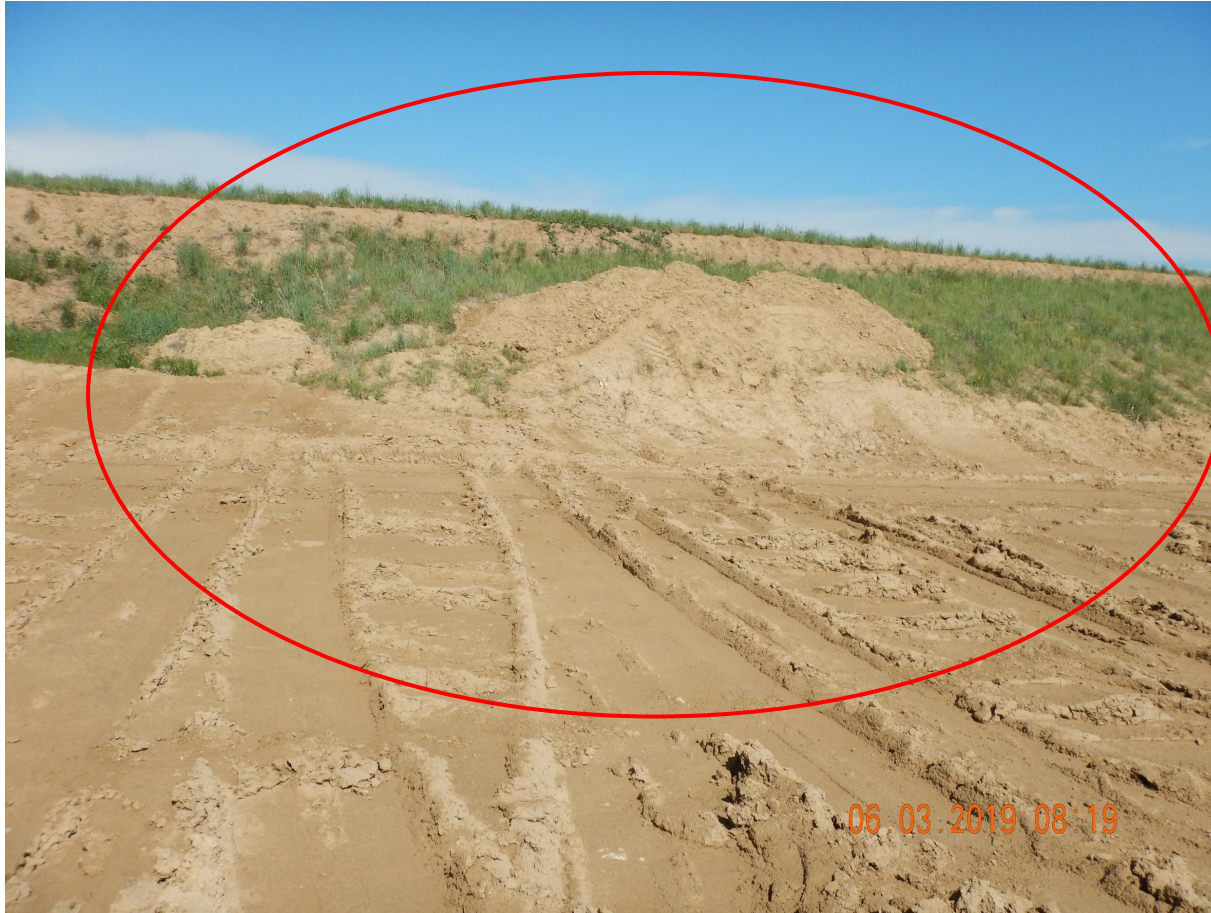
**Photo 5.** Photo taken from the southern topsoil stockpile, facing West. Appears the Operator has scrapped off material from the well pad and placed it on the topsoil stockpile. Operator shall protect topsoil from degradation due to contamination.

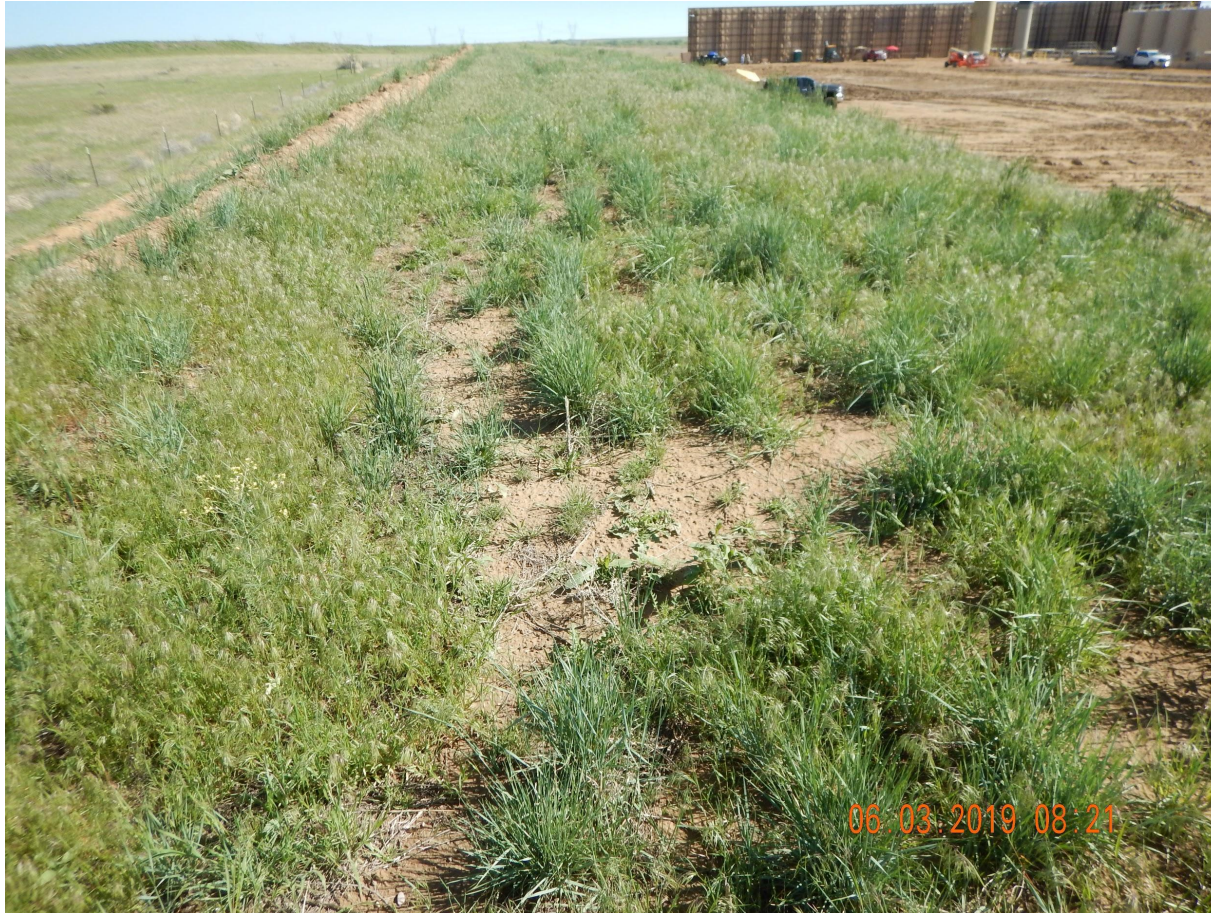
**Photo 6.** Photo taken from the southern topsoil stockpile, facing North. Operator has failed prevent weed establishment on the topsoil stockpile.

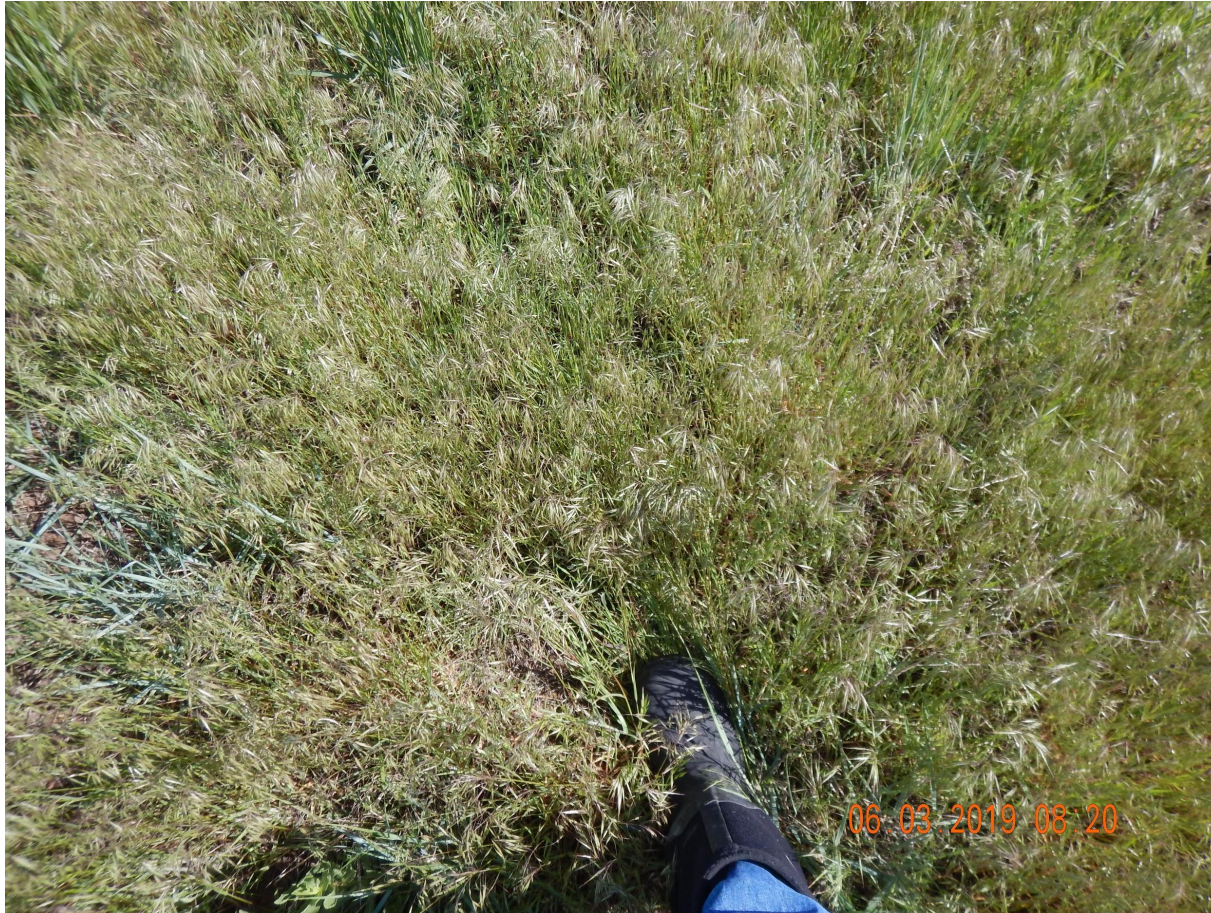
**Photo 7.** Close up photo taken from the topsoil stockpile. Photo illustrates the establishment of cheatgrass, a weedy annual List C Colorado noxious weed.
