Inspection Photos

06/20/2019

Operator: MURFIN DRILLING COMPANY INC -
61650

Location ID: 387013
Lincoln County, CO

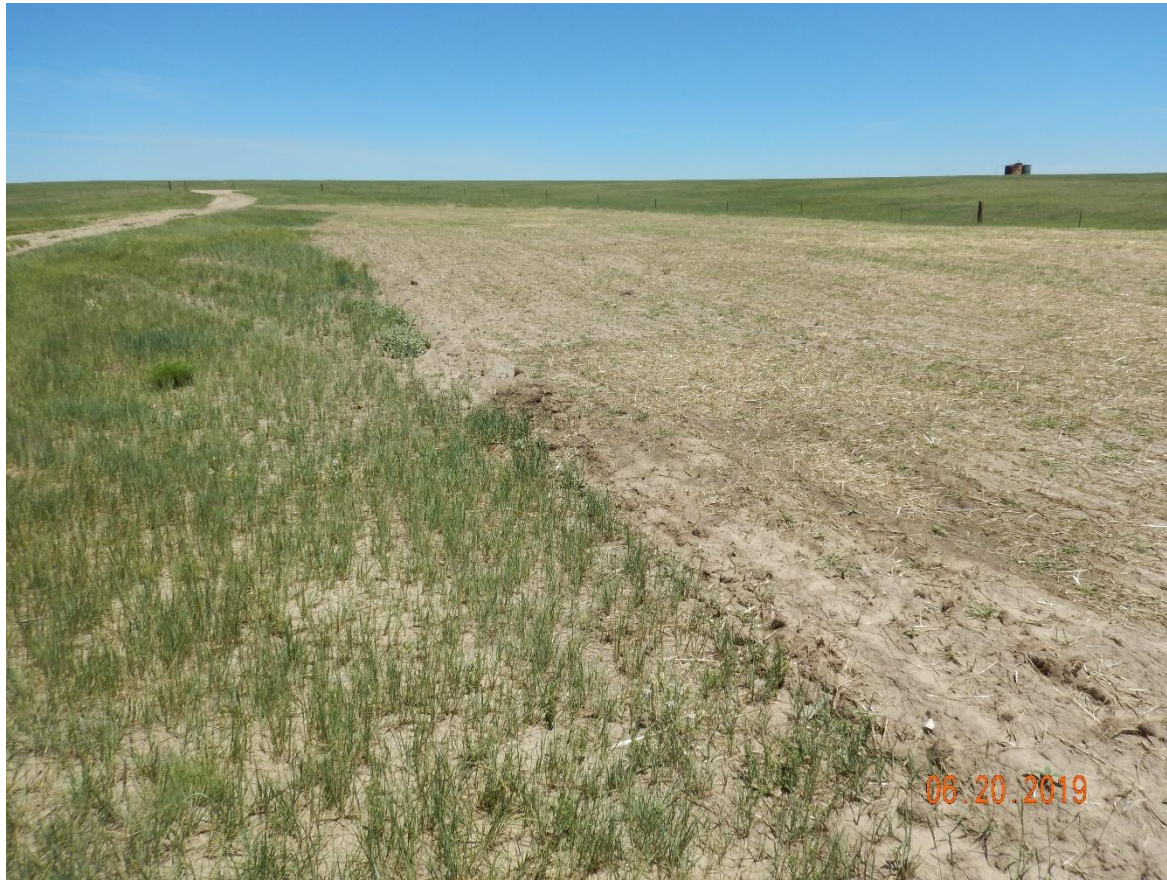
Photo 1: Photo taken from the north end of the location, facing east. Photos 1-3 provide an overview of the location from east, to south, to west. Photos show additional reclamation activities appear to have been conducted.

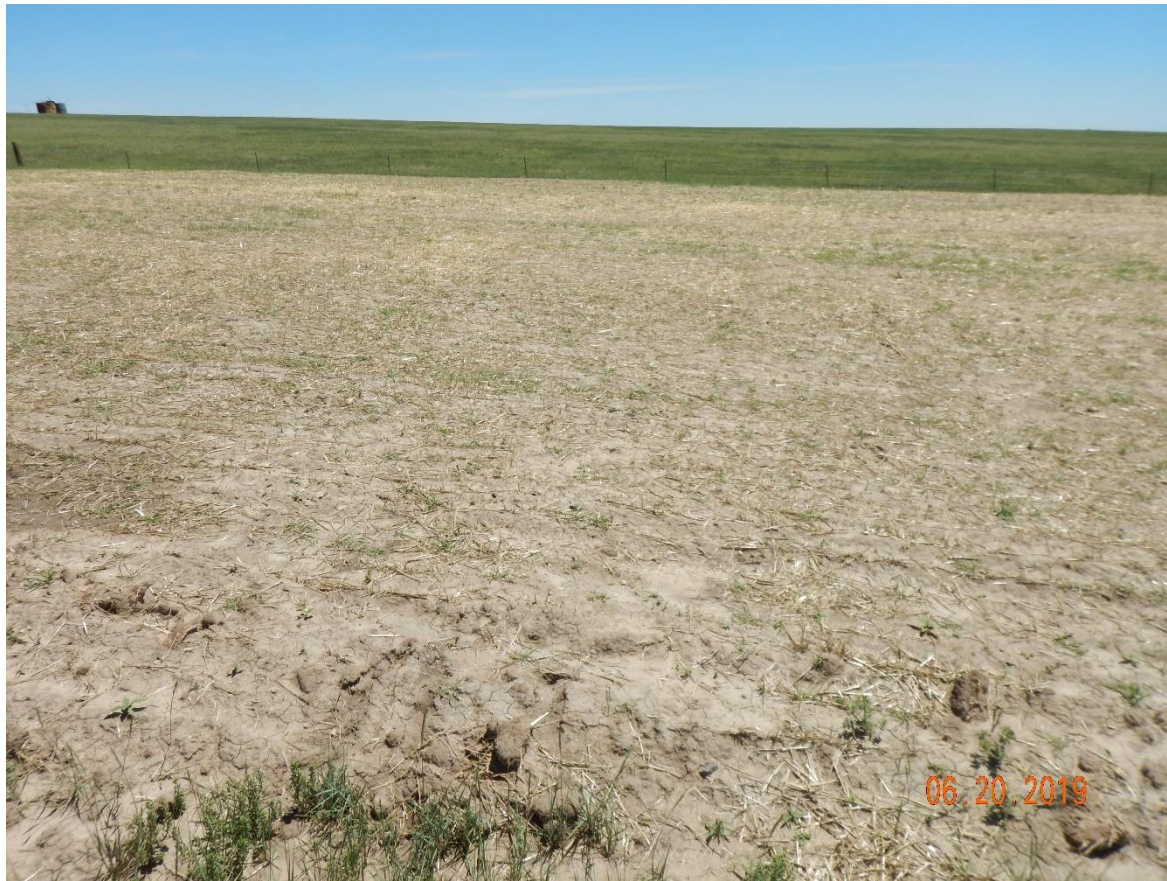
Photo 2: See comments under photo 1.

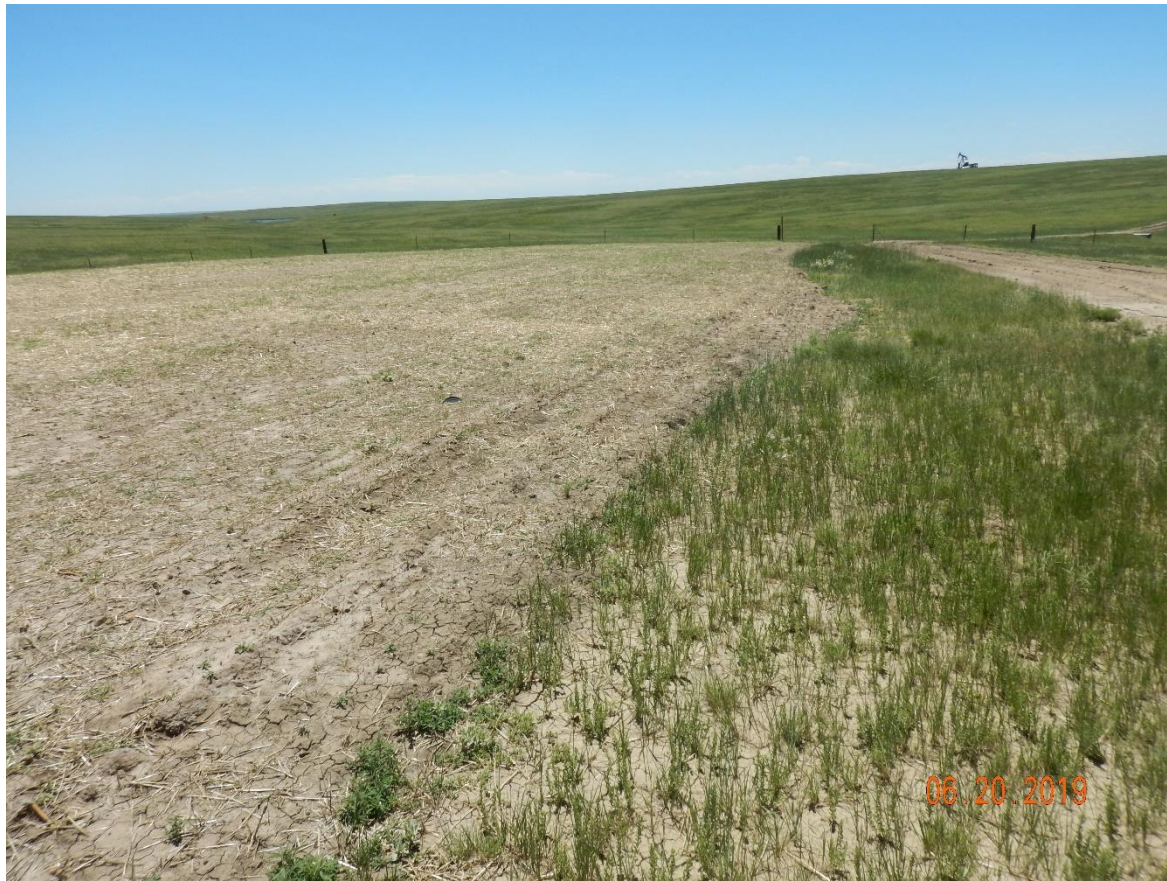
Photo 3: See comments under photo 1.

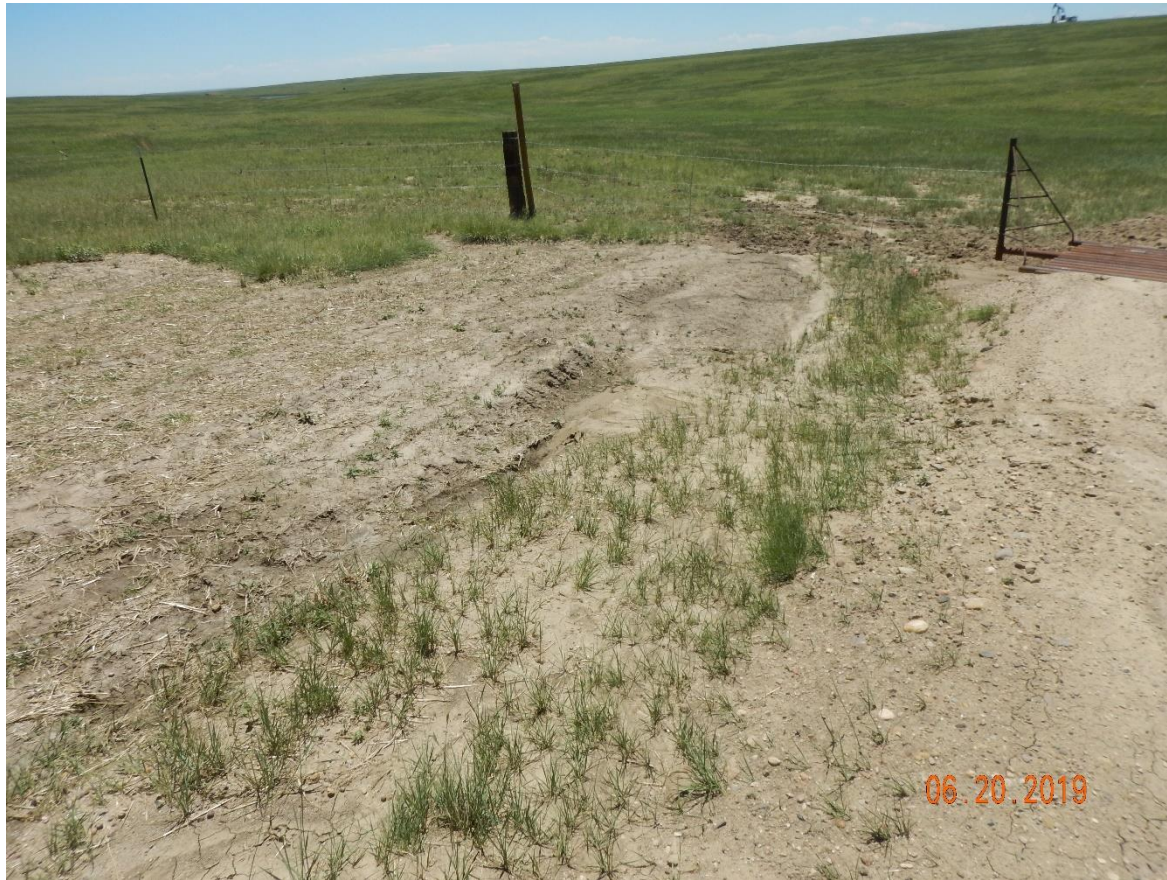
Photo 4: Photo taken from the southwest end of the location, facing southwest. Photo shows stormwater runoff is beginning to cause erosion degradation with sediment discharge onto the adjacent lands. Advise installing BMPs

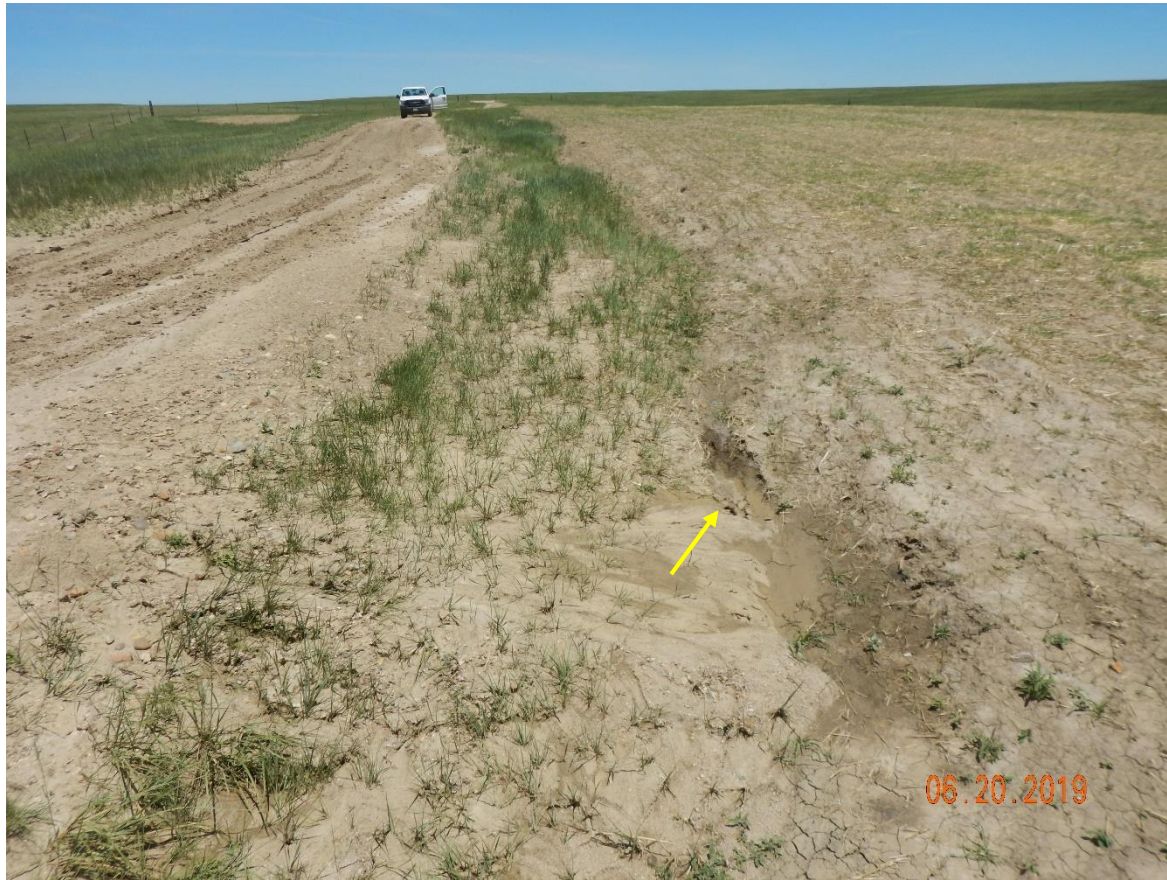
Photo 5: Photo taken from the southwest end of the location, facing northeast. Photo shows stormwater runoff is beginning to cause erosion degradation with sediment discharge onto the adjacent lands. Advise installing BMPs
