Inspection Photos

06/20/2019

Operator: PRONGHORN OPERATING LLC -
10422

Location ID: 438713
Lincoln County, CO

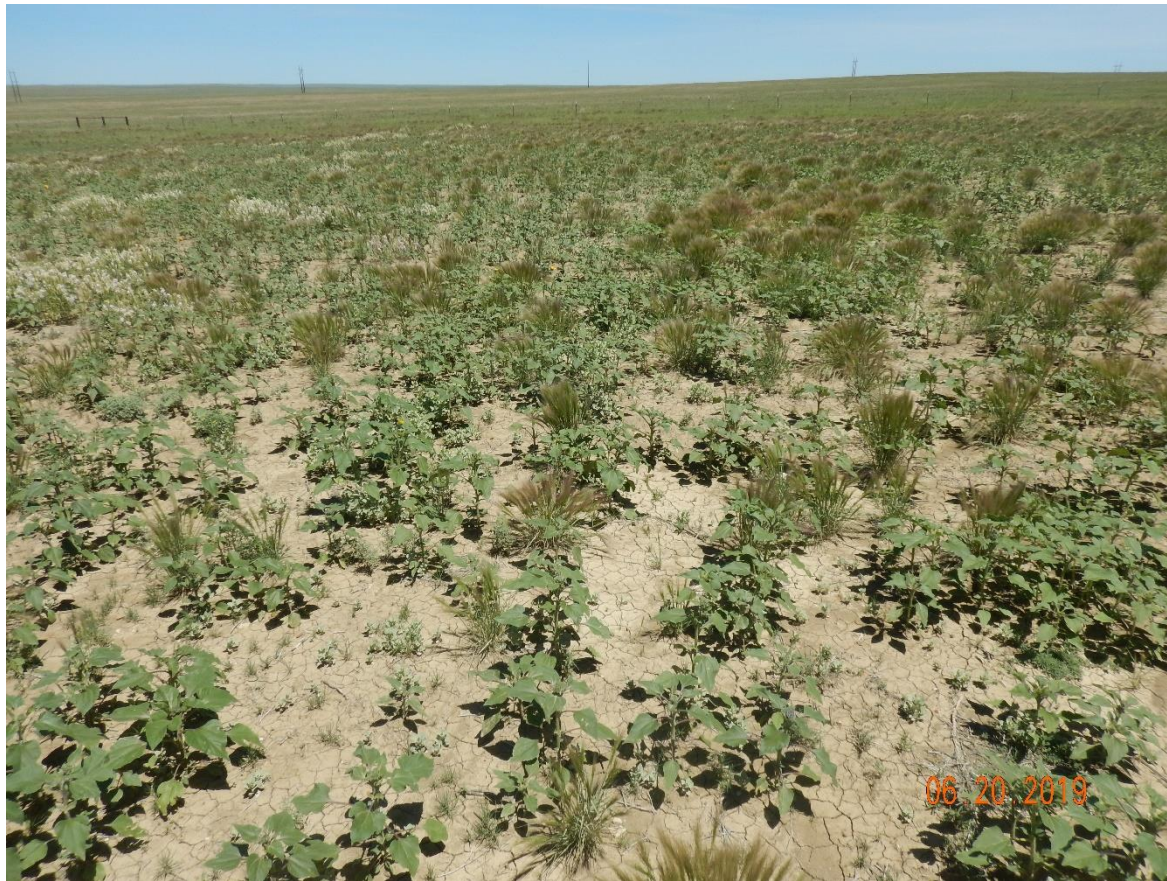
Photo 1: Photo taken from the central area of the location, facing north. Photos 1-4 provide an overview of the location from north, to south, to east, to west. Photos show vegetation over the reclamation area. Vegetation observed is predominantly undesirable weedy plant species (such as Kochia, Amaranth, Chenopodium and Salsola sp), and annual forbs. Unable to find evidence that additional reclamation/seeding activities have been conducted, or stabilization controls installed per corrective actions.

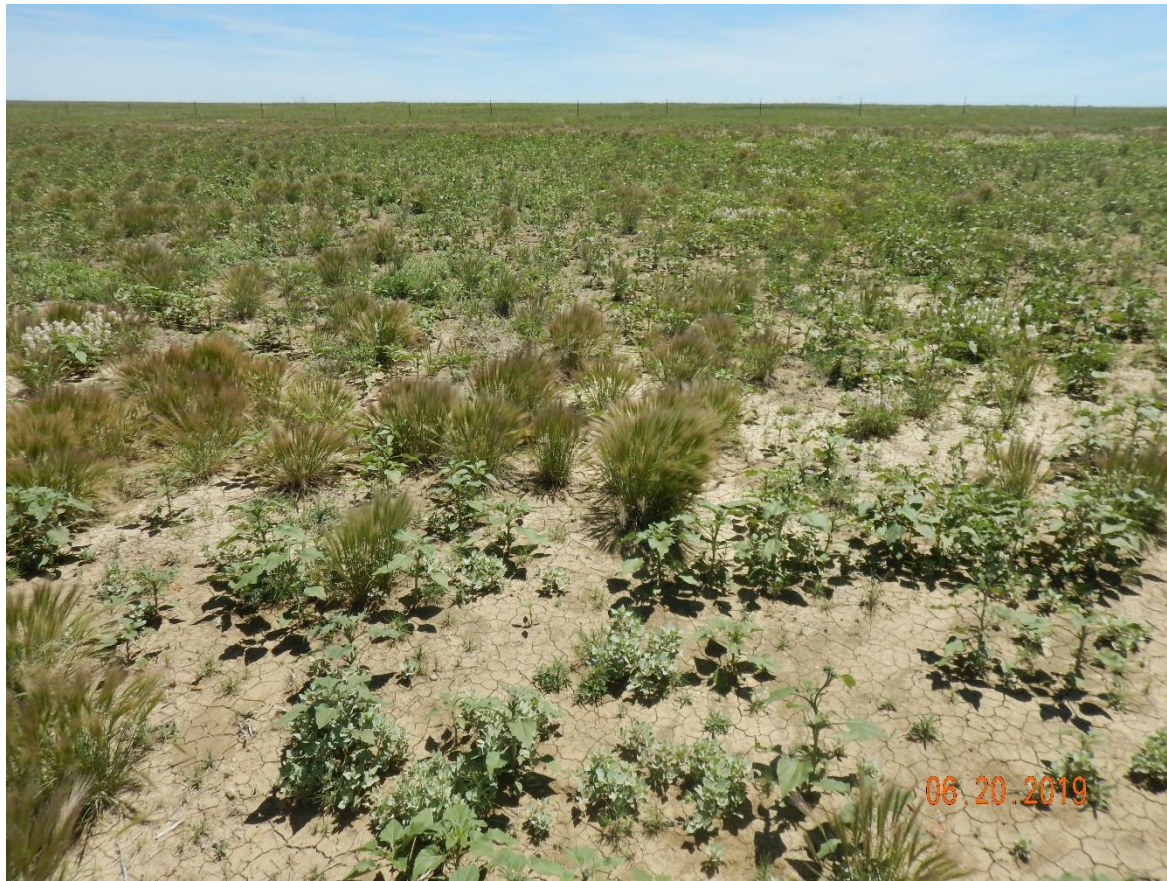
Photo 2: See comments under photo 1.

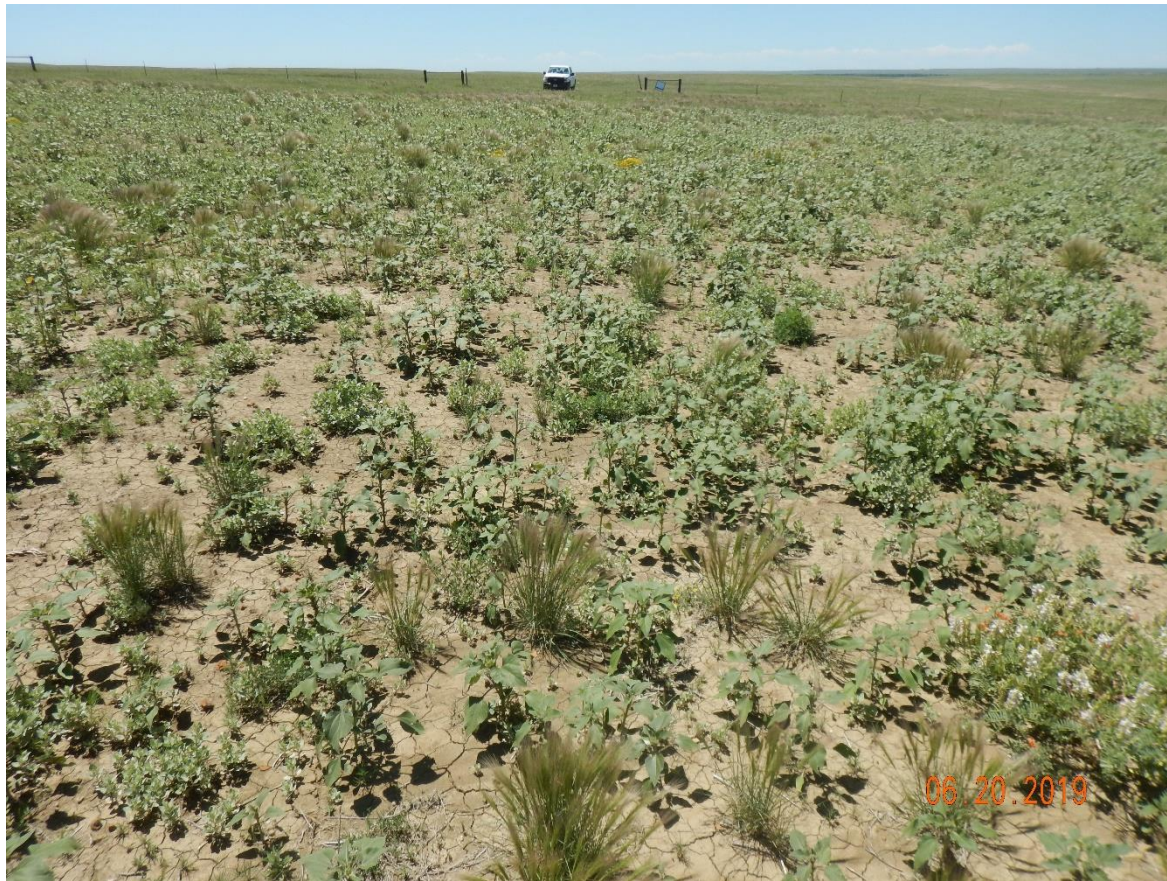
Photo 3: See comments under photo 1.

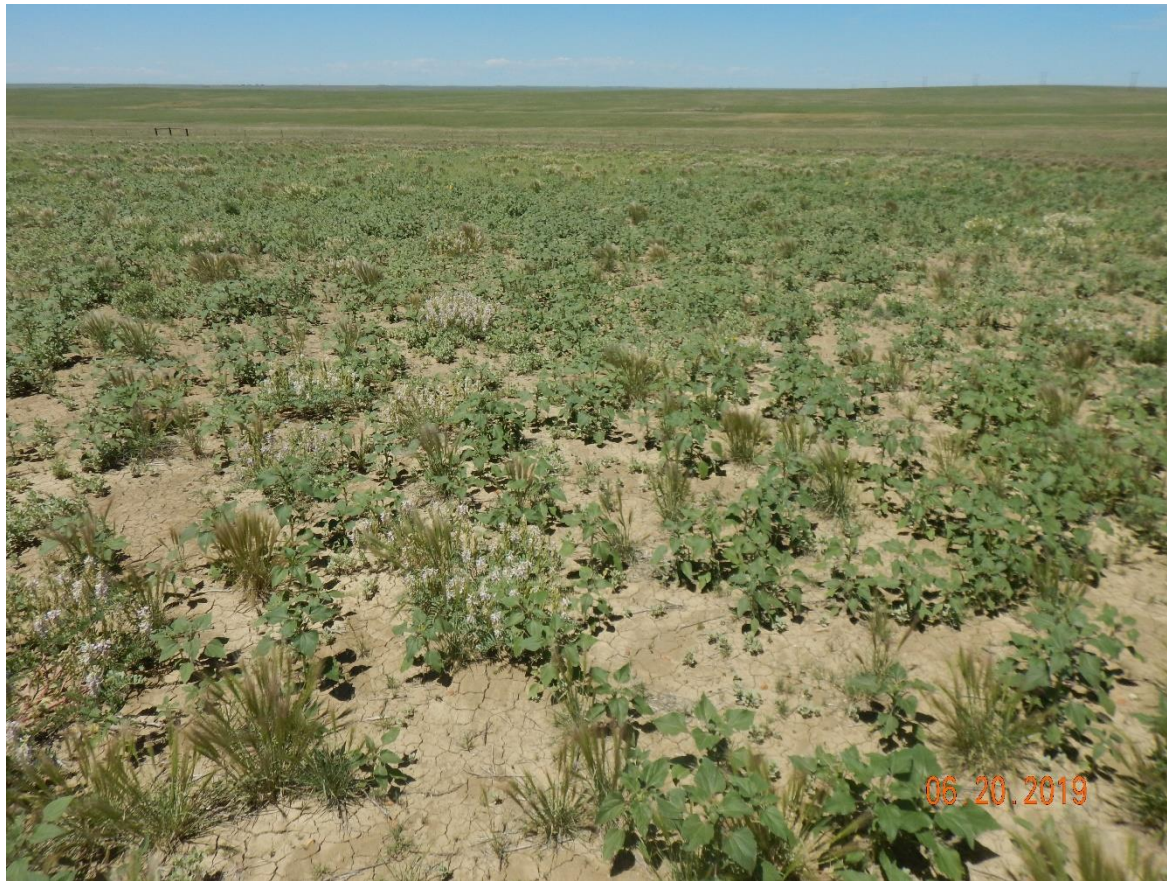
Photo 4: See comments under photo 1.

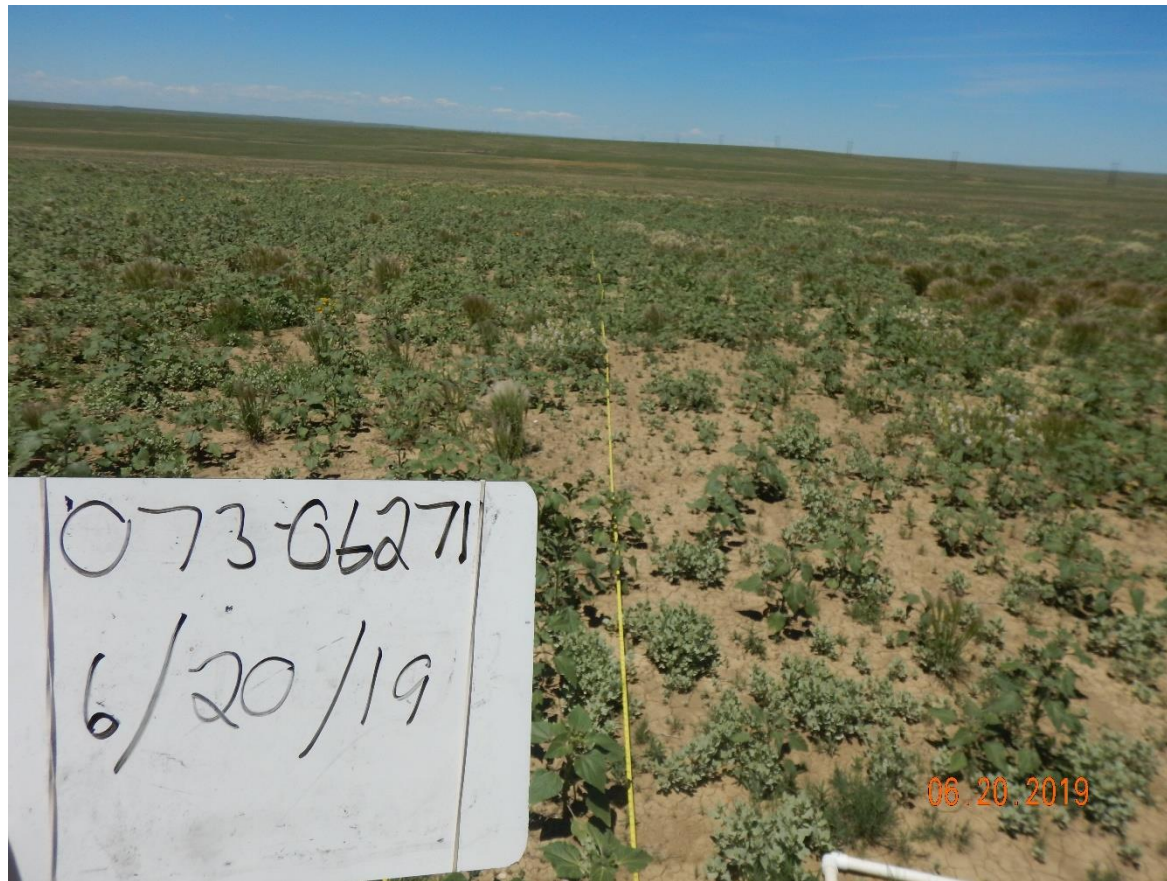
Photo 5: Photo taken from the east-central area of the location, facing west. Photo shows germination survey transect #1 conducted on the location.

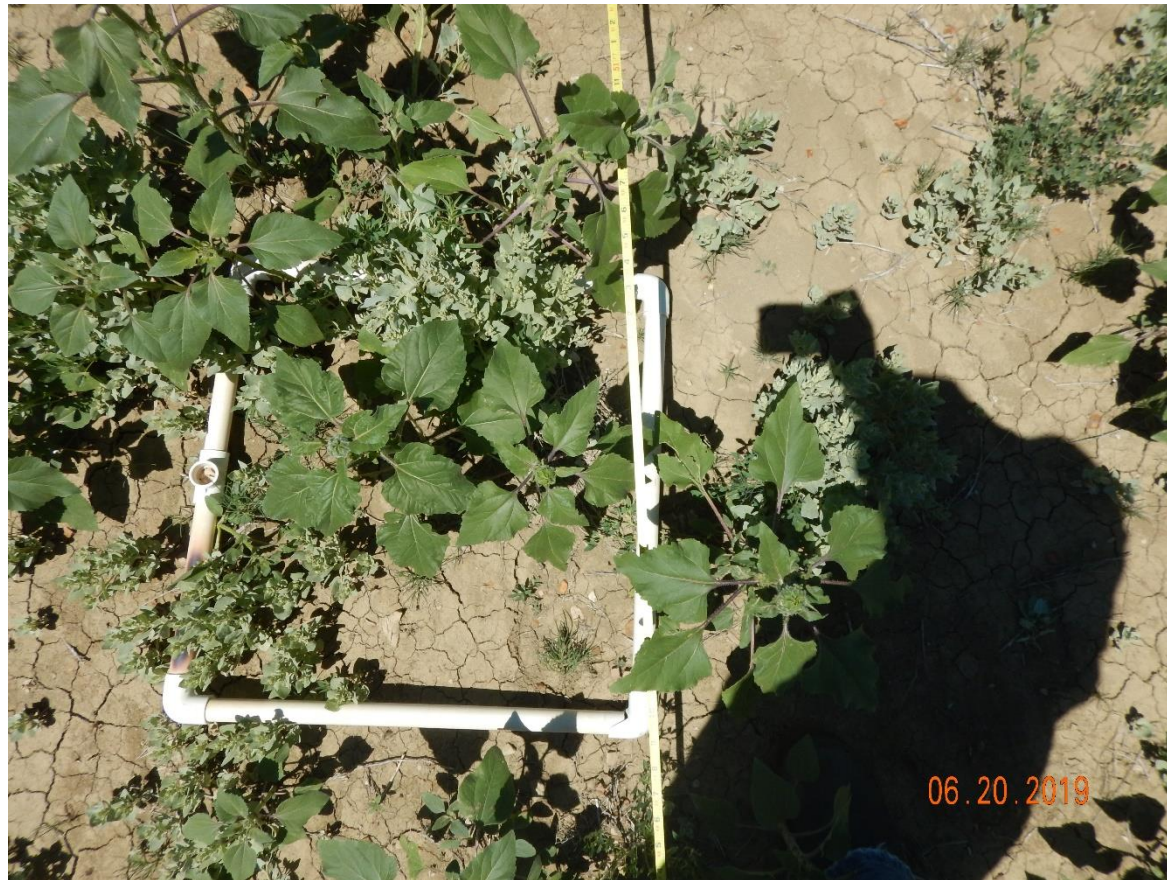
Photo 6: Photo taken from the 50th point of germination survey transect #1. Vegetation seen in photo include *Helianthus annuus*, *Chenopodium* sp., and *Kochia*. Very little desirable perennial vegetative germination and establishment observed.

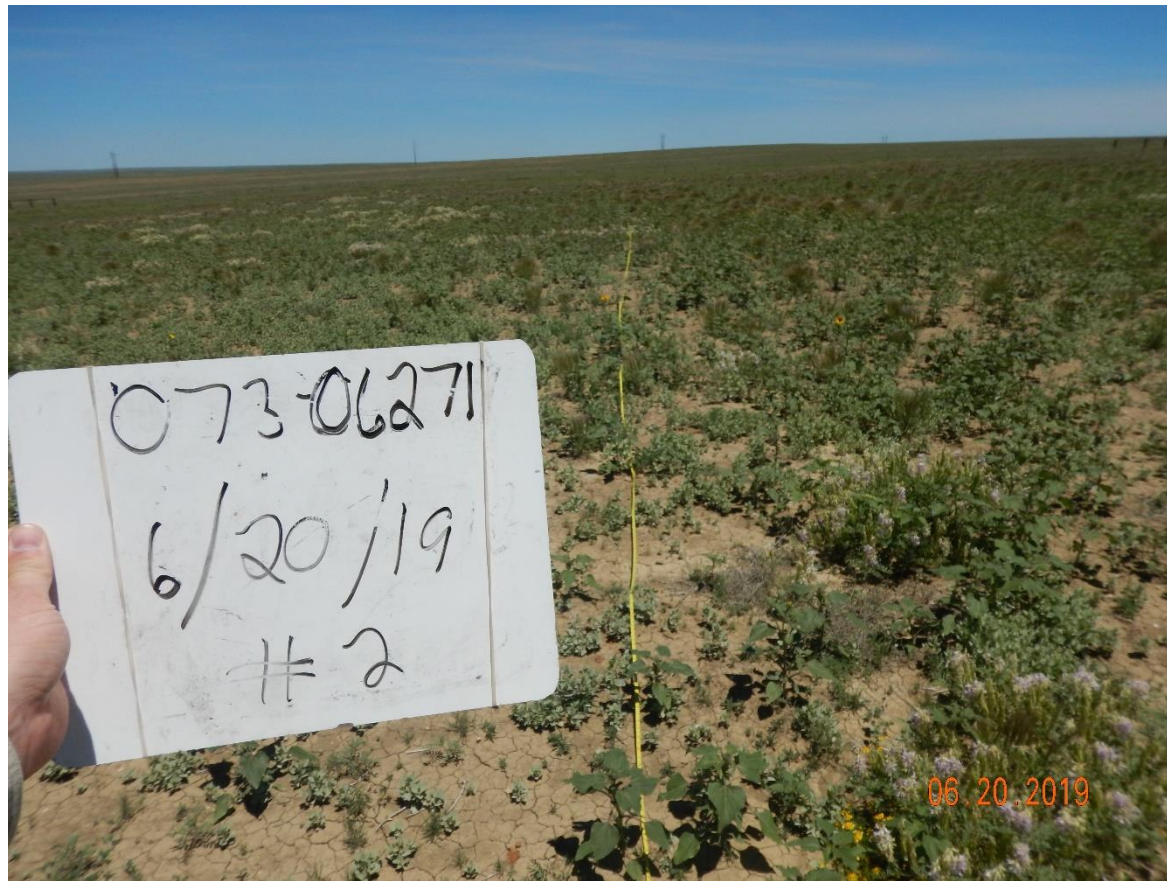
Photo 7: Photo taken from the south-central area of the location, facing north. Photo shows germination survey transect #2 conducted on the location.

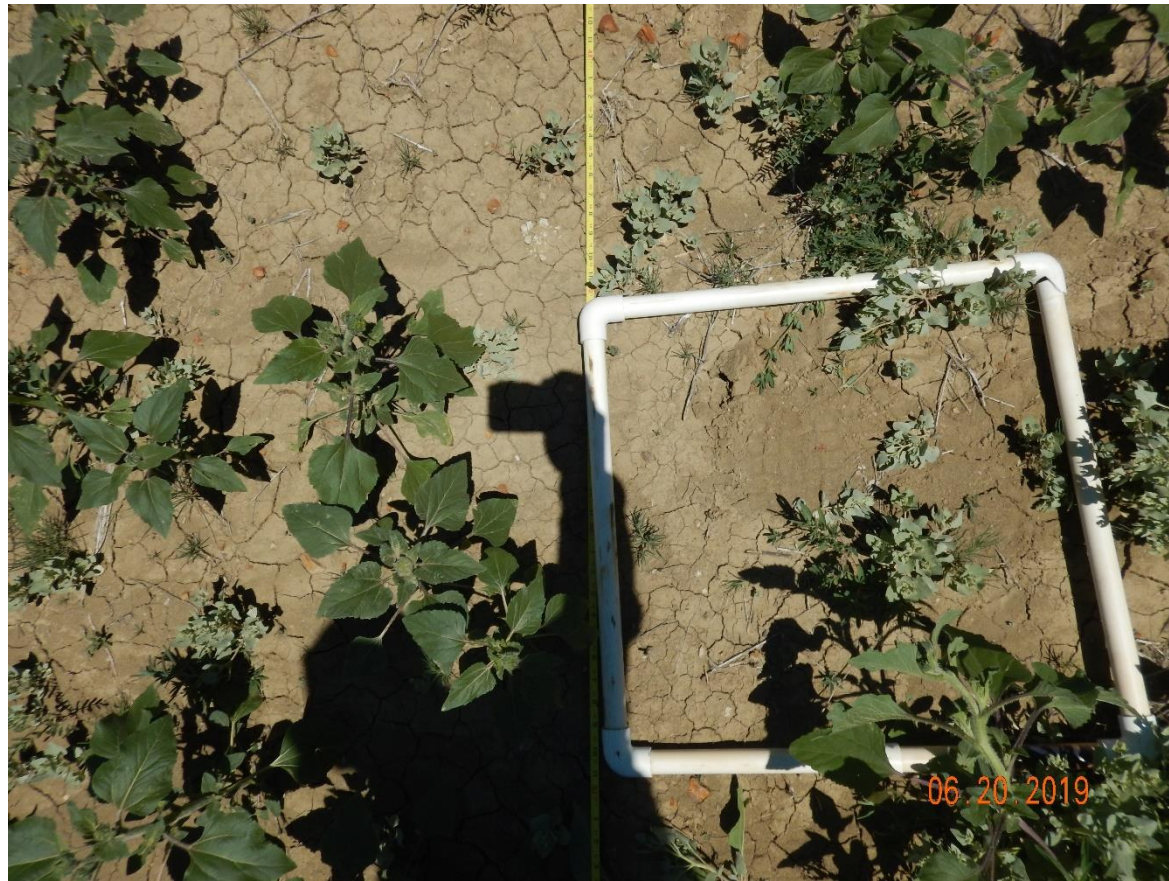
Photo 8: Photo taken from the 50th point of germination survey transect #2. Vegetation seen in photo include *Helianthus annuus*, *Chenopodium* sp., and *Kochia*. Very little desirable perennial vegetative germination and establishment observed.

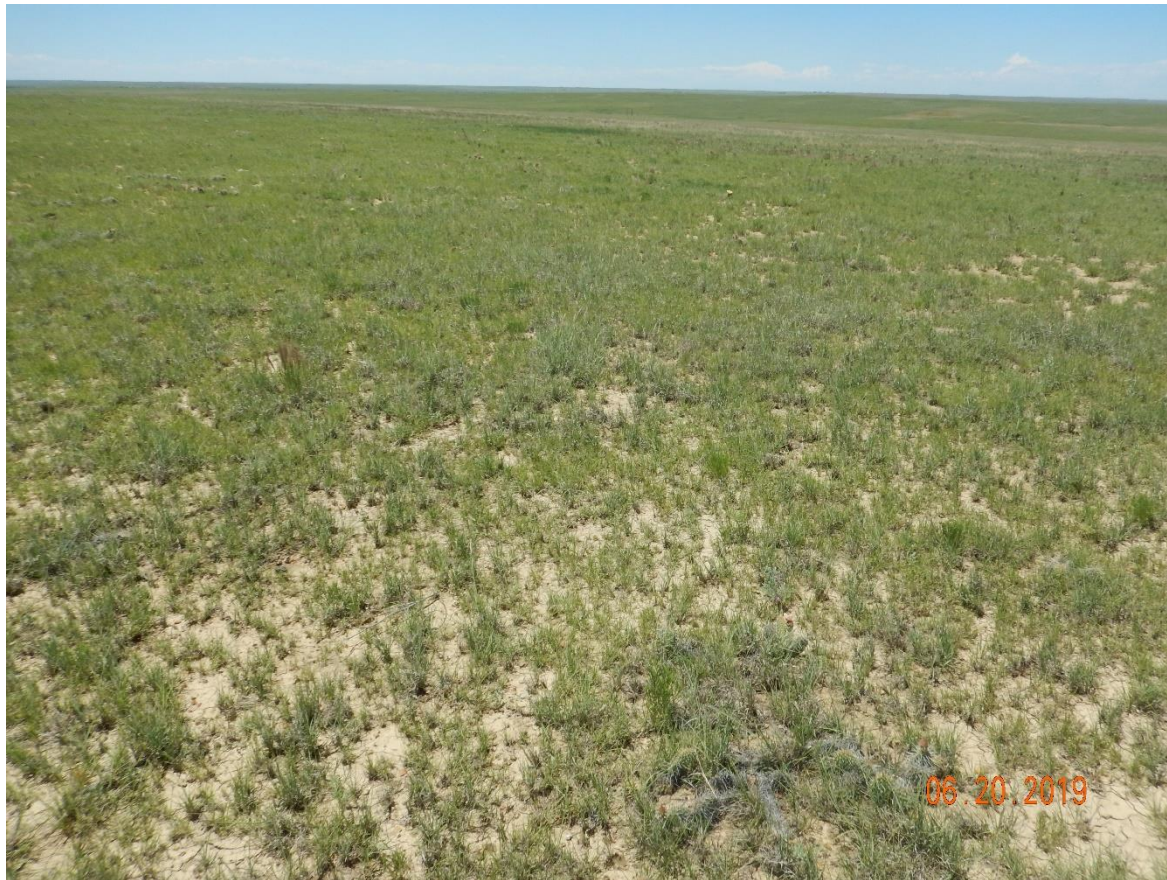
Photo 9: Photo taken from the adjacent reference area. Photo shows reference vegetation to compare to vegetation on the location.
