# Final Reclamation Inspection

Operator: KERR MCGEE OIL & GAS ONSHORE LP #47120

API: 05-123-14957

Inspection Photos  
Location Name: FIELDS #X8-11  
API: 05-123-14957

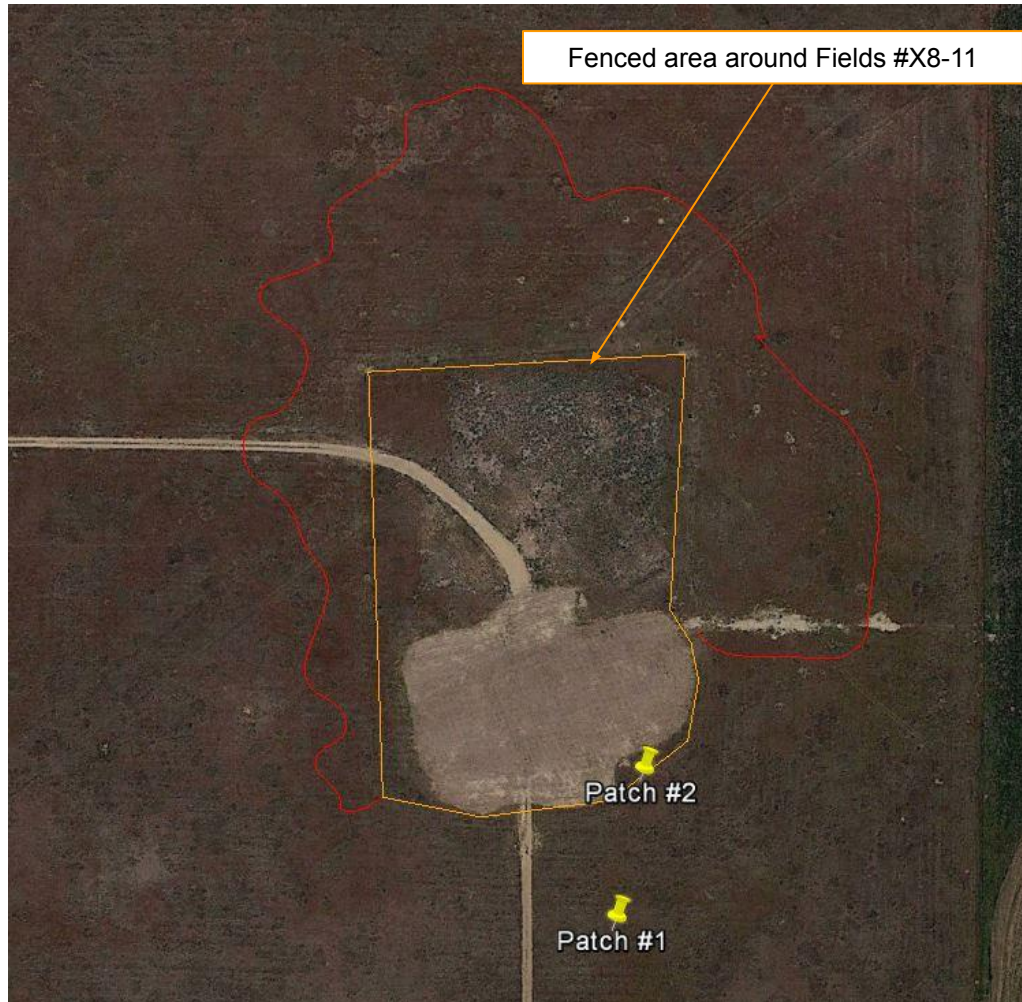
Google Earth aerial imagery taken 6/9/2017, illustrating the approximate fenced area (orange line) and the approximate extent of Scotch thistle (red line) that was established on July 3, 2018. This red line area is the extent to which the Operator is responsible for controlling Scotch thistle. However, if the Operator fails to properly control Scotch thistle within this red line and lets the noxious weed go to seed then this extent could change.

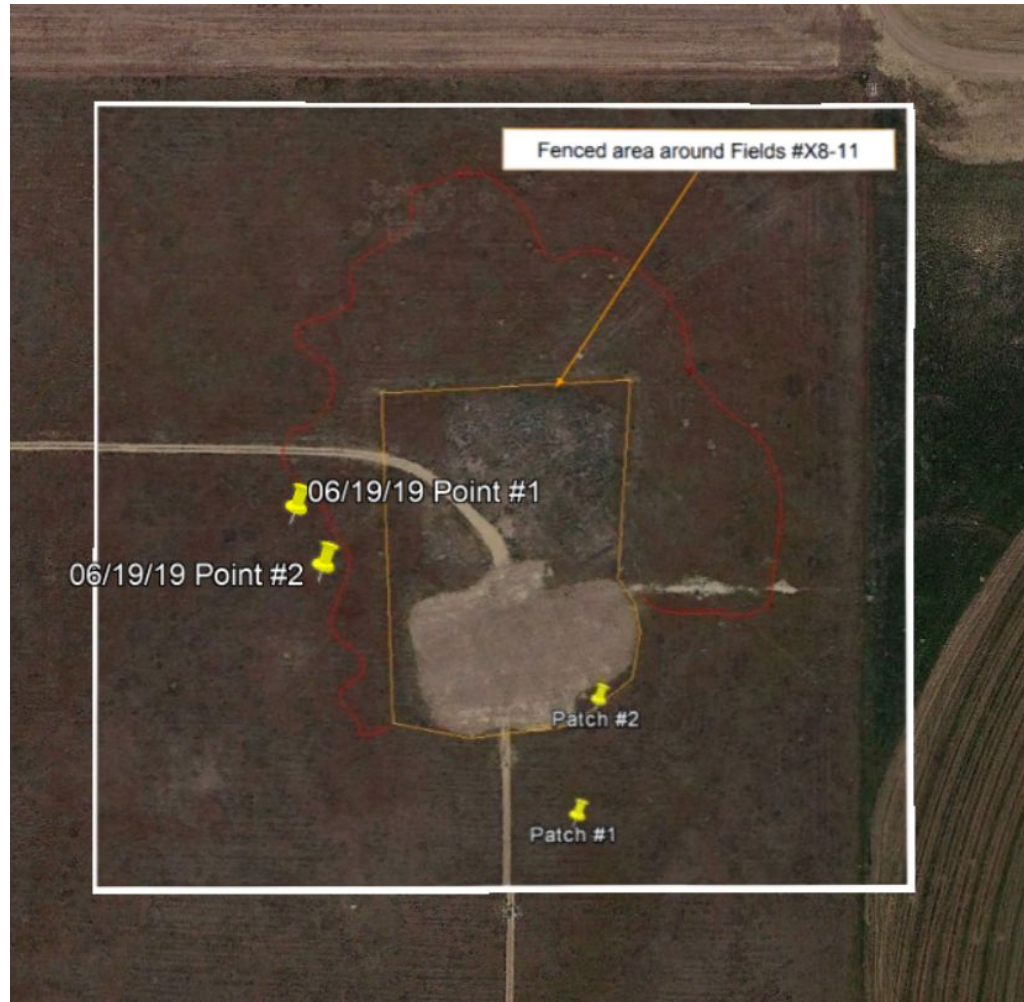
COGCC staff conducted an inspection on June 19, 2019 in response to a complaint about a grass species and Scotch thistle. Staff assessed whether or not the Operator was within compliance for controlling Scotch thistle within the red line area. Staff took two points where it appeared the westernmost thistles were being managed by the Operator. It appears the Operator is controlling Scotch within its responsible extent, if not slight beyond- see Photos 2 & 3.

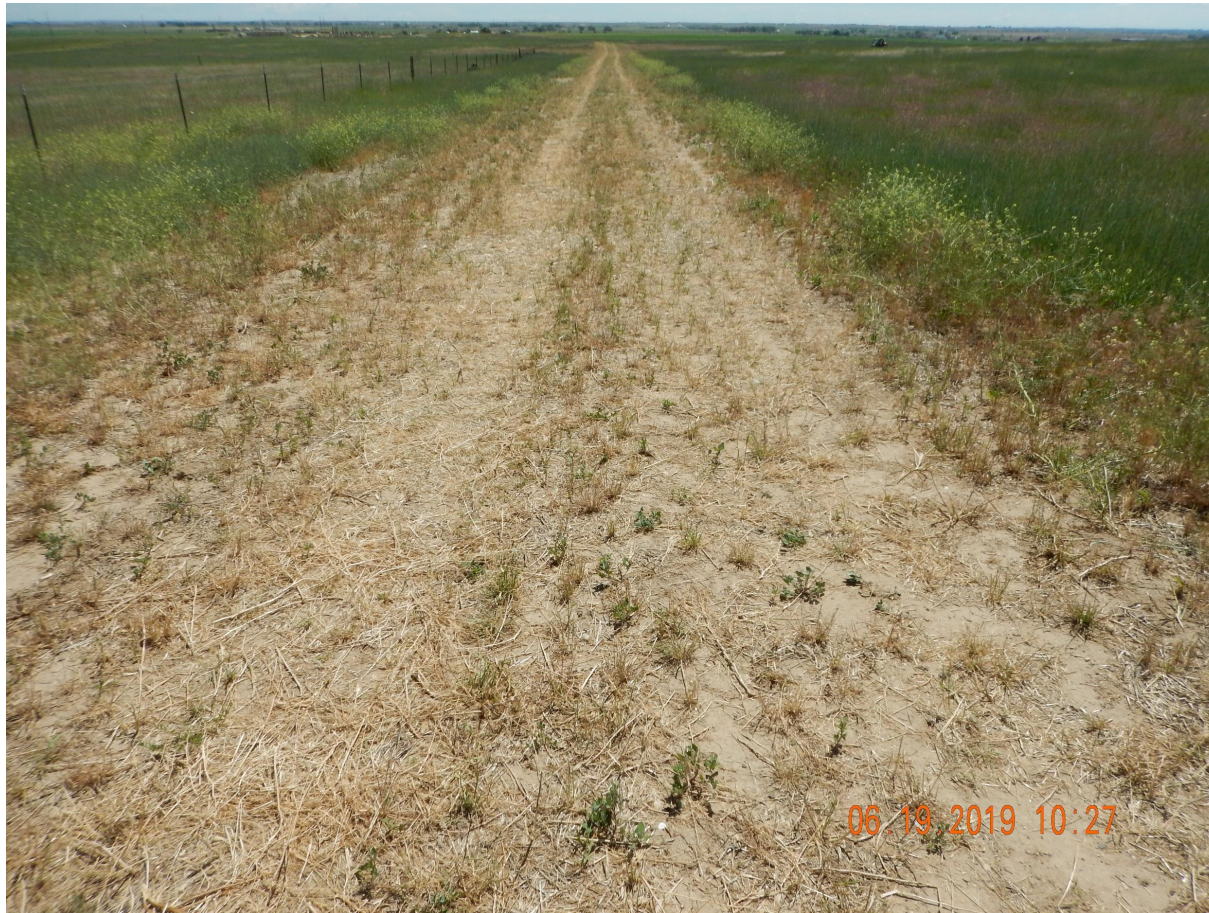
**Photo 1.** Photo taken from the western access road, facing East. Photo illustrates the establishment of *Hordeum jubatum* throughout most of the access road. Surface owner thought this was a listed weed species; however, it is a native cool season grass. Therefore, there is no violation with the presence of this grass species.

Operator plans to perform compaction alleviation and reseed the access road as soon as possible in response to the lack of establishment of desirable species.

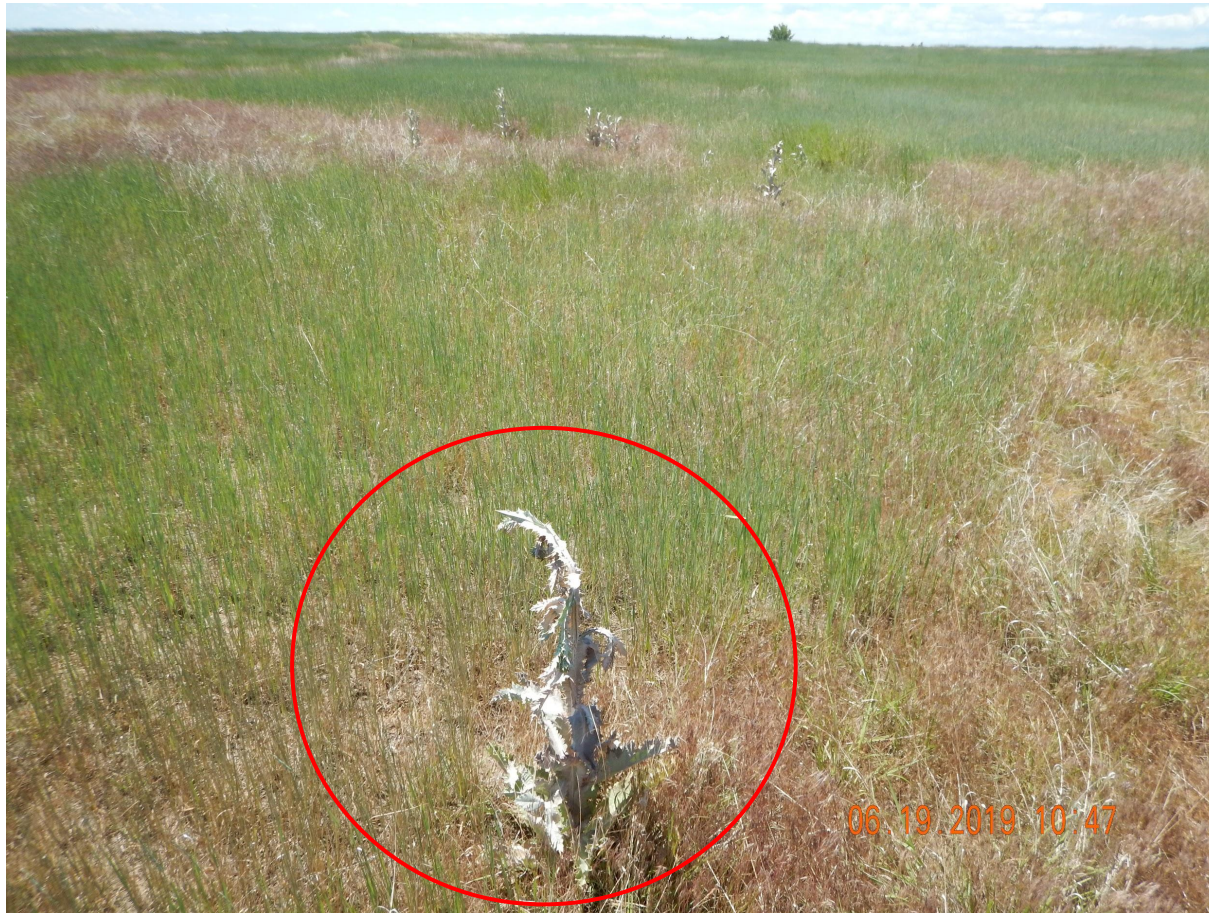
**Photo 2.** Photo taken from the 6/19/19 Point #1 location. Photo illustrates an individual Scotch thistle plant that appears to have been recently sprayed as it appears to be wilting.

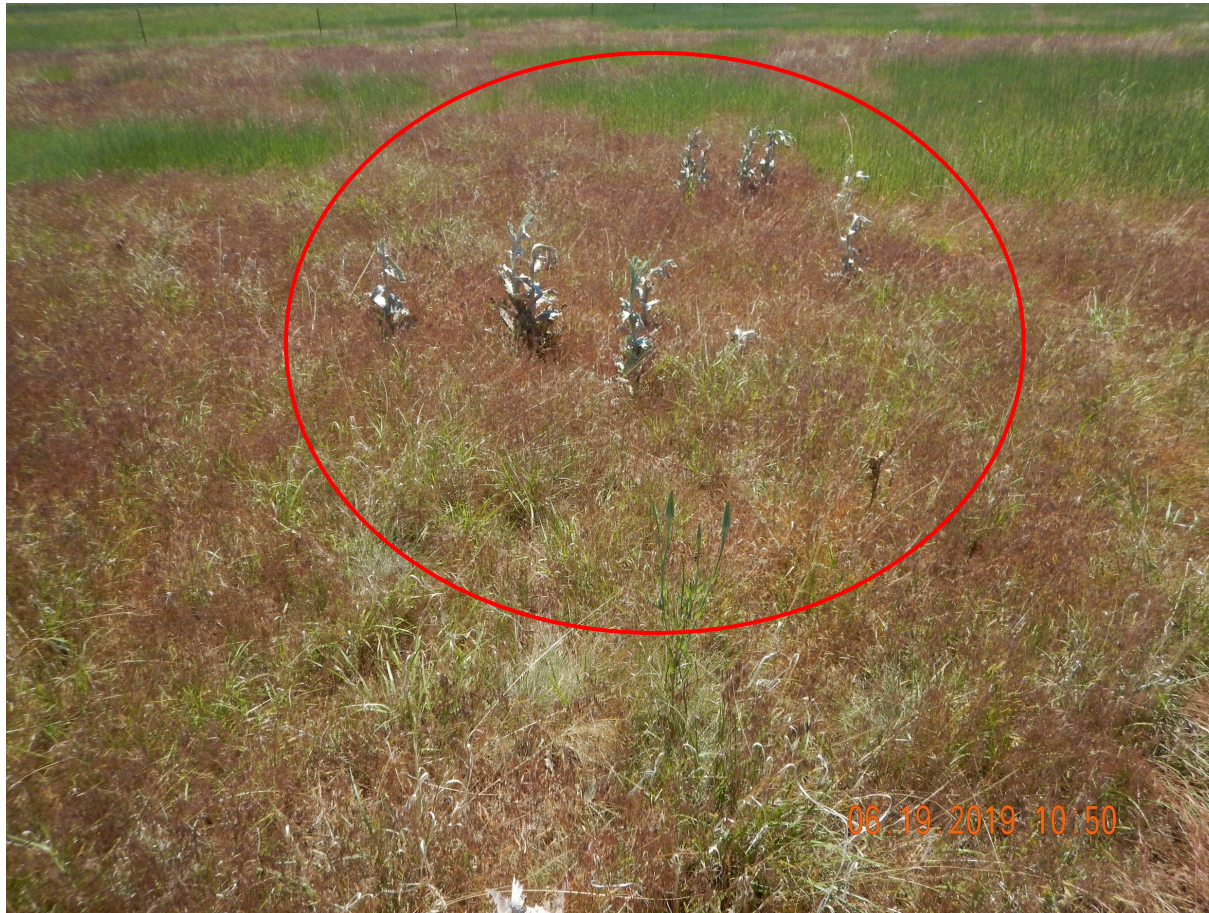
**Photo 3.** Photo taken from the 6/19/19 Point #2 location. Photo illustrates a group of Scotch thistle plants that appear to have been recently sprayed as they appear to be wilting.
