# Interim Reclamation and Stormwater Inspection

Operator: KERR MCGEE OIL & GAS ONSHORE LP- #47120

Location ID: 458702

Inspection Photos  
Location Name: BUDDY /17-7HZ  
Location ID: 458702

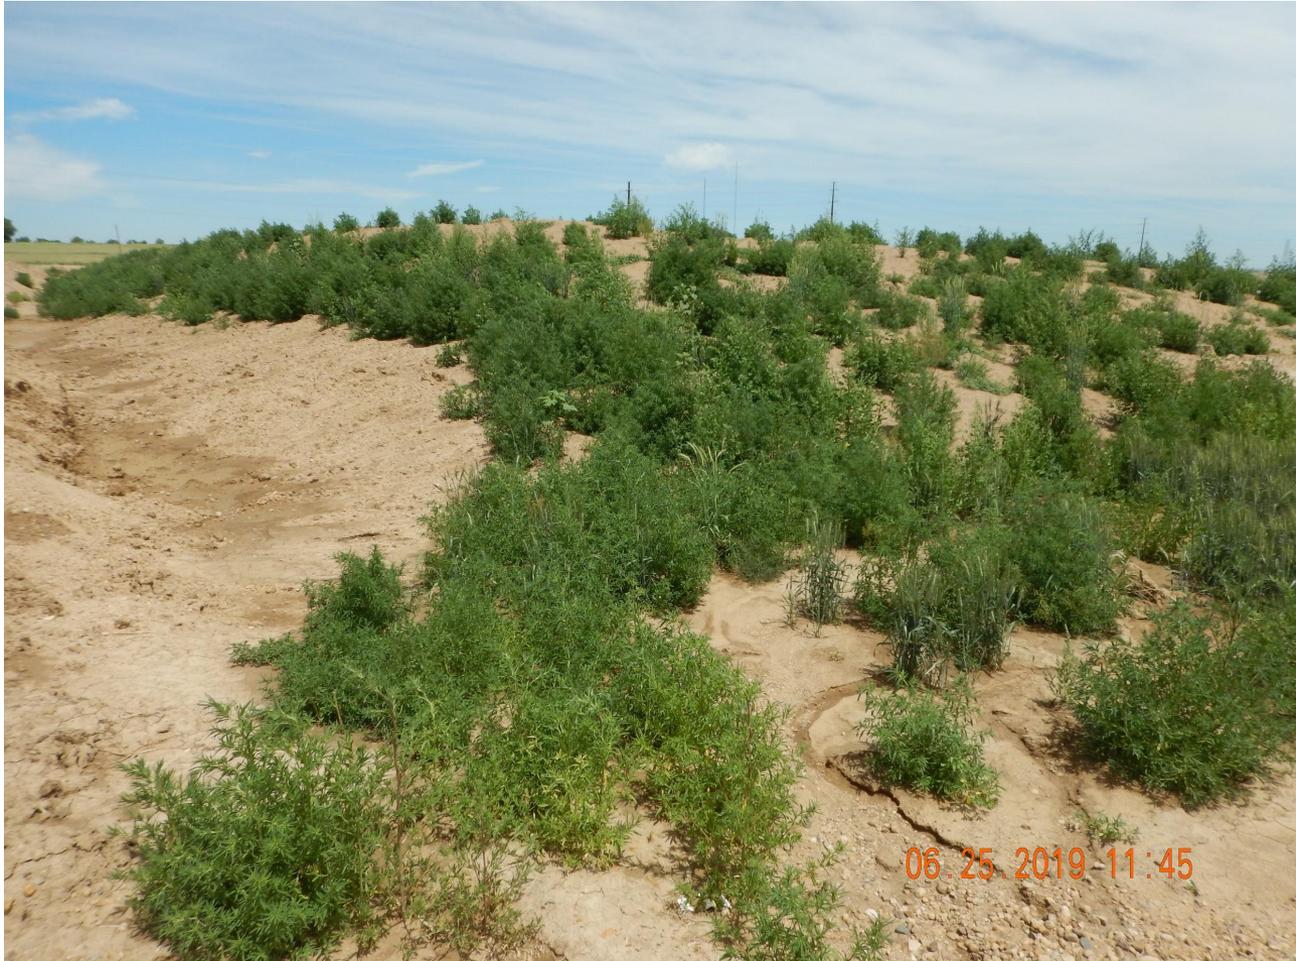
**Photo 1.** Photo taken of the northern topsoil stockpile, facing North. Photo illustrates the Operator has failed to protect the topsoil from erosion and weed establishment. Weeds were approximately 3' tall and erosion was observed throughout the stockpile.

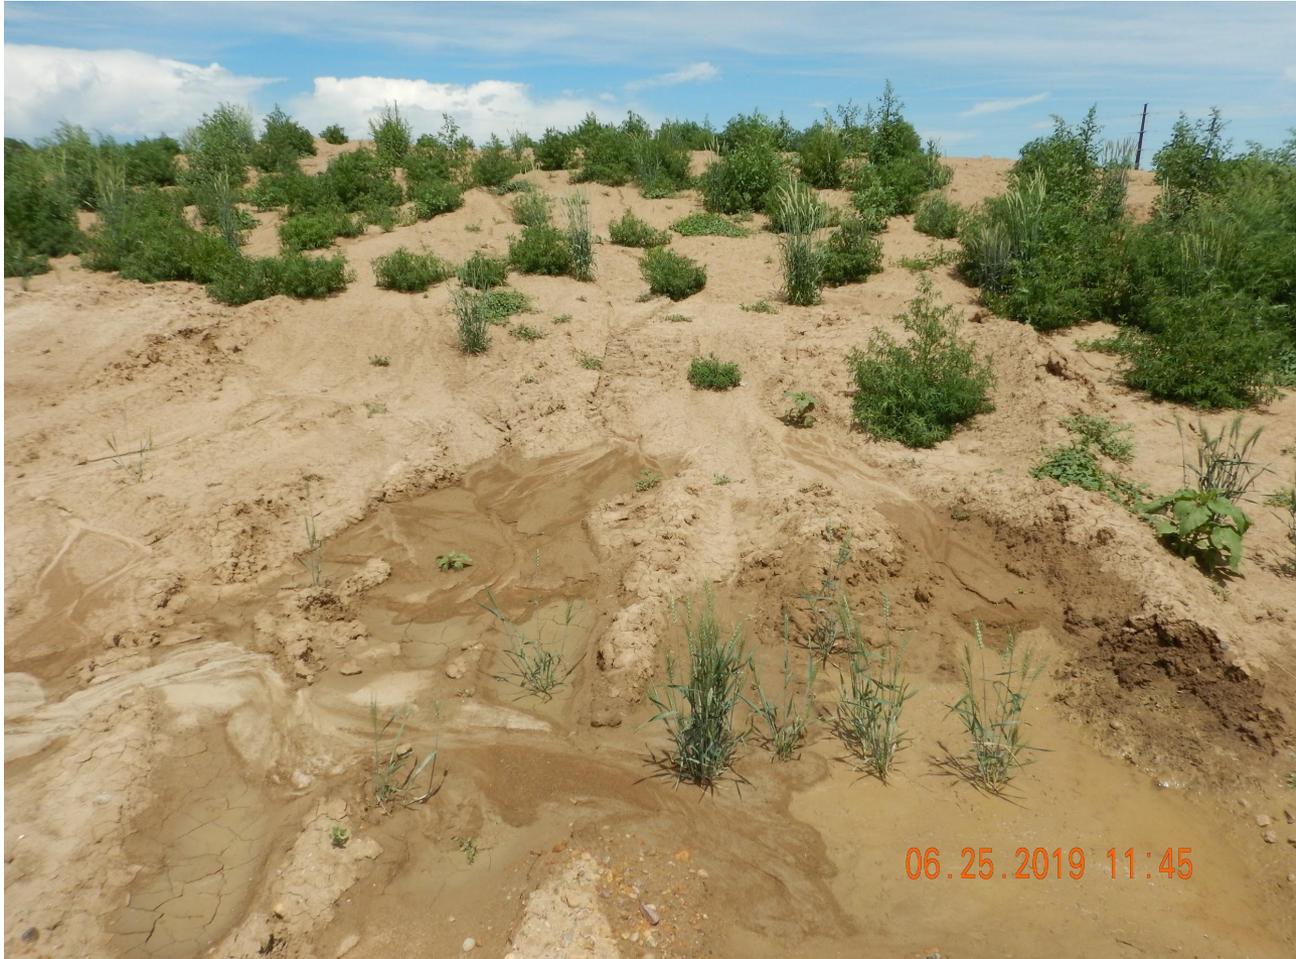
**Photo 2.** Photo taken from the south-side of the northern topsoil stockpile, facing North.  
See comments under Photo 1.

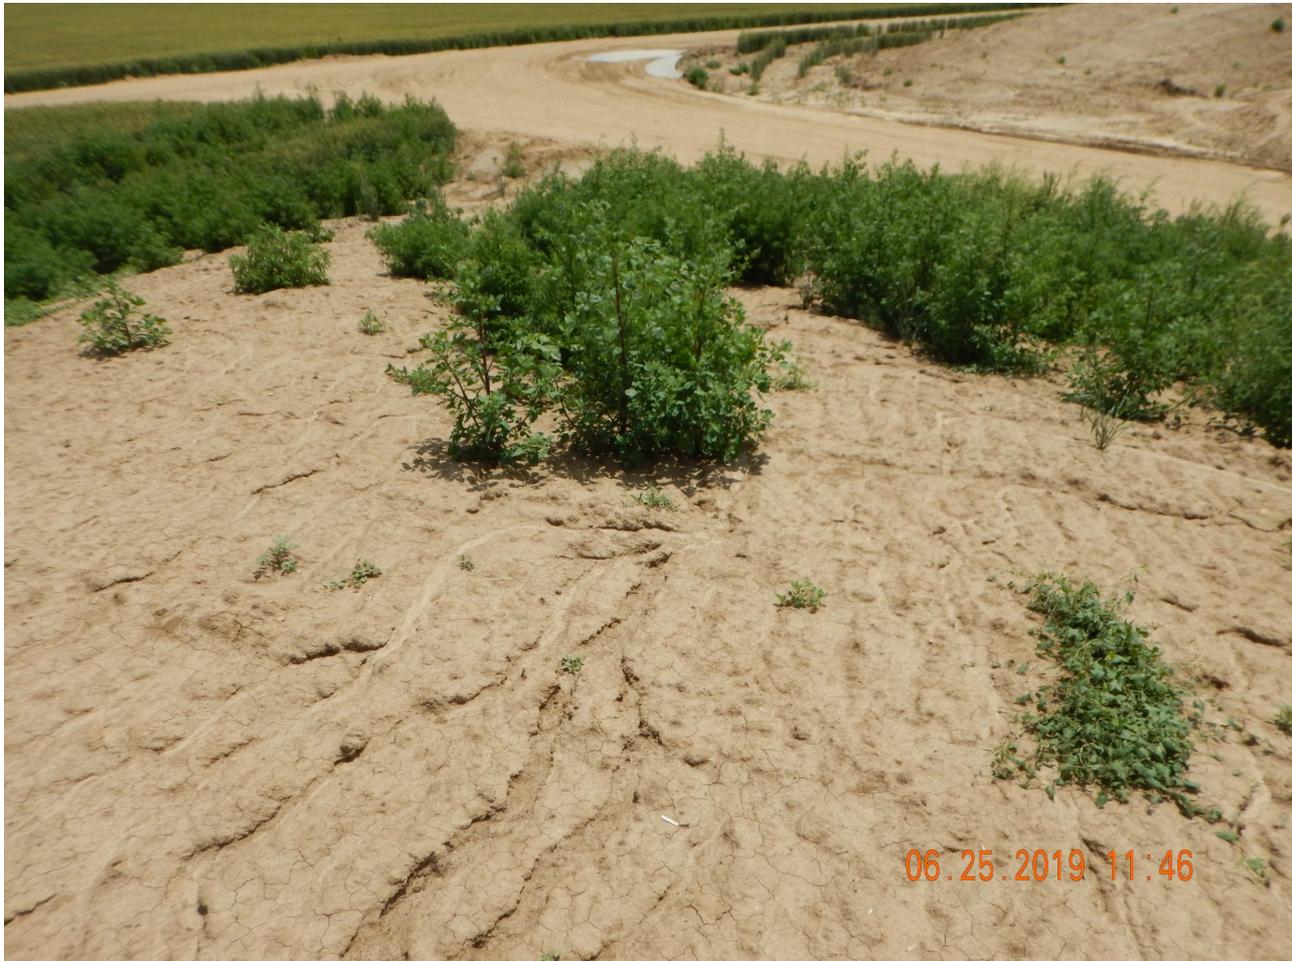
**Photo 3.** Photo taken from the south-side of the northern topsoil stockpile, facing South.  
See comments under Photo 1.

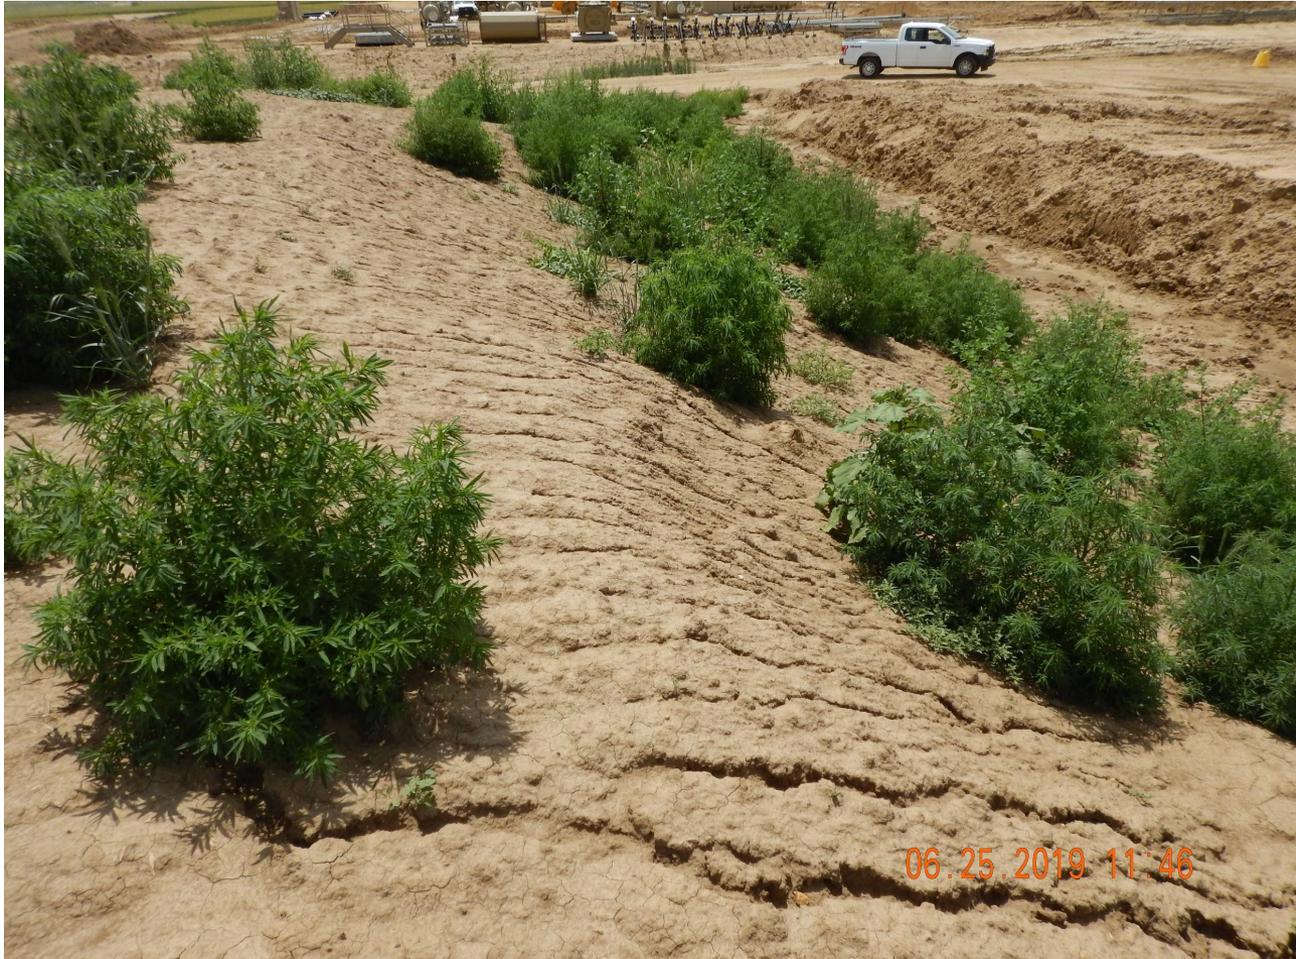
**Photo 4.** Photo taken from the west-side of the northern topsoil stockpile, facing South.  
See comments under Photo 1.

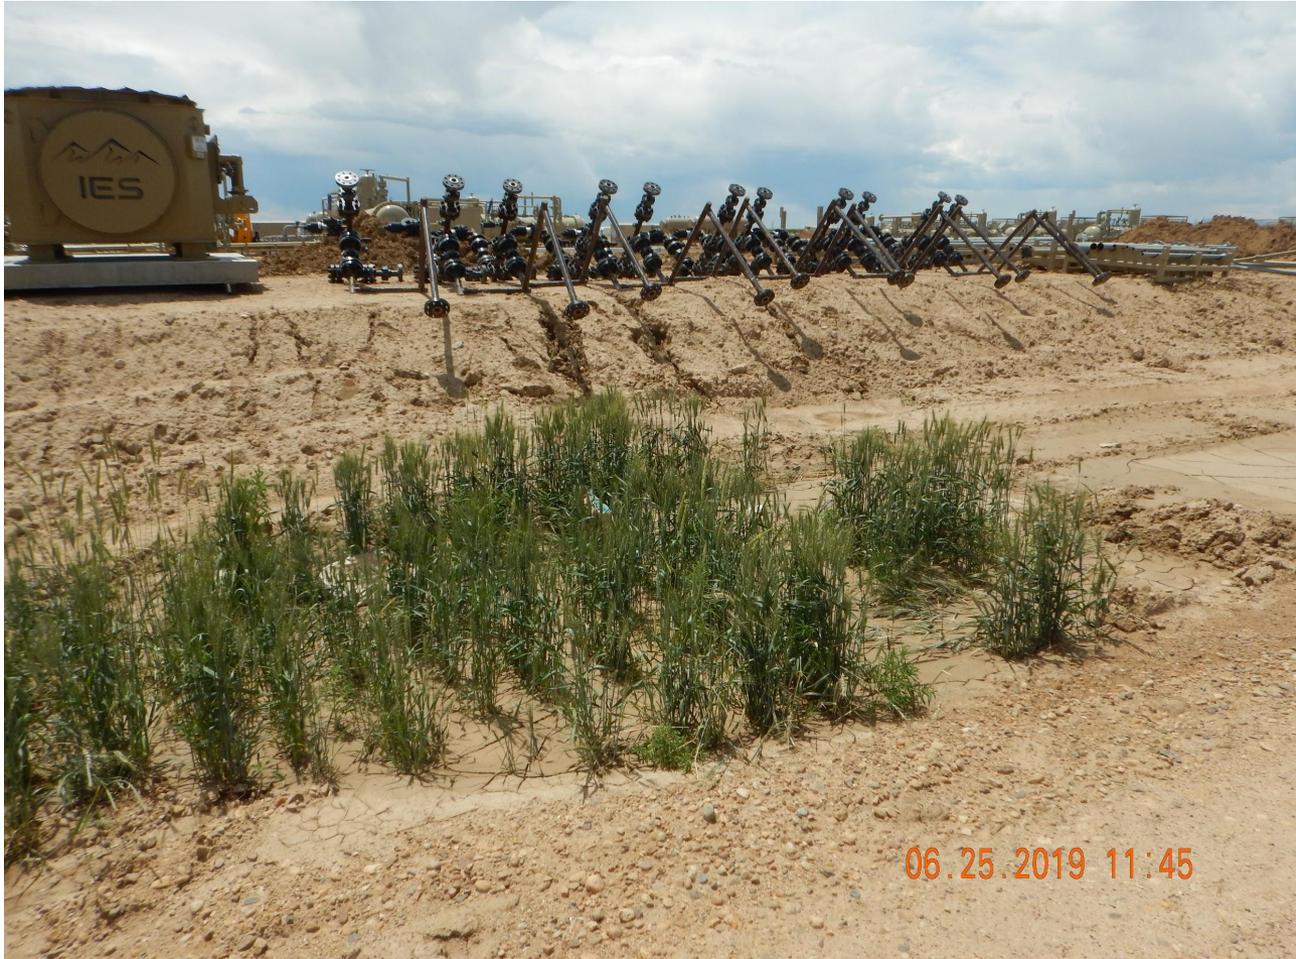
**Photo 5.** Photo taken of the fill slope of the southern pad, facing South. Photo illustrates the Operator has failed to maintain the location so as to reasonably minimize erosion, and site degradation per Rules 1002.e. and 1002.f.

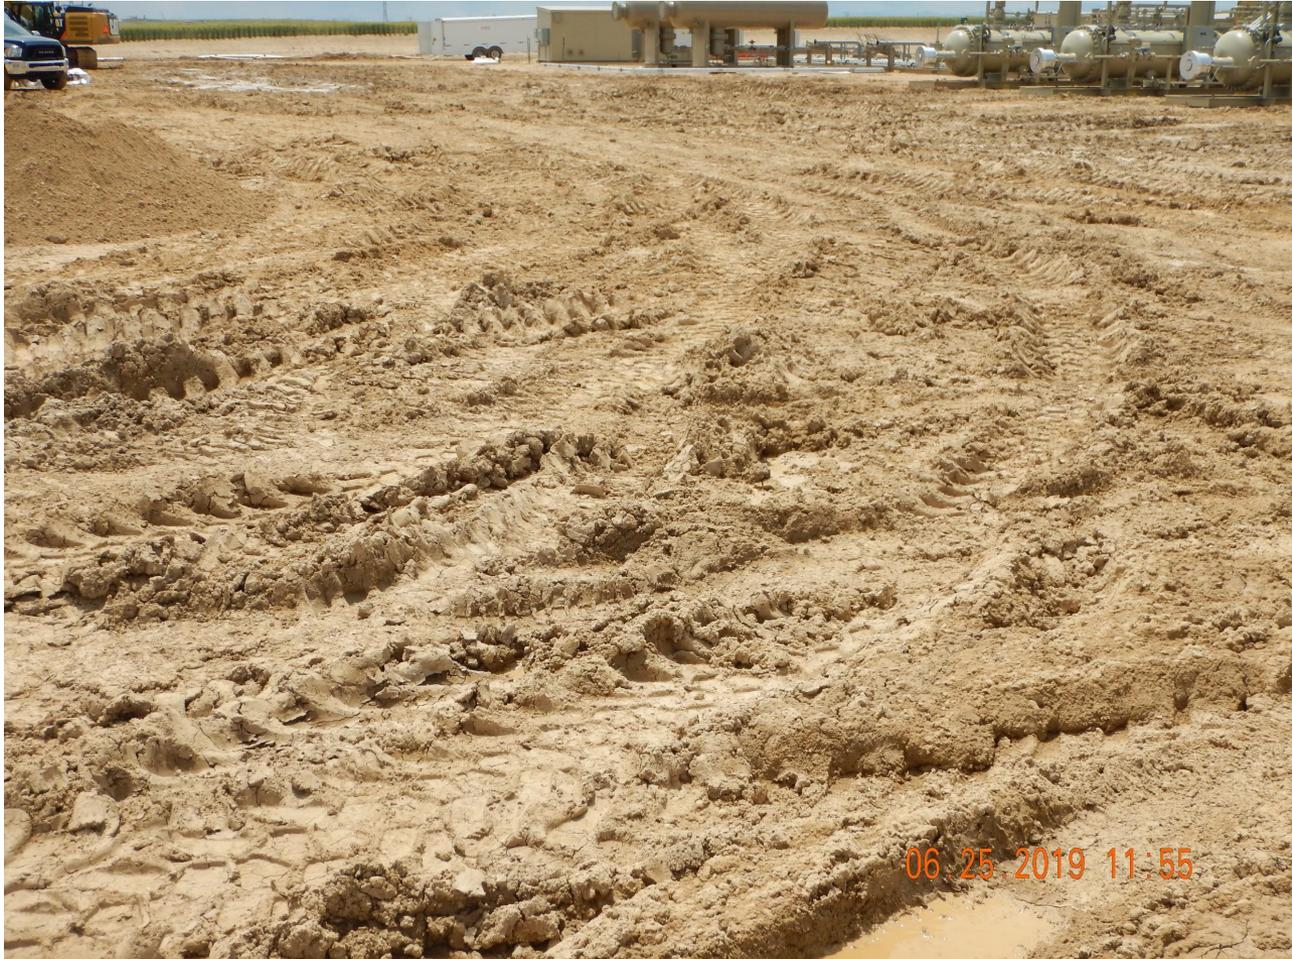
**Photo 6.** Photo taken from the southern pad, facing East. See comments under Photo 5. Photo also illustrates rutting throughout the location which the Operator is tracking off location because there are no vehicle tracking device BMPs at either of the entrances. The vehicle tracking device has only been installed at the intersection of CR 15.

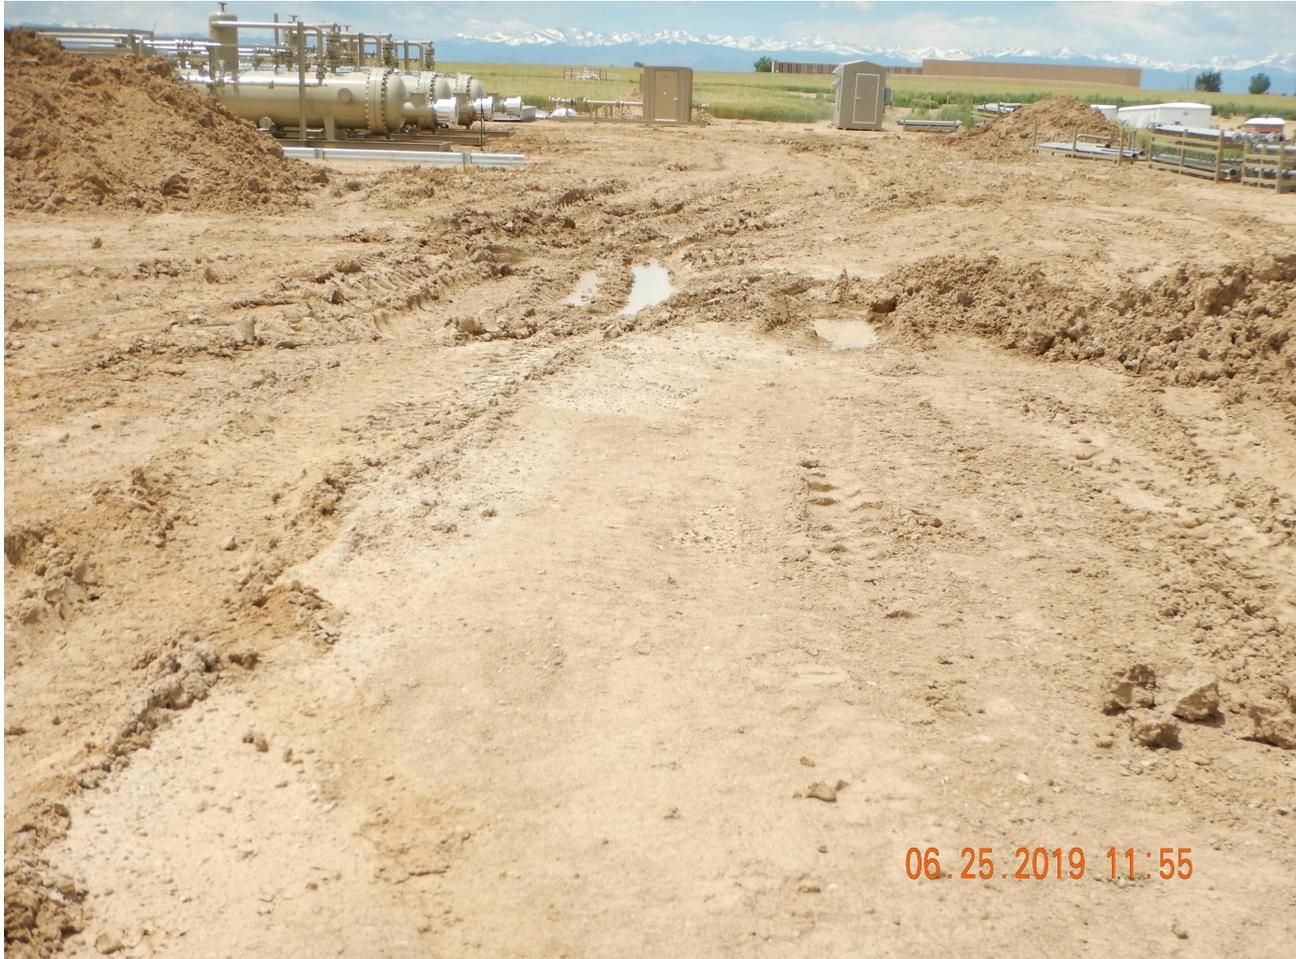
**Photo 7.** Photo taken from the southern pad, facing West. See comments under Photo 6.

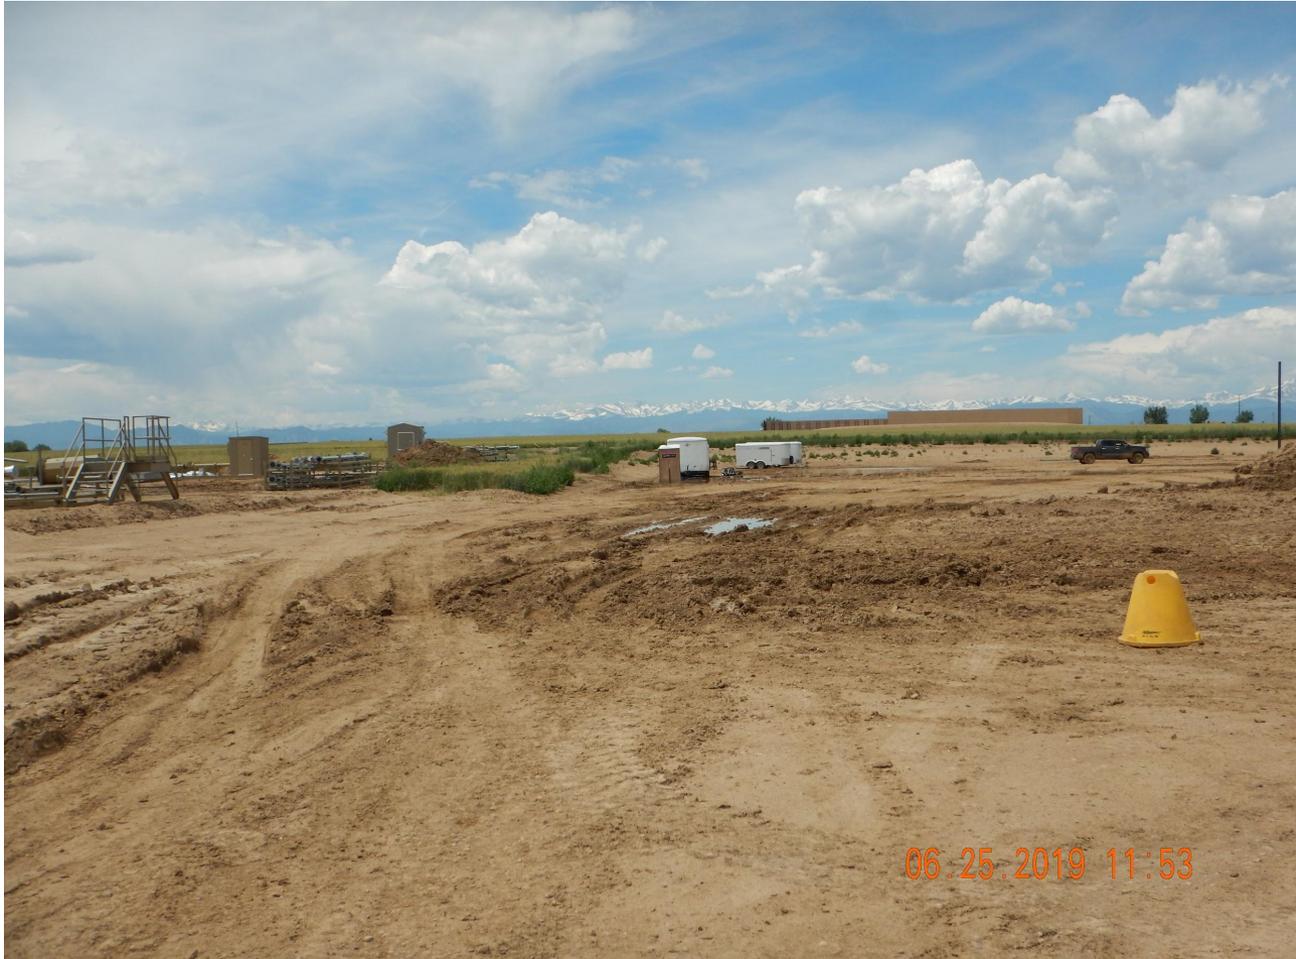
**Photo 8.** Photo taken from the northern pad, facing West. See comments under Photo 6.
