Interim Reclamation Inspection

Operator: K P KAUFFMAN COMPANY INC - 46290

API: 05-123-09493

Location Name: MILTON H. NELSON UNIT B #1

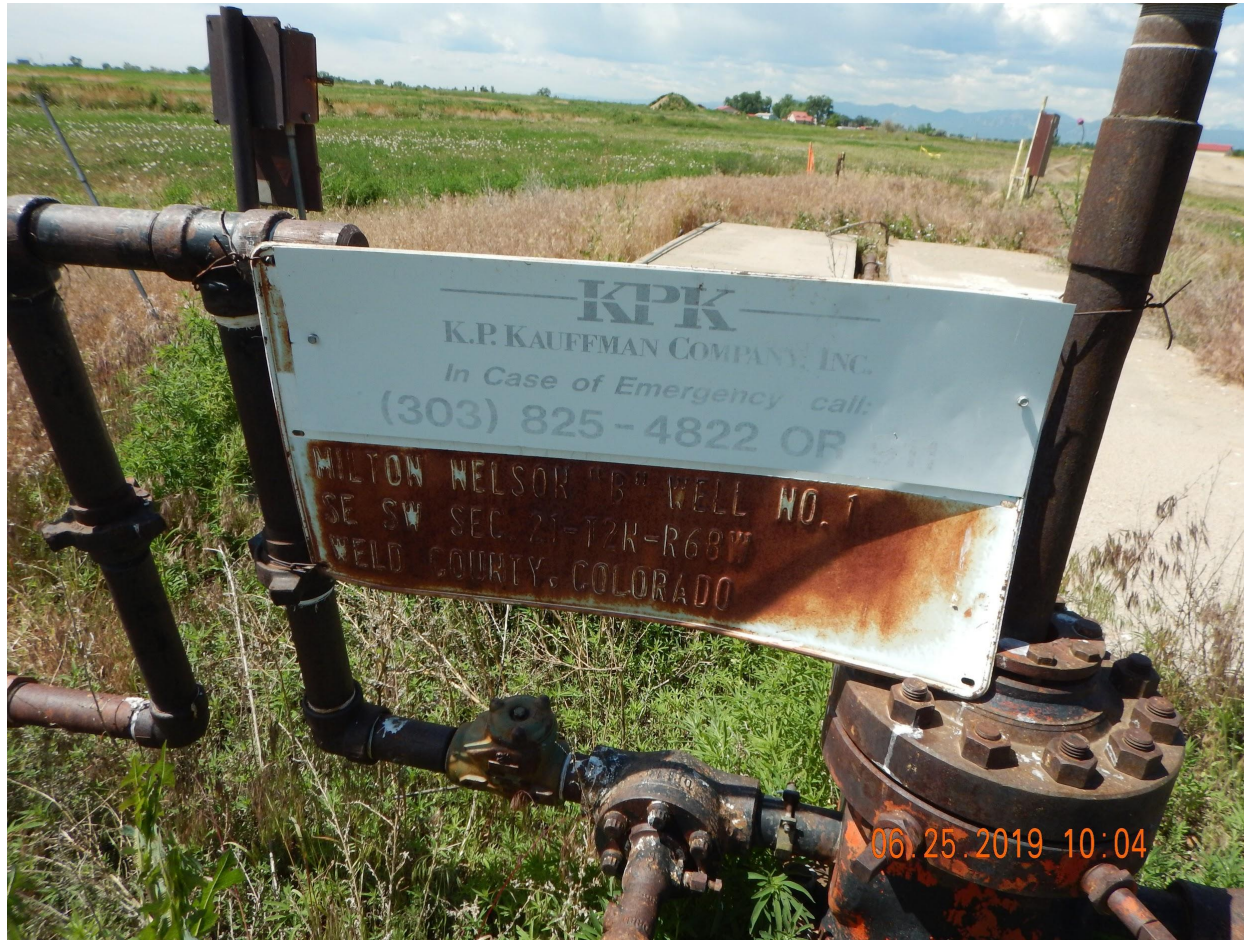
Photo 1. Photo taken from the well sign, facing West. Operator sign is fading and may need to be replaced in the near future.

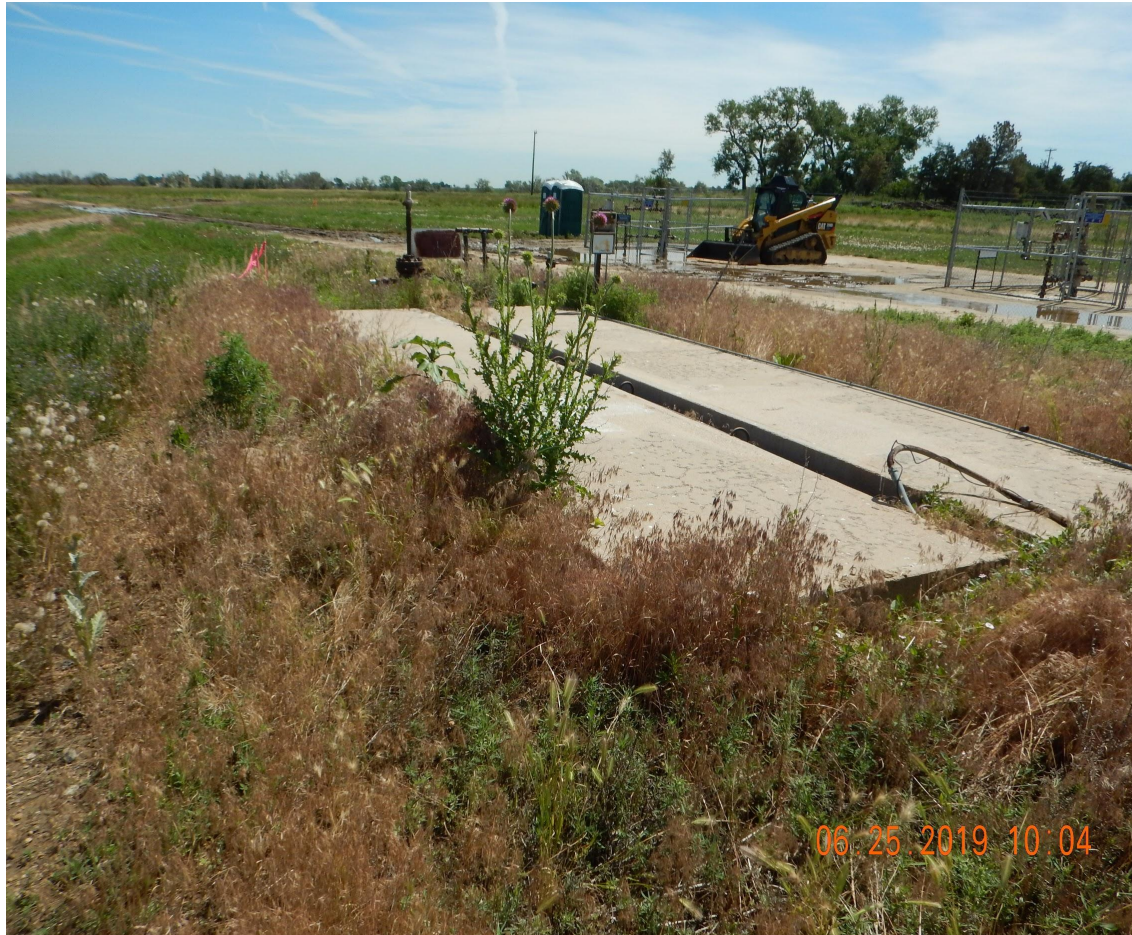
Photo 3. Photo taken from the western location, facing East. Pumpjack is no longer in use and has been gone for at least 9 years; therefore, Operator shall remove the concrete slabs.

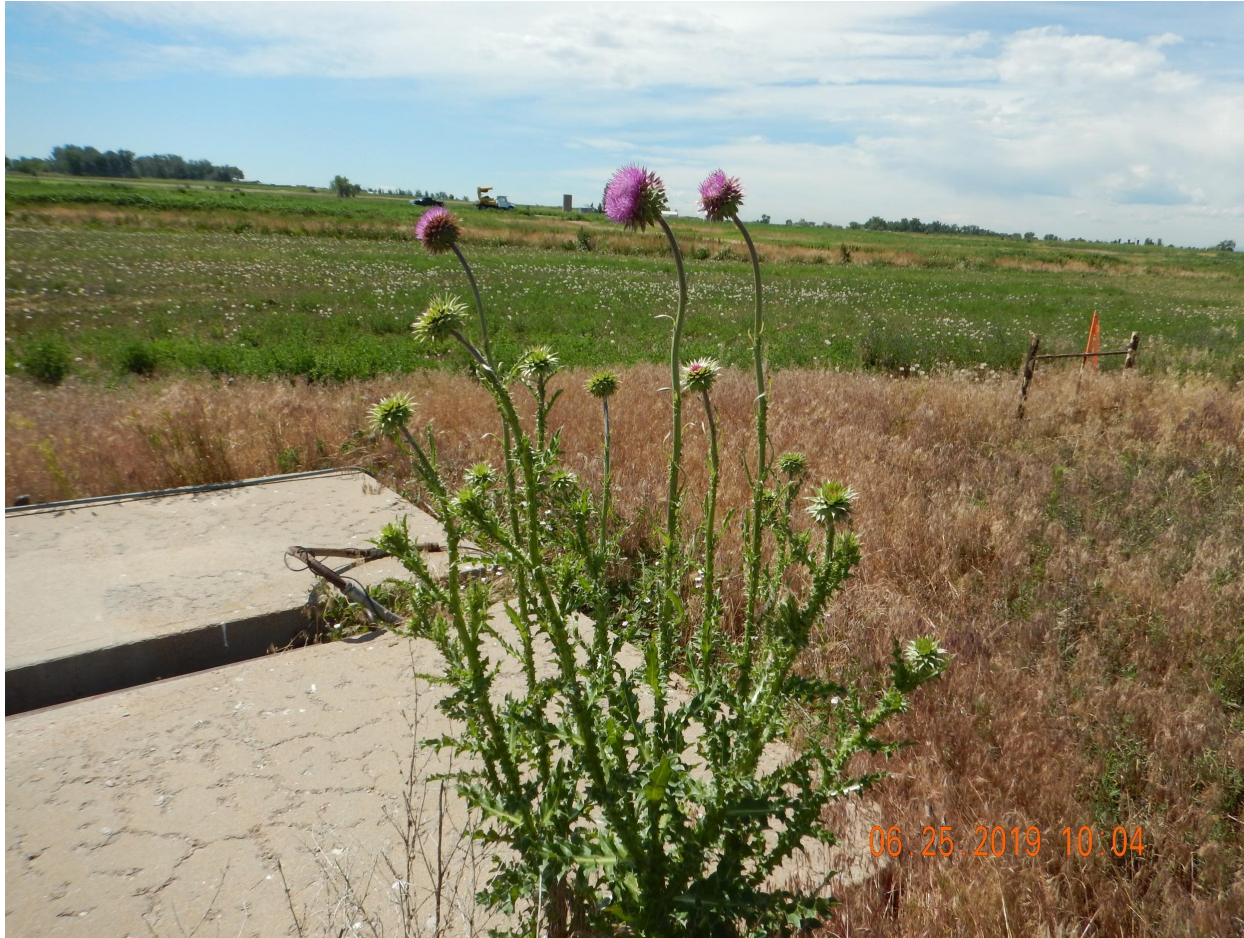
Photo 4. Close up photo taken of a List B Colorado Noxious weed, Musk thistle, that is not being managed. Operator shall immediately control and manage all noxious weeds.
