Interim Reclamation and Stormwater Inspection

Operator: NOBLE ENERGY INC- #100322

Location ID: 434344

Location Name: No Worries PC /G14-63-1HN Tank

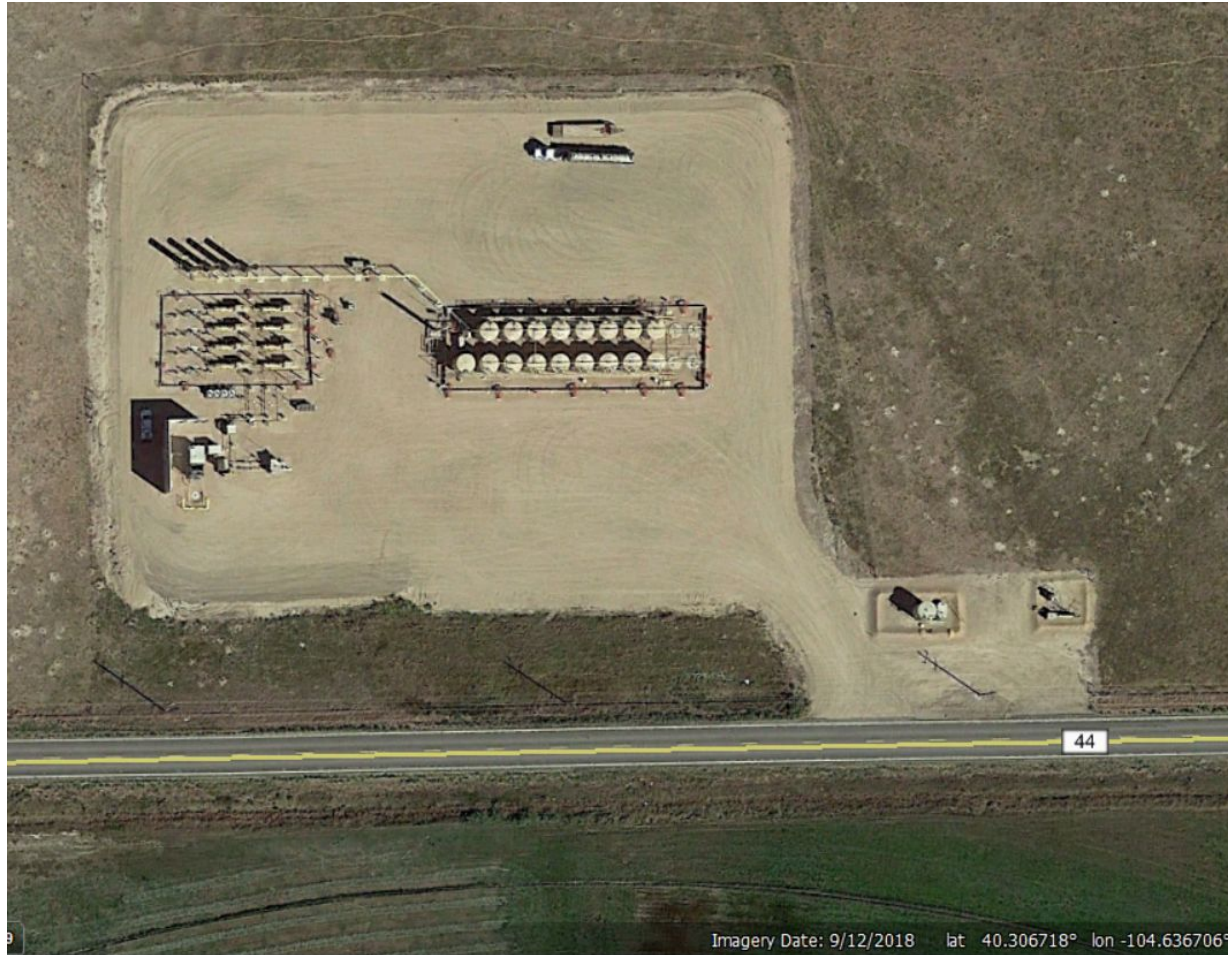
Google Earth aerial imagery taken on 9/12/2018 illustrates that portions of the Production Facility area do not appear to be needed for production operations. Operator shall comply with Rules 1002 and 1003.

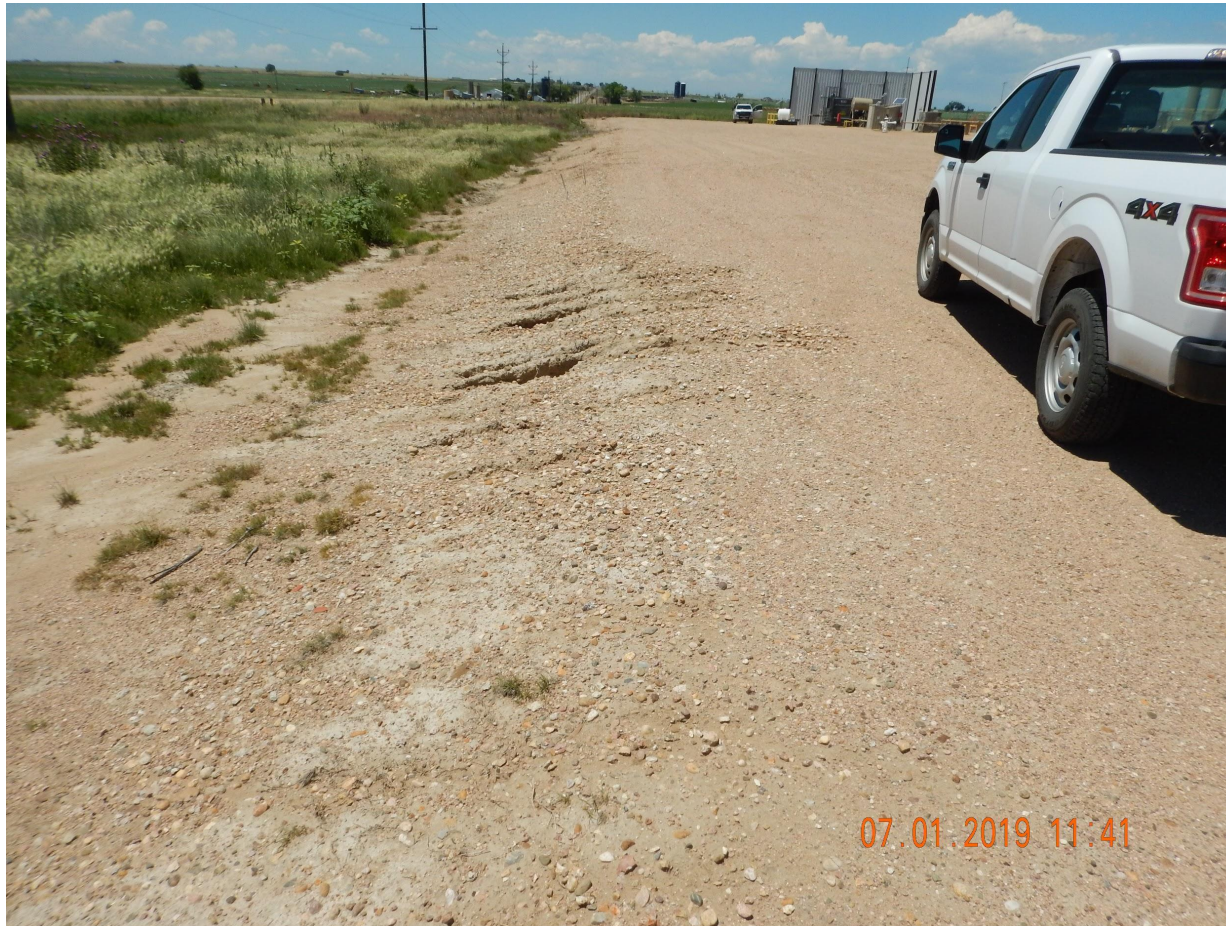
Photo 1. Photo taken from the southeastern location, facing West. Site degradation due to erosion was observed along portions of the perimeter of location without stormwater erosion control BMPs.

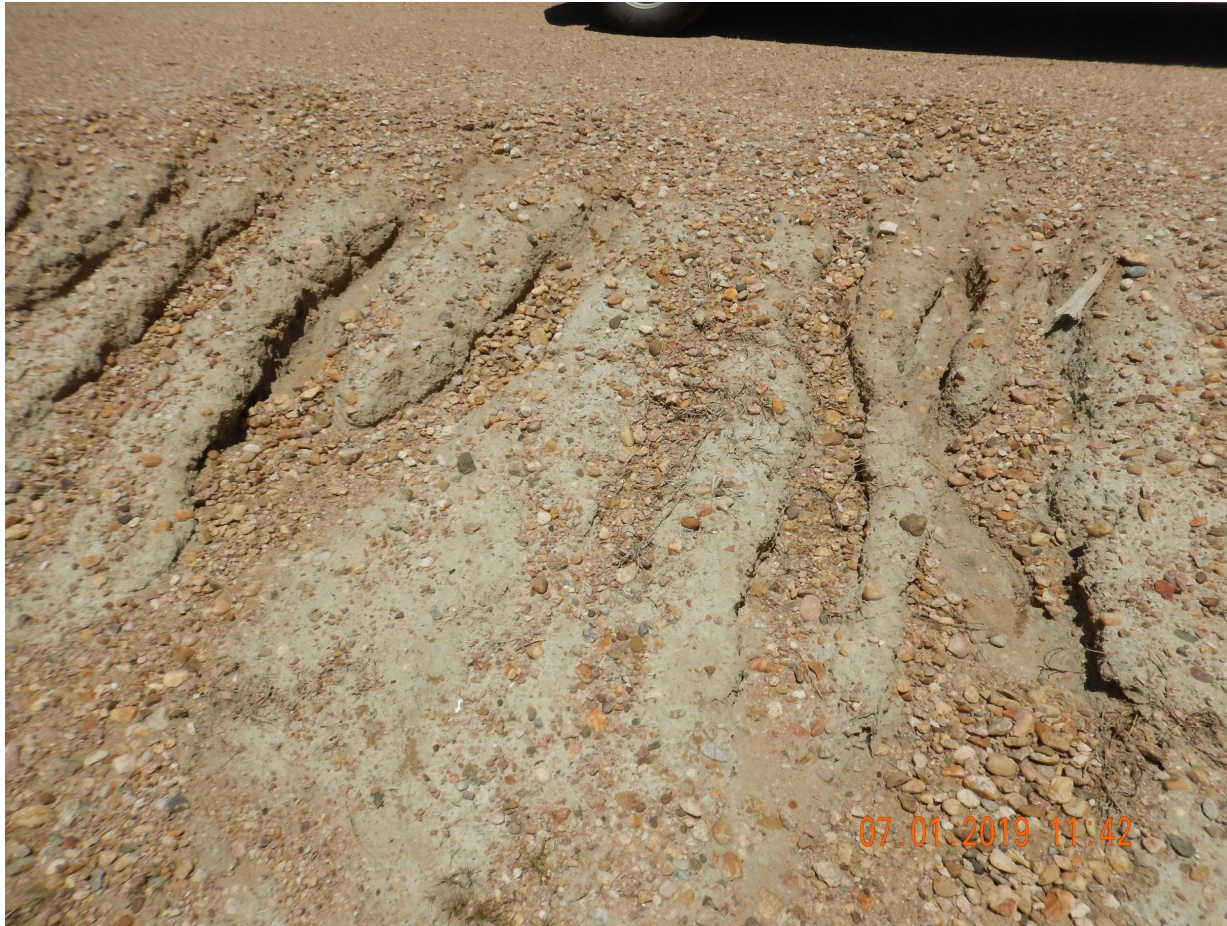
Photo 2. Photo taken from the southeastern location, facing North. Photo illustrates site degradation along the fill slope without stormwater erosion control BMPs.

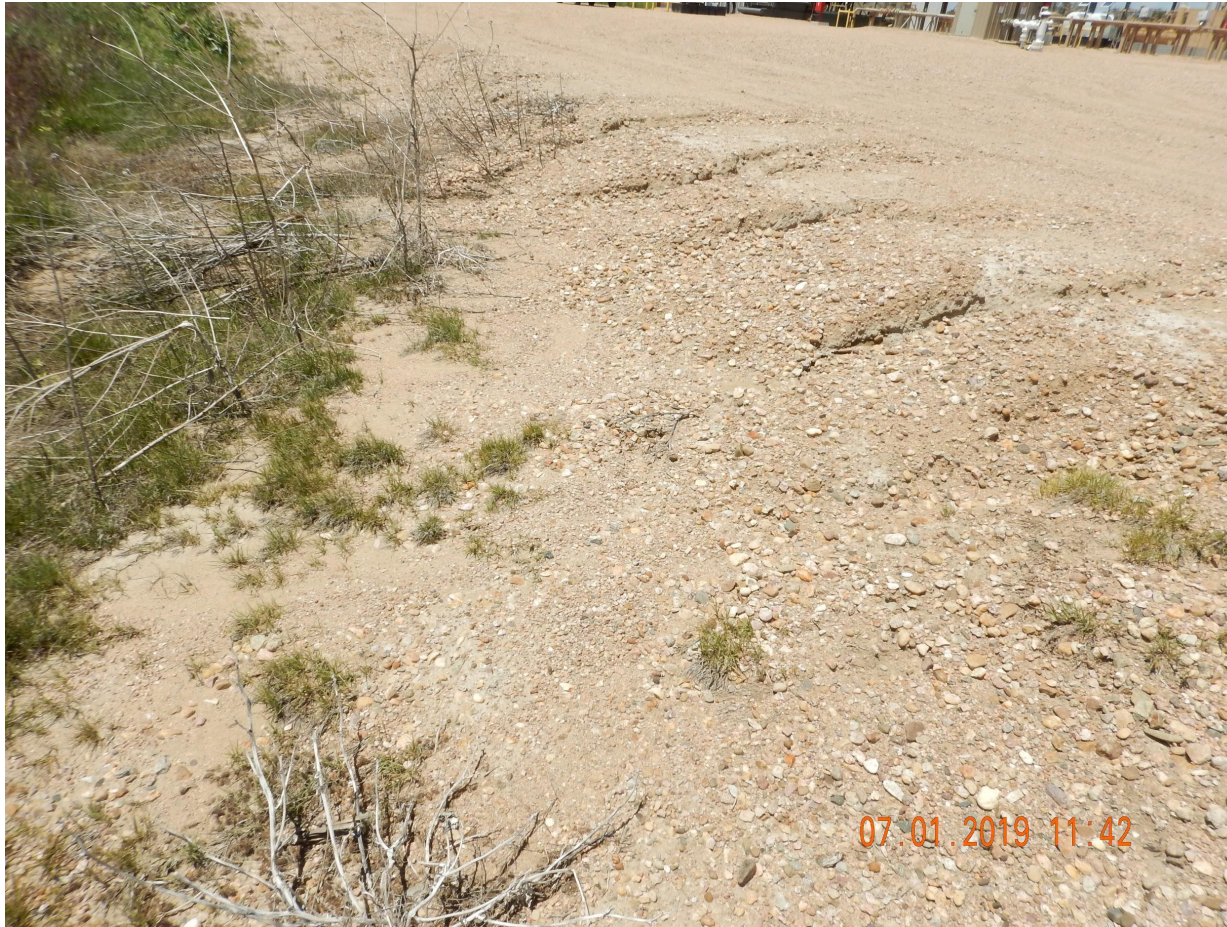
Photo 3. Photo taken along the southern location, facing West. See comments under Photo 2.

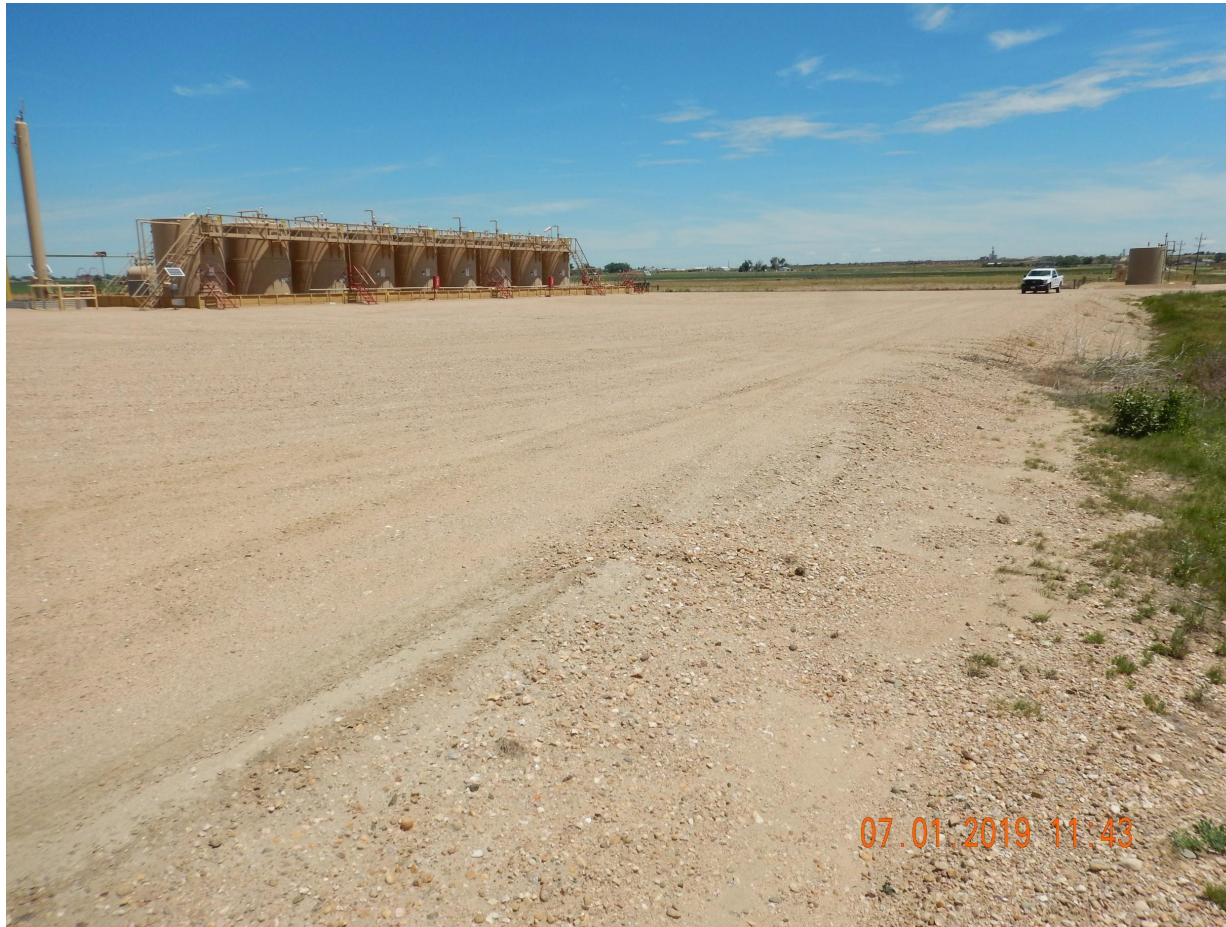
Photo 4. Photo taken along the southwestern location, facing East. Photo illustrates areas that do not appear to be needed for production operations; however, the Operator has not performed interim reclamation. Also, there was no apparent topsoil stockpile to facilitate future reclamation.

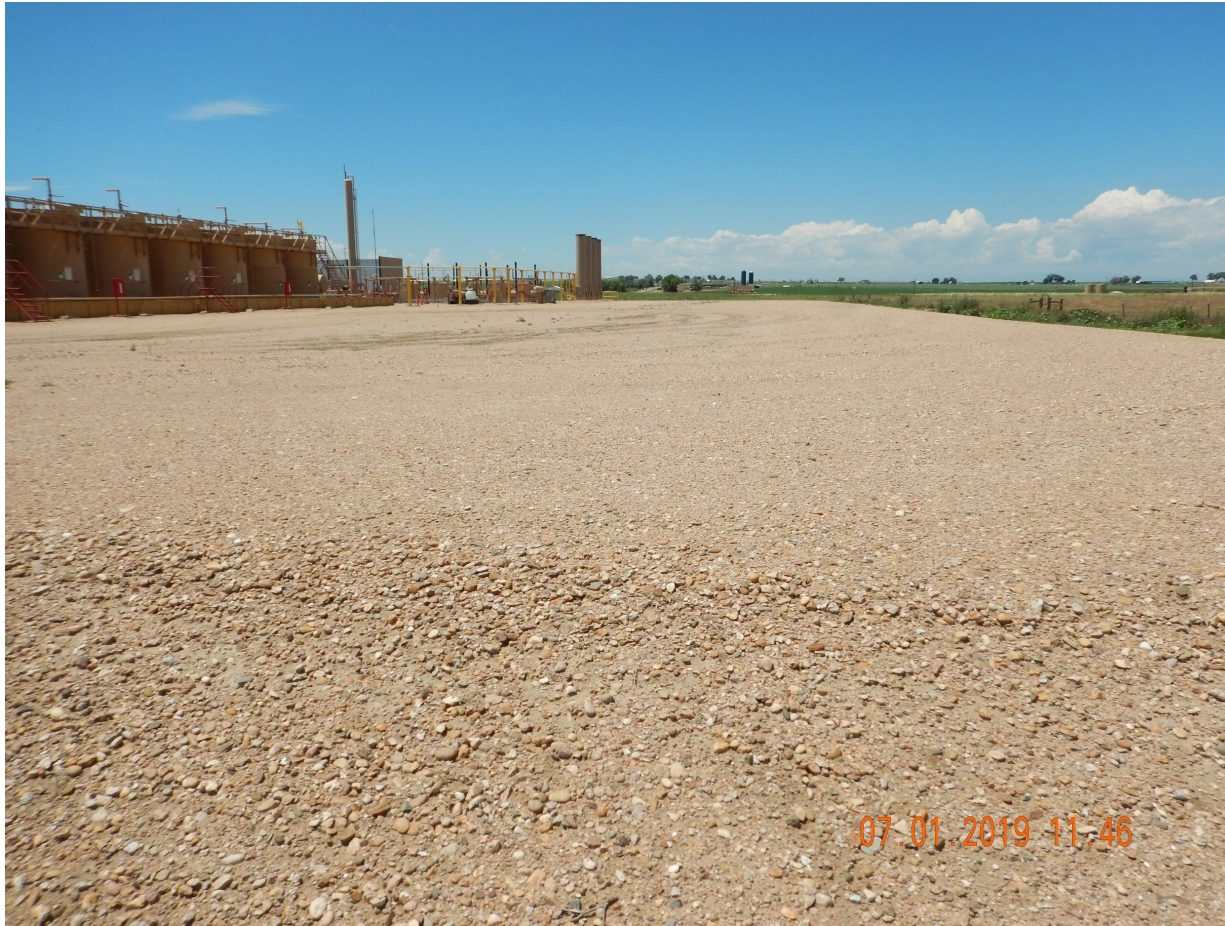
Photo 5. Photo taken along the northeastern location, facing West. See comments under Photo 4.

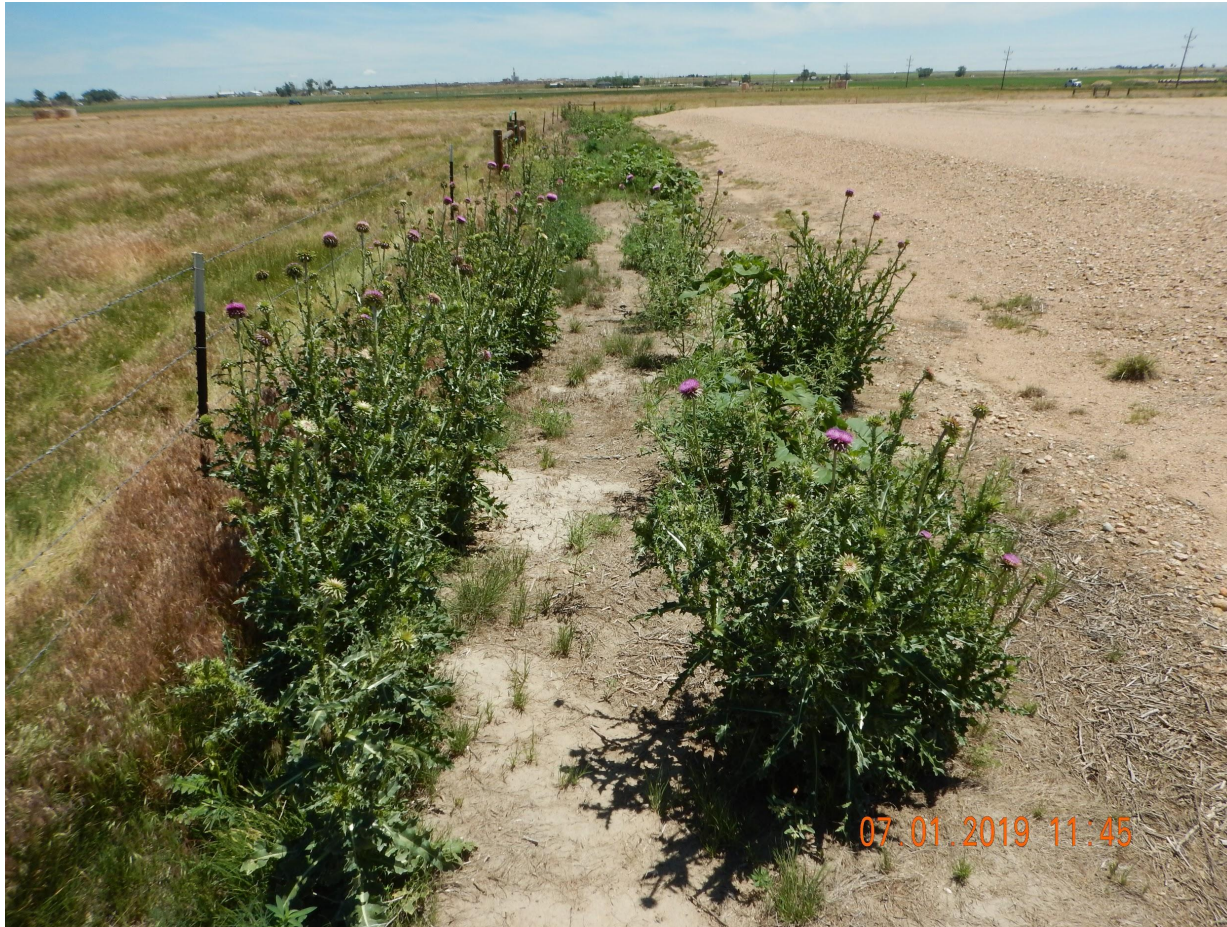
Photo 6. Photo taken along the northern location, facing East. Photo illustrates unmanaged noxious weeds, Musk thistle.

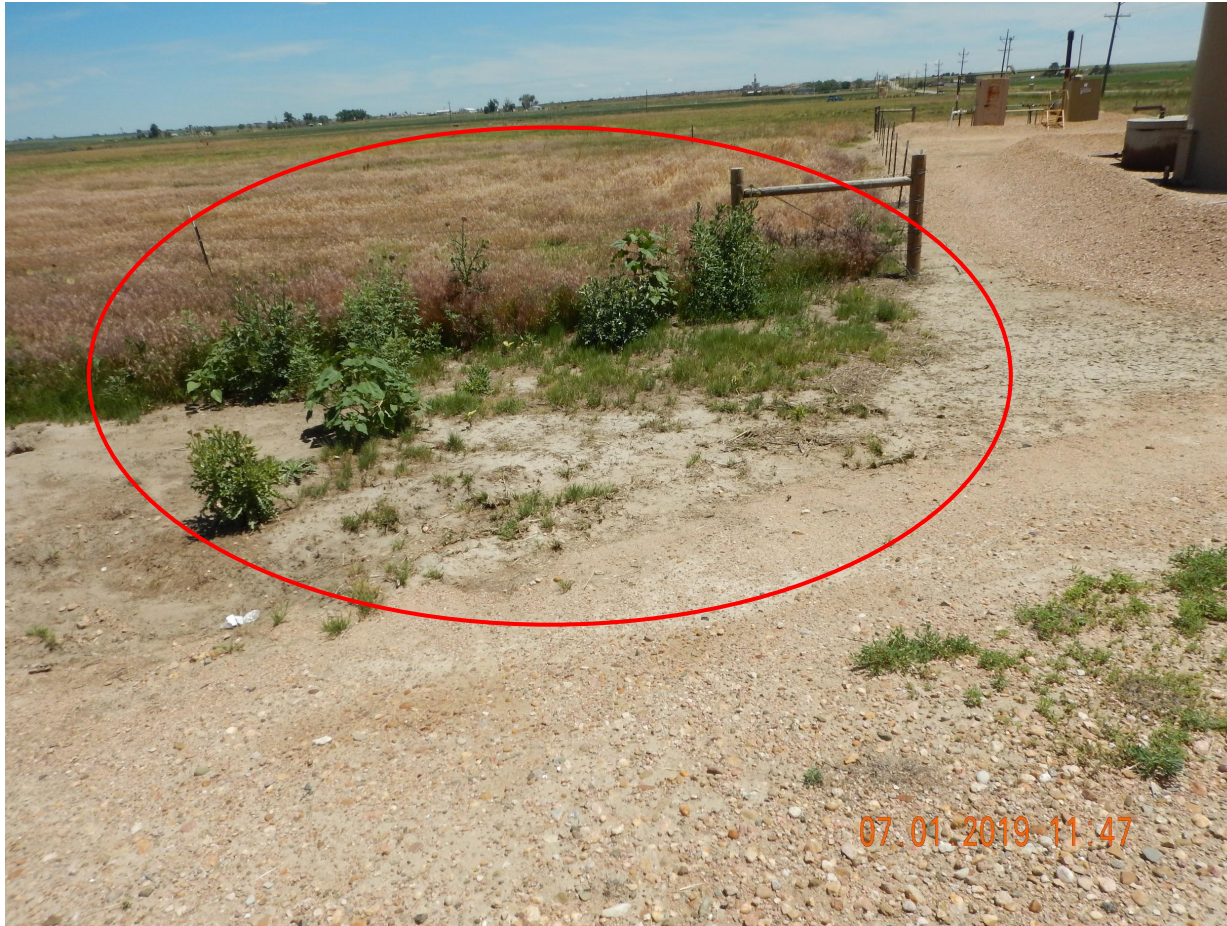
Photo 7. Photo taken from the southeastern location, facing East. See comments under Photo 6.
