Inspection Photos

Location Name: LORENCITO 9-17-34-66

API#: 05-071-06666

INSP. #: 695100976

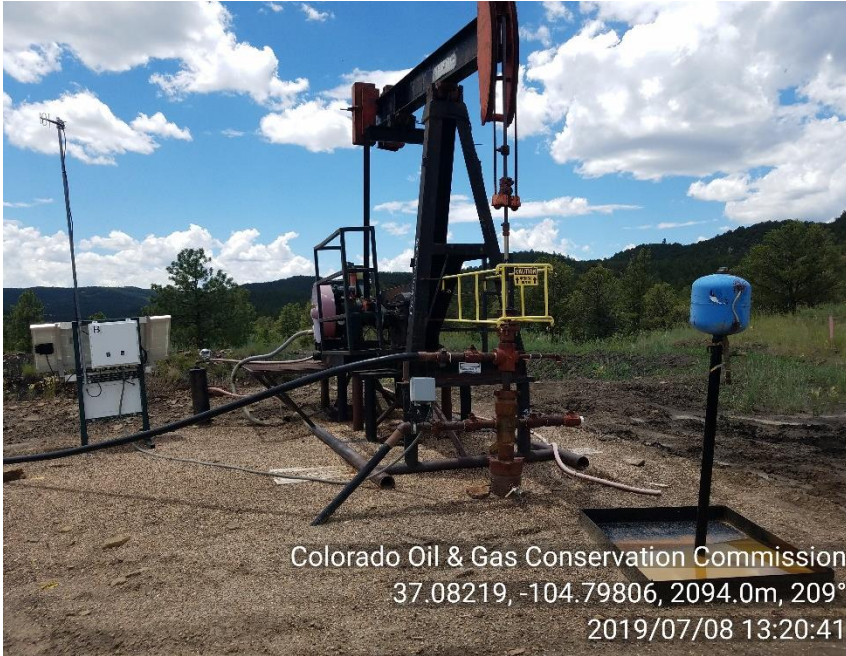
PHOTO 1: WELLHEAD

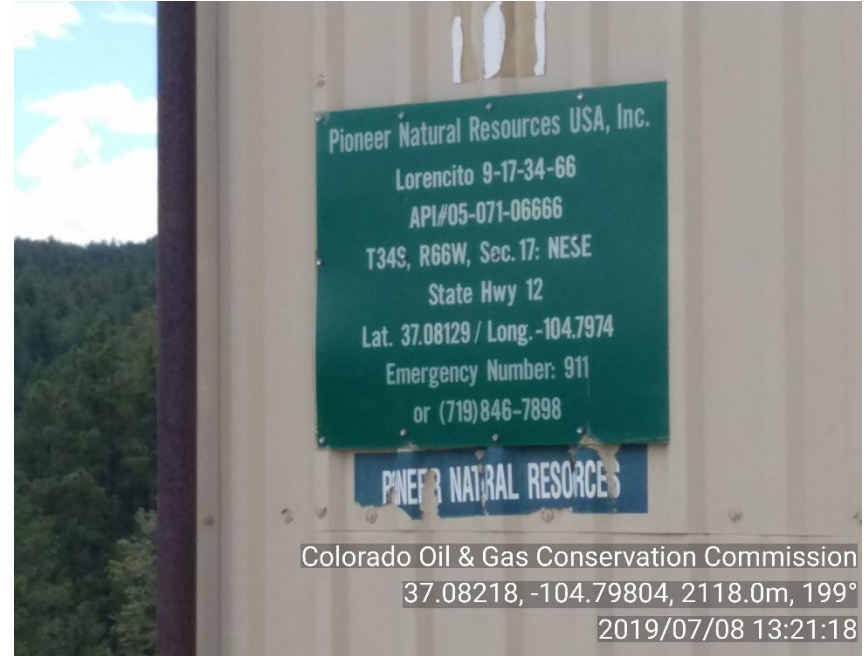
PHOTO 2: WELL SIGN

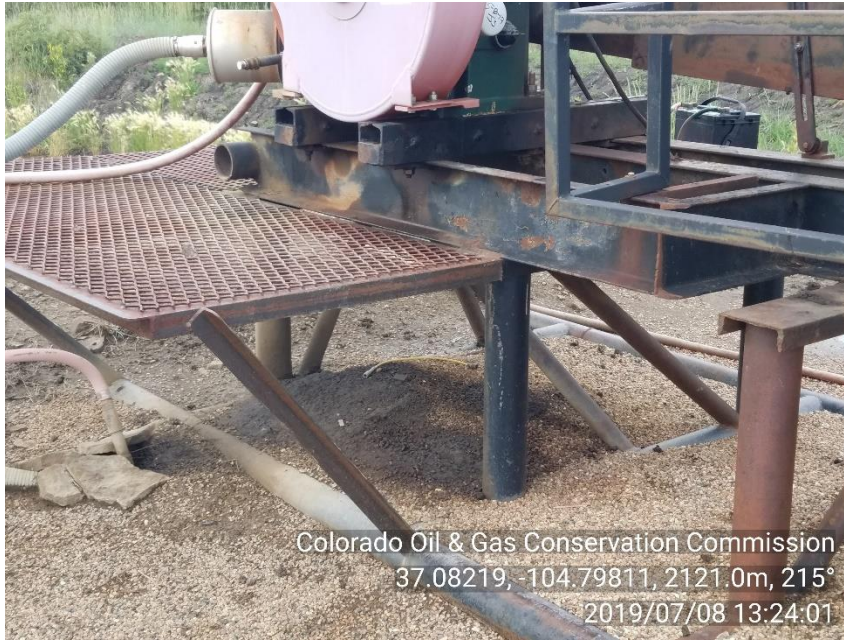
PHOTO 3: IMPACTED SOIL UNDER PUMPJACK PRIME MOVER. Remove and dispose impacted material in approved manner, service and maintain equipment and self inspect to prevent recurrence of conditions per 1002.f(2) and 907. CA DATE 8/8/19.

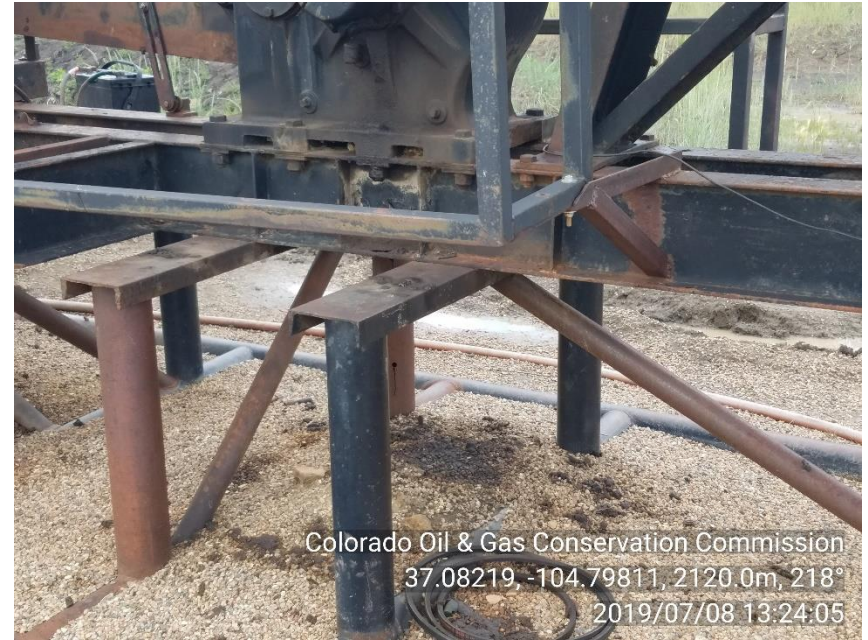
PHOTO 4: IMPACTED SOIL UNDER PUMPJACK GEAR BOX. Remove and dispose impacted material in approved manner, service and maintain equipment and self inspect to prevent recurrence of conditions per 1002.f(2) and 907. CA DATE 8/8/19.
