Inspection Photos

07/08/2019

Operator: BISON OIL & GAS II LLC # 10661

Location ID: 452871

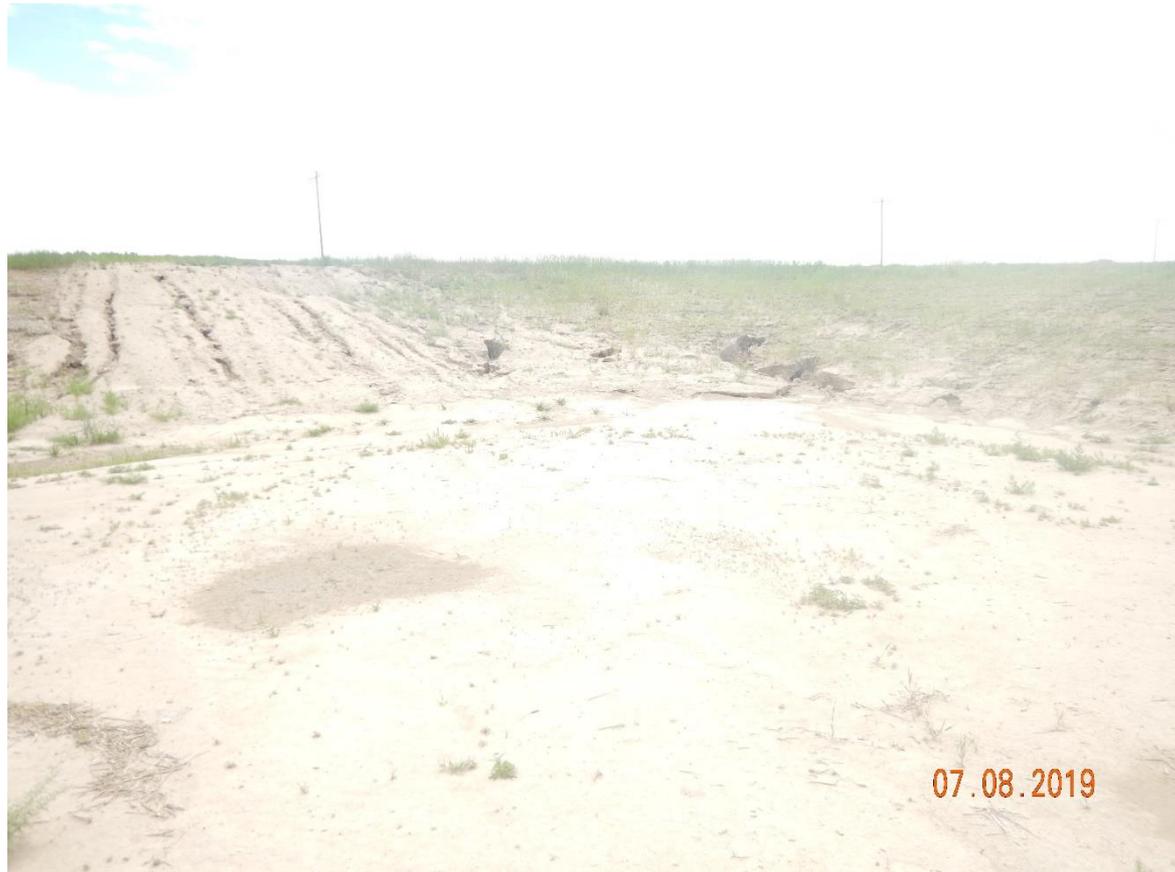
Photo 1: Photo taken from the southeast corner of the pad, facing southeast. Photo shows erosion degradation along slopes.

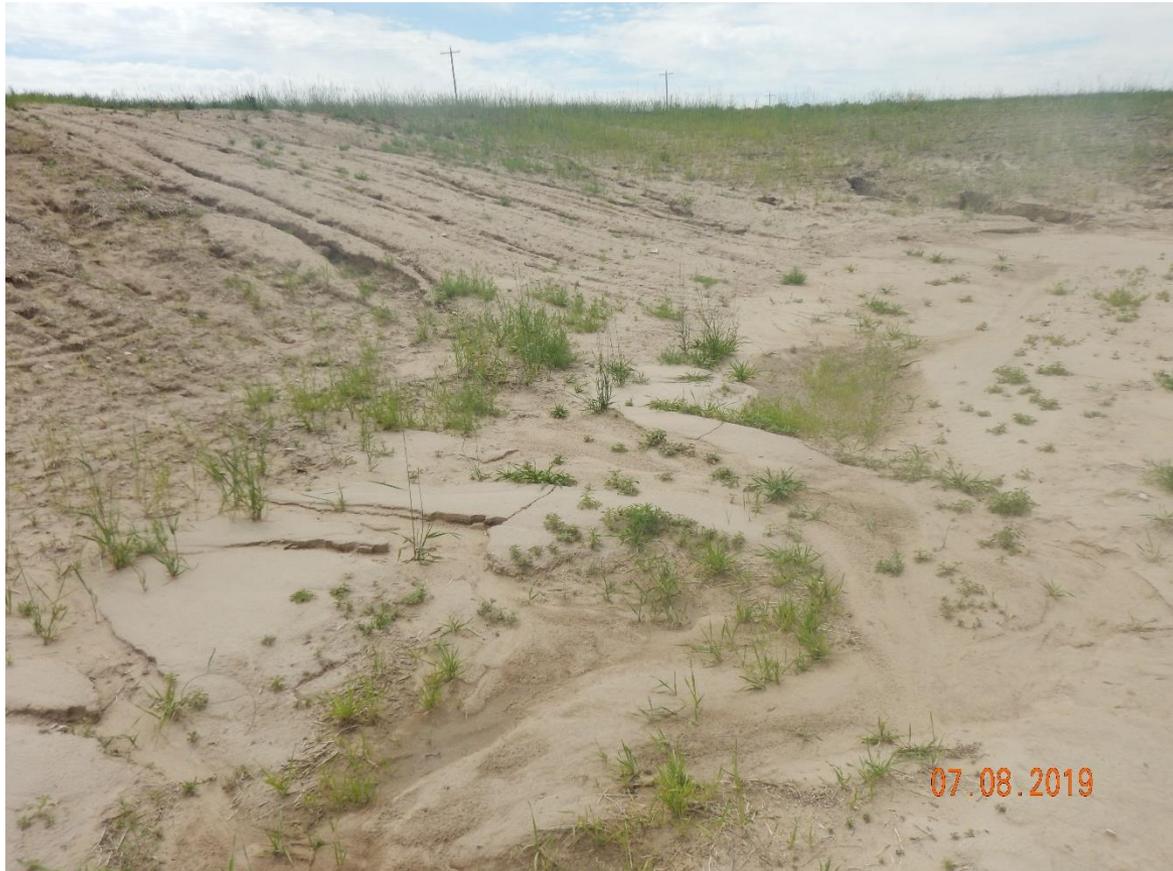
Photo 2: Continued from photo 1. Photo shows erosion degradation on slopes and sediment deposition has filled in the stormwater ditch.

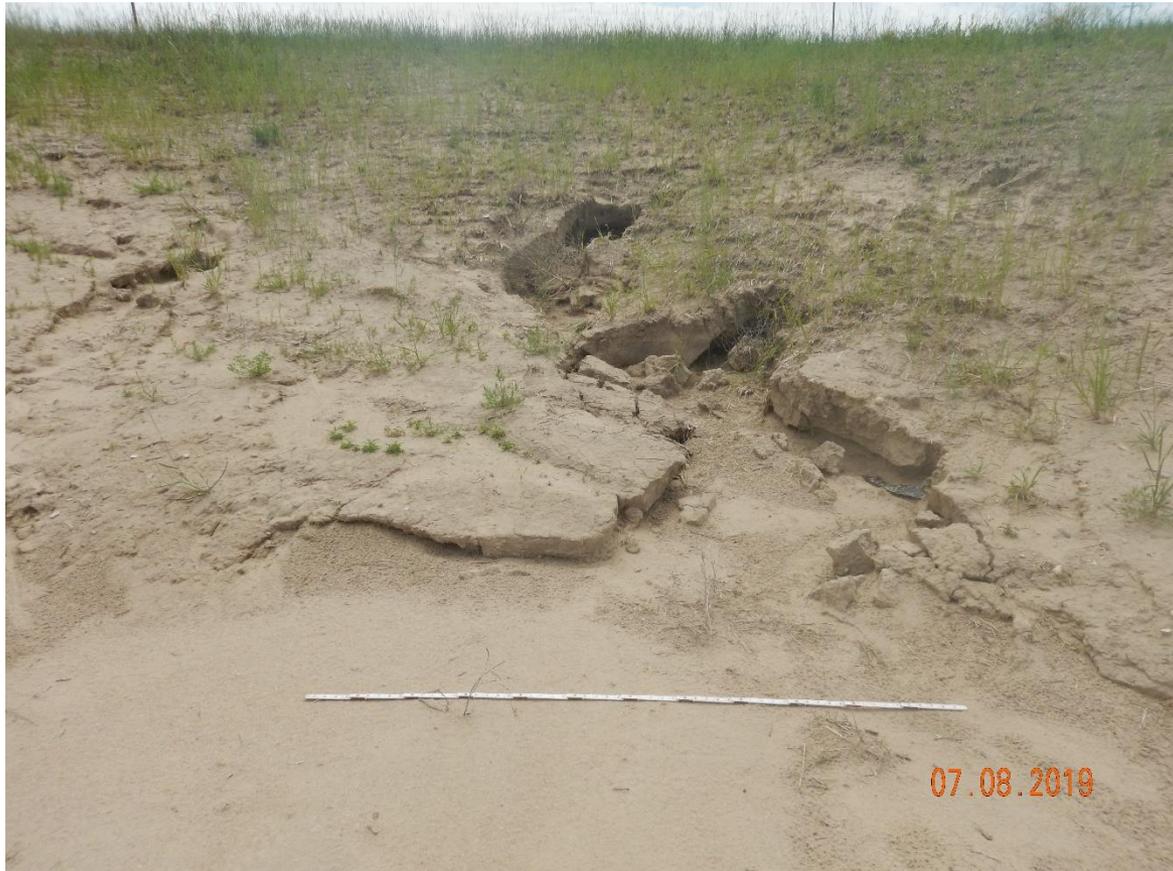
Photo 3: Continued from photo 1. Photo shows erosion degradation on slopes and sediment deposition has filled in the stormwater ditch. 6 foot measuring stick for reference.

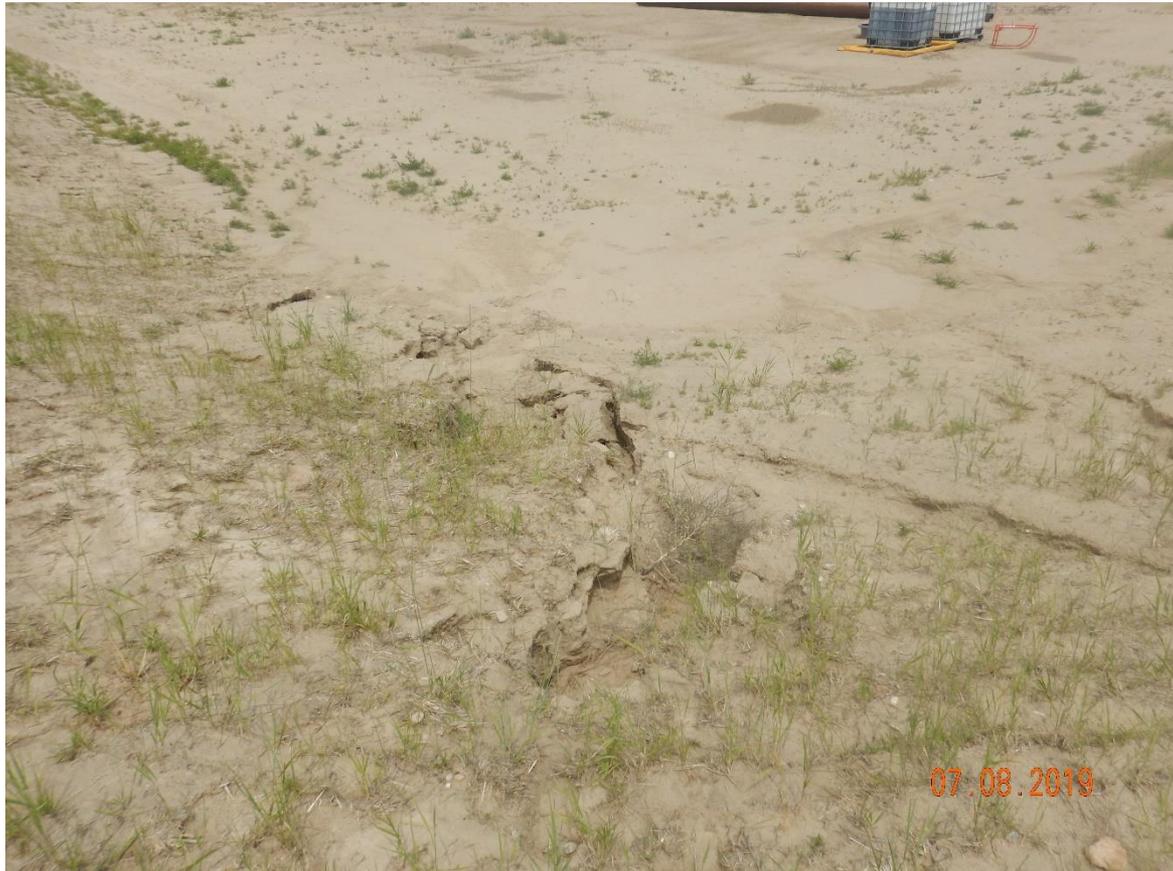
Photo 4: Photo taken from the southeast corner of the location, facing northwest. Photo shows erosion degradation on slopes and sediment deposition has filled in the stormwater ditch.

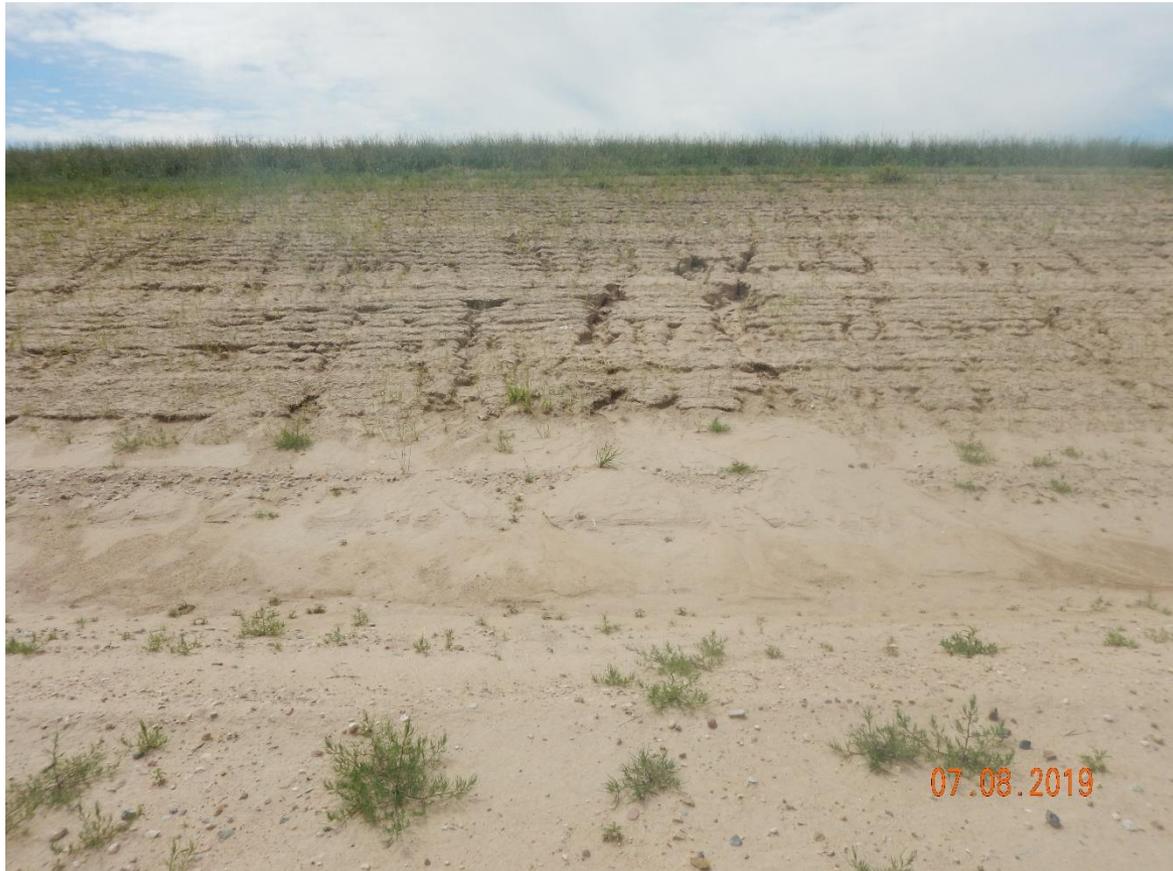
Photo 5: Erosion degradation on the slopes to the south.

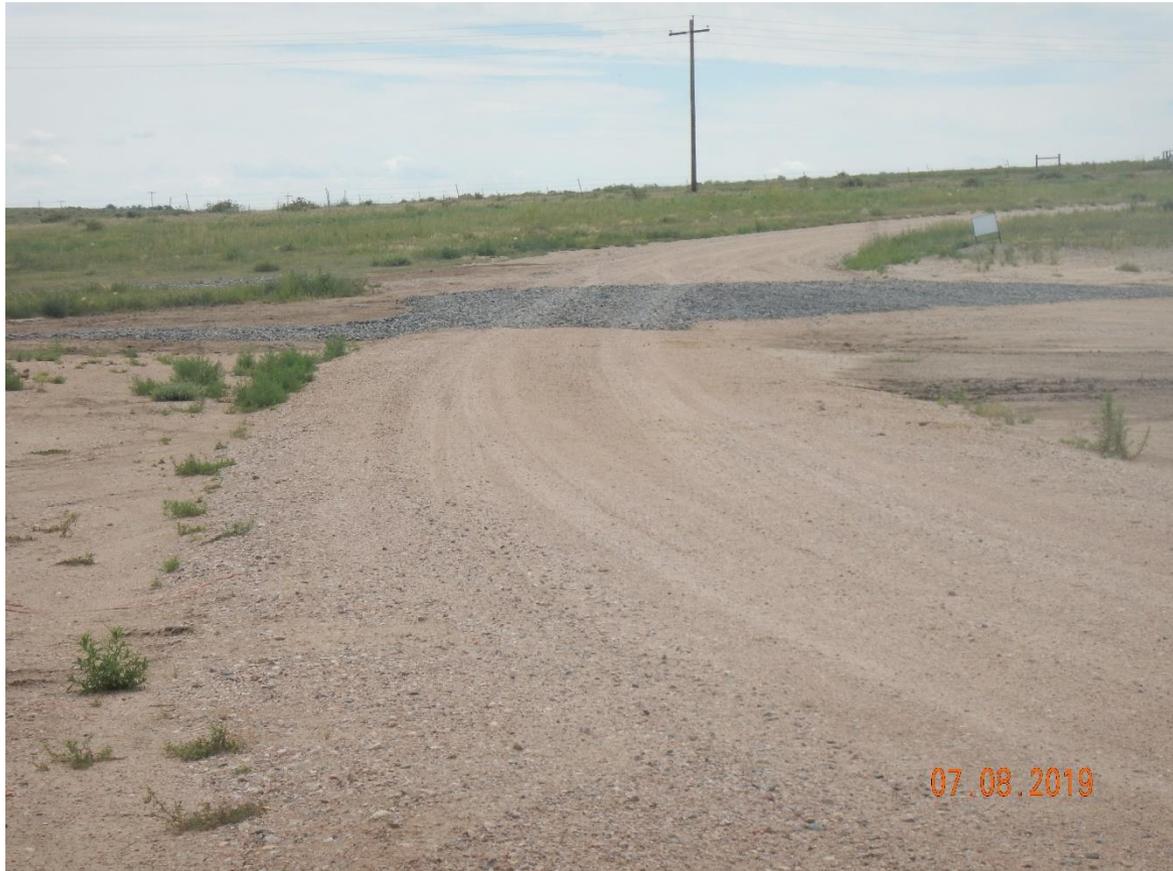
Photo 6: Tracking pad at location entrance.
