Inspection Photos

Location Name: LORENCITO 7-14-34-67

API#: 05-071-07656

INSP. #: 695100997

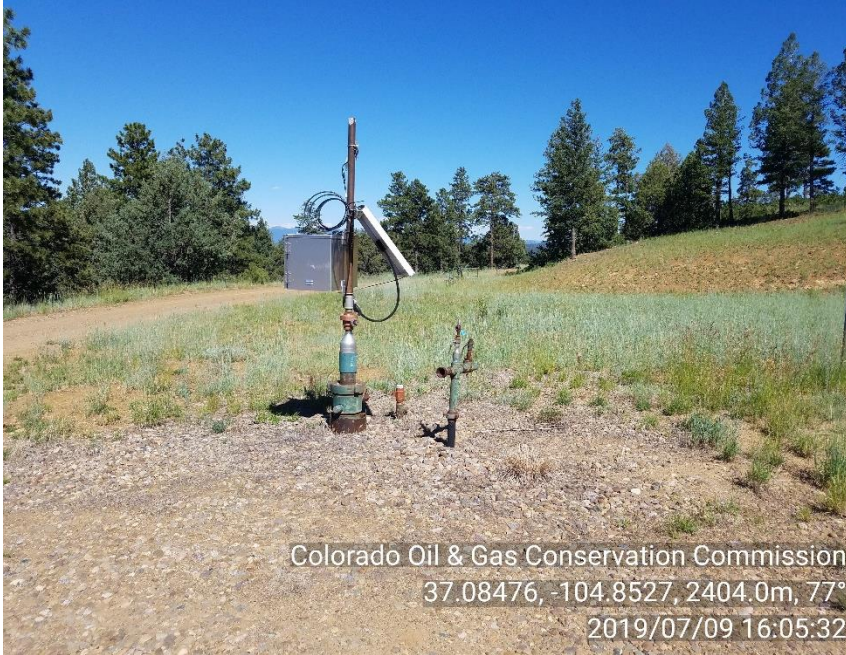
PHOTO 1: WELLHEAD/ UNUSED EQUIPMENT (TWO 2" AND ONE 1" RISER). REMOVE UNUSED RISER'S IN ACCORDANCE WITH NTO & RULE 603.f. CA DATE 10/9/19

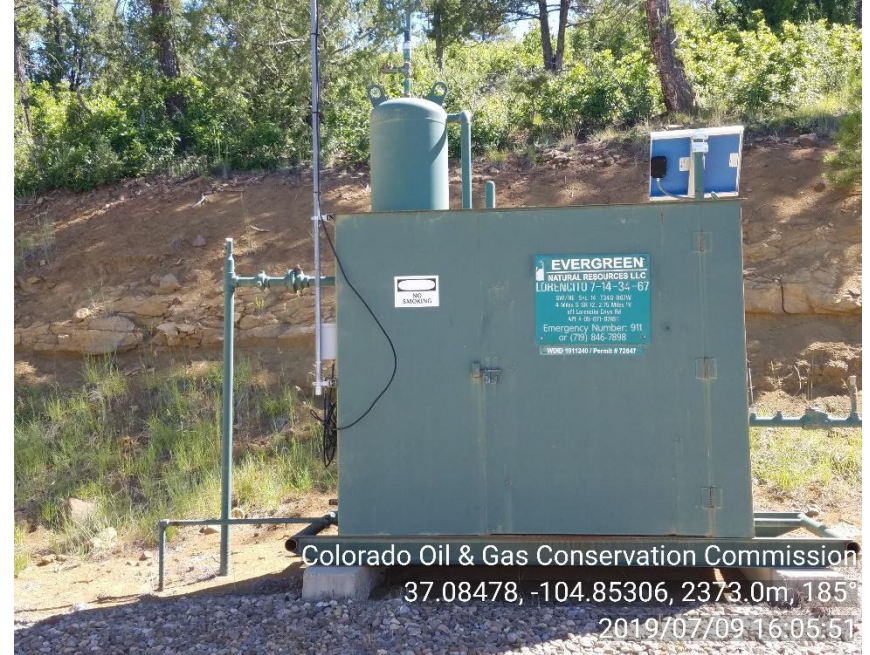
PHOTO 2: WELL SIGN
