Inspection Photos
Location Name: MOUNTAIN LION 11-18
API#: 05-071-06575
INSP. #: 695101009

Inspection Photos

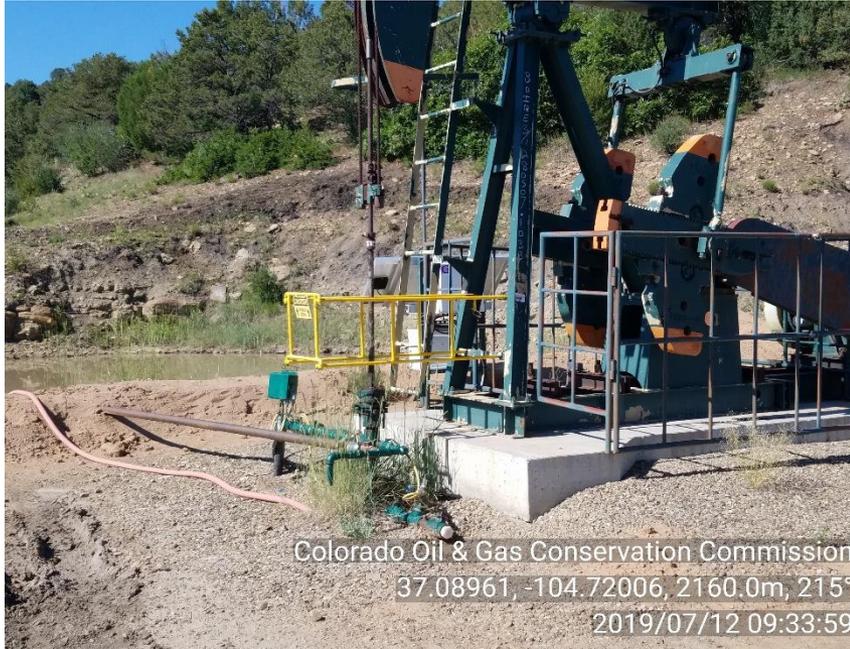
PHOTO 1: WELLHEAD

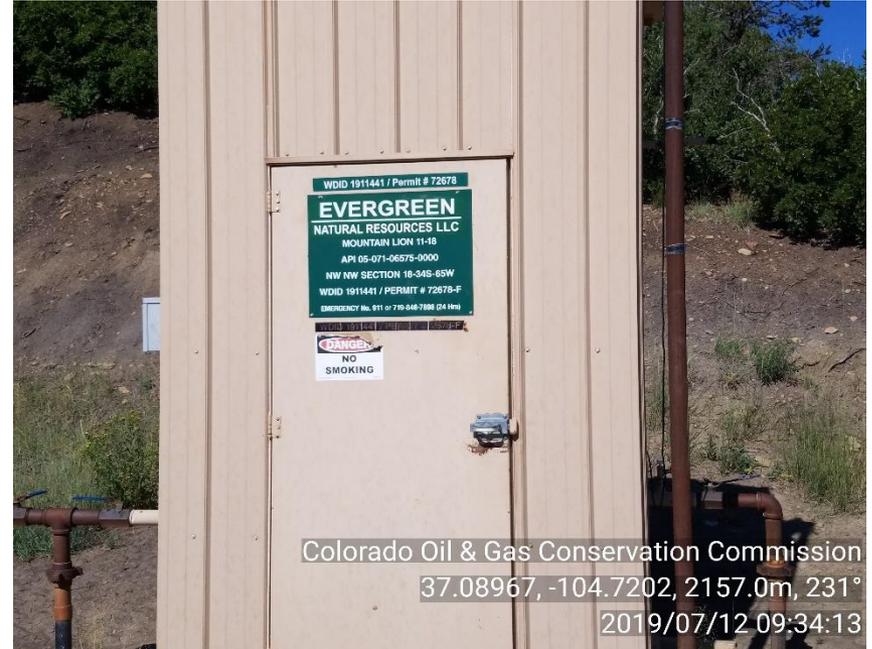
PHOTO 2: WELL SIGN

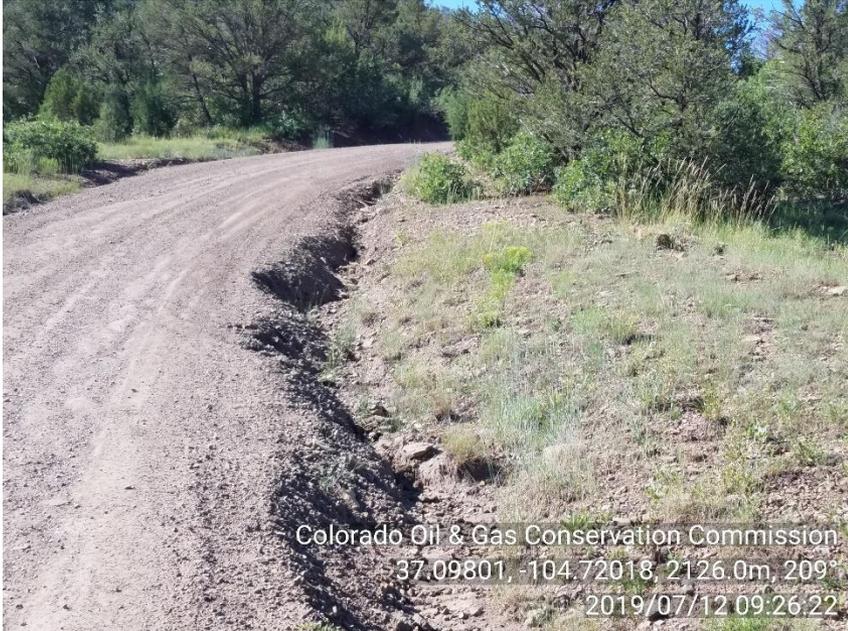
PHOTO 3: AREA OF EROSION ON WEST SIDE OF ROW NORTH OF LOCATION TOWARD THE BOTTOM OF THE HILL. REPAIR EROSION AND REPAIR OR INSTALL BMP'S TO PREVENT EROSION AND COMPLY WITH RULE 1002.f. CA DATE 8/12/19

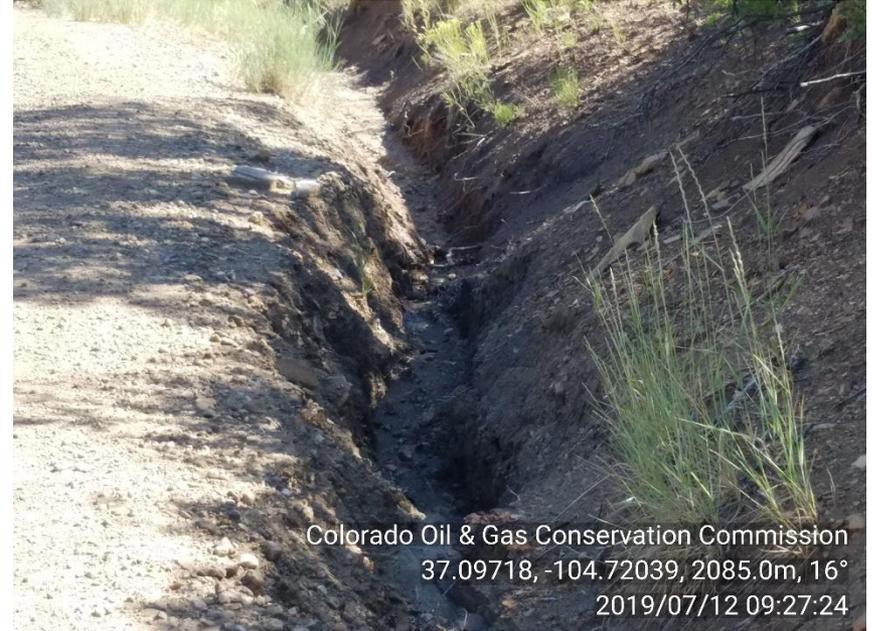
PHOTO 4: AREA OF EROSION ON EAST SIDE OF ROW NORTH OF LOCATION TOWARD THE BOTTOM OF THE HILL. REPAIR EROSION AND REPAIR OR INSTALL BMP'S TO PREVENT EROSION AND COMPLY WITH RULE 1002.f. CA DATE 8/12/19

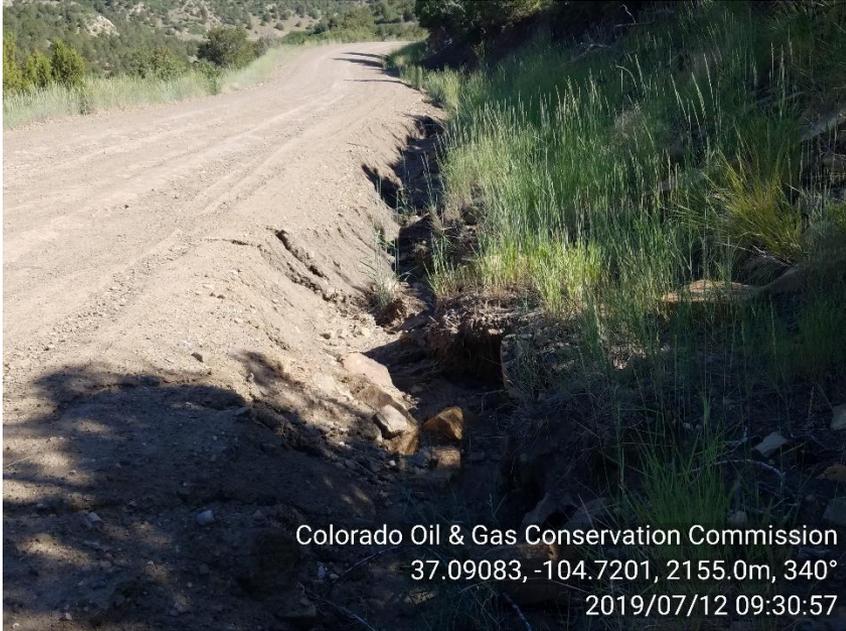
PHOTO 3: AREA OF EROSION ON EAST SIDE OF ROW APP. 200 YARDS NORTH OF LOCATION. REPAIR EROSION AND REPAIR OR INSTALL BMP'S TO PREVENT EROSION AND COMPLY WITH RULE 1002.f. CA DATE 8/12/19
