Inspection Photos
Location Name: DOE 42-12
API#: 05-071-06599
INSP. #: 695101050

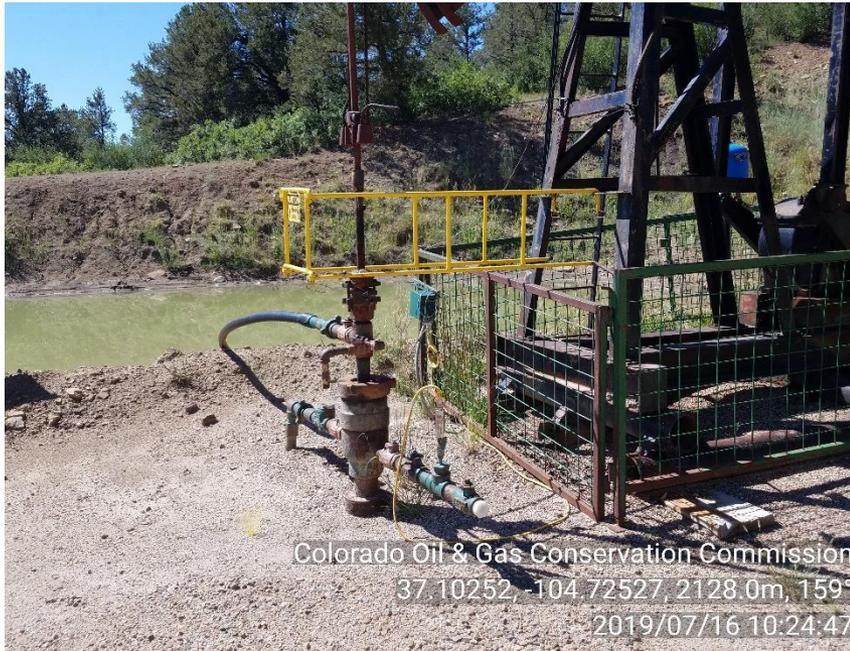
PHOTO 1: WELLHEAD

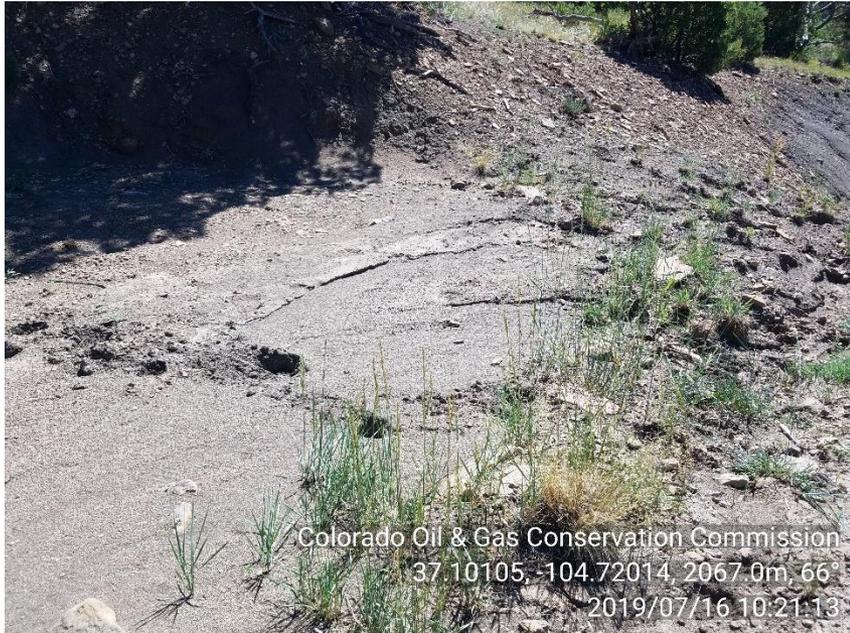
**PHOTO 3: CULVERT IS FULL OF SEDIMENT
ALLOWING STORMWATER TO ERODE BMP.**

**CLEAN CULVER, Install or repair required
BMPs per Rule 1002.f. CA DATE 8/16/19.**

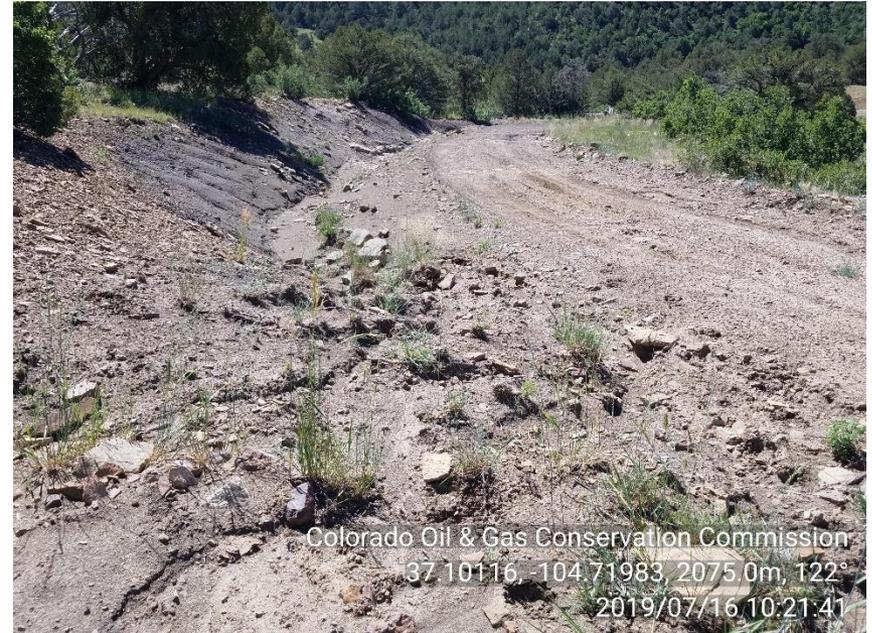
**PHOTO 4: ANOTHER IMAGE OF EROSION DOWN GRADE OF
BURIED CULVERT**

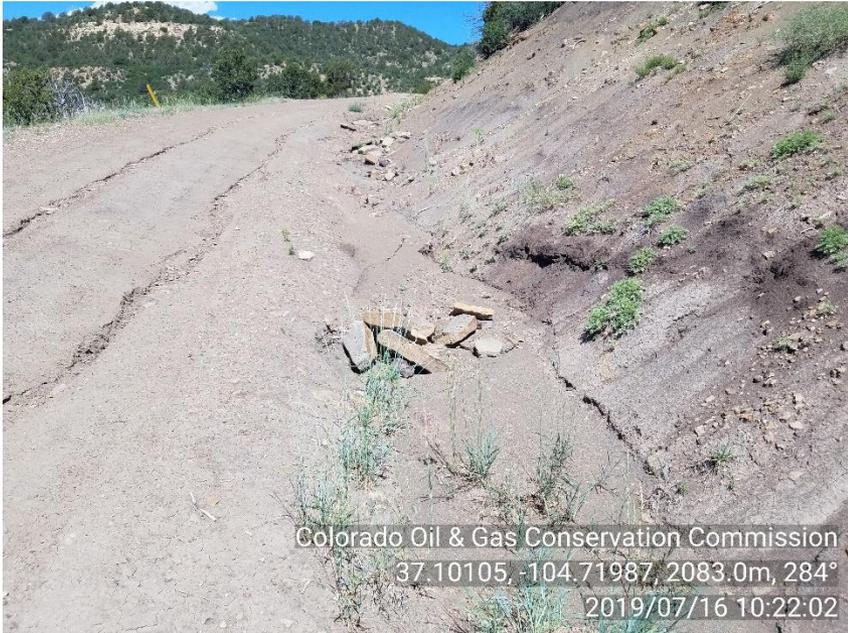
**PHOTO 5: BMP'S HAVE FAILED UP GRADE OF
BURIED CULVERT. *Install or repair required*
*BMPs per Rule 1002.f. CA DATE 8/16/19.***
